# Feasibility Report

## Middle Riley Creek Stabilization

Prepared for  
Riley Purgatory Bluff Creek Watershed District

March, 2020

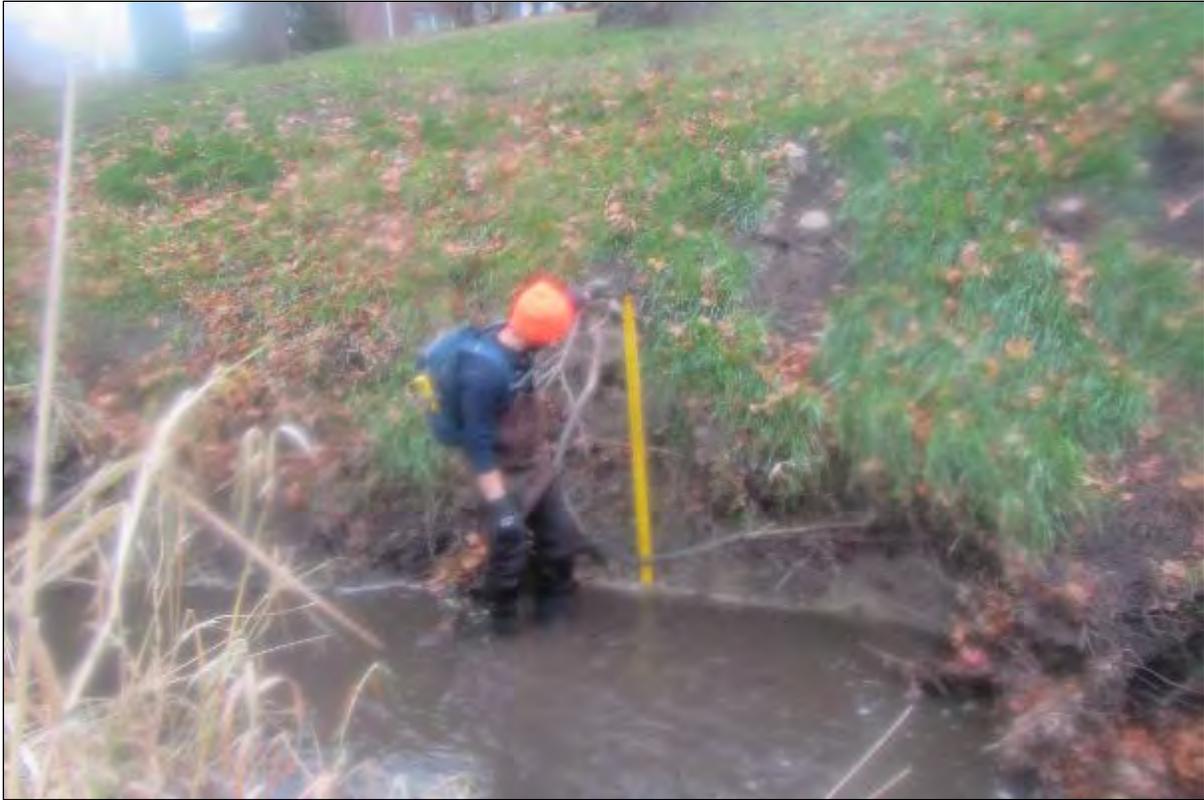
**Figure 5-3 Stream along golf course near Hole 16 green (between Bearpath Trail and Riley Lake Road)**

Based on the existing conditions analyses, the risk of a deep-seated failure at this site appears to be low. However, the drained conditions model suggests that the factor of safety against a shallow surface slide is less than 1.0. This result corresponds with field observations of surface erosion/sloughing along the face of the Hole 16 green slope. Stabilization options that focus on protecting surface soils at the site from shallow surface erosion and water flow should be used. Discussion of potential stabilization options is presented in Sections 8.2.1 and 8.2.2.

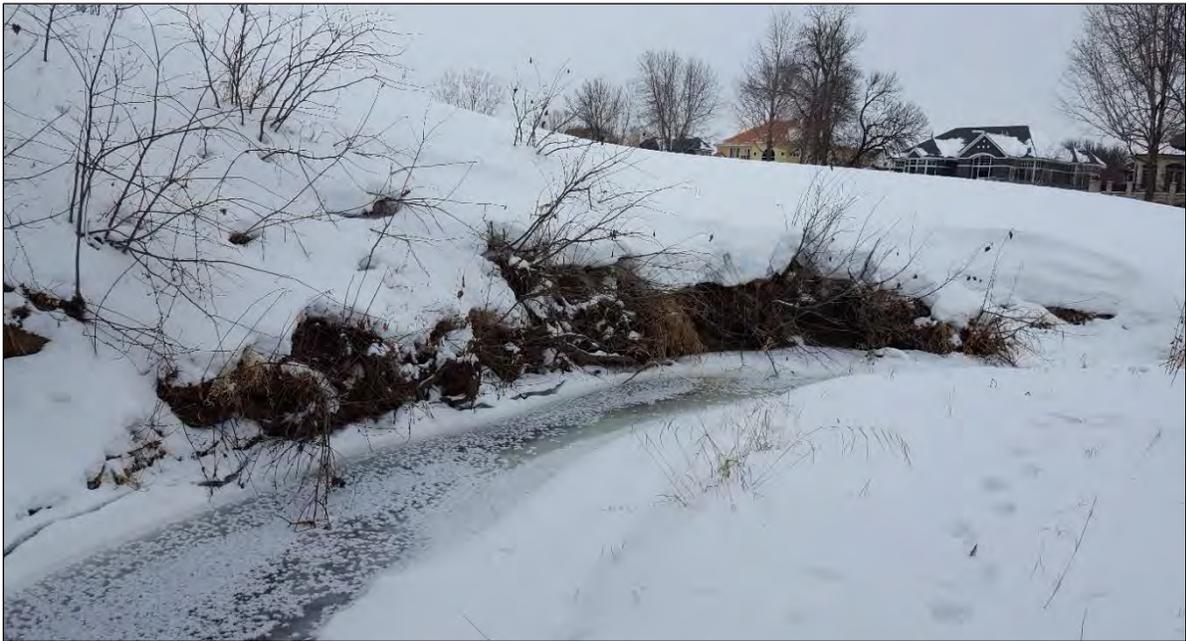
**Figure 5-4 Erosion upstream of crossing with Lake Riley Road**

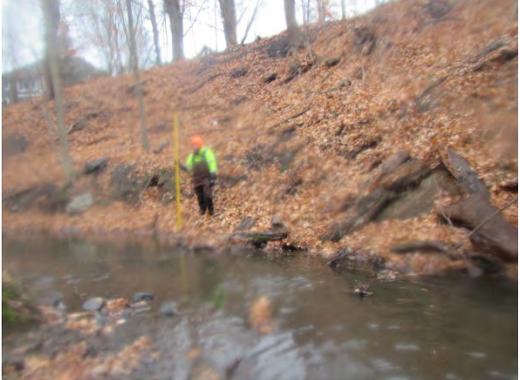
Towards the beginning of the subreach, staff observed some erosion measuring up to 5ft high by 30ft along the right bank (IMG\_2157). There were boulders in and along the channel throughout the start of the subreach (IMG\_2157). The substrate was primarily composed of gravel and sand, with some silt occurring in the few pooling areas, and some cobble present within the riffles. Just downstream there was another stretch of erosion along the right bank, measuring 4ft high by 20ft (IMG\_2158). Staff continued to see woody debris in-stream, including a small woody debris dam (IMG\_2159). At this point there was some more erosion along the left bank measuring 3.5ft high (IMG\_2159, IMG\_2160). Continuing downstream, staff observed a stretch of cutting measuring 0.25ft high which was continuous along the right bank (IMG\_2161). However, due to the presence of moss, the right bank was stable, despite the continuous cut bank. The stream then came up to a culvert under a driveway along the outside bend of the left bank as it shifted south (IMG\_2162). The culvert was nearly full of sediment and the immediate sediment as seen in IMG\_2163 was extremely soft muck/silt. The stream channel then shifted south and there was yet another stretch of erosion along the left bank, 3ft high by 30ft (IMG\_2163). A considerable amount of sandy/silt deposition can also be seen in IMG\_2163 on the opposing right bank. The stream at this point was 0.94ft deep by 11ft wide. At the start of the Bearpath golf course, staff encountered another woody debris dam (IMG\_2165) which was causing some erosion measuring 3ft high by 10ft along the left bank. The golf course was adjacent to the left bank at this point; the grass was mowed to the stream edge (IMG\_2165). Staff observed one final patch of erosion on the right bank before entering the next subreach (IMG\_2166). The stream at this point measured 1.24ft deep by 6.4ft wide.

<p><b>IMG_2157</b></p> <p>Erosion, 5ft by 30ft, RB.</p>

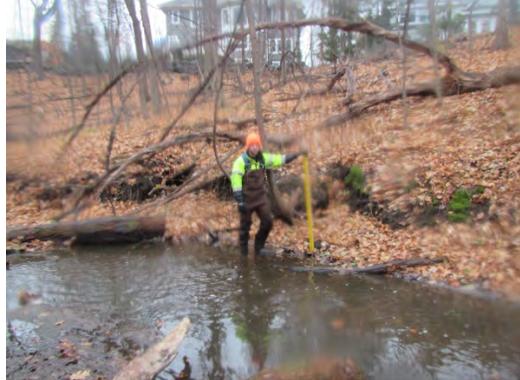
<p><b>IMG_2158</b></p> <p>Erosion, 4ft by 20ft, RB.</p>

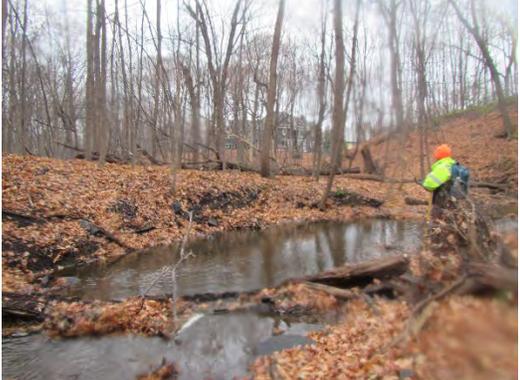
<p><b>IMG_2159</b></p> <p>Woody debris dam; bank erosion, LB.</p>

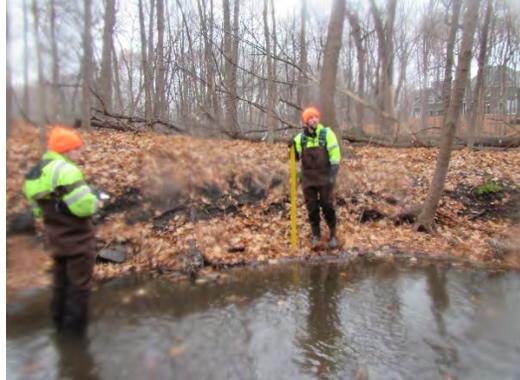
<p><b>IMG_2160</b></p> <p>Erosion, 3.5ft high, LB.</p>

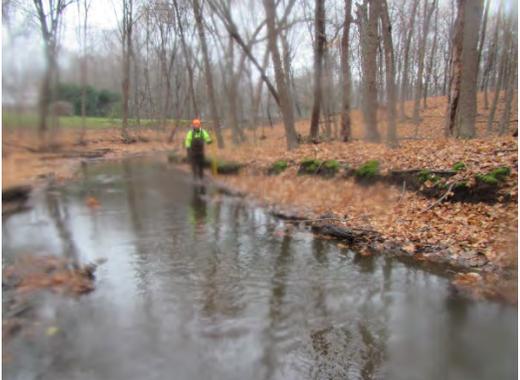
<p><b>IMG_2161</b></p> <p>General erosion, 0.25ft high, RB; moss on banks.</p>

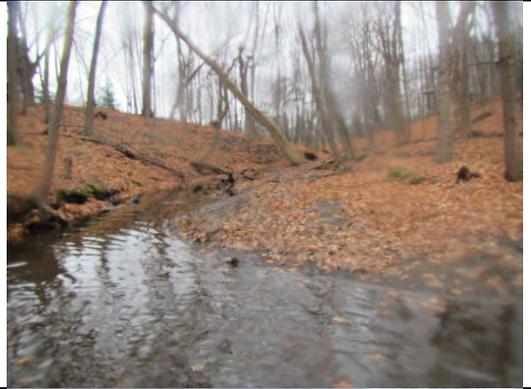
<p><b>IMG_2163</b></p> <p>General stream picture; erosion measuring 3ft high by 30ft, LB.</p>

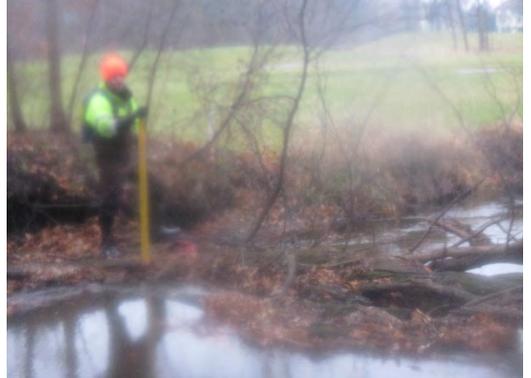
<p><b>IMG_2165</b></p> <p>Woody debris dam causing erosion, 3ft by 10ft, LB.</p>

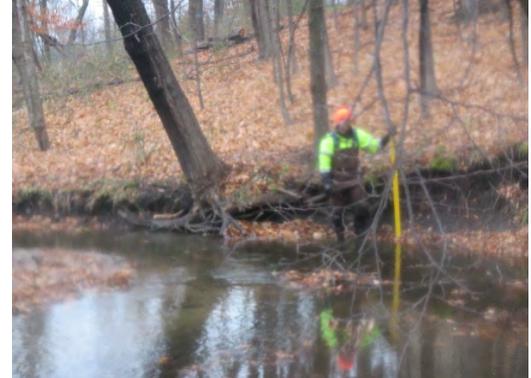
<p><b>IMG_2166</b></p> <p>Erosion near end of subreach, RB.</p>

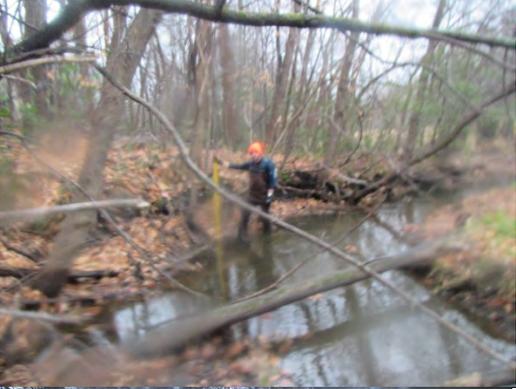
<p><b>IMG_2181</b></p> <p>Erosion on LB, 2ft high by 100ft.</p>

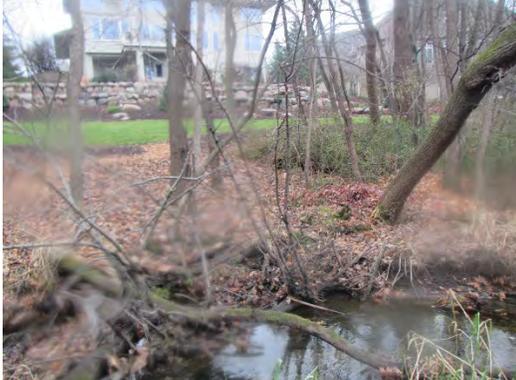
<p><b>IMG_2182</b></p> <p>Yard waste dump site, LB.</p>

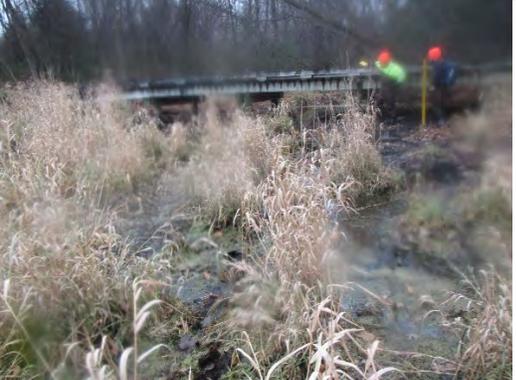
<p><b>IMG_2183</b></p> <p>Walking/cart bridge across stream; mucky sediment; end of subreach.</p>

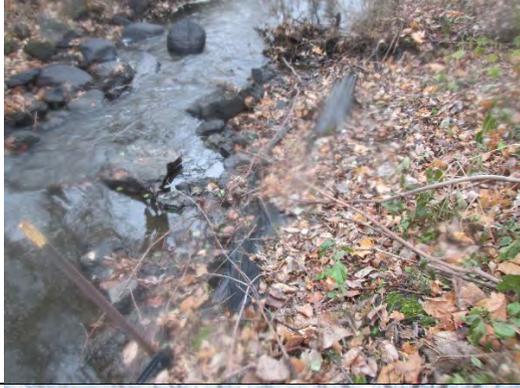
<p><b>IMG_2187</b></p> <p>Boulder riffle; exposed erosion blanket, RB.</p>

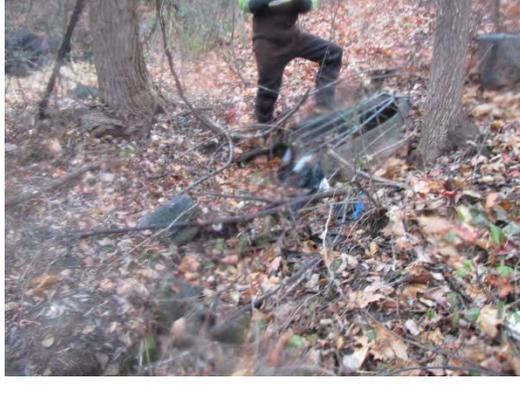
<p><b>IMG_2188</b></p> <p>Stormwater culvert causing minor erosion, RB.</p>

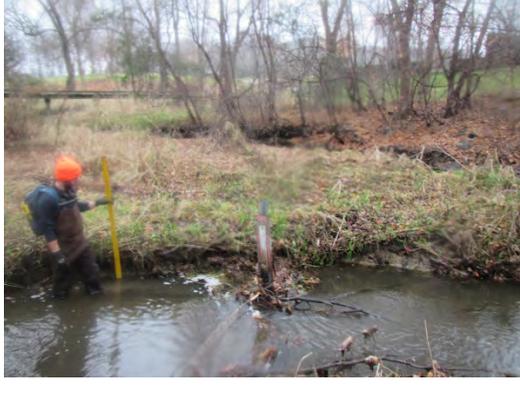
<p><b>IMG_2189</b></p> <p>Erosion along left bank, 1ft by 50ft.</p>

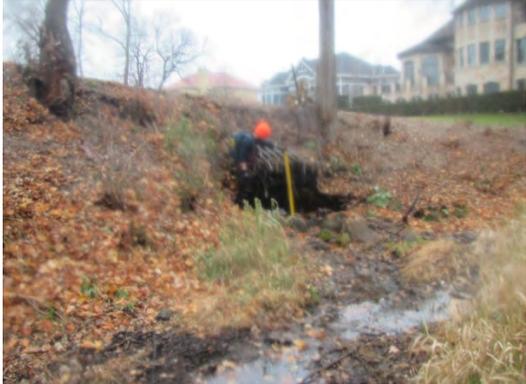
<p><b>IMG_2191</b></p> <p>Stormwater culvert suspended 3ft and undercut 3.5ft, RB, US.</p>

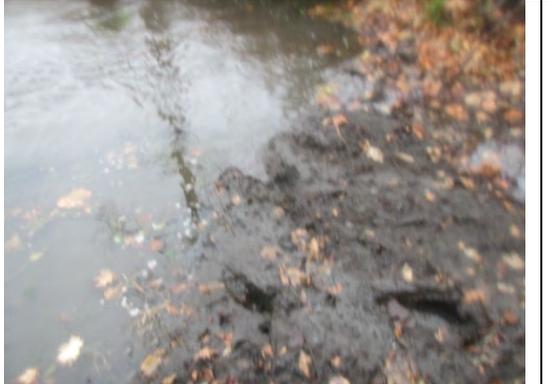
<p><b>IMG_2192</b></p> <p>Silt deposition DS of culvert.</p>
--	--	--	--

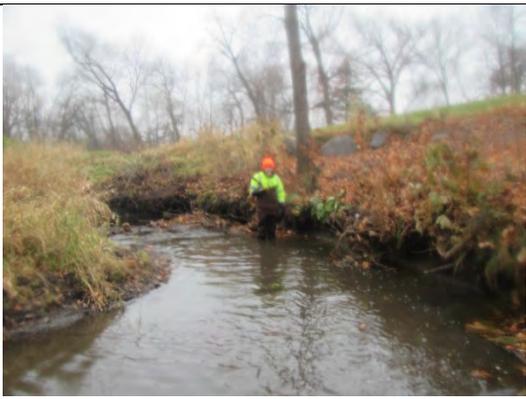
<p><b>IMG_2193</b></p> <p>Erosion 3ft high by 100ft, RB.</p>

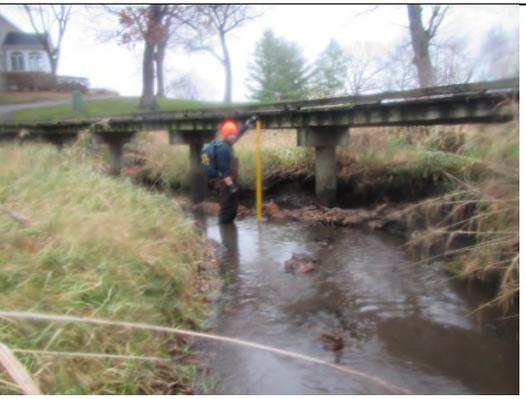
<p><b>IMG_2194</b></p> <p>Walking bridge/cart path; erosion, RB.</p>

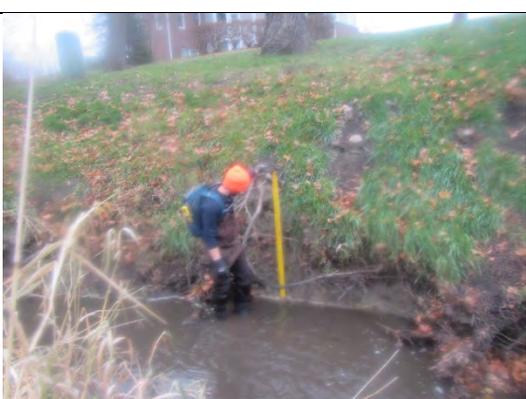
<p><b>IMG_2195</b></p> <p>Erosion 2ft high by 20ft, LB; grass mowed to channel.</p>

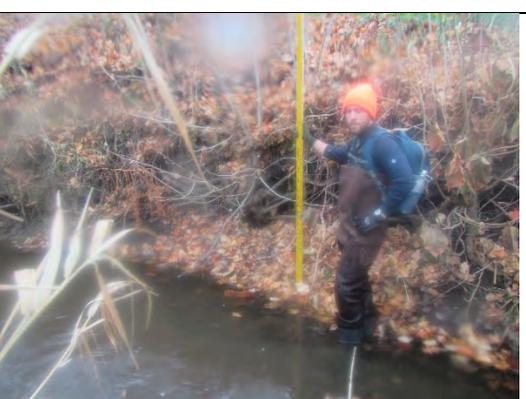
<p><b>IMG_2196</b></p> <p>Erosion 4.5ft by 40ft, LB.</p>

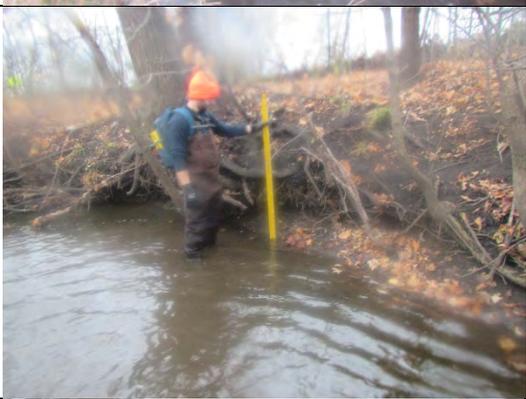
<p><b>IMG_2197</b></p> <p>Erosion 2.5ft by 30ft, RB.</p>

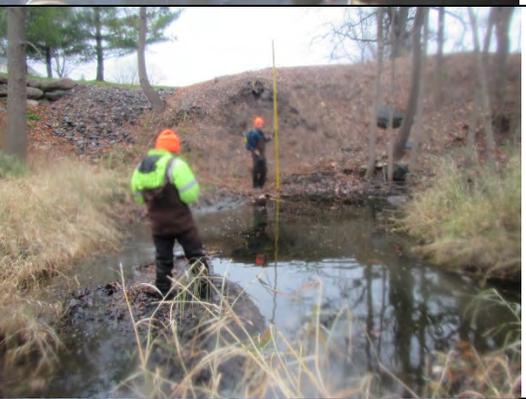
<p><b>IMG_2198</b></p> <p>Silt deposition and bare banks, LB.</p>
