Creek Restoration Action Strategy – Upper Riley Creek Sediment Source Assessment

Chanhassen, MN

Prepared for
Riley Purgatory Bluff Creek Watershed District

April 2017

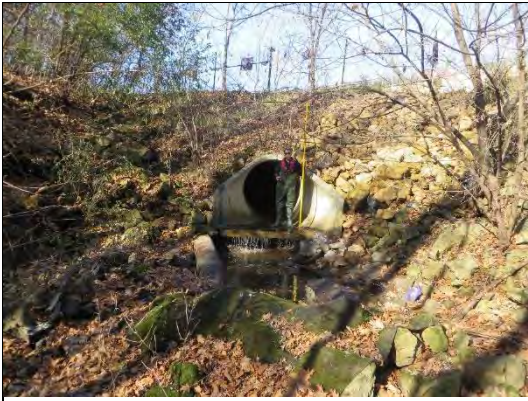
IMG-0183
Culvert under
under
Highway 5,
photo taken
facing
upstream

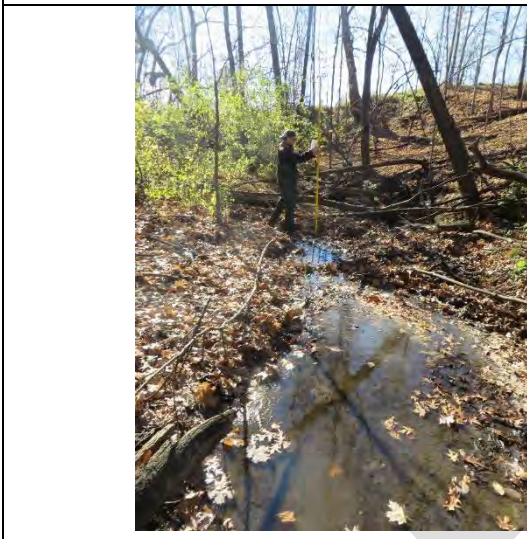
IMG-0193
Debris dam

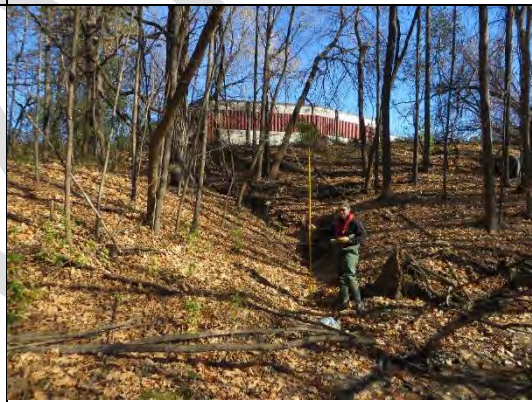
IMG-0195
Eroded ravine caused by uphill business drainage on left bank

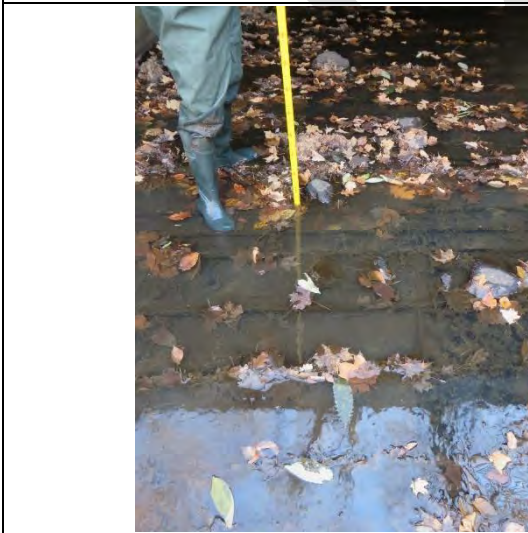
IMG-0237
Exposed rebar inside culvert

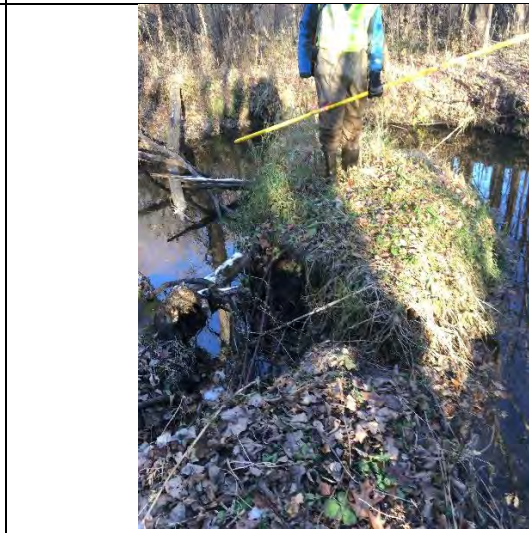
IMG-0312
Channel trying to cut through horseshoe curve, right bank

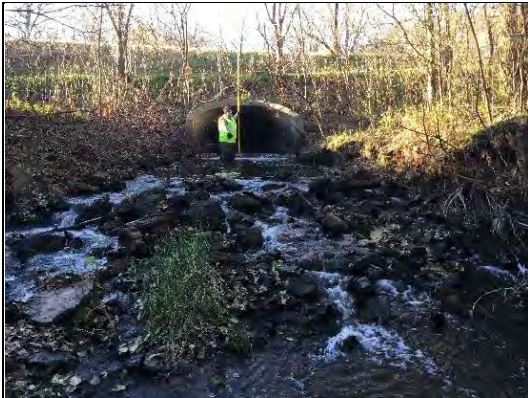
IMG-0316

Photo of culvert under Powers Blvd and artificial riffle (facing upstream)

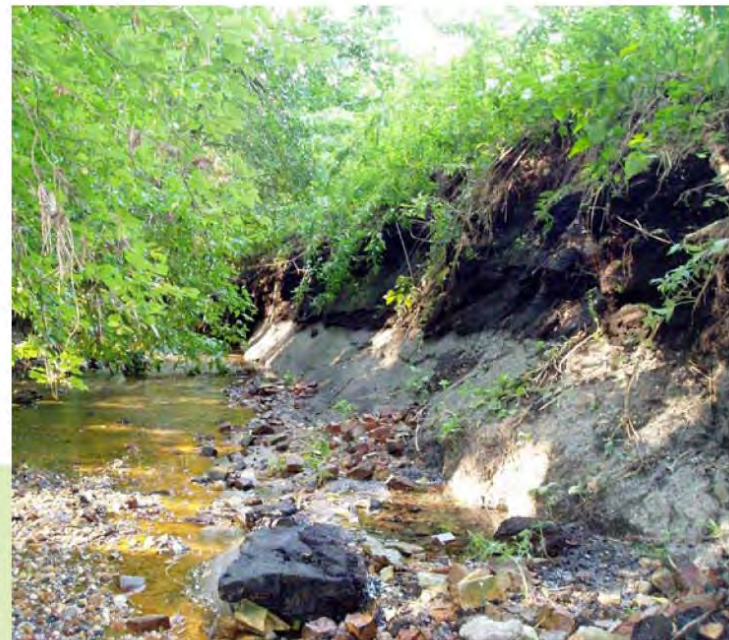
Fluvial bank erosion is caused by water in the stream moving past the streambanks. The shear stress caused by the flow entrains soil particles into the flow, causing the stream bank to erode away. This is the most common type of erosion that occurs in streams. Virtually all streams experience this type of erosion as their flow path evolves over time. However, the rate of fluvial bank erosion can increase when the stream is out of equilibrium with its watershed. Increased flow from a watershed will increase the rate of fluvial bank erosion. In many cases, it appears to be a part of the natural process of stream evolution. In places where the channel is confined by the valley walls, however, fluvial bank erosion can lead to failure of the high banks. It can also undermine storm sewer inlets.

Stone Toe Protection is constructed from cobble-sized rock on the creek edges. It extends to approximately the bankfull level, which will protect the channel banks for flow events that occur every 1 to 2 years or less. The material will extend into the ground to resist scour. Coarse gravel is used to separate the larger rock material from underlying soil. Stone toe protection is typically used in conjunction with revegetation of the upper banks.

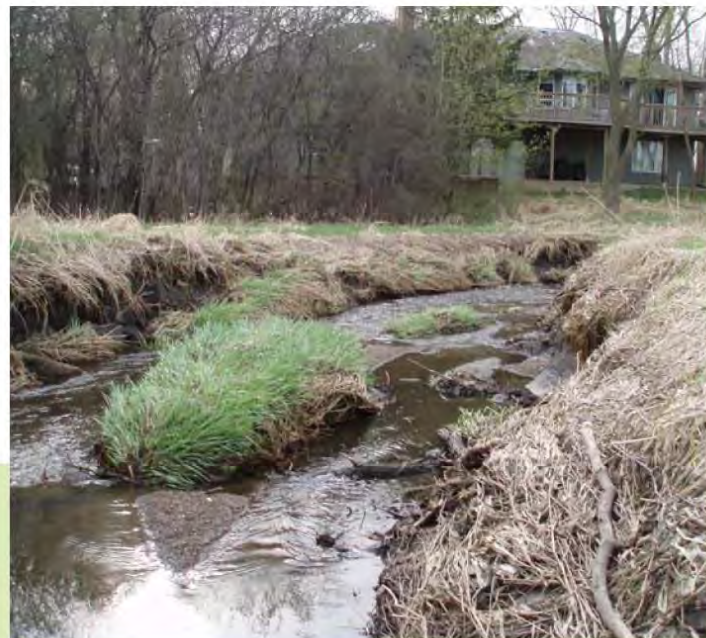
Fluvial bank erosion is caused by water in the stream moving past the streambanks. The shear stress caused by the flow entrains soil particles into the flow, causing the stream bank to erode away. This is the most common type of erosion that occurs in streams. Virtually all streams experience this type of erosion as their flow path evolves over time. However, the rate of fluvial bank erosion can increase when the stream is out of equilibrium with its watershed. Increased flow from a watershed will increase the rate of fluvial bank erosion. In places where the channel is confined by the valley walls, however, fluvial bank erosion can lead to failure of the high banks. It can also undermine storm sewer inlets.

Rock vanes are constructed from boulders on the creek bottom. They function by diverting channel flow toward the center and away from the bank. They are typically oriented in the upstream direction and occupy no more than one third of the channel width. Vanes are largely submerged and inconspicuous. The rocks are chosen such that they will be large enough to resist movement during flood flows or by vandalism, with additional smaller rock material to add stability. Rock vanes function in much the same way as root wads in that they push the stream thalweg (zone of highest velocity) away from the outside bend. They also promote sedimentation behind the vane, which adds to the toe protection.

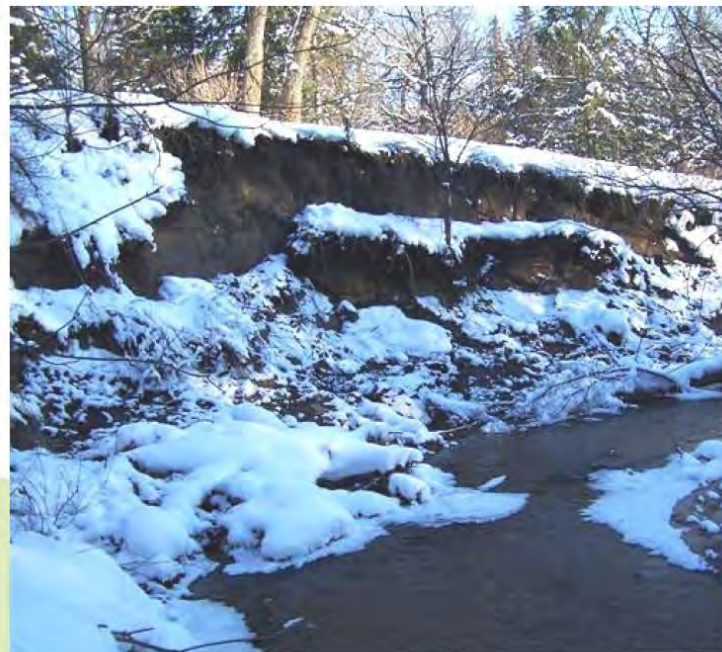
Fluvial bank erosion is caused by water in the stream moving past the streambanks. The shear stress caused by the flow entrains soil particles into the flow, causing the stream bank to erode away. This is the most common type of erosion that occurs in streams.

Virtually all streams experience this type of erosion as their flow path evolves over time. However, the rate of fluvial bank erosion can increase when the stream is out of equilibrium with its watershed. Increased flow from a watershed will increase the rate of fluvial bank erosion.

In places where the channel is confined by the steep valley walls, however, fluvial bank erosion can lead to failure of the high banks. It can also undermine storm sewer inlets. For sites where groundwater seepage is a problem and where it is desirable to maintain steep banks, soil pillows are a feasible solution.

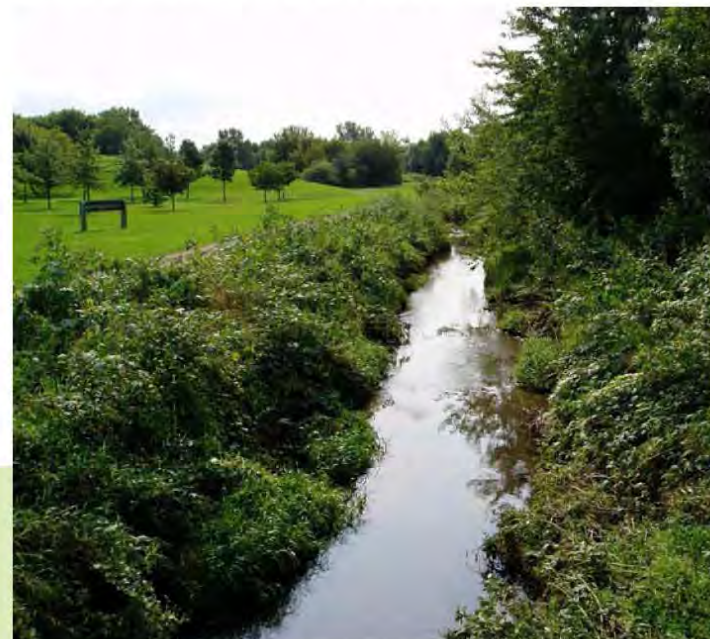
Channel incision occurs when there is an imbalance between the sediment supply and the sediment carrying capacity of the stream. Erosion will occur when the sediment carrying capacity of a stream exceeds the sediment supply. In streams with cohesive banks and steep channel slope, the erosion will first occur primarily on the channel bottom because that is where the erosive forces are the strongest. As the channel deepens, the stream will gradually become wider as the banks eventually fail. The stream will gradually return to equilibrium; however, the process can take many years and significant amounts of erosion will occur during the process.

Grade control measures are used where channel downcutting has occurred. Various types of weirs are commonly used to provide grade control on streams, particularly in steeper systems. Weirs can be constructed of sheetpile, concrete, or natural materials such as rock. In most cases, natural rock is used to emulate natural riffles. Large boulders would comprise the core of the structure, with smaller rock material placed on the upstream and downstream sides of the boulders to provide a gradual transition to the channel.

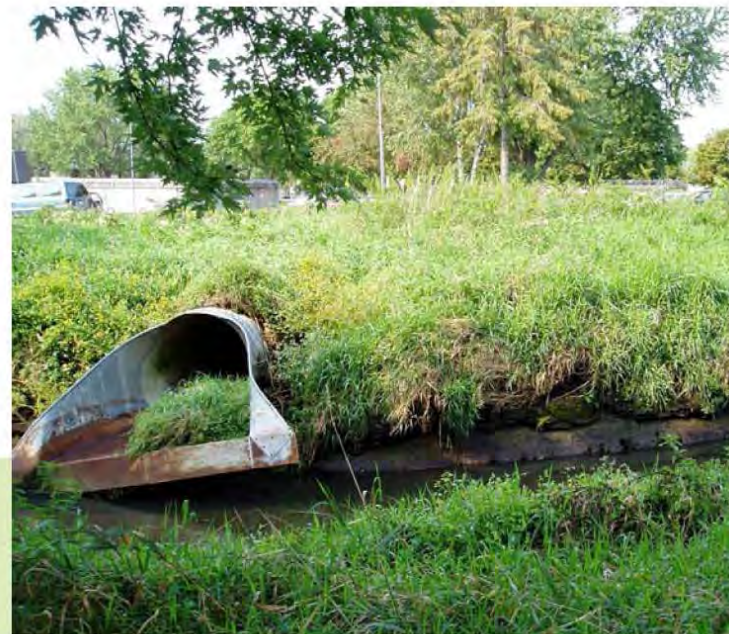
Erosion is frequently observed at culvert outlets for a variety of reasons, including insufficient erosion protection at the culvert outlet, streambank erosion, and channel downcutting, which leaves the culvert perched above the channel. Filter fabric is often used at culvert outlets to separate riprap protection from underlying soils, however the fabric provides a slippery surface for the riprap, which commonly slides into the channel.

Culvert Stabilization is somewhat unique to each situation, depending on the site circumstances. Most sites require additional rock placement with a granular filter layer (rather than filter fabric). Some cases may require re-alignment and/or lowering of the outlet to better align with the stream channel. Typically, outlets should be aligned in the downstream channel direction so that flow doesn't impinge on the opposite bank. It is usually desirable for the culvert to enter the stream at or just above the normal water level in order to minimize the potential for undercutting.
