2023 Water Resources Report

Josh Maxwell, *Water Resources & Fisheries Manager*
Andrew Hartmann, *Water Resources Technician*

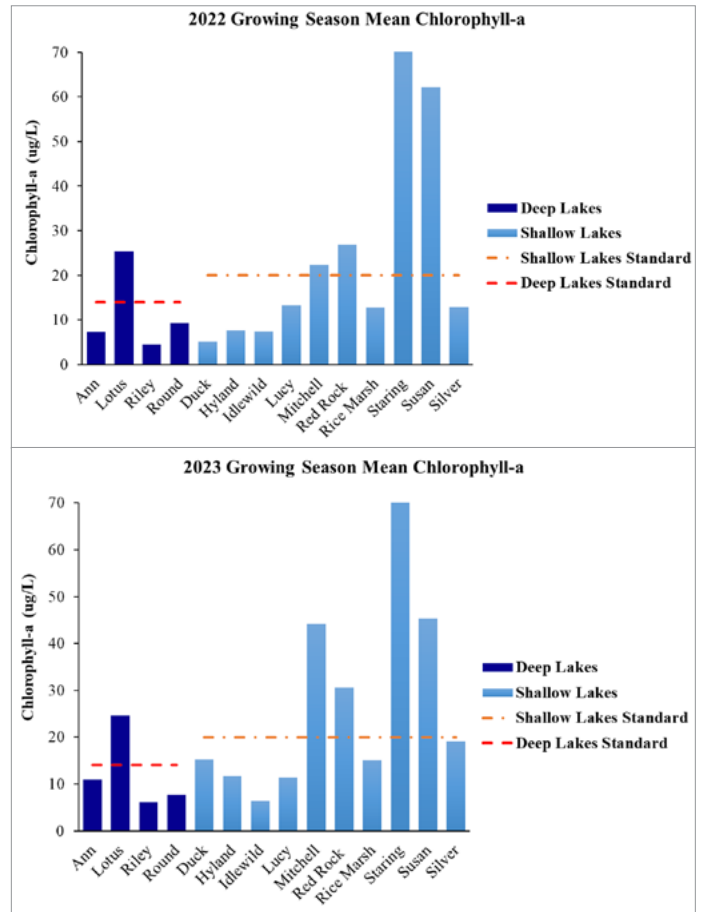
Lakes growing season (June-September) mean chlorophyll-a concentrations ($\mu\text{g/L}$) for shallow (lakes <15 ft. deep, >80% littoral area-light blue bars) and deep lakes (lakes >15 ft. deep, <80% littoral area-dark blue bars) in the Riley Purgatory Bluff Creek Watershed District during 2021 and 2022. The dashed lines represent the Minnesota Pollution Control Agency water quality standards for Chlorophyll-a for shallow (<20 $\mu\text{g/L}$ -orange dashed line) and deep lakes (<14 $\mu\text{g/L}$ -red dashed line).

treatment, Lake Riley had the lowest summer Chl-a average of all lakes sampled in 2023 at 6.1 ug/L. (4.5 ug/L in 2022, 2.3 ug/L in 2021, and 2.8 ug/l in 2020). Similarly, Round Lake has also met the standard since the first alum treatment in 2012. Lotus Lake did not meet the standard in 2023 and had Chl-a average concentrations at 24.6 ug/L (consistent with 25.4 in 2022 and 25.3 in 2021).

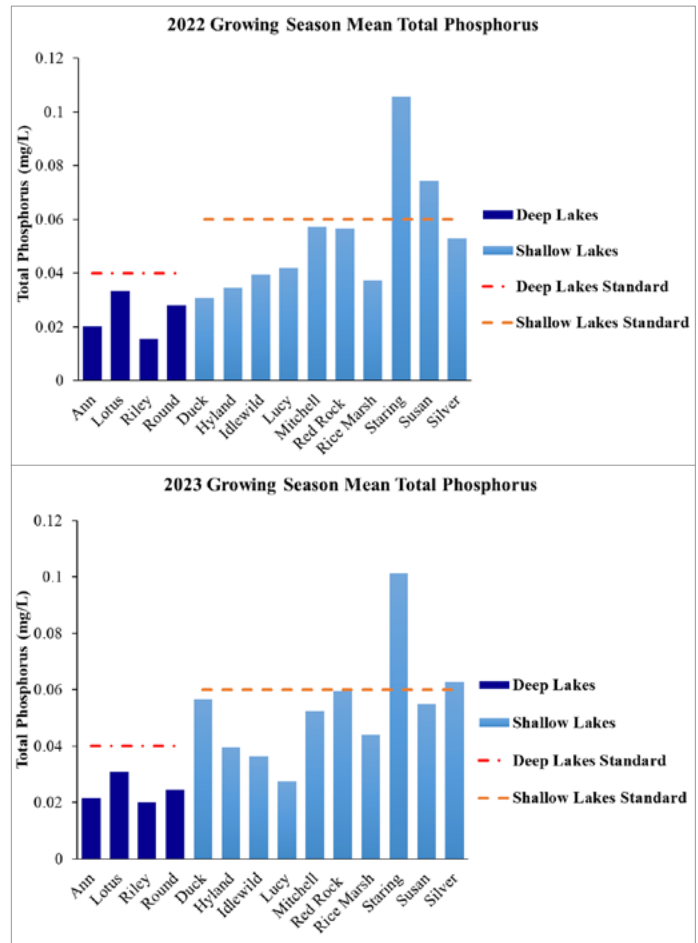
Lakes growing season (June-September) mean total phosphorus concentrations (mg/L) for shallow (lakes <15 ft. deep, >80% littoral area- light blue bars) and deep lakes (lakes >15 ft. deep, <80% littoral area- dark blue bars) in the Riley Purgatory Bluff Creek Watershed District during 2022 and 2023. The dashed lines represent the Minnesota Pollution Control Agency water quality standards for Total Phosphorus for shallow (<0.060 mg/L-orange dashed line) and deep lakes (<0.040 mg/L-red dashed line).

(2022-0.015 mg/L, 2021-0.016 mg/L, 2020-0.0178 mg/L) followed by lake Ann (0.022 mg/L). For shallow lakes, the MPCA TP standard (<0.060 mg/L) was met by Duck Lake, Hyland Lake, Lake Idlewild, Lake Lucy, Red Rock Lake, Mitchell Lake, Rice Marsh Lake, and Lake Susan in 2023. Silver Lake and Staring Lake both did not meet the MPCA TP standard in 2023. Silver Lake had barely met the standard the previous two years and slightly increased back above it in 2023. Staring Lake significantly increased from 2021 (0.042 mg/L) to 2022 (0.106 mg/L) and then decreased slightly in 2023 (0.104 mg/L). This is likely from a combination of very low water levels, increasing sediment resuspension via wind mixing, and the reduced vegetation following the whole lake fluridone treatment meant to reduce Eurasian Watermilfoil. These values will likely decline as native

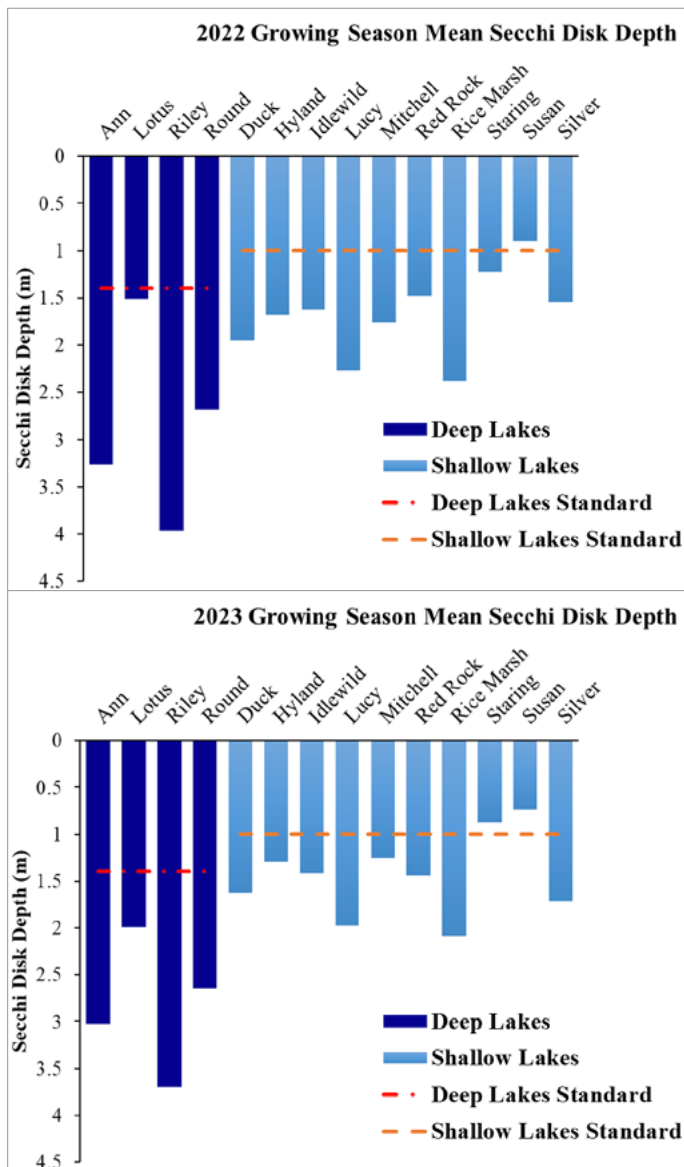
Lakes growing season (June-September) mean Secchi disk depths (m) for shallow (lakes <15 ft. deep, >80% littoral area-light blue bars) and deep lakes (lakes >15 ft. deep, <80% littoral area-dark blue bars) in the Riley Purgatory Bluff Creek Watershed District during 2022 and 2023. The dashed lines represent the Minnesota Pollution Control Agency water quality standards for Secchi disk depths for shallow (>1 m-orange dashed line) and deep lakes (>1.4 m-red dashed line).

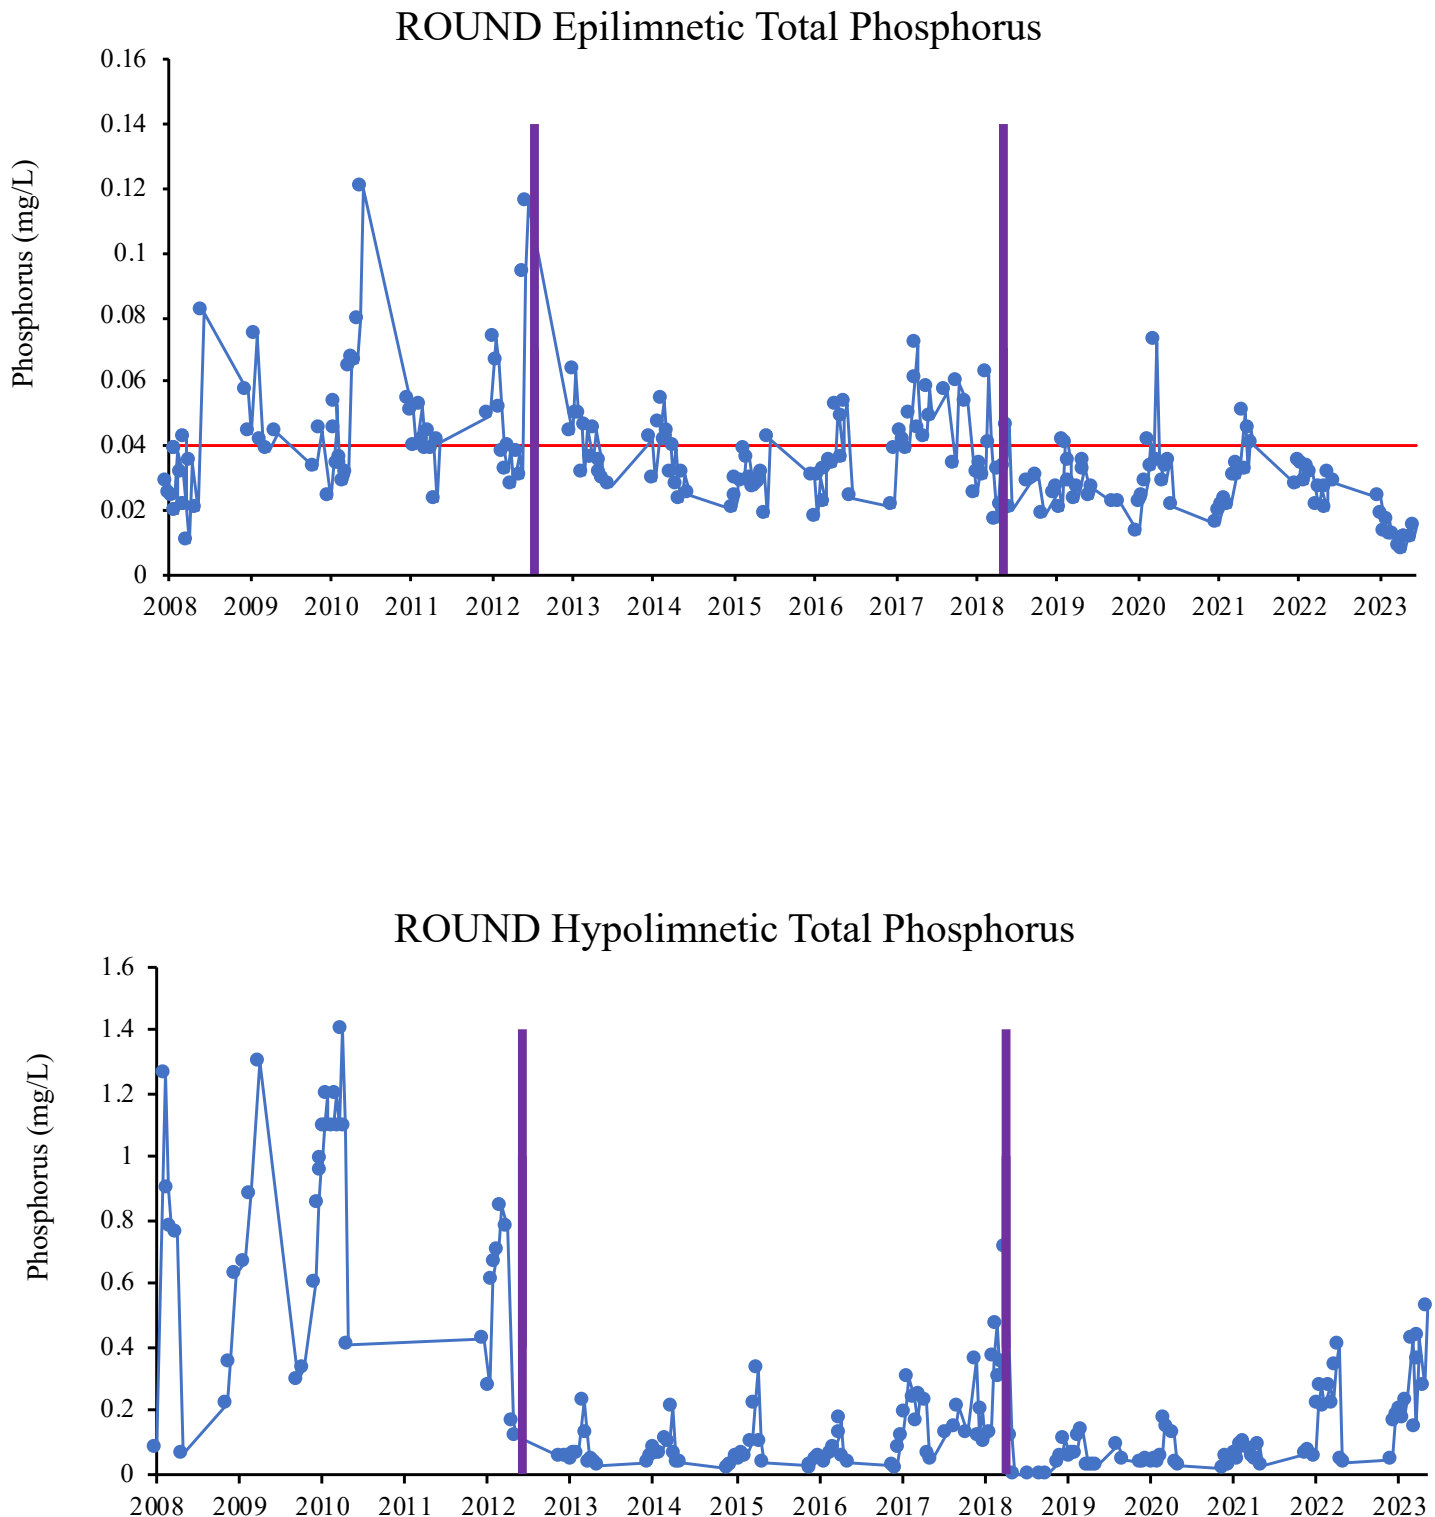
Figure 13. Round Lake Total Phosphorus Levels pre and post-alum treatment.

Total phosphorus levels (TP) in Round Lake between May 15, 2008 and October 26, 2023. The aluminum sulfate (alum) treatments occurred on November 15, 2012 and October 25, 2021 (indicated by vertical bars). The upper graph displays TP levels (mg/L) measured from 0-2 m composite samples and the lower graph displays the TP levels (mg/L) measured from samples taken 0.5-1 m above the sediment near the deepest point in the lake. The MPCA water quality standard for TP is represented in the upper graph by the horizontal red line (0.04 mg/L).

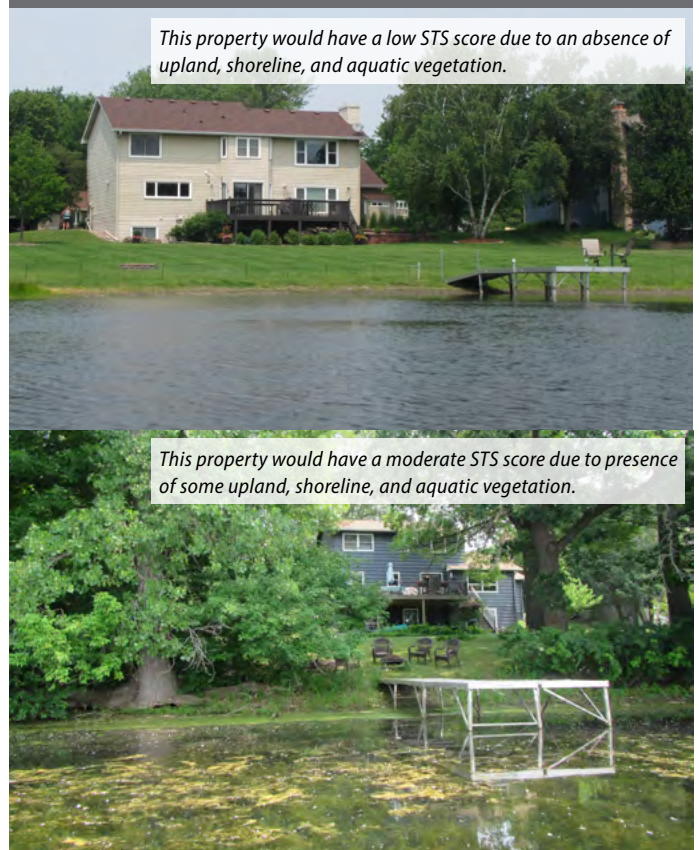
Figure 21. Example of a STS low scoring property (top) and STS high scoring property (bottom).

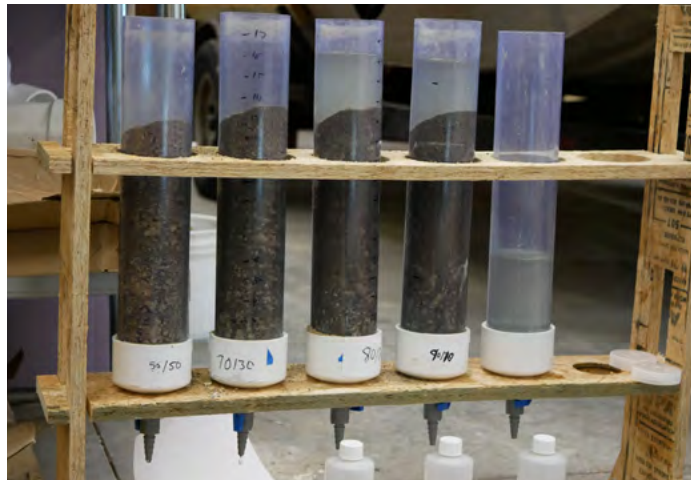
Figure 58. Column testing for lime/sand mixture.

out of the spent lime system, leaving the phosphorus behind. Observation and monitoring data collected by District staff in 2016 - 2018 indicated inconsistent system performance and periods of extended inundation, which deviated from the original design parameters. District staff worked with Barr to review monitoring data and identify potential shortcomings of the system (e.g., monitoring, materials, influent, changed conditions, etc.) It was discovered that the spent lime media appeared to be significantly restricting flow of water through the filter. District and Barr staff conducted field testing of the filtration capacity of the spent lime and discovered that the spent lime structure had degraded into a clay-like consistency, thus essentially preventing water from filtering through the media. During the summer of 2019, District staff completed laboratory column testing for mixtures of spent lime and sand. Column testing indicated that mixing spent lime with sand improves the filtration capacity of the media, while still removing phosphorus. Figure 58 is a photograph of the column testing completed by District staff during 2019. The testing revealed the following key points:

- Filtering water through sand washed to MnDOT standard specifications (washed sand) results in phosphorus export from the test columns.
- Water filtered through the various spent lime/pool sand mixtures elevated the pH in the effluent water, thus supporting the chemical reaction to precipitate phosphorus (i.e., remove phosphorus).
- Filtration rates through the various spent lime/pool sand mixtures appear relatively unchanged after 114 days of inundation and continuous flow for 10 days did not reduce

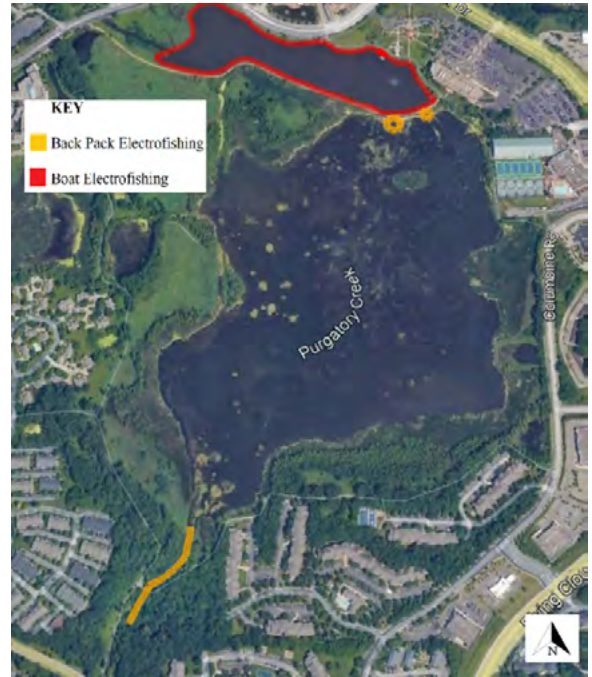
Figure 72. PCRA Spring Removal Site Map

Backpack electrofishing and block nets were utilized in the channel upstream and downstream of the barrier and at the breach in the berm that separates the Upper and Lower Purgatory Creek Recreational Area ([Figure 72](#)). In the past, most of the fish had been captured/removed via backpack electrofishing at the breached berm site. This breach allows water to short circuit the overflow structure. Water is always flowing at this location which leads to carp concentrating in the shallow water near the breach before trying to move upstream. The sheet piling, combined with the consistent flow, has eroded the downstream side of the berm, causing a drop that impedes carp movement. A block net is anchored on the downstream side of the flow at the breach, stretched around the congregating carp, trapping them between the berm and net. During the heavy spawning run, staff repeated the process, sometimes up to three times a day, taking about an hour each time from installation of the net to completion of removal. In 2023 only one successful removal event occurred at the berm. Water levels were either too high or too low for this method to be successful. Additionally, a majority of the carp in this system are now larger in size and able to navigate the berm more easily. Upon visual inspection, it appears that the berm has further eroded and/or subsided, making it easier for fish to move freely

In 2023, the backpack electrofishing below the barrier combined with a block net across two sampling events yielded a total 144 carp removed or 416 lbs. By sex, 26% were males and 74% were females Utilizing all spring gear types in the past, a total of 315 carp were removed in 2022, 511 in 2021, 201 in 2020, 441 in 2019, and 1,901 carp in 2018. Most of the fish removed were from the 2015-year class, in which approximately 3000 YOY carp had entered Staring Lake from LPCRA and started to grow rapidly (Sorensen et al., 2015). This year class was a result of the last major recruitment event that occurred in the system until 2023 (Figure 71). In 2023, most of the carp were removed on May 23rd and 26th when water was over the top of the staff gauge and the water temperature was 20.2 degrees Celsius (May 26th). This is compared to April 19, 2022, when upstream barrier water levels were 57.4 inches (based on the installed staff gauge) and water temperatures at 7.8 degrees Celsius; April 19th, 2021, at 57.4 inches and 7.8 degrees; May 7, 2019, at 37.5 inches and 17.2 degrees; and June 29th, 2020, at 39 inches and 22 degrees Celsius. District staff have been working with the City of Eden Prairie to stabilize the berm and correct/improve

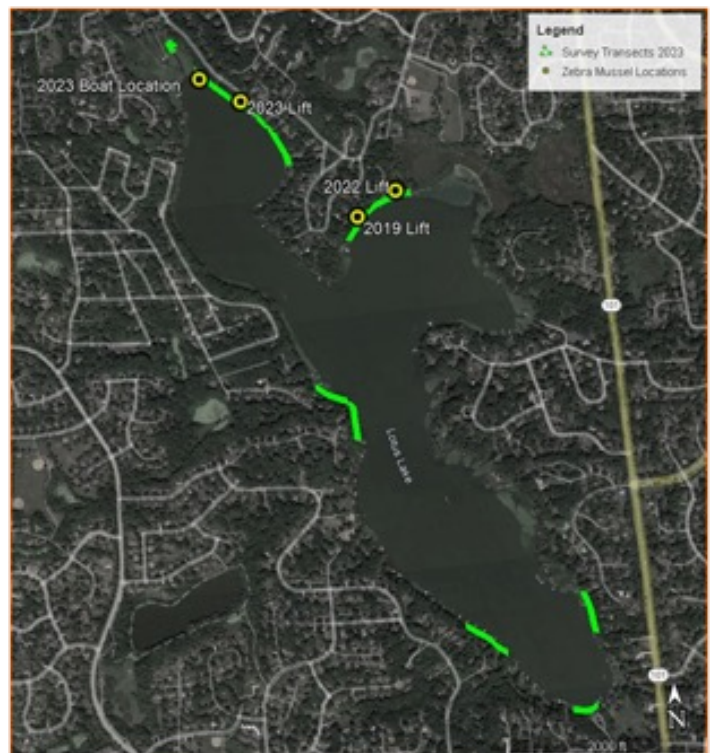
Figure 75. Lotus Lake Zebra Mussel summary map.

On August 30, 2019, five Zebra Mussel veligers were found in veliger tows collected by Carver County from the public access of Lotus Lake (Figure 75). No Zebra Mussel veligers were found in samples collected on June 20, 2019, or on September 10, 2019, by the RPBCWD. Additional in-lake searching occurred on October 9, 2020, by RPBCWD staff. No adult Zebra Mussels were found during the search. An additional veliger tow was collected

Similar to 2020 and 2021, veliger tows were collected twice in spring 2022 but yielded no Zebra Mussel veligers. Both boat launch and mussel plate checks (five plates, previously 10 plates) yielded no adult mussels. Staff visually searched multiple areas of the lake for mussels twice in 2022, once in August and once in October after docks were pulled. Many desiccated mussels were found on boat lifts at different locations in the east bay in 2019 and in 2022 during the fall surveys, but none were found in the lake or elsewhere. The eDNA results for 2022 were the first negative result since 2019 when mussels were found in Lotus

Lake. Several hundred Zebra Mussels were found desiccated on a lift in 2023 during the fall survey on the north end of the lake. Staff will continue to monitor for Zebra Mussels in 2024.
