Rice Marsh Lake

Rice Marsh Lake Water Quality by the Numbers

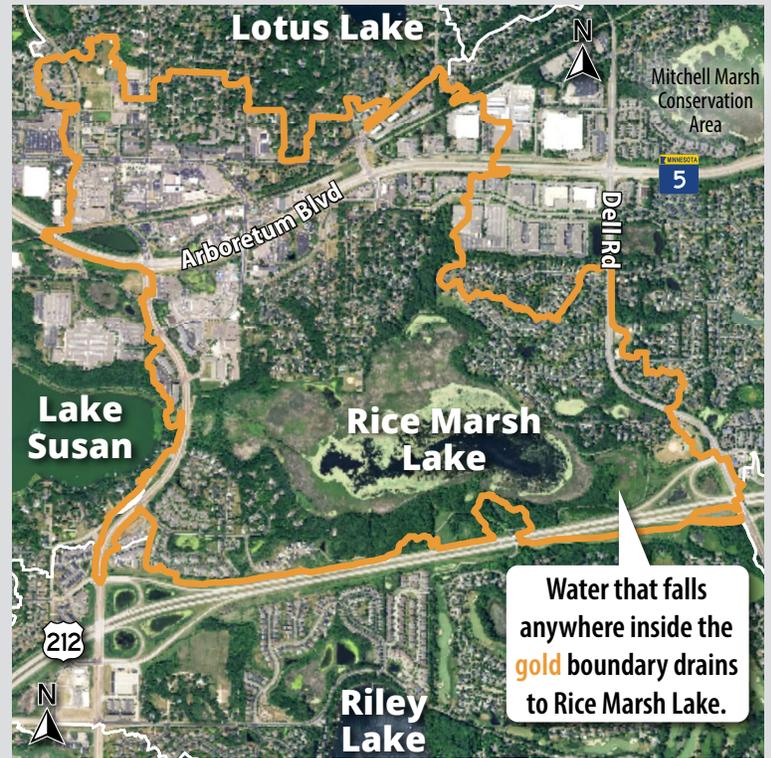
Watershed Boundary

Water that falls anywhere inside the gold boundary drains to Rice Marsh Lake.

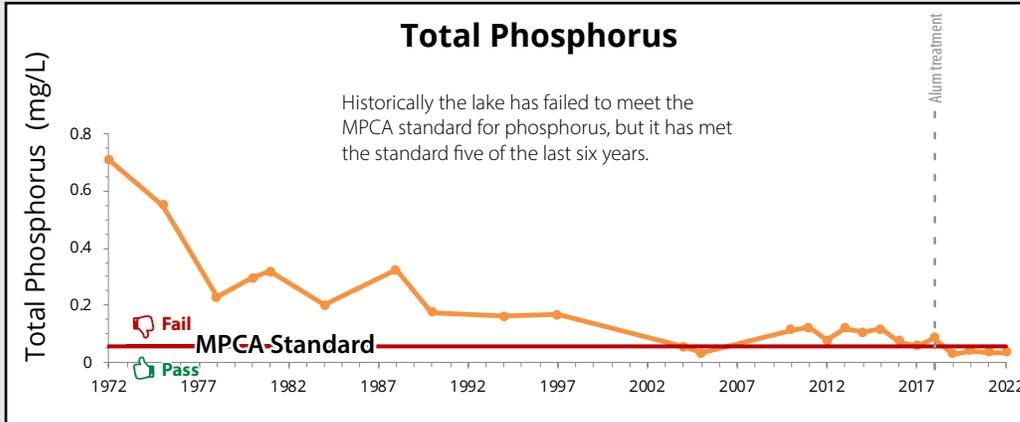
Total Phosphorus: Levels have decreased since monitoring began in 1972. In 2022, the lake met the MPCA standard with an average total phosphorus level of 0.037 mg/L.

Rice Marsh Lake received an alum treatment in 2018. Alum limits the availability of phosphorus in lakes to control algae growth & improve water clarity.

Phosphorus is a nutrient plants and algae need to grow. Too much phosphorus may cause algae blooms.

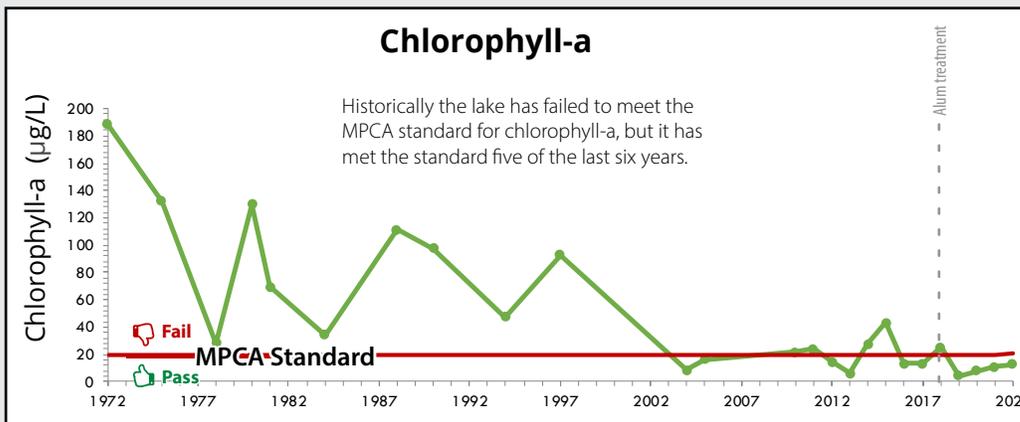
Chlorophyll-a: Levels have decreased since monitoring began in 1972. In 2022, the average reading for chlorophyll-a was 12.8 µg/L.

Chlorophyll-a is the main pigment in algae and indicates how much algae is growing in the water. High levels mean excess growth.

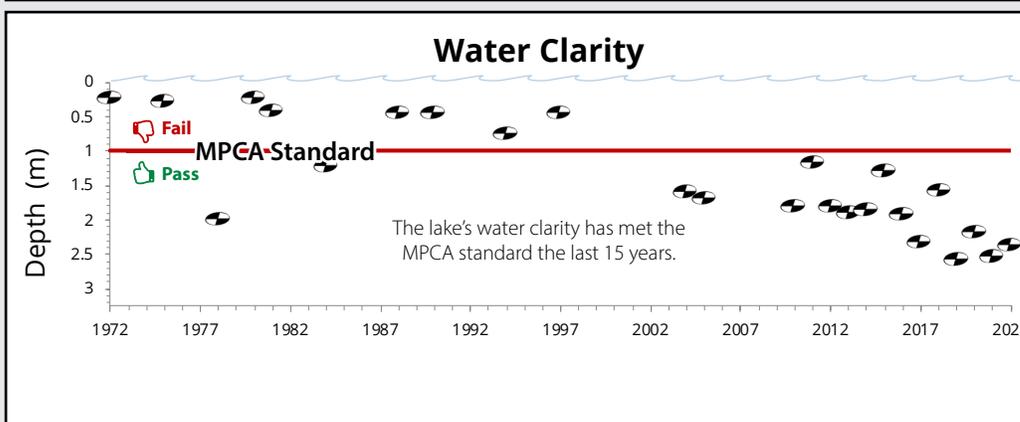
Water clarity: Since 1972, average Secchi disk depths have increased, and the lake consistently meets the standard for water clarity. The average reading in 2022 was 2.4 meters.

Water clarity is measured by lowering a Secchi Disk into the water. The depth at which the disk is no longer visible is the water's clarity measurement.
