Aquatic Plant Community of Red Rock Lake: 2015 Hennepin County, MN (#27-0076-00)

Point-Intercept Surveys: Jun 2 and Aug 12, 2015
Curlyleaf Turion Survey: Nov 2, 2015

Surveying, Analysis, and Reporting by:
James A. Johnson – Freshwater Scientific Services, LLC

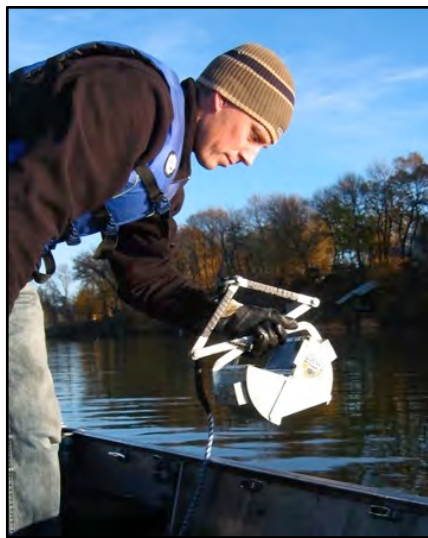
Figure 3. JA Johnson (Freshwater Scientific Services) preparing to collect a sediment sample with the Ponar dredge.

Freshwater Scientific Services, LLC conducted a sediment turion survey for Red Rock Lake on Nov 2, 2015 to assess the abundance and distribution of curlyleaf turions in the lake's sediments. For this survey, we collected sediment samples with a petite Ponar dredge (225 cm² basal area, Fig 3) at 40 sites that were randomly selected from the set of points used for the 2015 vegetation surveys (Fig 4). Upon retrieving each sediment sample, we removed any material from the outside of the closed Ponar dredge, emptied its contents into a sifting bucket (1-mm screen), and gently sifted the sample in the field to remove fine sediment. The contents remaining in the bucket after sifting were placed into a labeled plastic bag and stored in a cooler while in the field. In the lab, we manually sorted turions from other debris and recorded total turion counts for each sample. Small turion fragments that did not include a portion of a central turion stem and severely decayed turions that did not retain their shape when lightly squeezed were discarded and were not included in the final turion counts. Turion counts from each sample were divided by the sampled area (0.0225 m²) to yield sediment turion abundance (turions/m²) for each sampled site (Table 4, Figs 5-7).

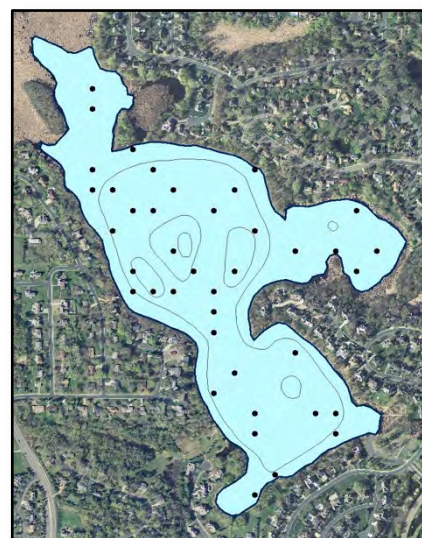
Figure 4. Sample locations for the 2015 Red Rock Lake sediment turion survey; 5-ft contour interval lines shown.

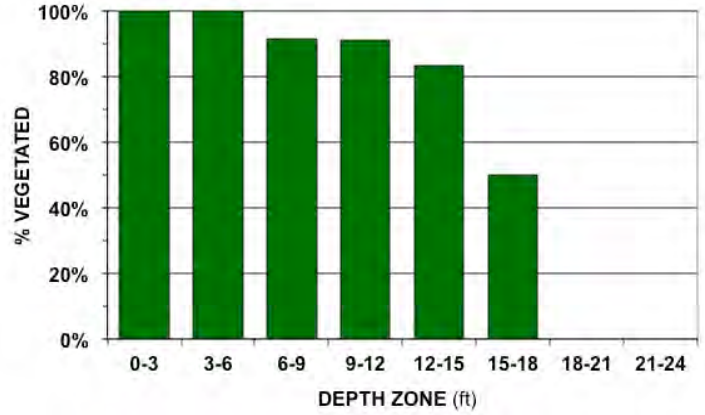
2015 Red Rock Lake – Aquatic Plant Abundance (all taxa combined)

Surveyed: Jun 2 and Aug 12, 2015
 Surveyor: JA Johnson
 Affiliation: Freshwater Scientific Services, LLC
 Methods: Rake, Sonar, Depth Rod
