# Staring Lake Watershed Basin Inventory and Maintenance Assessment

## **CITY OF EDEN PRAIRIE**

## **WENCK ASSOCIATES, INC.**

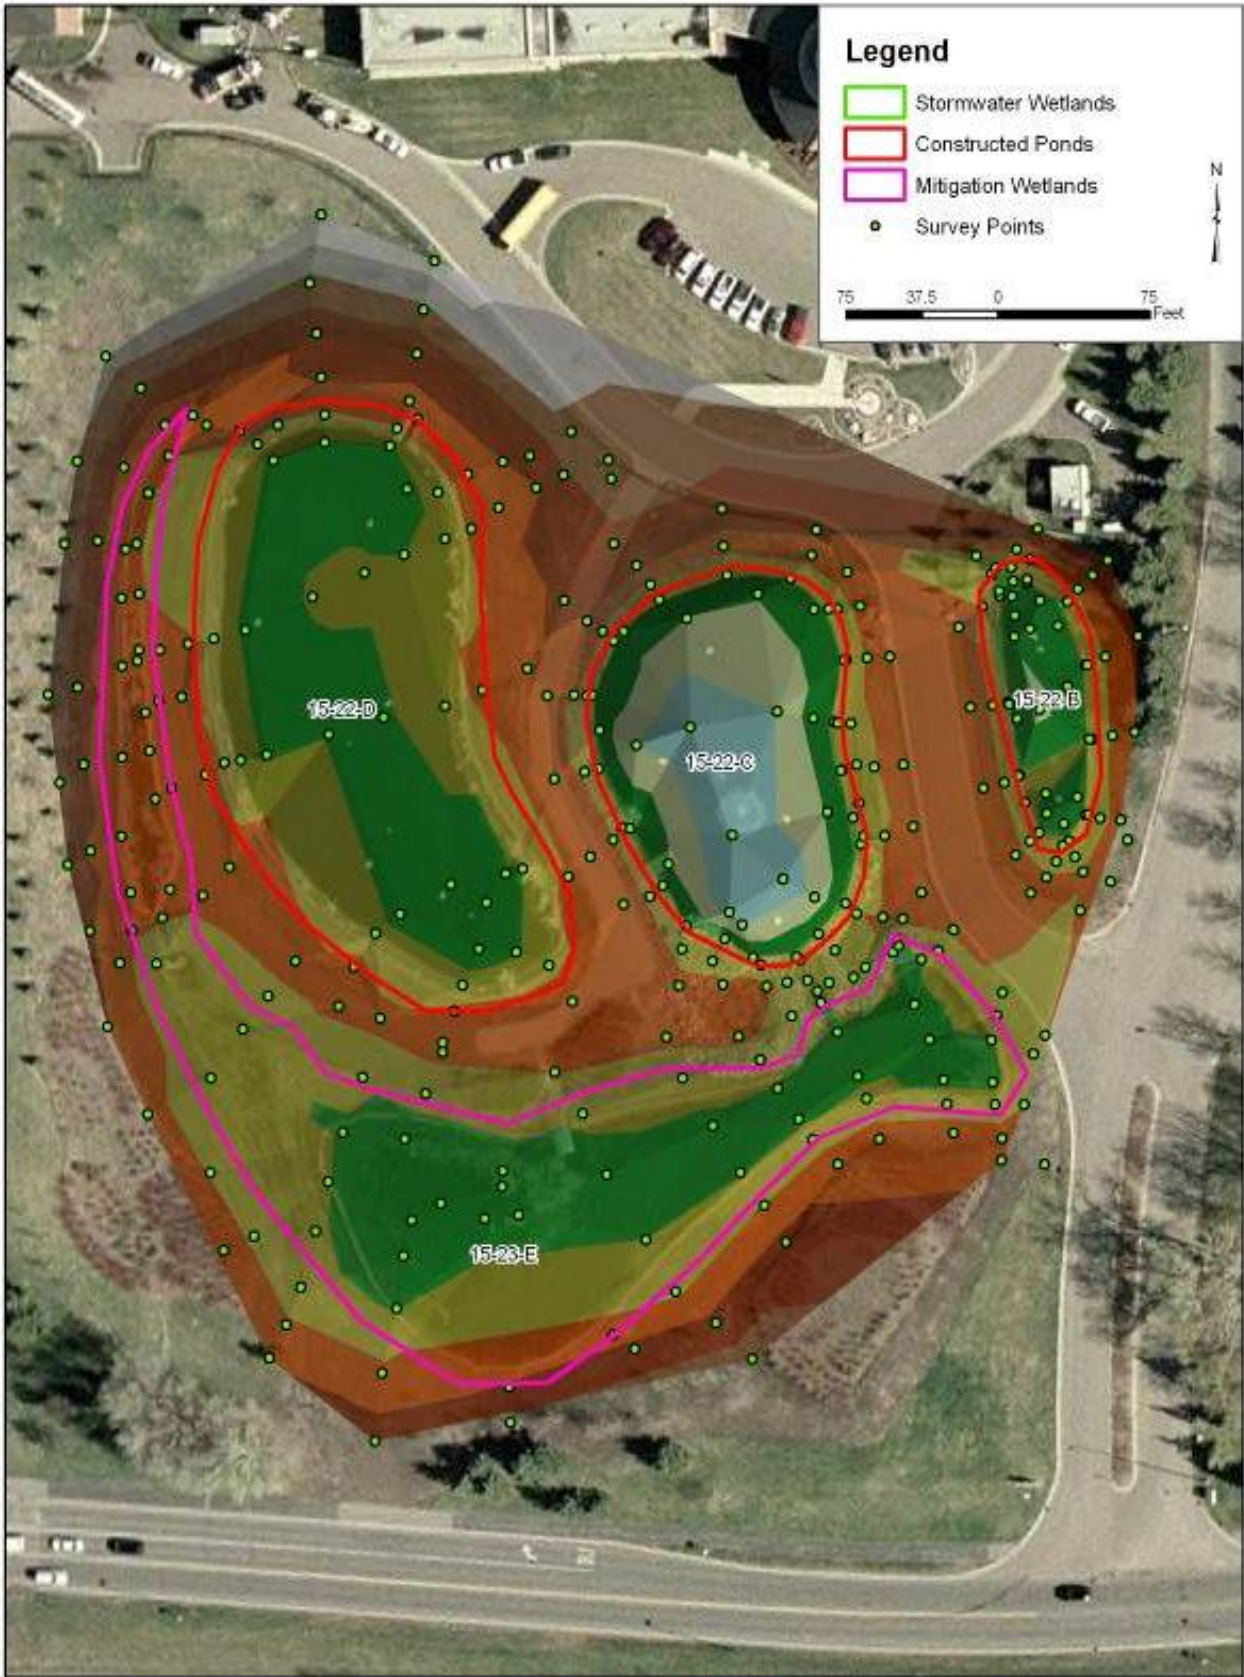
Figure 2.2. Plan view of a typical stormwater basin.

The permanent pool, or dead storage volume, is the volume below the outlet elevation. The flood pool is the volume between the outlet and the overflow point. If no outlet is present, the permanent pool was calculated as the volume below the overflow point.

The extent of sediment deposition in the stormwater ponds was estimated by comparing the existing permanent pool volume to the estimated "original" permanent pool volume for each pond. Determining the original permanent pool volume of a basin can be a challenge, as accurate data on the "as-built" construction of the basin is not often readily available. In fact, errors in the as-builts often resulted in negative values for changes in permanent pool volume, though some positive values were noted. Since it is unlikely that permanent pool volumes increased, it was determined that these values were likely associated with inaccuracies in the as-built documents.

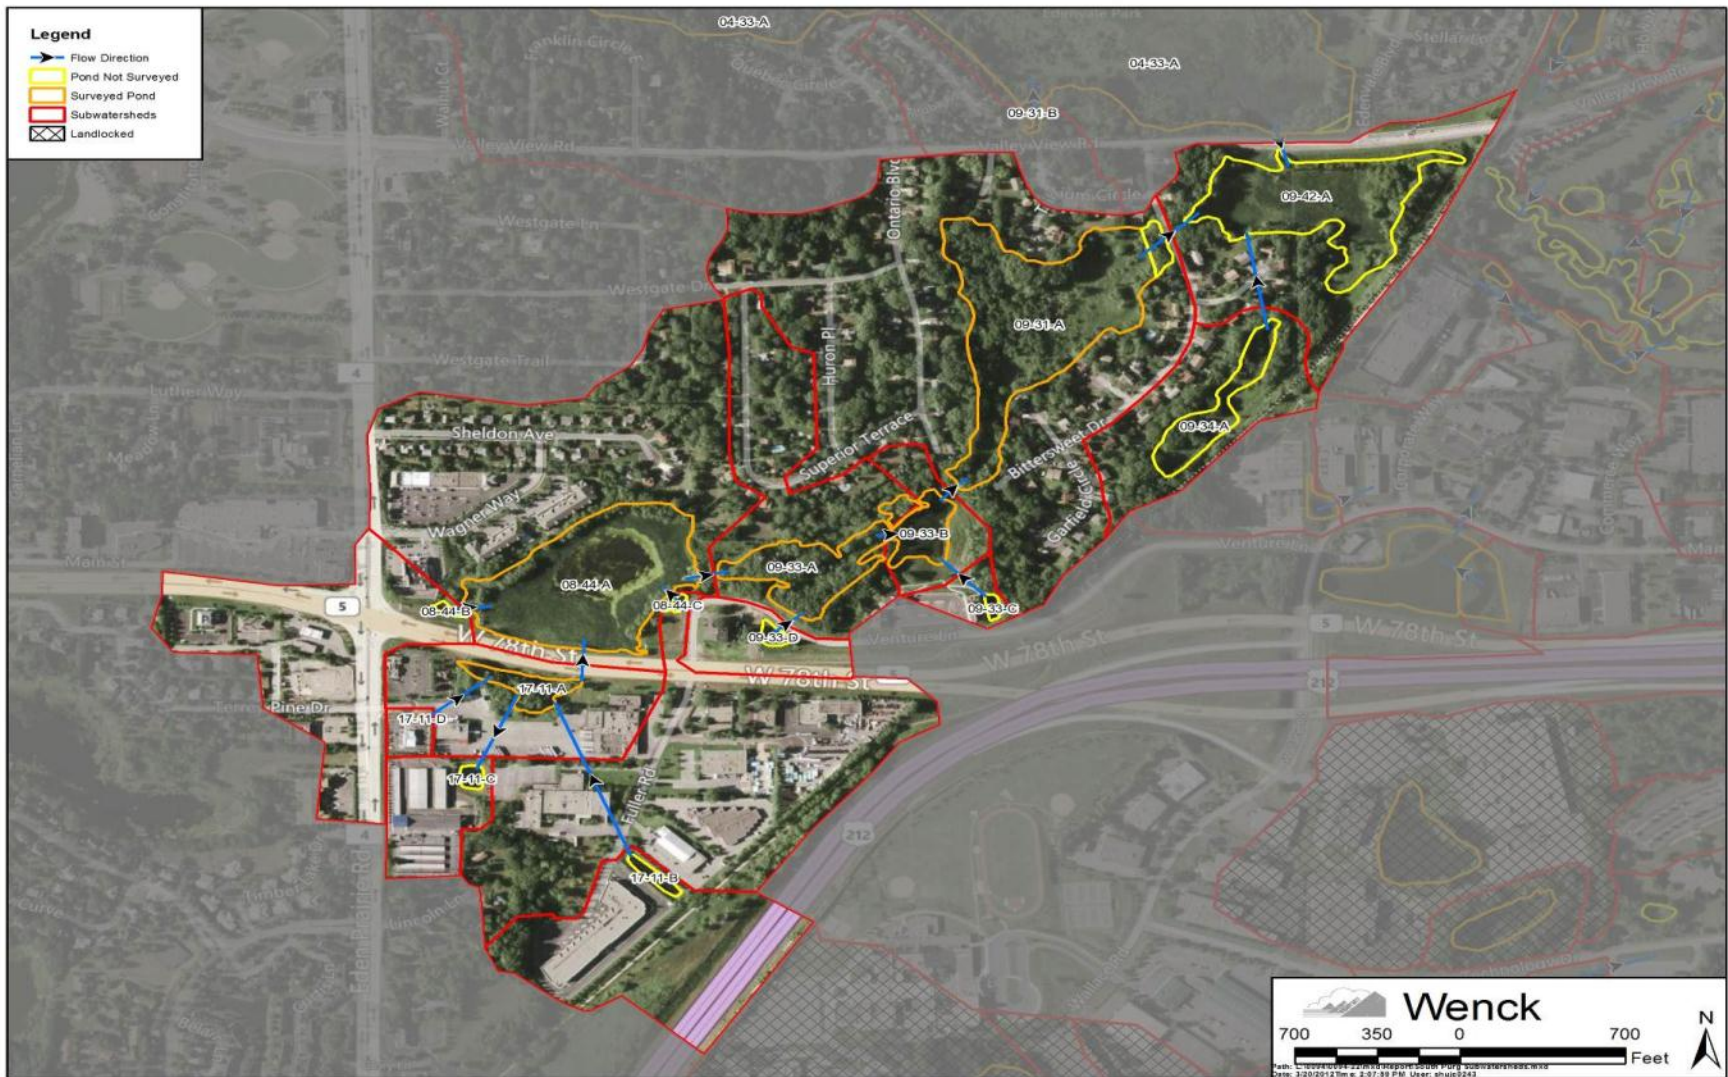
The South Purgatory Creek Area includes basins south of Valley View road and north of Highway 5 (Figure 3.4). All of the basins drain to Purgatory Creek (09-42-A).

Figure 3.4. Ponds, wetlands and flow patterns in the South Purgatory Creek Area subwatershed.

The Highway 5 and Mitchell Road area contains a sequence of basins in the southwest corner of the intersection which, along with a large portion of the highway and Mitchell Road, ultimately drain to constructed pond 10-33-F (Figure 3.4). When evaluated in series, the upstream ponds and stormwater wetlands are appropriately sized for NURP except for stormwater wetland 16-11-A (Table 3.9). However, the entire chain performs quite well for water quality purposes and does not need any improvements.

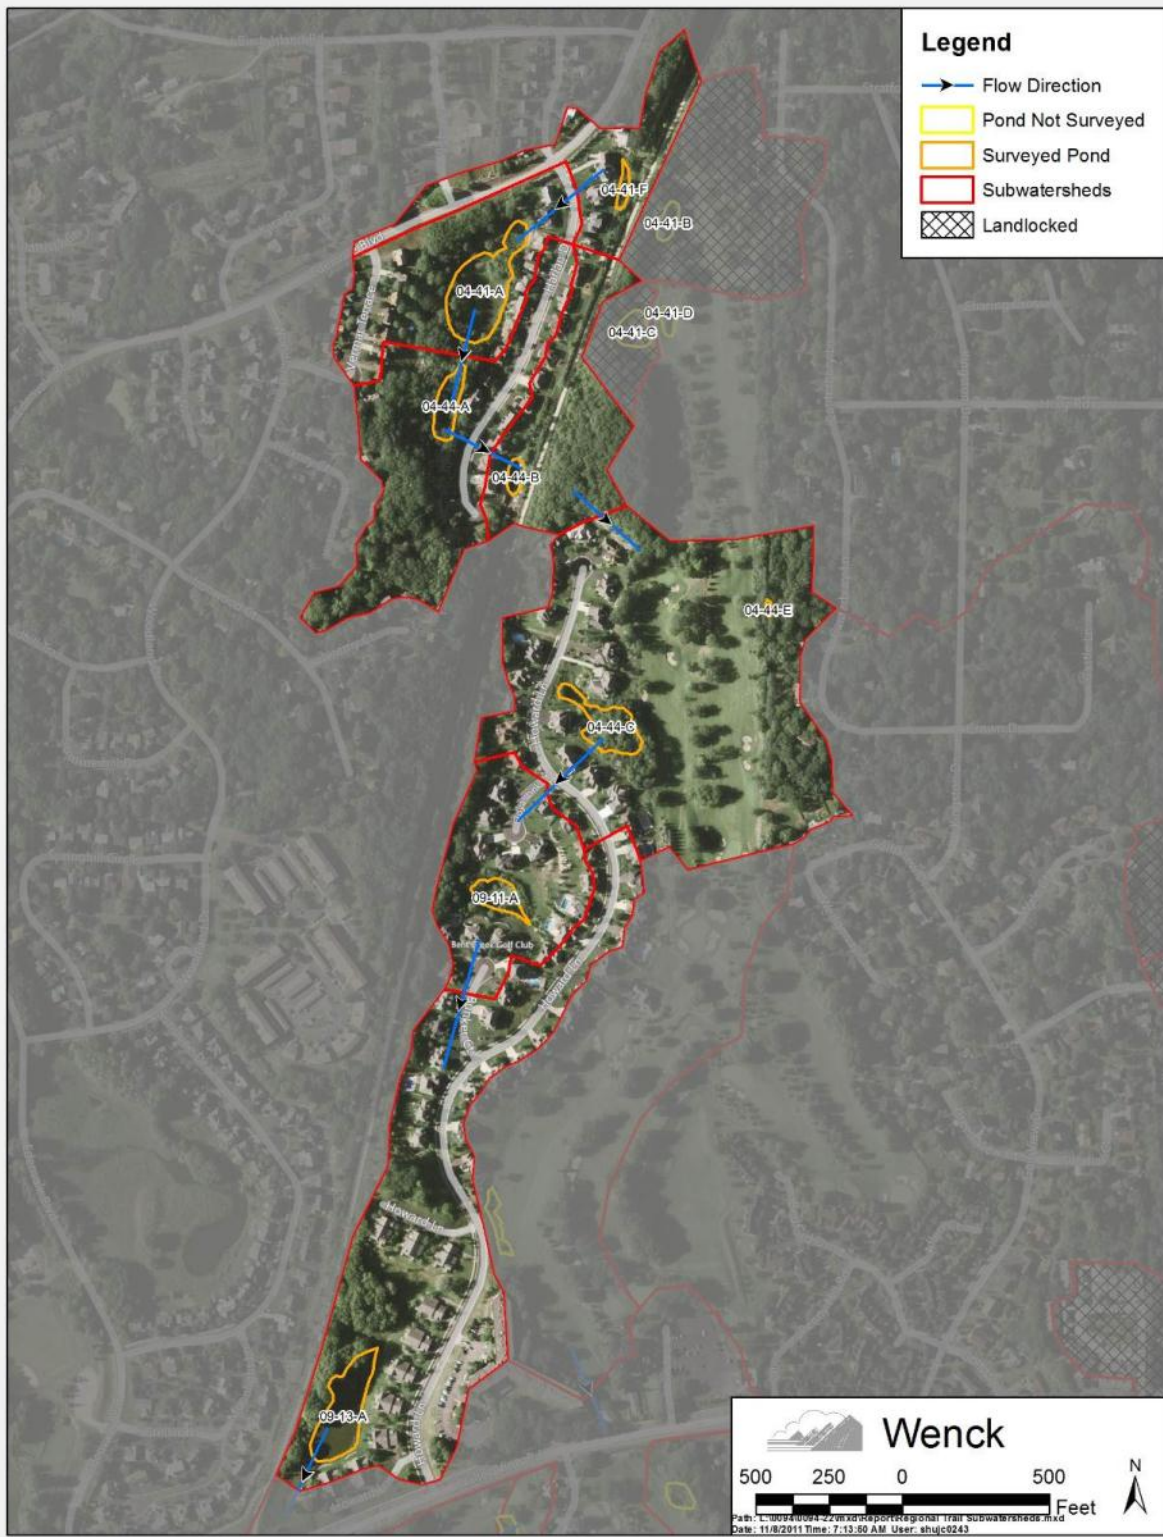
Figure 3.10. Ponds, wetlands and flow patterns in the Regional Trail Area subwatershed.

The surveyed permanent pool (0.12 acre-feet) for stormwater wetland 04-44-A was significantly smaller than as-built document (0.36 acre-feet) which suggests that the wetland could be expanded to meet the as-built conditions. However, because there is adequate ponding downstream and the basin exceeds NURP standards, it is not recommended that the City pursue any action pertaining to this wetland at this time.

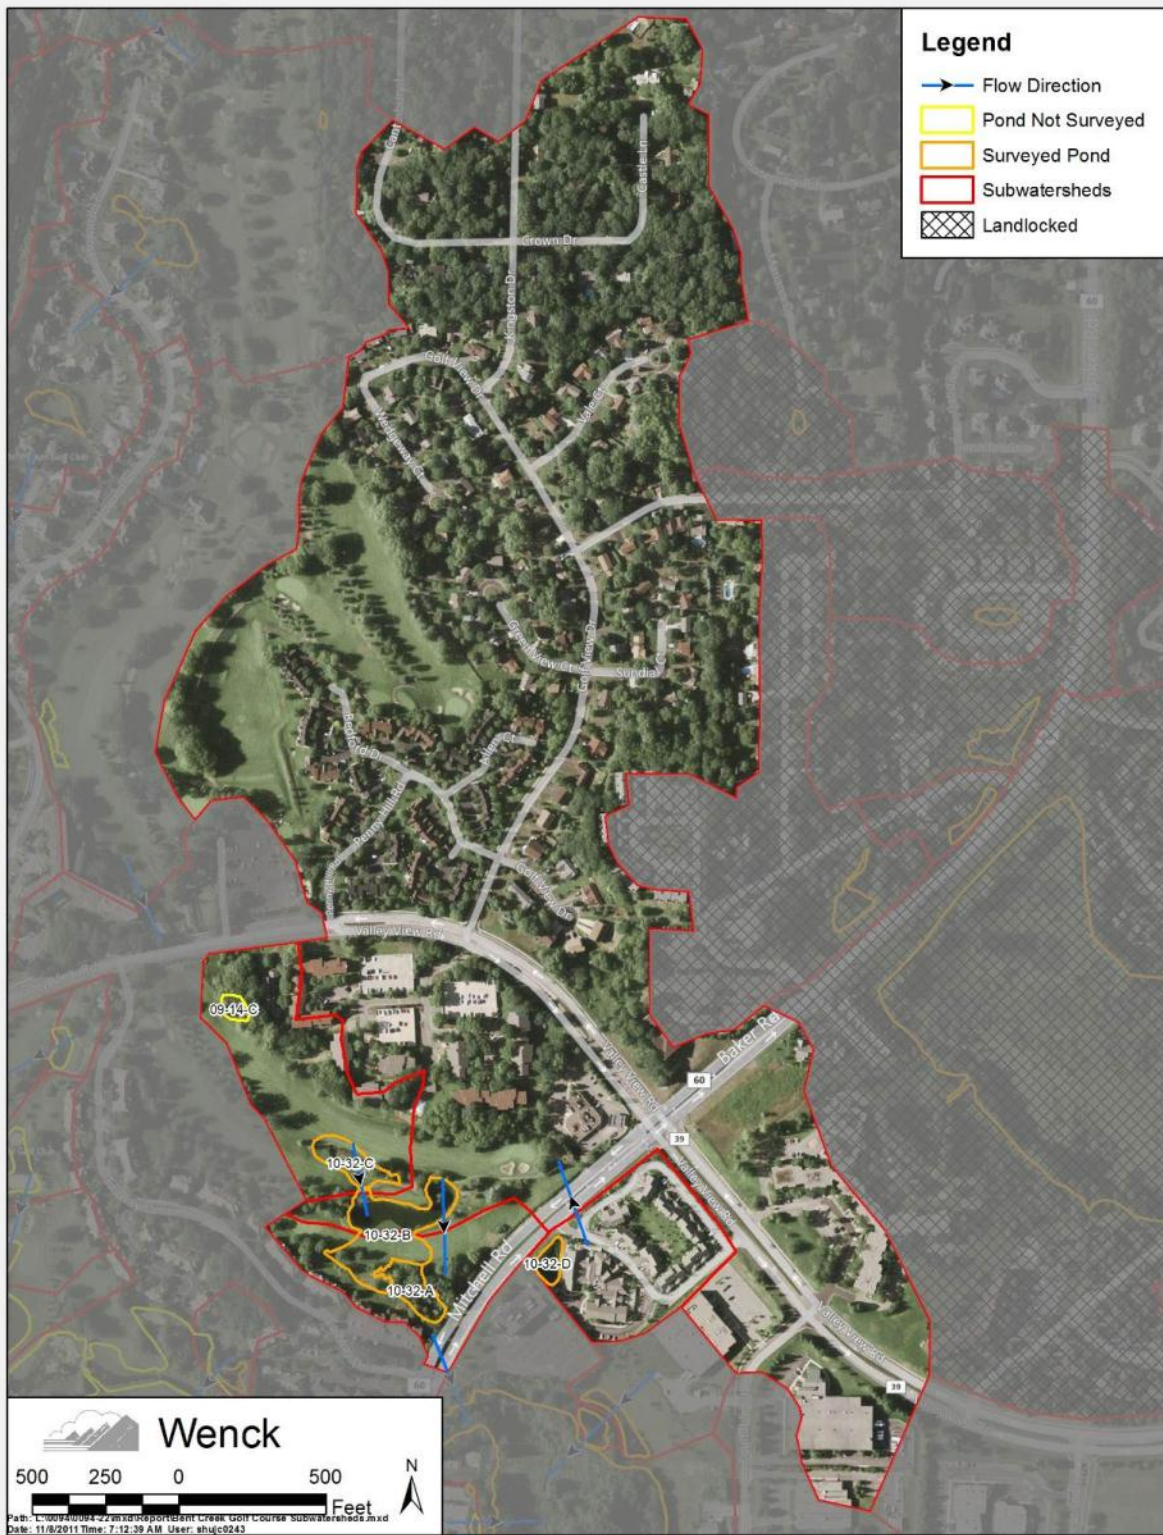
Figure 3.11. Ponds, wetlands, and flow patterns in the Bent Creek subwatershed.

The infrastructure linking stormwater wetlands 10-32-A and 10-32-B was repaired in 2010. However, wetland 10-32-B should be evaluated to determine if the wetland can be cleaned out of accumulated sediment in the future.

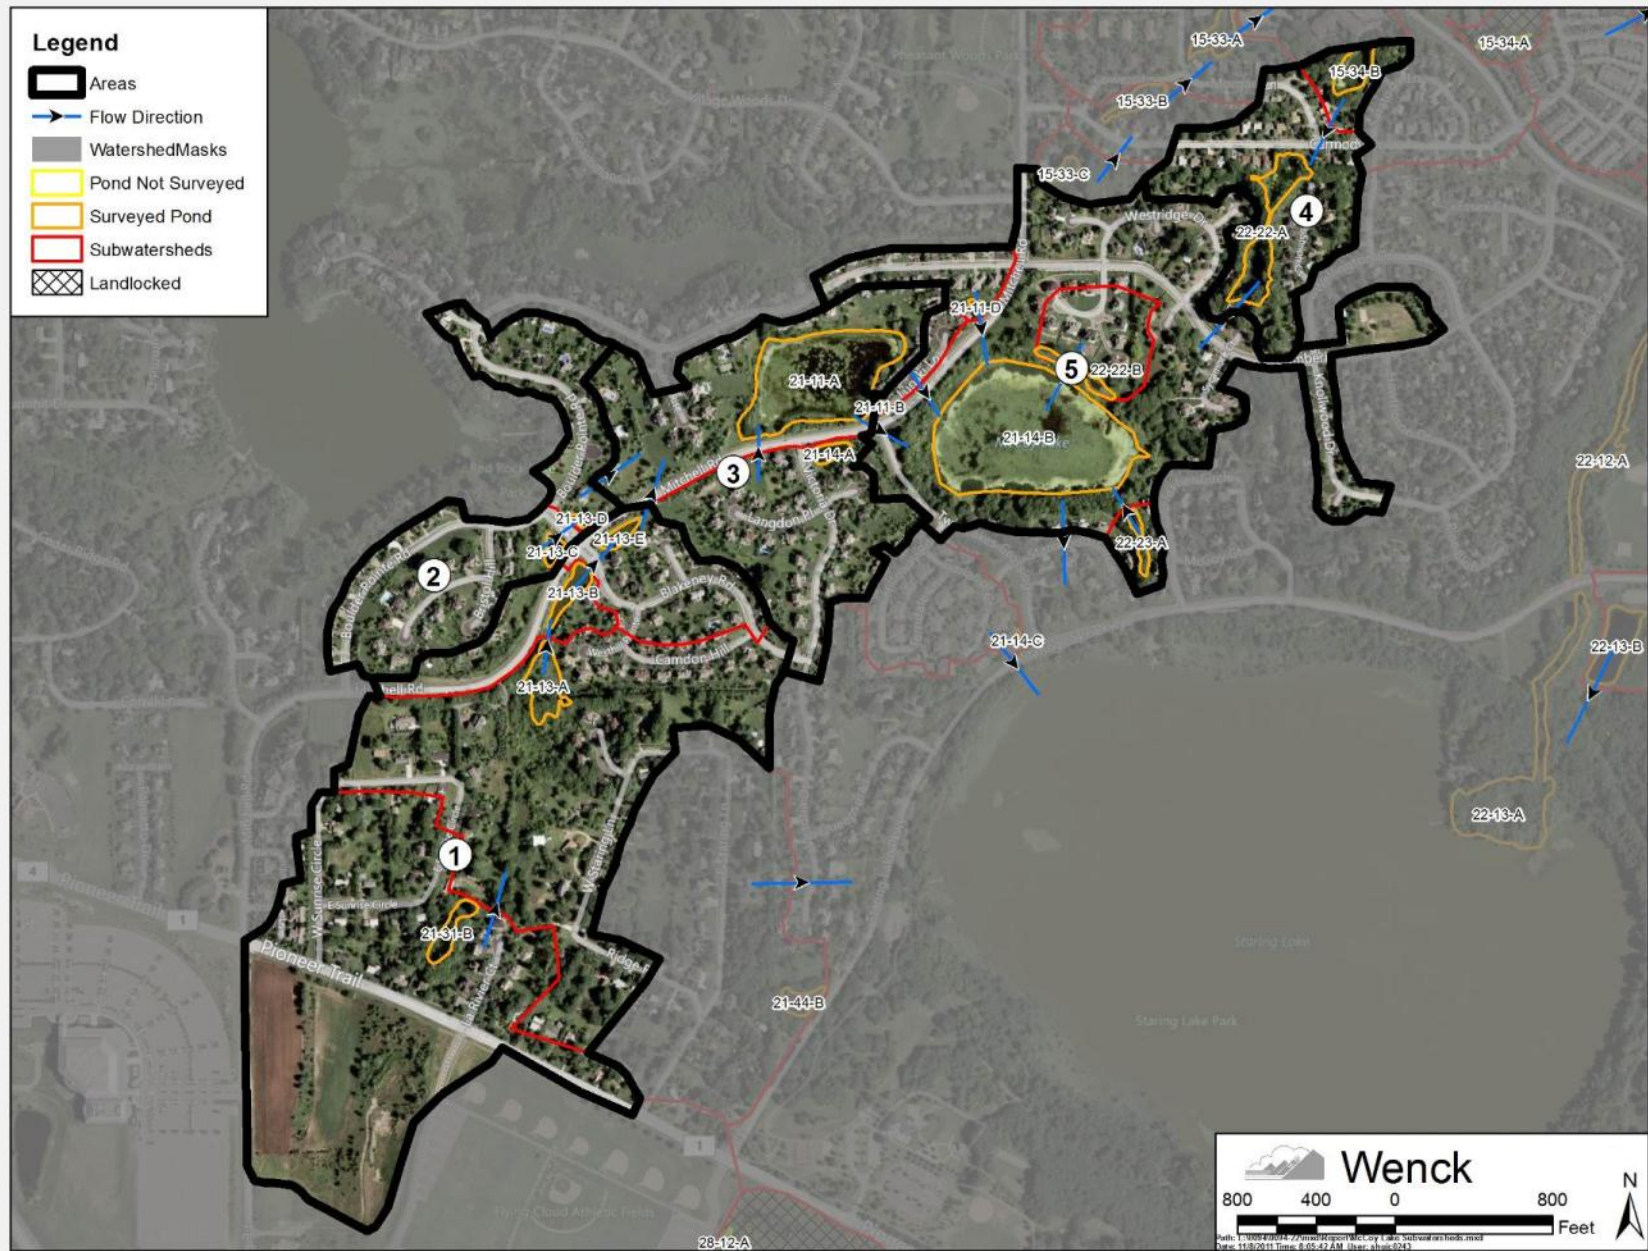
Figure 3.14. Ponds, wetlands, and flow patterns in the McCoy Lake Area subwatershed.

Wetland 21-11-A was noted as having accumulated sediment and could potentially benefit from a clean out. However, this is a large natural wetland that is a DNR protected basin and potential options for cleaning the wetland would have to be evaluated.

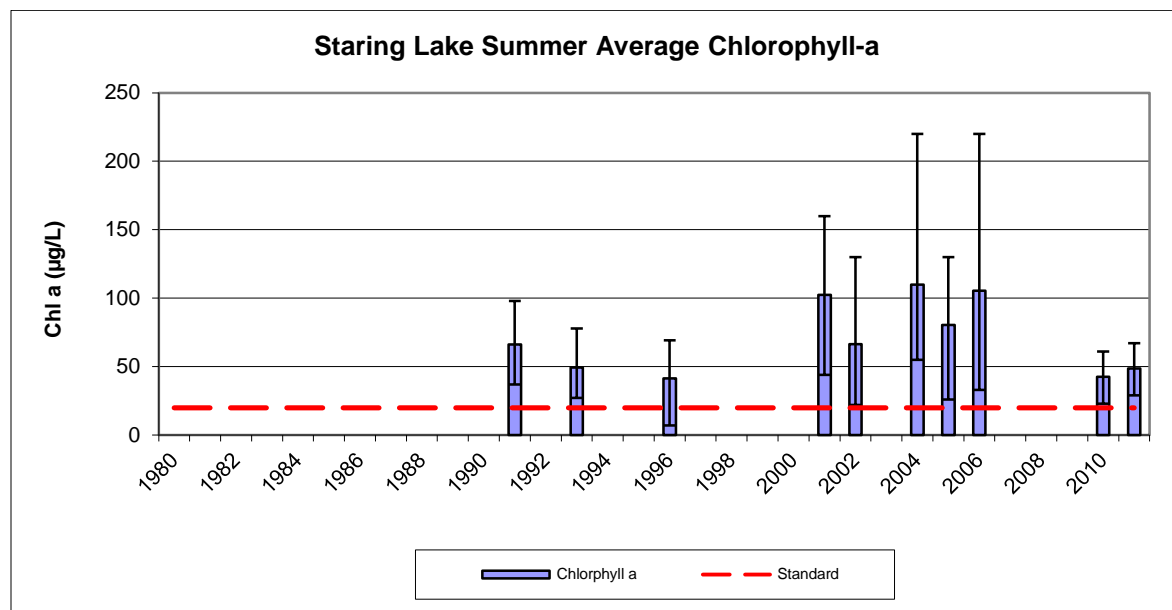
Figure 4.3. Summer (June 1 – September 30) average chlorophyll-*a* for Staring Lake.

The red line indicates the State of Minnesota’s standard for shallow lakes in the North Central Hardwood Forest Eco region. Error bars represent the minimum and maximum values. Only data with more than 4 summer samples are shown on the graph.

Summer Average chlorophyll-*a* concentrations in Staring Lake are extremely high ranging from 49 to 100 µg/L (Figure 4.3) with all of the monitored years exceeding the state water quality standard for shallow lakes in the North Central Hardwood Forest Eco region (<20 µg/L as a summer average). These data clearly demonstrate that Staring Lake is in an algae dominated state where severe nuisance algal blooms occur.

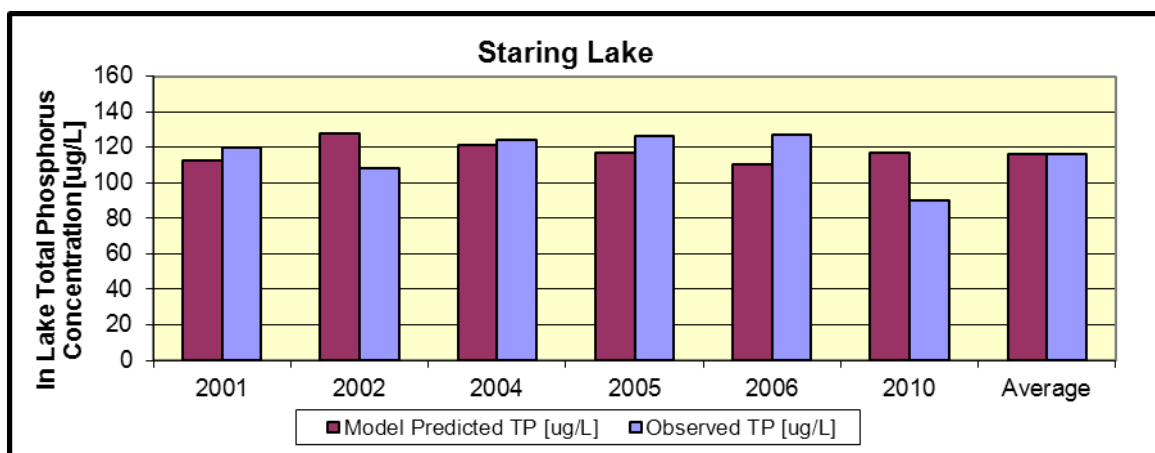
**Figure 4.6. Modeled and monitored in-lake total phosphorus concentrations.**

Lake response modeling was conducted for six years (2001, 2002, 2004-06, and 2010), where good data were available for Staring Lake. Modeled in-lake total phosphorus concentrations were within 30% of measured values in all the modeled years, and within 15% in four out of the six years (Figure 4.6). Consequently, the model was determined to be a reasonably calibrated model.

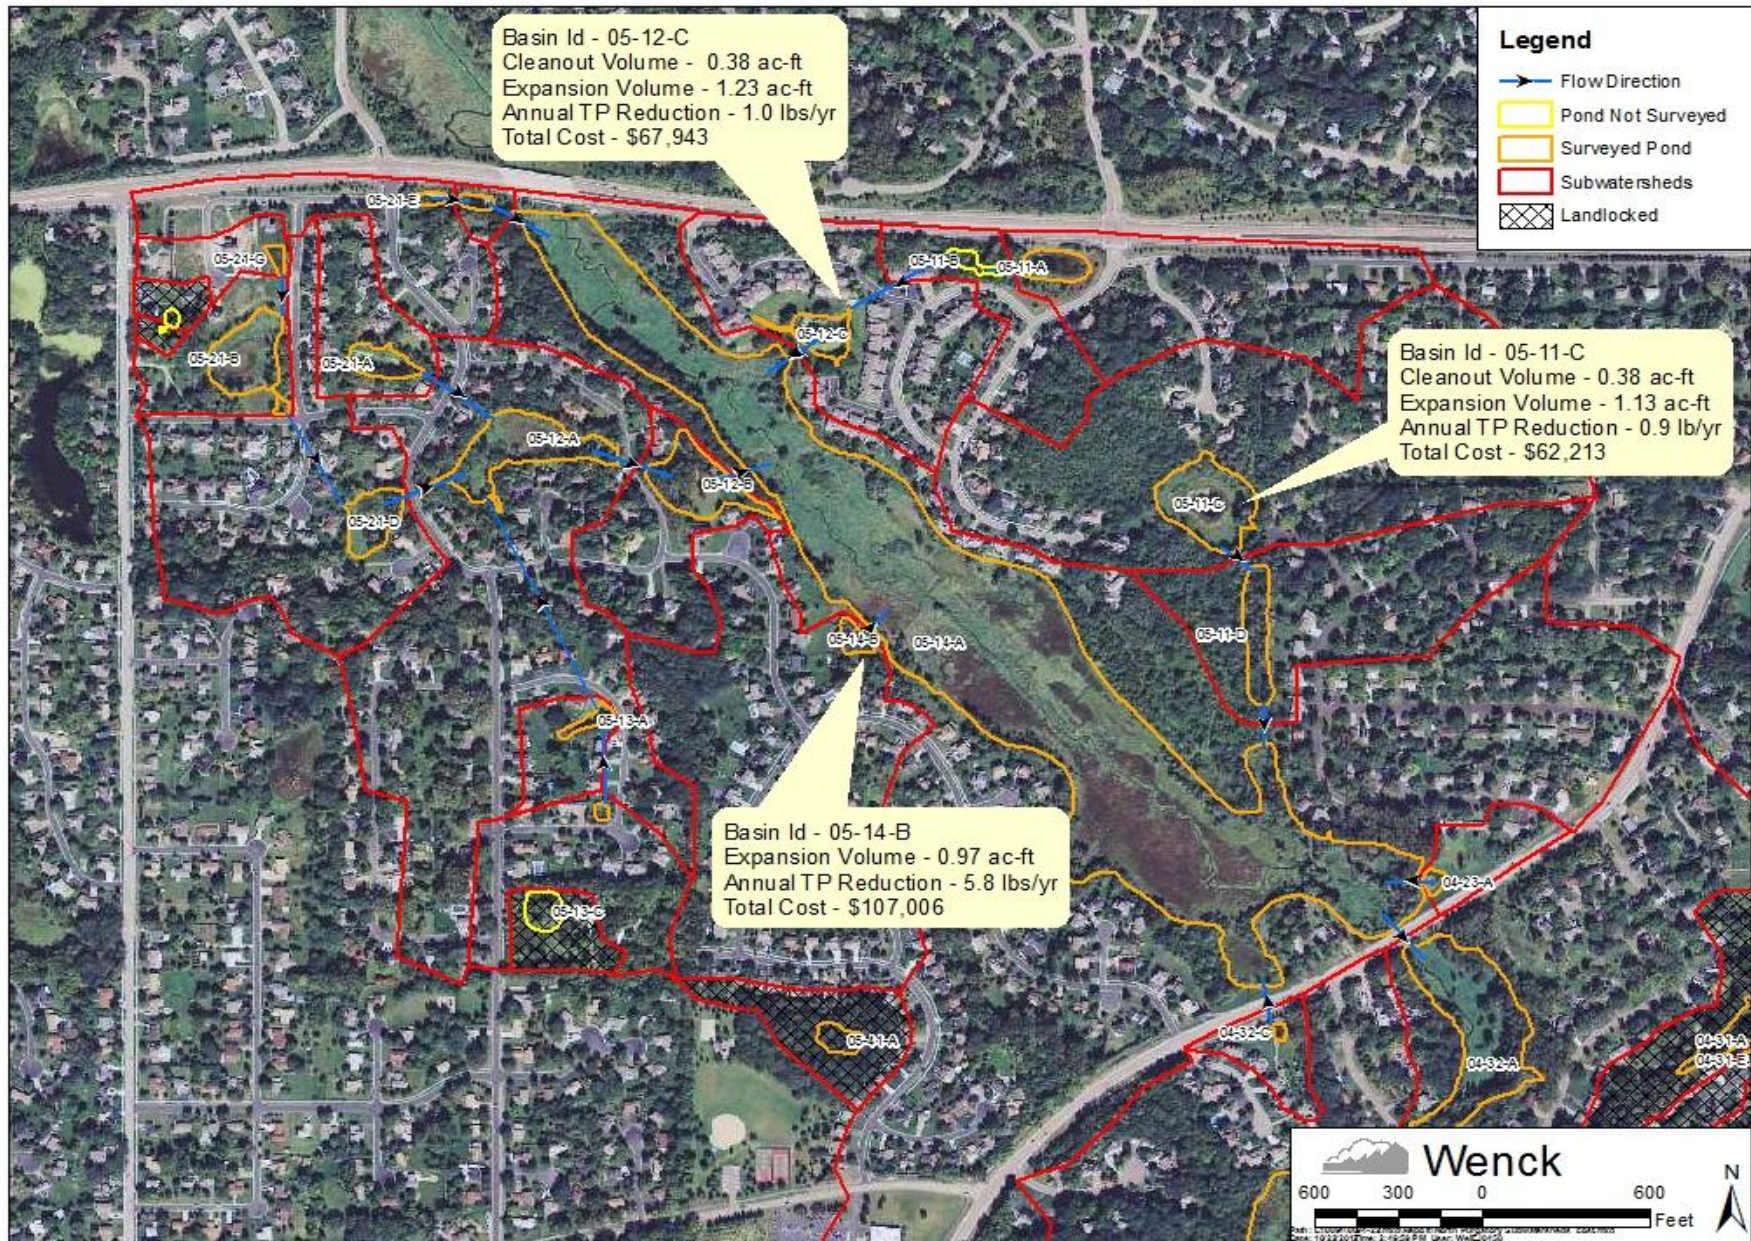
Figures 5.1 through 5.3 show the locations of the projects identified in Table 5.2. Cleanout volumes are associated with projects that were identified as having accumulated sediment and expansion volumes associated with basins that have as-built information available.

Figure 5.1. Northern Purgatory Creek improvement projects.
