Duck and Red Rock Lake Watersheds Basin Inventory and Maintenance Assessment

CITY OF EDEN PRAIRIE

WENCK ASSOCIATES, INC.

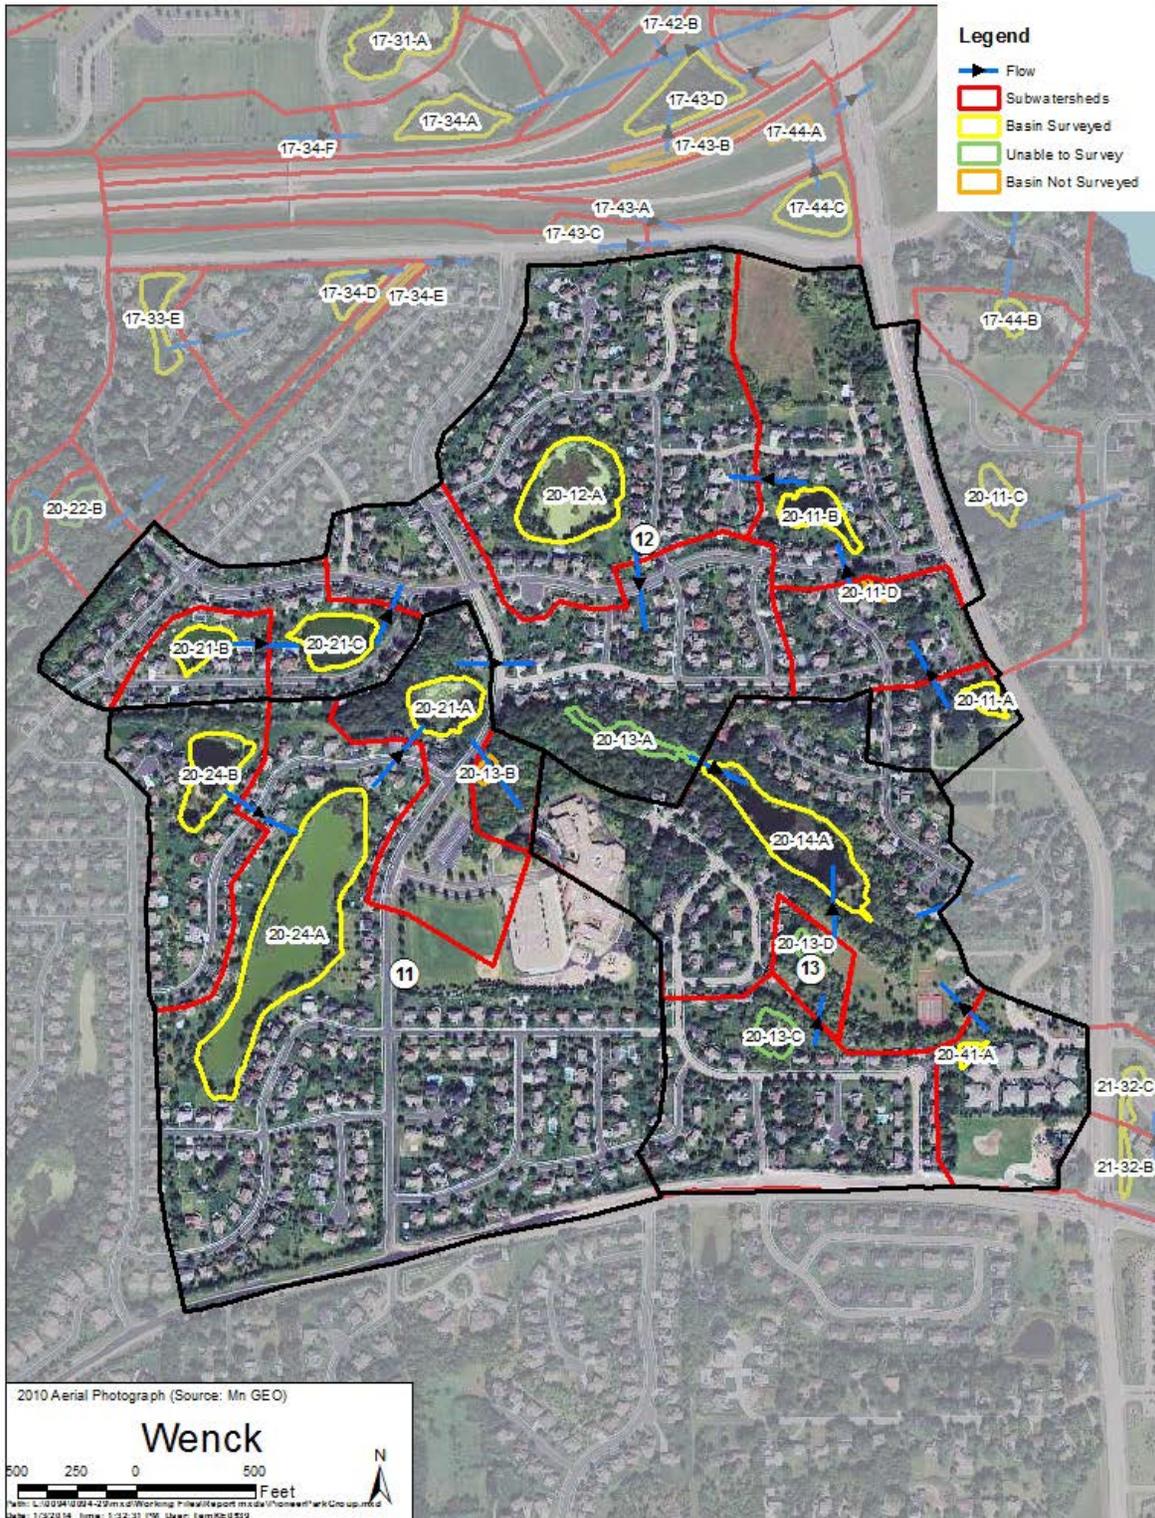
Figure 3.8. Constructed Ponds, Wetlands and Flow Patterns in the Pioneer Creek Area Subwatershed.

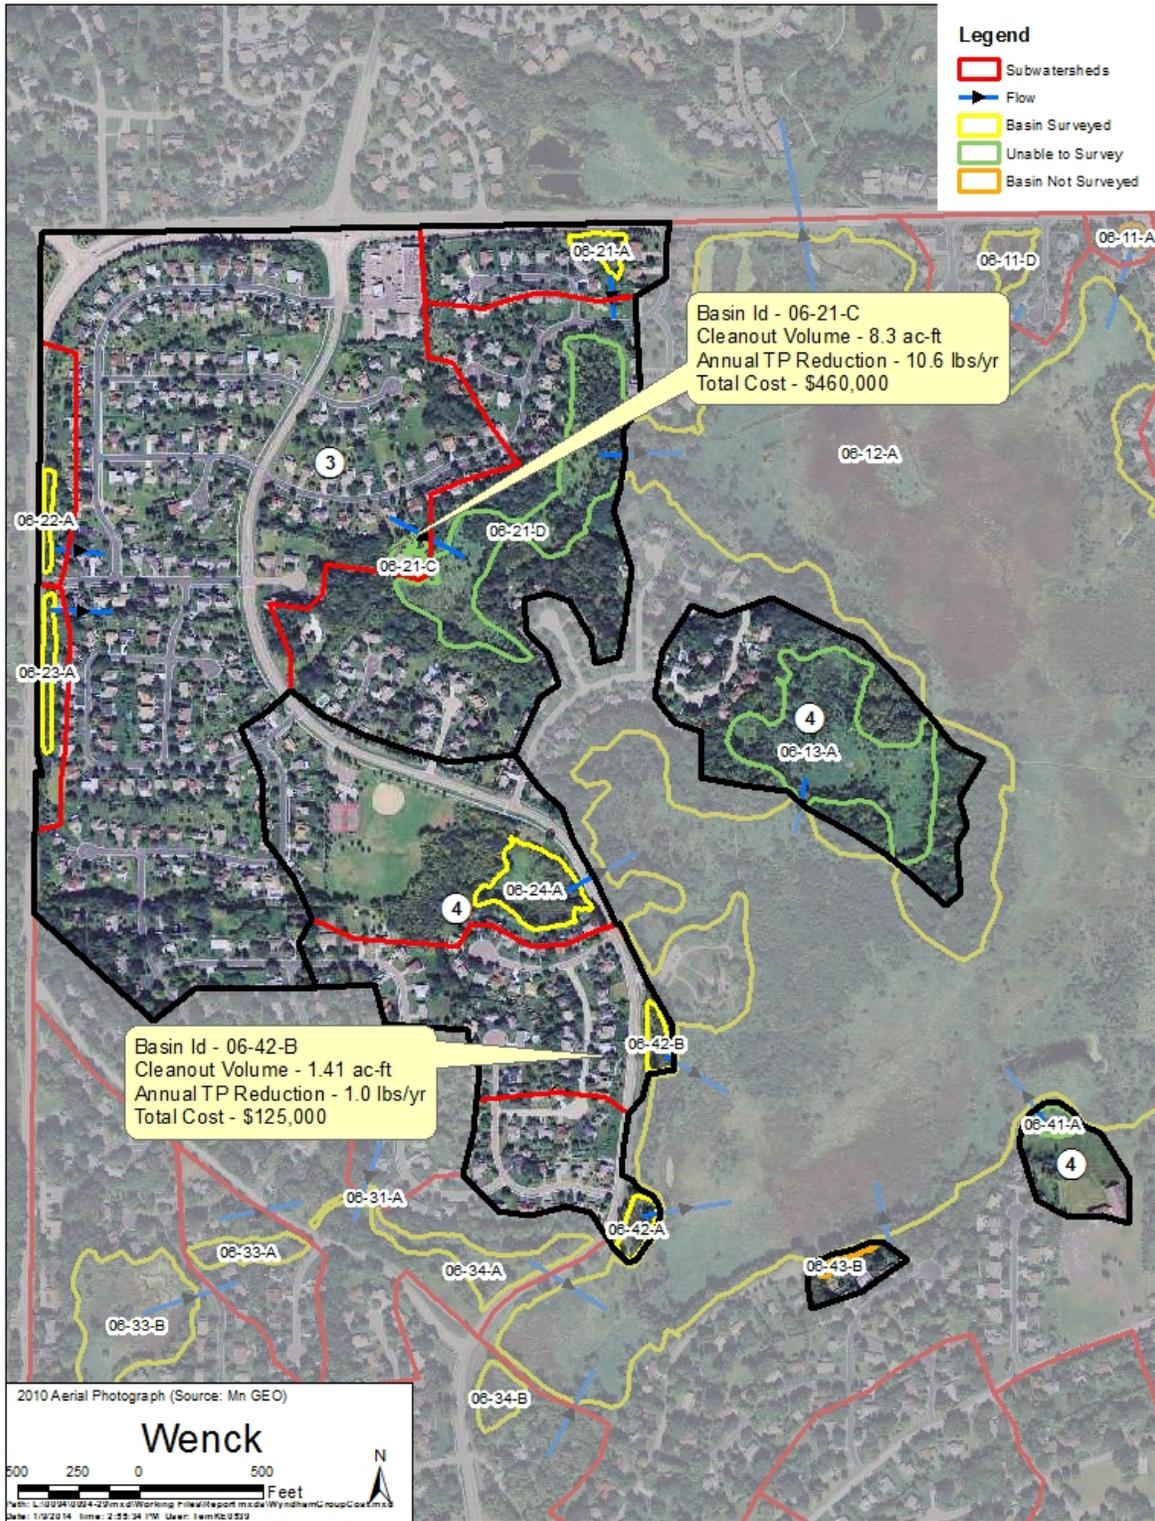
Figure 5.1. Project Locations Identified in the Wyndham Knoll Park Area.

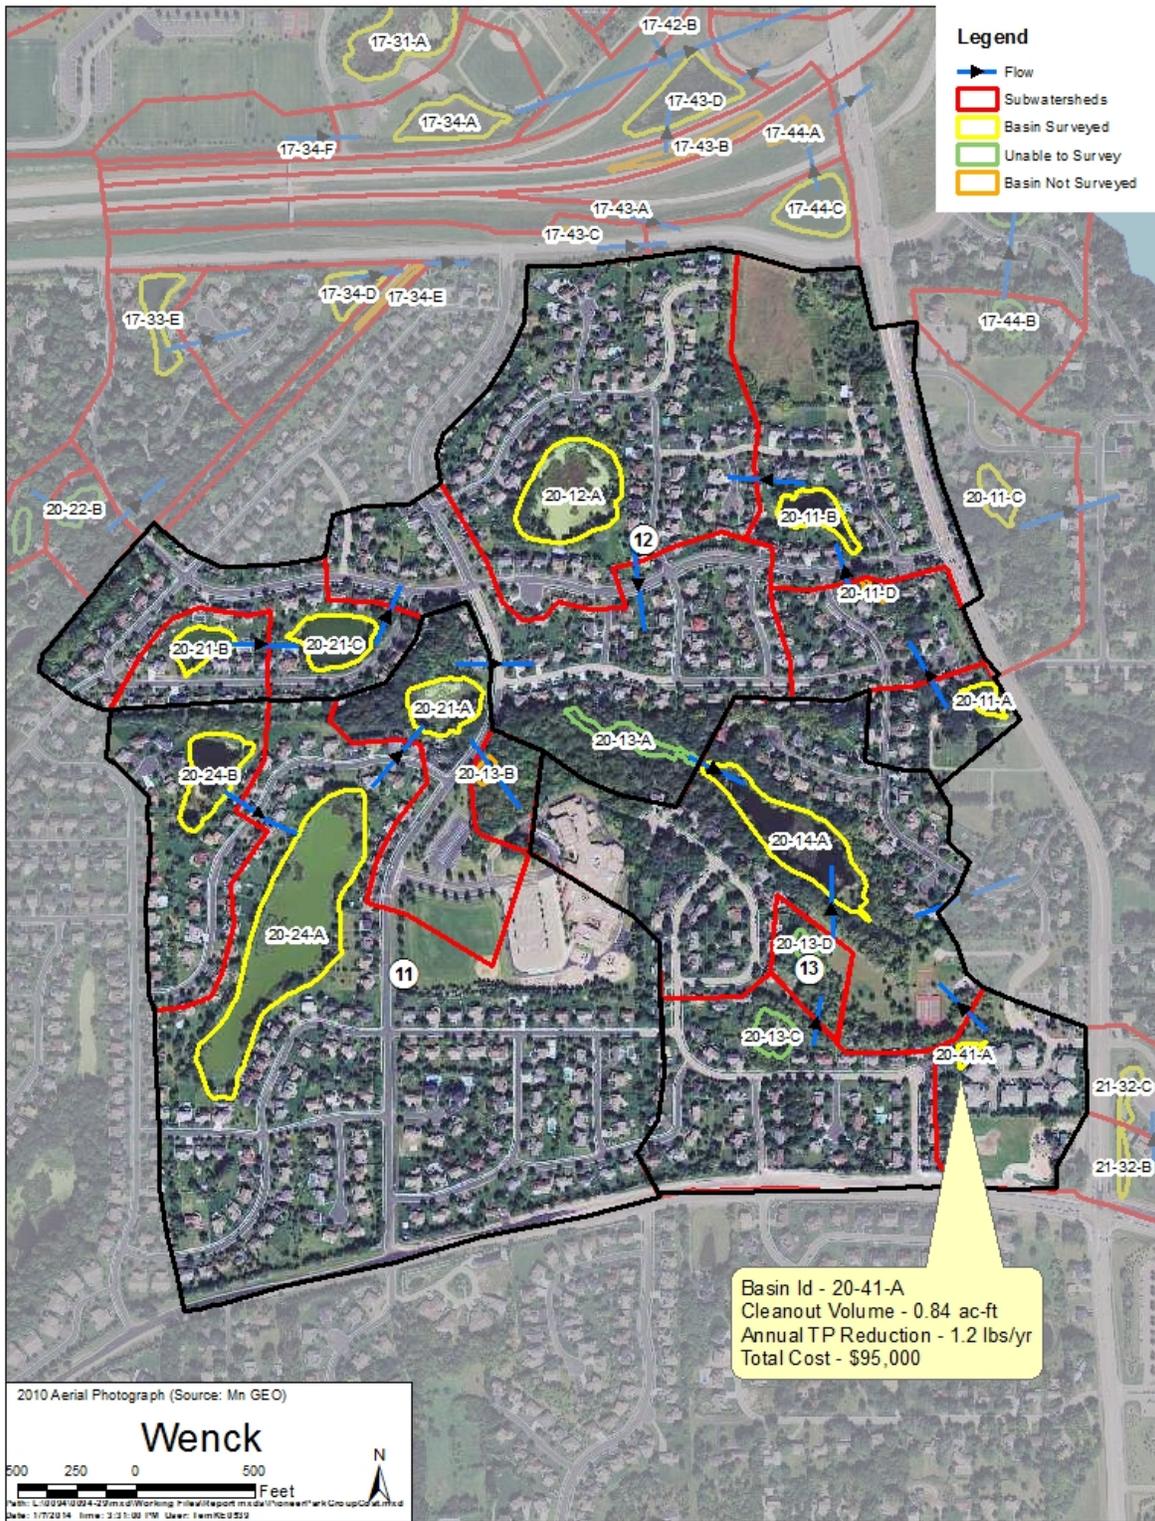
Figure 5.4. Project Locations Identified in the Pioneer Park Area.
