***Purgatory Creek  
Use Attainability Analyses***

***Prepared for  
Riley-Purgatory-Bluff Creek Watershed District***

***January 2005***

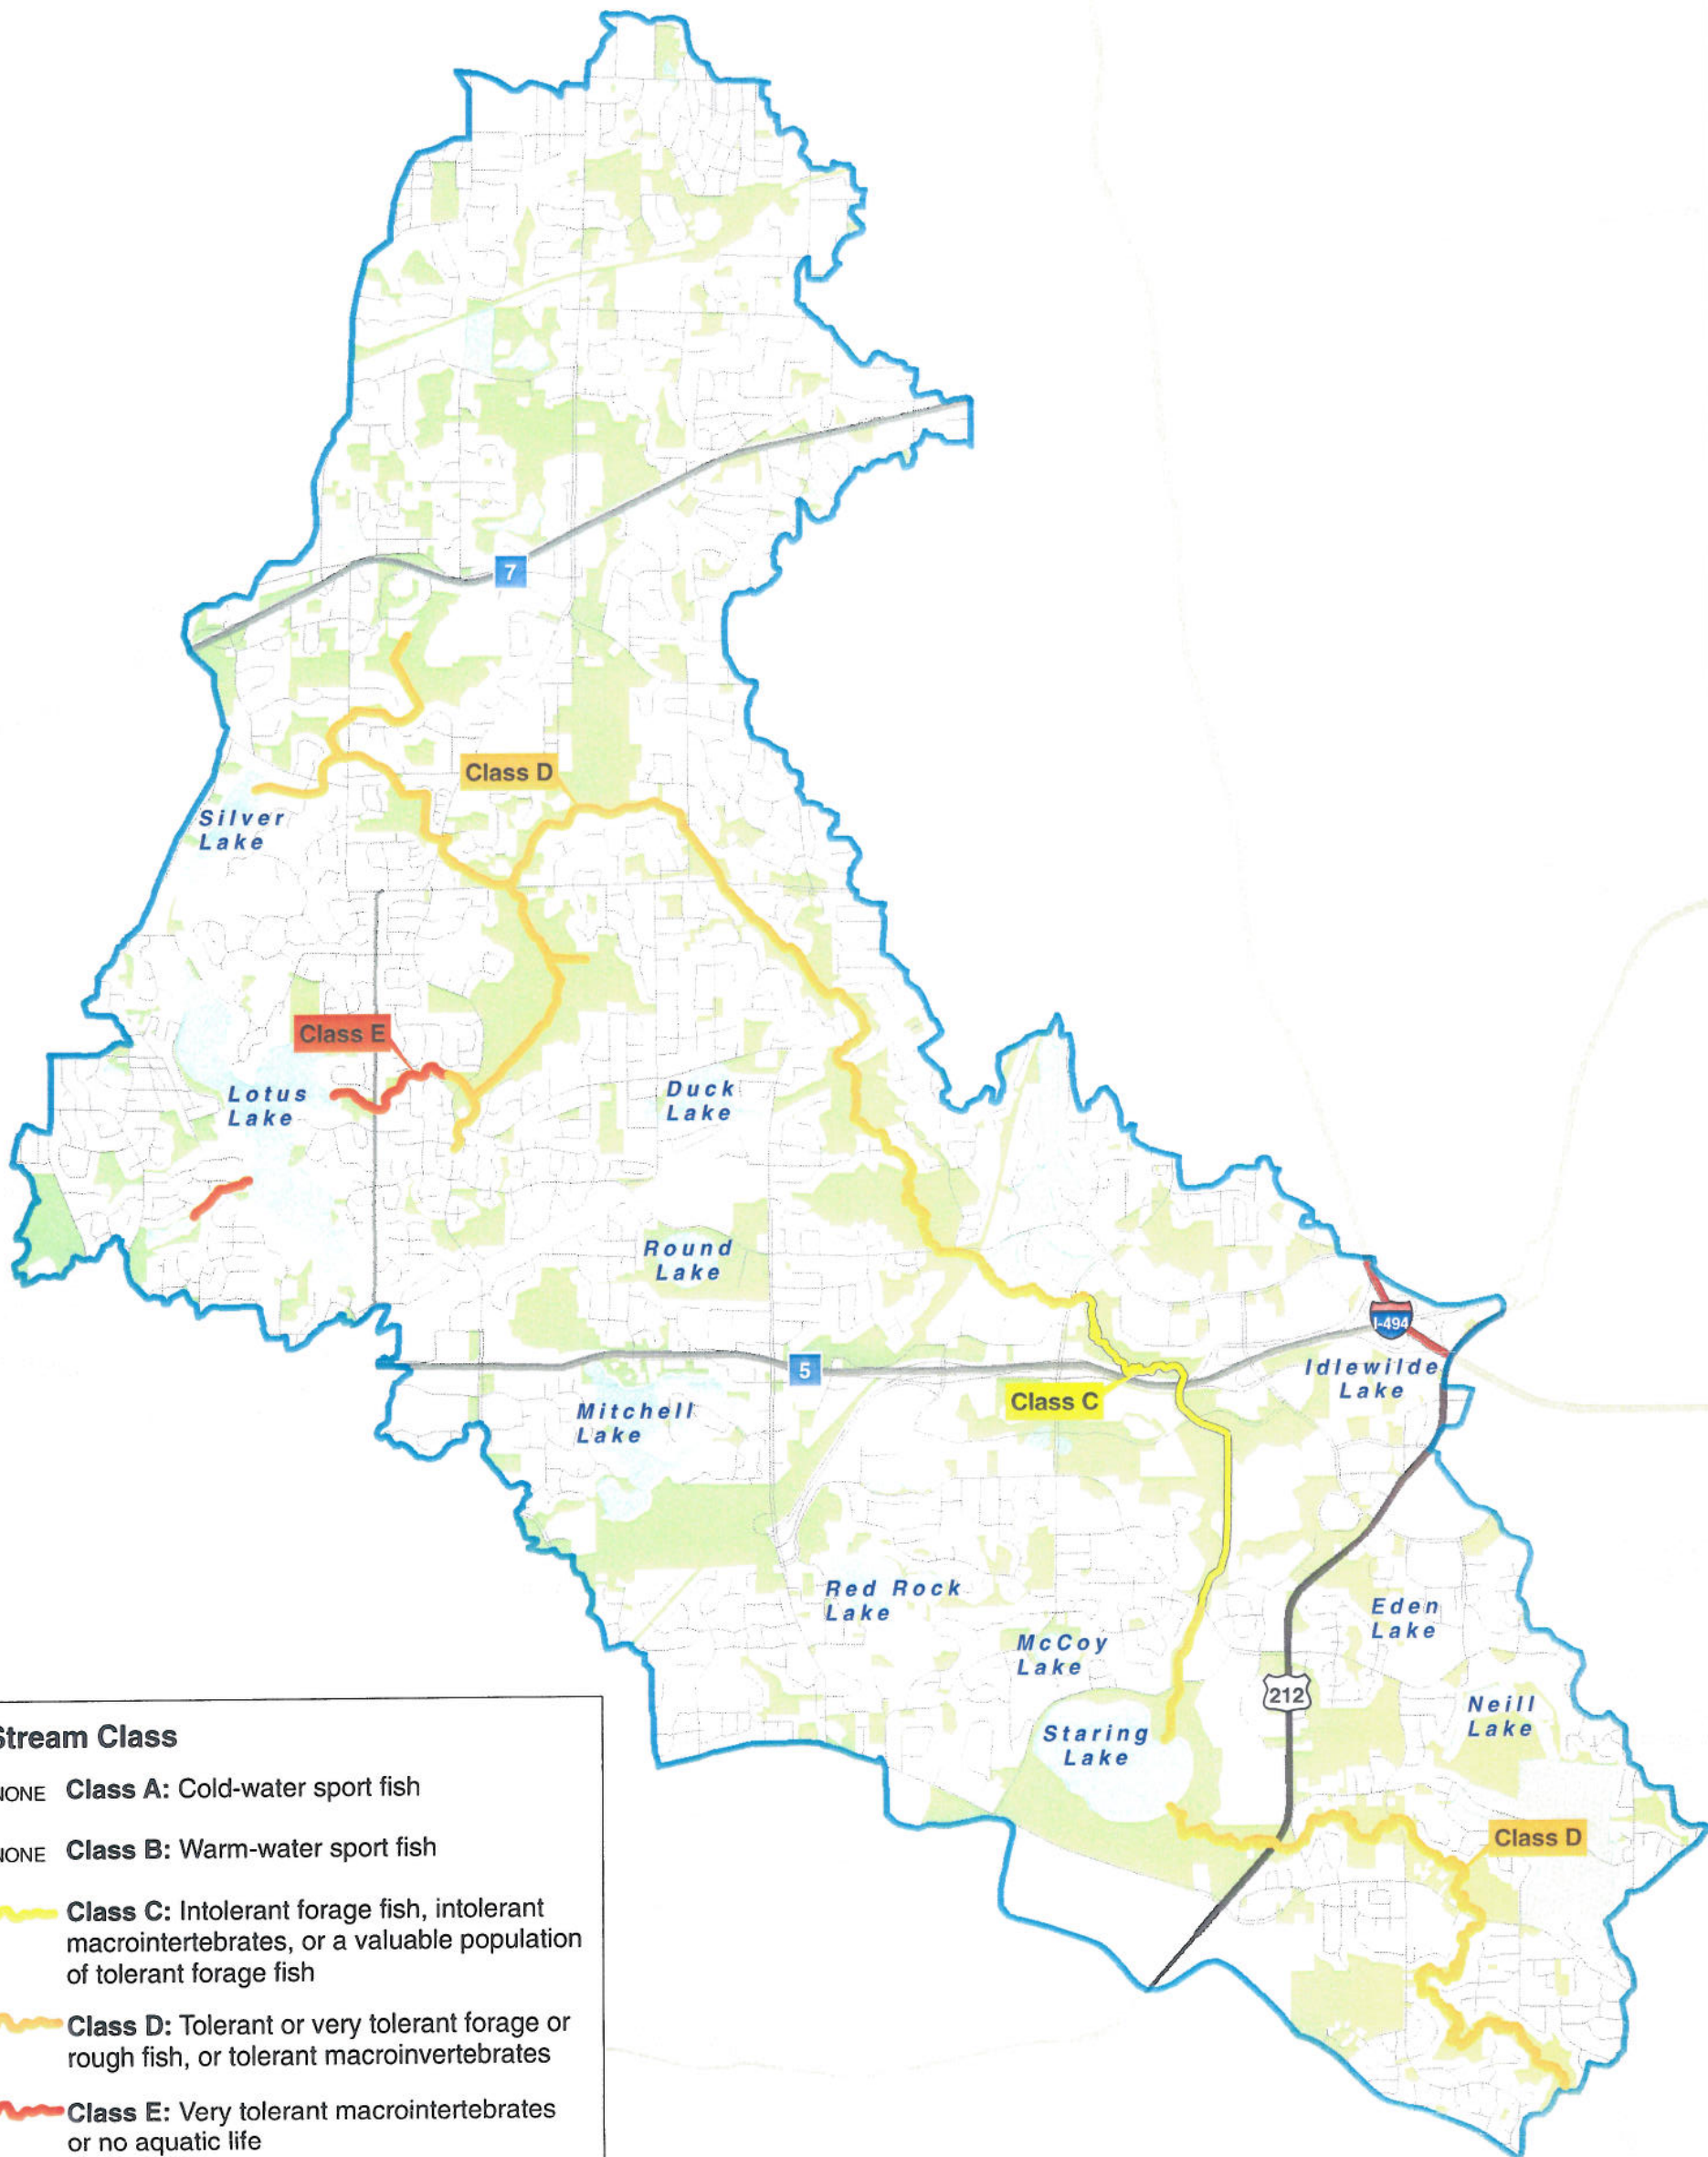
A use attainability analysis of Purgatory Creek was completed. The analysis began with a comparison of the existing, historical, and potential uses. When no differences occurred, the stream's attainable use was the same as the existing, historical, and potential uses. However, whenever the potential use was higher than the stream's biological use (existing and/or historical), an evaluation was completed to determine whether the constraining variables were controllable or uncontrollable. If the constraining variables were considered uncontrollable (i.e., not possible or not feasible to change by management practices), the attainable use was based on the stream's historical biological use. However, if implementation of feasible stream management practices is expected to attain the potential use, the attainable use was based on the stream's potential use rather than the stream's historical biological use. Whenever the stream's historical biological use was better than the stream's potential use, the historical use became the attainable use. The attainable use classification of Purgatory Creek is summarized in Figure EUC8 and Table EUC6.

The stream's attainable ecological use is generally consistent with the impervious cover of the stream's watershed. All of the stream reaches have watershed IC above 25 percent, which is the stream degradation threshold. Hence, the impervious cover model (ICM) predicts that Purgatory Creek exhibits degraded stream conditions and non-supporting stream quality (CWP, 2003). Most stream reaches noted an attainable ecological use of Class D (P-1, P-2, P-4, P-5, P-6, and P-7) and the remaining stream reaches noted a Class C use (P-3) or a Class E use (P-8). Only reach P-3 noted an attainable ecological use that is better than predicted by the ICM (See Section 3.3.1 Impervious Cover of Purgatory Creek Watershed). The long-term fish community of this reach indicates fish are able to survive despite suboptimal habitat or water quality conditions.
