Researching solutions

Management Strategies for Rice Marsh Lake and Lake Riley

Rice Marsh Lake and Lake Riley Use Attainability Analysis Update | Executive Summary

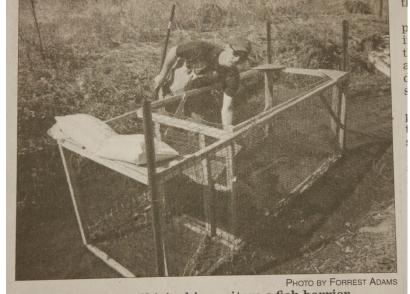
Researcher Chris Chizinski monitors a fish barrier between Lake Susan and Rice Marsh Lake.

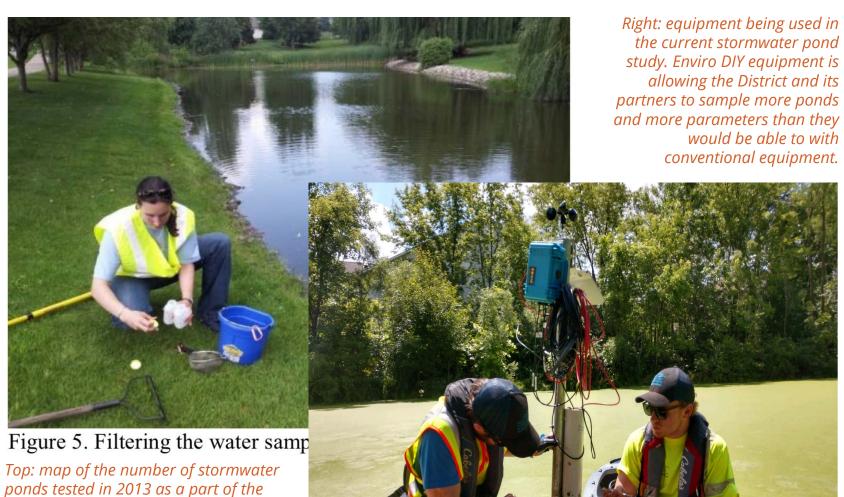
Left: District staff install Enviro DIY stormwater monitoring equipment

Despite their importance, there is little understanding of what makes an individual stormwater pond successful or not. In 2010, the District began a long-term monitoring study of local stormwater ponds¹¹, and is currently a partner in four different studies of stormwater ponds. The collected data has been requested worldwide for various research¹⁰.

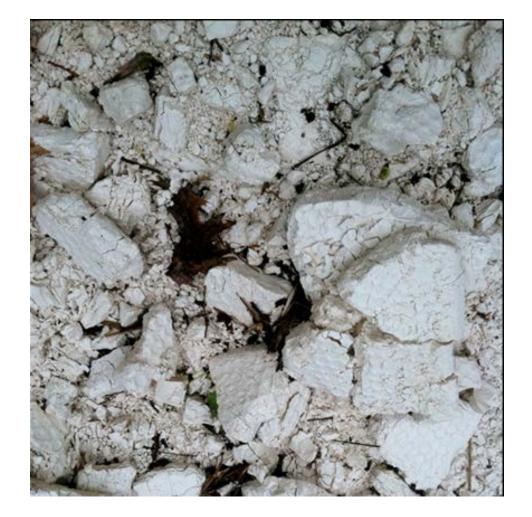
Left: the spent lime system, soon after installation

When phosphorus in the water comes into contact with the lime (which is left over from drinking water treatment) it binds to it and is filtered out²². Spent Lime is a promising but relatively new strategy, and this is the first time the District has used it. The facility was completed in 2018. The District has been conducting tests on the lime and facility as a whole in order to best understand and fine-tune this new technology.
