Implementing projects

Over the past fifty years, the District has worked with its partners to implement many projects. Explore these panels to learn about a few through history, and discover something new. None of these projects would have been possible with out the many partners that are a part of the watershed district community.

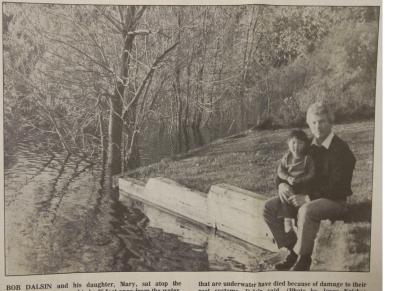
BOB DALSIN and his daughter, Mary, sat atop the retaining wall that used to be 25 feet away from the water. All that remains of their former beach is at their feet. Trees Local residents show property flooding (EPN)

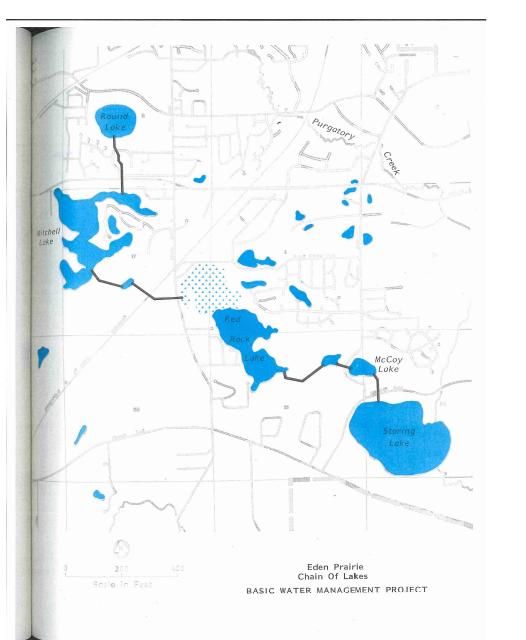
Far left: map from the Chain of Lakes project, showing pipe sections to be installed (MNHS)

One of the largest projects in the District's history, the Chain of Lakes Basic Water Management Project sought to stabilize water levels and prevent erosion in Round, Red Rock and Mitchell Lake, and McCoy pond. These water bodies did not have natural outlets, and rapid development during the late 1970s and early 1980s had caused the lake levels to rise significantly. Severe flooding in the mid- 1980s made it clear that something needed to be done.

In 1984 alone, the city of Eden Prairie had to pump over 120 million gallons of water from Round Lake into Mitchell Lake. Subsequently in 1985, the city petitioned the District to pursue the "Chain of Lake Basic Water Management Project" - the installation of surface water outlets connecting the water bodies. Excess water would flow from one water body to the next, finally entering Purgatory Creek via Staring Lake⁹. This project was first proposed in the District's 1973 Overall Management plan, and after three years of active planning, broke ground in 1987¹⁰. <section-header><text><text><text><text><text>

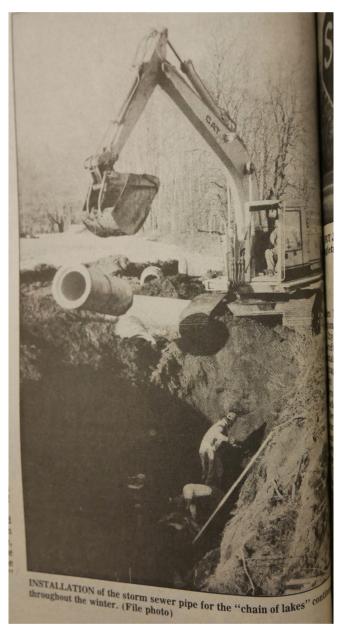
Near left: photo of construction of the storm water pipes for the project (EPN)

The District paid for the construction work, and the city agreed to pay for maintenance after it was completed. The project was constructed all at once to prevent the risk of flooding one area due to backups from an incomplete system. The construction proceeded on schedule and was finished in under a year⁵. The Chain of Lakes project was successful, helping to maintain a steady water level in all of the lakes and manage major flooding.

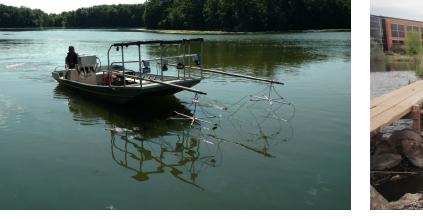
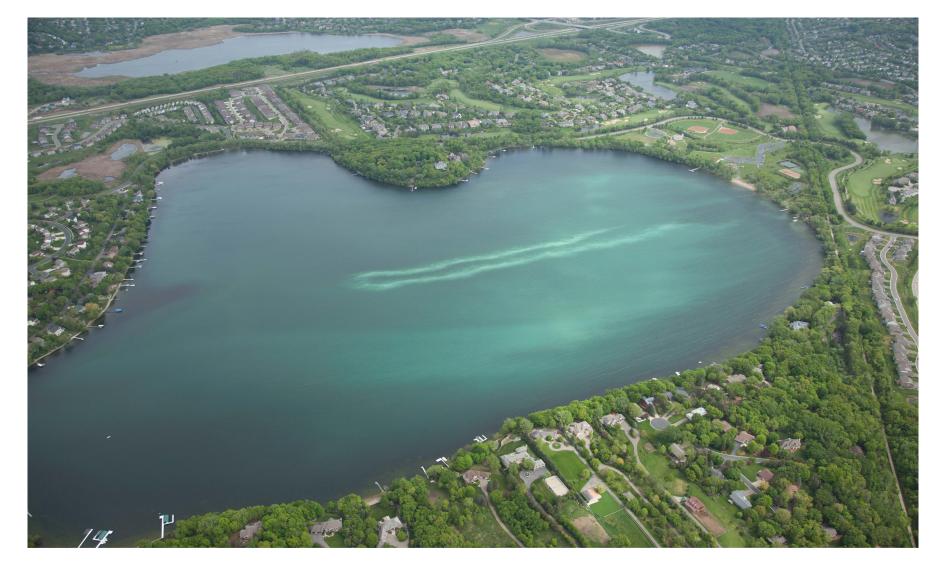
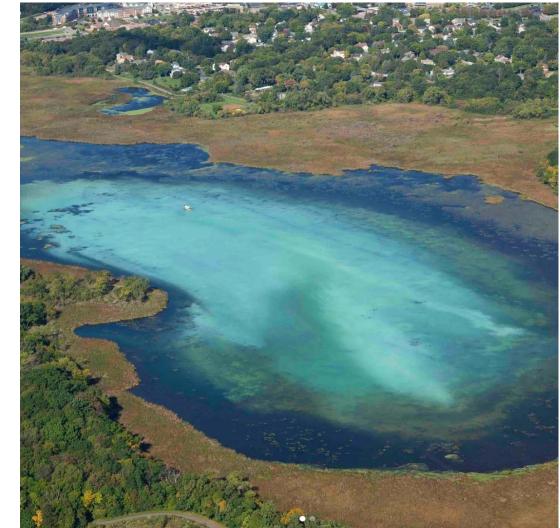
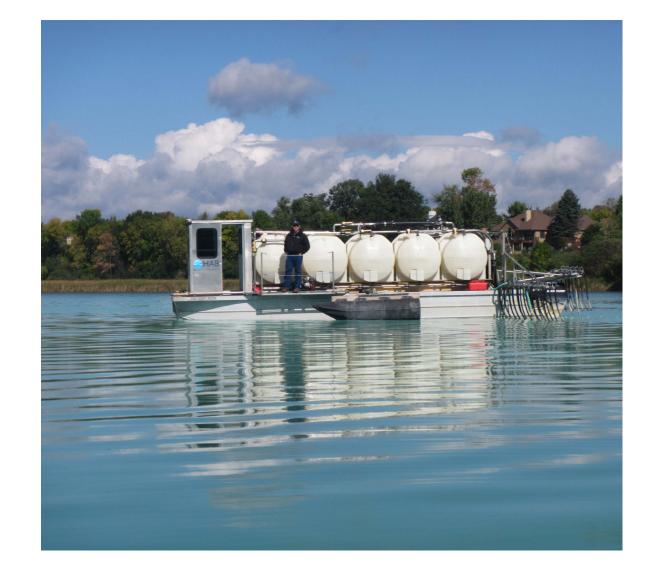
Bottom left: a light blue streak shows the path of the alum treatment barge on Lake Riley

Bottom middle: the bright blue-green water reflects the addition of the alum to Rice Marsh Lake

Bottom right: an alum barge Top right: an electrofishing boat for monitoring carp Top far right: interns net carp

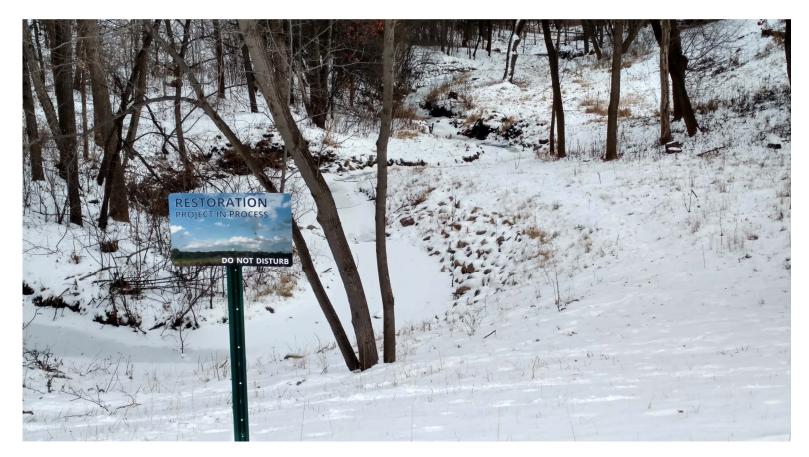
Photos: the restoration site on Purgatory Creek at County Roads 101 and 62. This was the District's first creek restoration project

In 2011, the City of Minnetonka petitioned the District to investigate and stabilize eroded areas of Purgatory Creek by the intersection of County Roads 101 and 62¹³. In 2014, Barr Engineering reported on 25 individual erosion sites along a 2,000 ft stretch of the creek¹⁴. This stream stabilization was the first project undertaken by the District to focus on creek restoration, and was completed in 2016¹³.

The project involved using a variety of methods to help slow and prevent erosion of the creek. The project used a variety of common and effective practices to prevent further erosion and restabilize the bank, including re-grading the bank slopes, installing rip rap, slowing stream velocity, and using vegetation to protect and anchor the topsoil. It was also necessary to remove an old, partially collapsed culvert, remove and replace riprap at a storm sewer outlet, and to reroute the stream around a stormwater pond to prevent increased erosion downstream¹⁴.

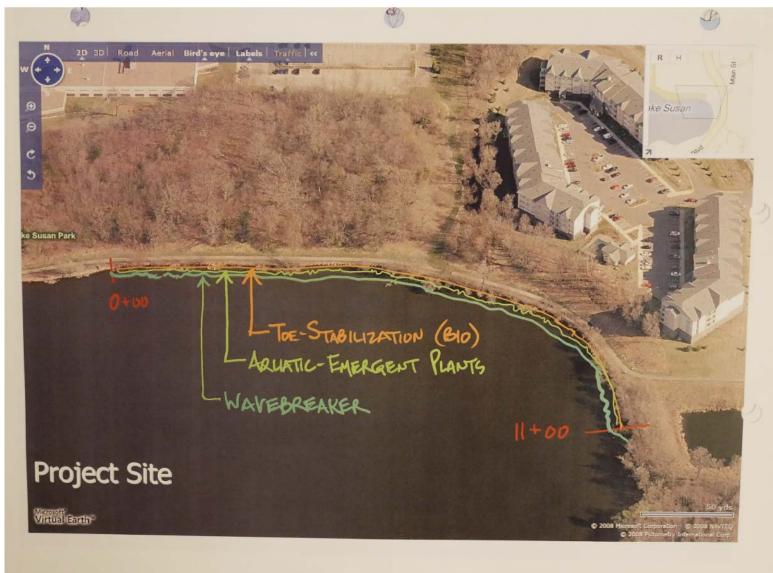
Design plans for the Lake Susan Restoration initiative from the project contractor (MNHS)

The project restored 1,030 ft of shoreline. Most of this area only required "soft measures" - planting native vegetation, placing cedar trees along the shore as wave-breaks, and using coconut-fiber "biologs" to help keep the soil in place. However, a 30ft stretch of shoreline was already so eroded that more intensive restoration was needed¹⁵. This included caged riprap and vegetated geotextiles - specialized layers of soil replacements with native plants¹⁶.

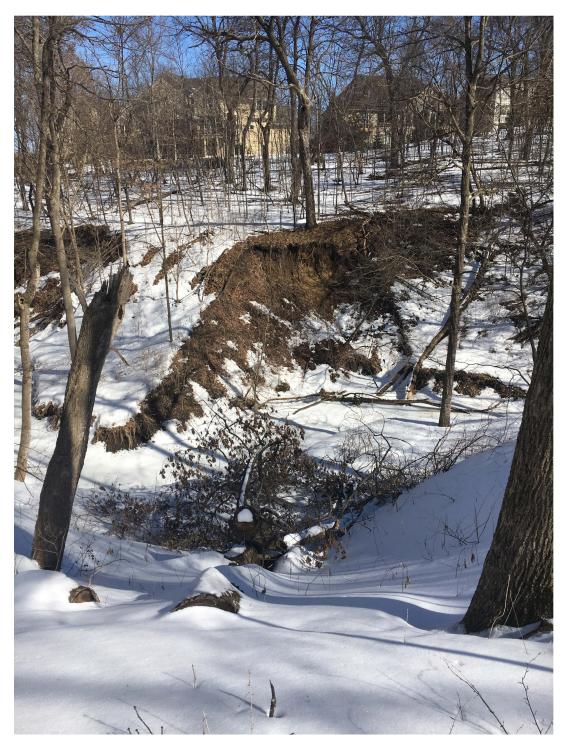
Below: an example of one of the slope failures in this reach

The project area includes 4,600 ft of Lower Riley Creek (Reach E) between Eden Prairie Road and Dell Road, as well as 375 ft of ravine (Site D3) that carries urban runoff to the creek. The project plans include reducing erosion, improving water quality, and improving natural stream habitat for aquatic organisms¹¹. To accomplish this goal, the plan includes a variety of improvement strategies, listed below. Each of them will provide either greater stream depth variability, more channel bed substructure types, or varied channel velocities.

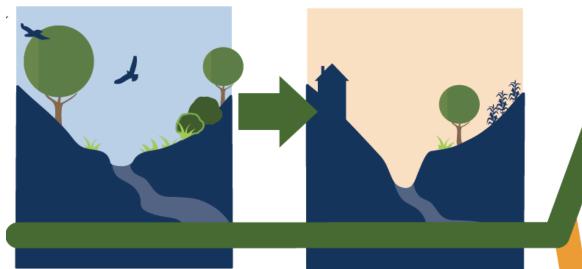
200 Years ago

Now

more water soaked into the ground when it rained, and less flowed into the creek. The creek channel was connected to its floodplain, and water spilled out during heavy rains, slowing the flow of the creek. Native plants with deep roots held the soil in place and created habitat for fish and animals.

less water can soak into the ground because of houses, roads, and other impervious structures that have been built. More water rushes more quickly to the creek, increasing erosion. The creek bed has eroded deeper, and is cut off from the floodplain, further increasing the power of the stream to erode its

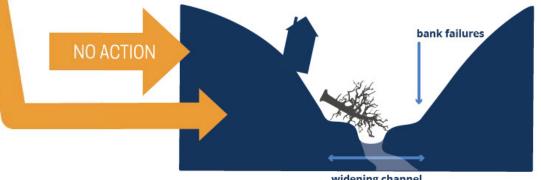
What Does Restoration Look Like?

196
Rock riffles	VRSS/Toe stabilization	Root wads	Cross vanes
Cravel or cabble sized	Soil lifts created with a	Tree trueks with the reet	Rouldors buried in the stream

material installed in the stream bed to create bed and extending partially or combination of root wads and ball attached, installed to Increase bank roughness entirely across the stream to long-lasting, biodegradable natural flow patterns and fabric and vegetated to and resistance to erosion, re-direct flows away from control stream bed elevations. The variety in re-direct flows away from banks, and provide for stabilize steep slopes and banks, encourage sediment deposition in selected areas, encourage establishment of flow and channel root systems for further establishment of vegetation, and control stream bed ubstrate size provides elevations. Scour pools develop eates overhanging bank over time near the vane, which habitat diversity for undercut/overhanging bank habitat features. aquatic species provide habitat diversit
