Water Resources Report

RILEY PURGATORY BLUFF CREEK WATERSHED DISTRICT
2018 ANNUAL REPORT

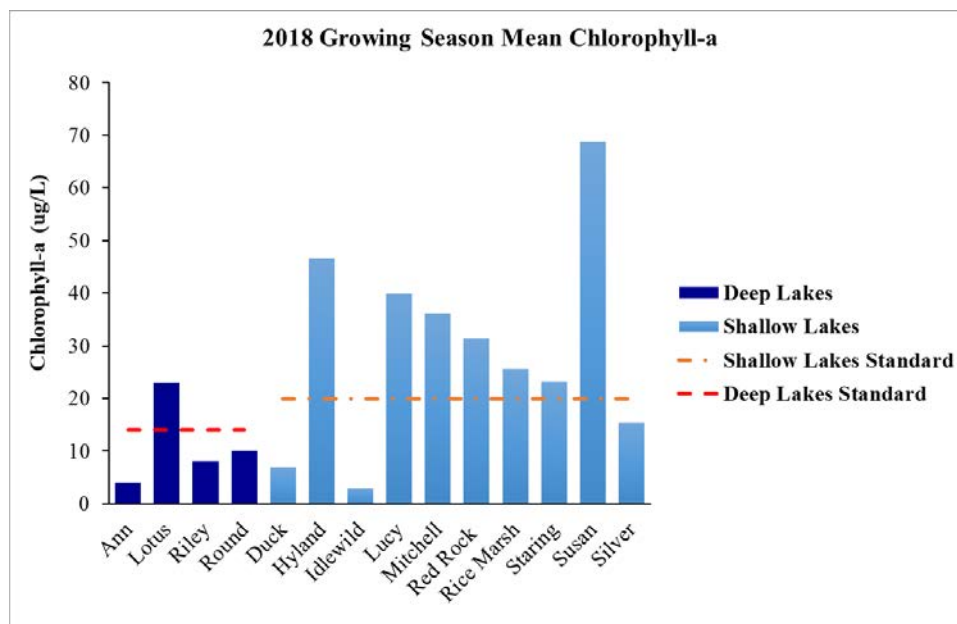
Figure 4-1 2018 Lake Growing Season Mean Chlorophyll-a

Overall, six of the 14 lakes sampled in 2018 met the MPCA Chl-a standards for their lake classification (six lakes also met standard in 2017, although not the same lakes): Lake Ann, Duck Lake, Lake Idlewild, Lake Riley, Round Lake, and Silver Lake.

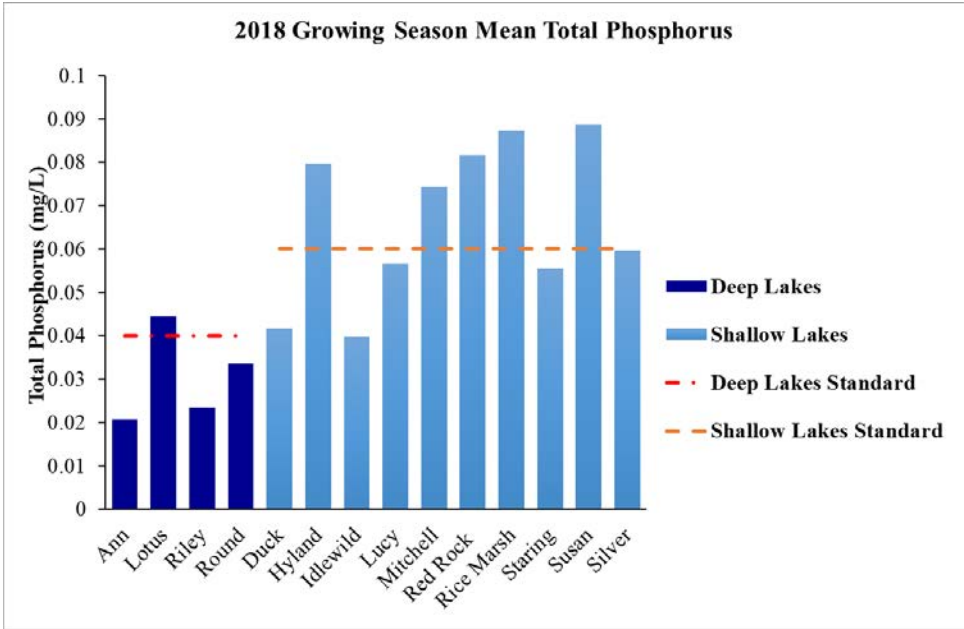
Figure 4-2 2018 Lakes Growing Season Mean Total Phosphorus

Overall, eight of the 14 lakes sampled met the MPCA total phosphorus standard for their lake classification in 2018: Lake Ann, Duck Lake, Lake Idlewild, Lake Lucy, Lake Riley, Round Lake, Silver Lake, and Staring Lake.

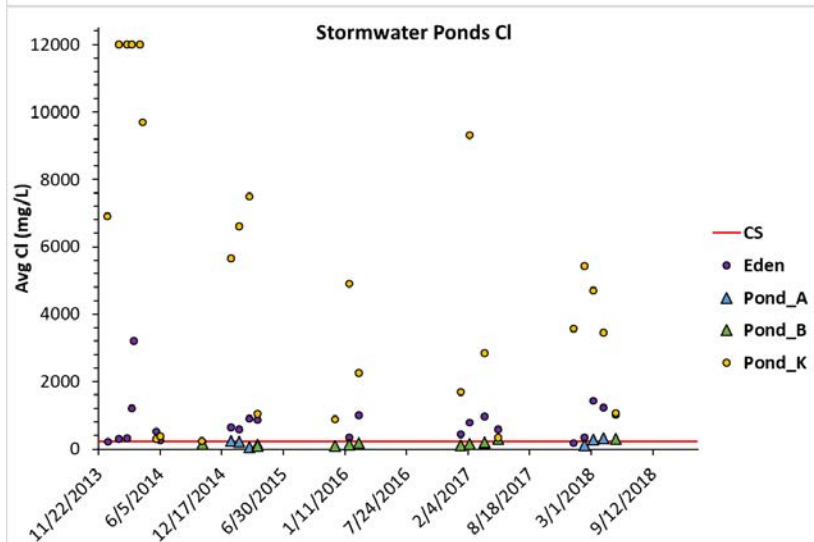
Figure 4-9 2013-2018 Chloride Levels within Stormwater Ponds

Figure 4-9 shows Cl levels within the four stormwater ponds, which includes all sampling events since 2013. In the spring of 2015, staff were no longer able to take accurate water samples on Pond A due to low water levels, so, sampling began on Pond B, directly upstream. In 2018, due to inconsistencies with getting samples without disturbing sediment, staff reverted to sampling Pond A in place of Pond B for several monitoring events. Most samples taken from Eden Pond greatly exceed the class 2B CS, some exceeding the class 2B MS. Except for two sampling events, all samples taken from Pond K exceed the class 2B MS, although, there has been a noticeable drop in Cl levels since sampling began in 2013. It is important to note that these stormwater ponds are not classified as class 2B surface waters by the MPCA; the CS is given in the figure to demonstrate how much higher Cl levels accumulating within these ponds are before water moves into Purgatory creek. Staff will continue the winter monitoring of Cl in the Purgatory Chain of Lakes in 2019 which will include: Lotus, Silver, Duck, Round, Mitchell, Red Rock, Staring, and Hyland Lake. Rice Marsh Lake will also be monitored for Cl in the 2019 winter, along with the stormwater ponds draining Eden Prairie Center, UPCRA, and LPCRA. Once-a-month Cl sampling will continue as part of sampling SOP's during the regular growing season on both lakes and streams.

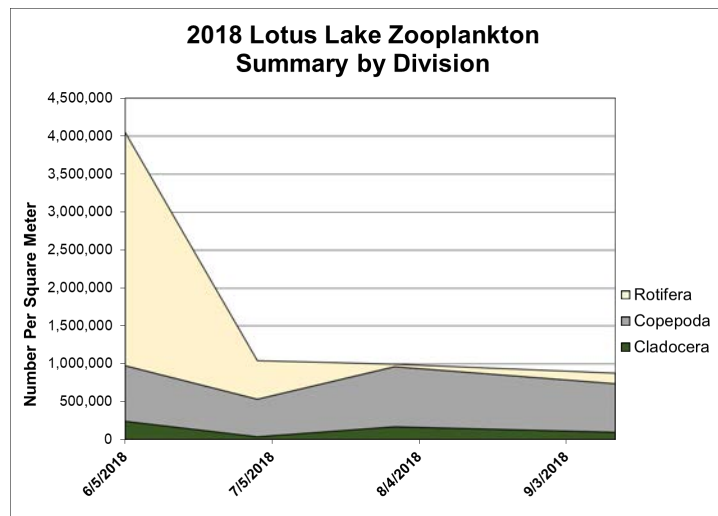
Figure 4-14 2018 Lotus Lake Zooplankton Counts (#/m²)

In 2018, all three groups of zooplankton were present in Lotus Lake (Exhibits C). Rotifers were the most abundant zooplankton sampled (Figure 4-14). June rotifer numbers were high (3 million) before declining to 511 thousand in early July and less 176 thousand for the remainder of the year. Copepod numbers remained relatively level throughout the year averaging 600 thousand across all sample dates. Cladoceran numbers began at 246 thousand in June before decreasing to an average of 100 thousand for the remainder of the year. The highest spring Cladocera numbers can be attributed to largest abundance of *Daphnia retrocurva* sampled in 2018. *Daphnia retrocurva* is known for its large curved helmet it develops in late spring-to-summer to reduce predation by planktivorous fish and invertebrates.

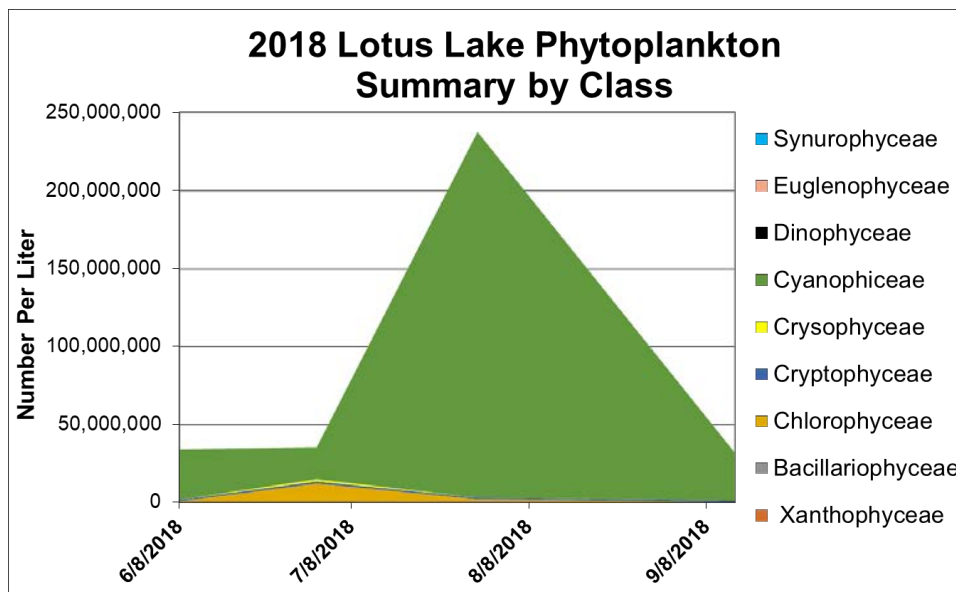
Figure 4-16 2018 Lotus Lake Phytoplankton Abundance (#/L) by Class.

During the summer of 2018, staff collected four phytoplankton samples on Lotus Lake (Exhibits D). The abundance of phytoplankton across all sampling dates is presented in Figure 4-16. Cyanobacteria was the dominant species across all sampling dates (96%, 58%, 99%, and 96% total phytoplankton abundance by sampling event). The June cyanobacteria population was dominated by *Aphanothece* sp. which may produce toxic compounds. *Aphanizomenon* sp. was the dominant species of cyanobacteria for the remainder of the year with a massive spike occurring in late July. *Aphanizomenon* are a potential cylindrospermopsin, anatoxins, and saxitoxins producer.

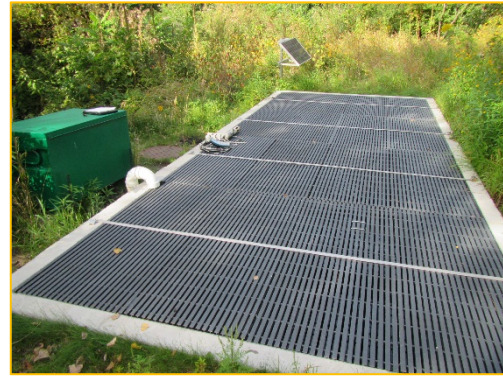
Figure 4-28 Spent Lime Treatment System

Observation and monitoring data collected by District staff in 2016, suggested the system was underperforming and inundated for extended periods, which deviated from the original design parameters. In the spring of 2017, Barr completed additional field investigations, and laboratory testing for the Lake Susan spent lime system. Utilizing spent lime from the system, it was found that soluble reactive phosphorus (SRP) removals were on the order of 80-90%; within column tests which simulate the contact time within the Lake Susan system, removals were 30-40%. Additional testing led to modifications to attempt to improve system performance and address observed short-circuiting of flow through the system at no cost to the District. These modifications included the replacement of the cleanout pipes to eliminate leaky joints, modification of the header pipe so that pipe joints have welded connections, filling holes at the bottom of splash basin at the entrance to the system and of the monitoring hole in the side of the chamber, adding additional spent lime to the system, and removal of one stoplog in the manhole with the intention of promoting water level fluctuation in the spent lime system. Following the modifications, the system was put online for the summer of 2017 and was sampled weekly during the summer and into the fall. Similar to 2016, the system continued to underperform in 2017.

In 2018, sampling ports were installed at various locations within the spent-lime and monitored to allow the District and Barr to see removals throughout the spent lime layers. Monitoring results within the spent lime were again highly variable and did not indicate the consistent removal of nutrients. Due to the observed differences in water levels between the water on the surface of the media and the underdrain system, the reduced ability to extract water from the sampling port within the spent lime by mid-summer, the observation of no flow through the media during bucket tests at the site, and limited shifts in pH, it is hypothesized that the water is unable to contact or filter through the spent lime. Therefore, the material has significantly limited opportunity to form the calcium precipitates and remove phosphorus.

- Mixing spent lime with sand to increase filtering capacity.
- Replace two clean outs with perforated pipe to increase flow through the system.
- Modify the inlet so that inflow can be more precisely controlled to limit inundation duration.
- Modify the underdrains so water flows upward through the filter media to an overflow to increase water contact time with the spent lime.
- Adding baffles within the filter to create a longer flow path and extend residence time to increase phosphorus reductions.

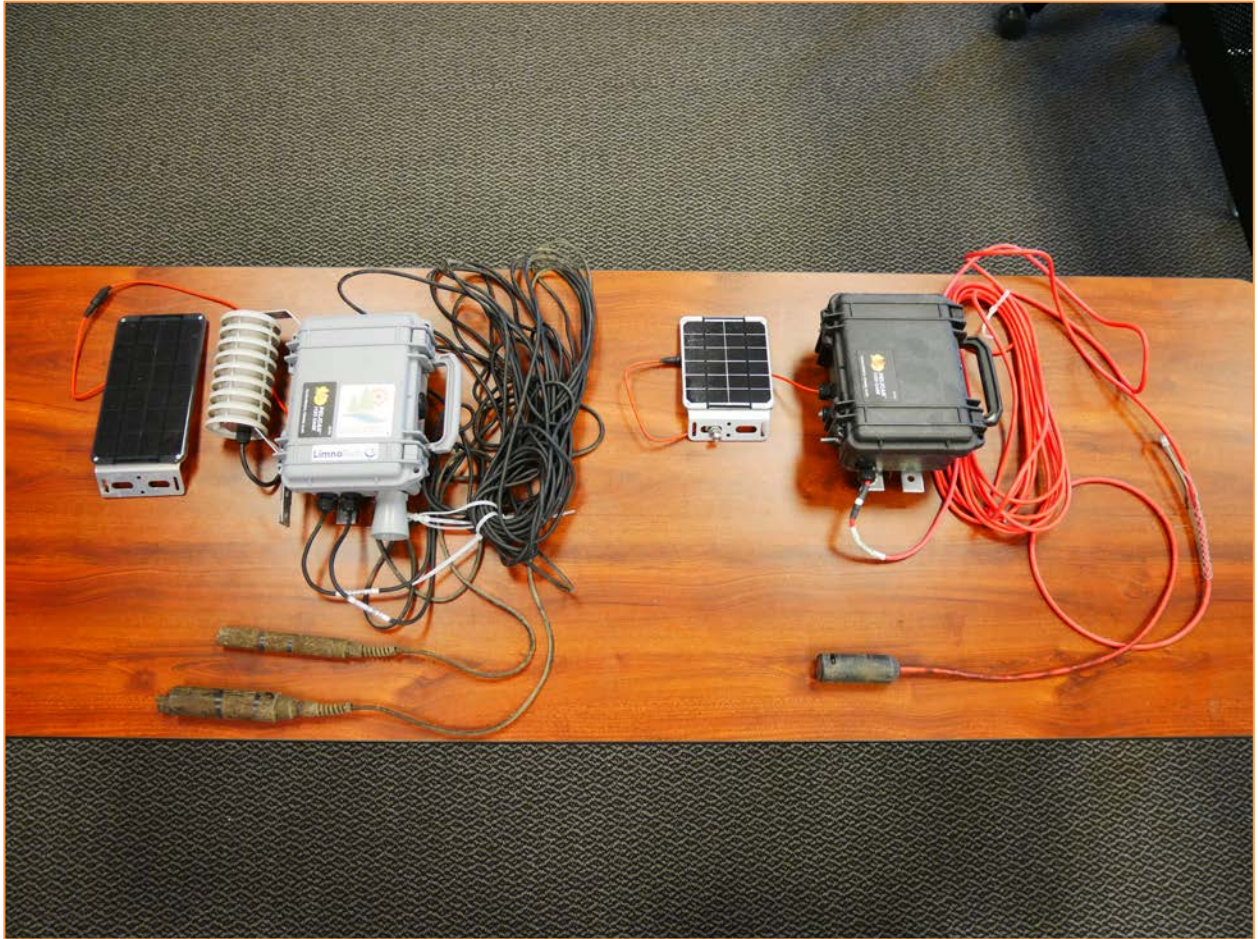
Figure 4-33 EnviroDIY Water Monitoring Stations

On December 13th, the District hosted another day-long workshop, led by LimnoTech staff, on programming, setup/connecting to, and troubleshooting/changing code of the EnviroDIY stations. In the week prior to this workshop, staff worked through a series of online tutorials on setting up and connecting instruments and devices to microprocessor boards, as well as tutorials on introduction to programming and accessing online repositories and resources. During the workshop, staff learned how to use existing, open-source code (found via code libraries provided by the EnviroDIY online community) to digitally locate and activate station sensors, as well as change and write code in order to make the sensors collect and log data. After completing this training, staff purchased parts to build two more general water monitoring sensors for the 2019 season. In total, the District has 10 EnviroDIY stations: eight built and programmed, and two which staff will assemble and program in 2019. Of these stations, four were installed at different sites around the District as a test deployment in 2018 (two general stations and two lake level stations). After some troubleshooting of sensor programming, these stations all measured and logged data continuously until they were removed for the winter (each station was programmed to collect sensor readings at a set interval, e.g. every 15 min). Staff plans on deploying all 10 in 2019.

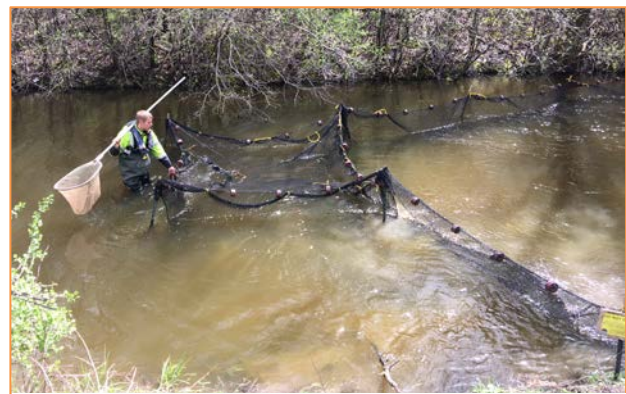
Figure 5-8 Large floating trap net deployed in Purgatory Creek.

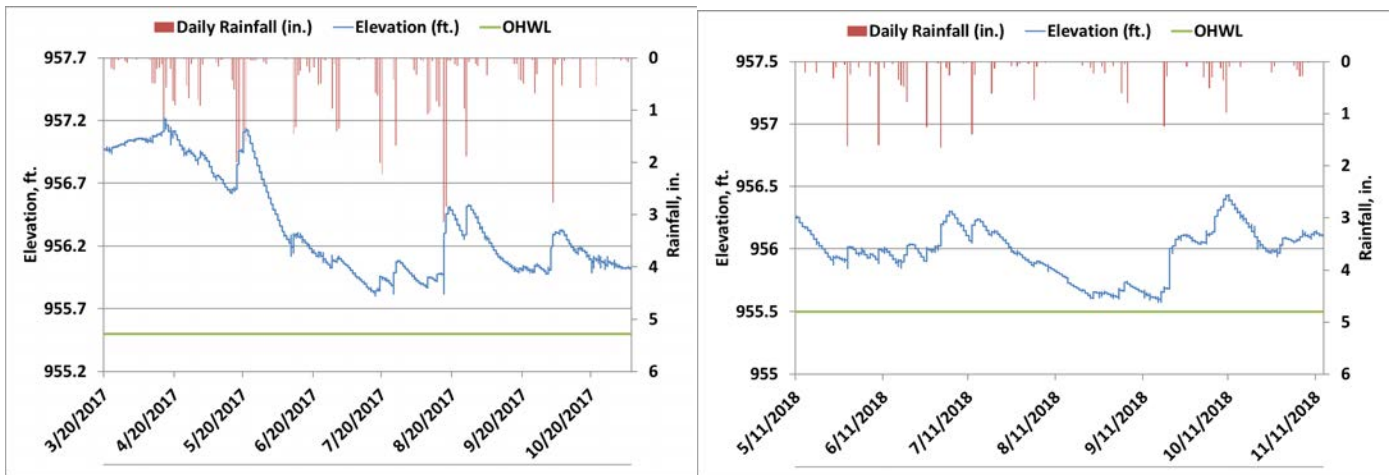
Figure A-1. **Lake Ann** level elevation data (ft.) for 2017 and 2018 along with the lake's ordinary high-water level (OHWL). Daily rainfall (in.) is displayed along the top of the graph (NOAA).

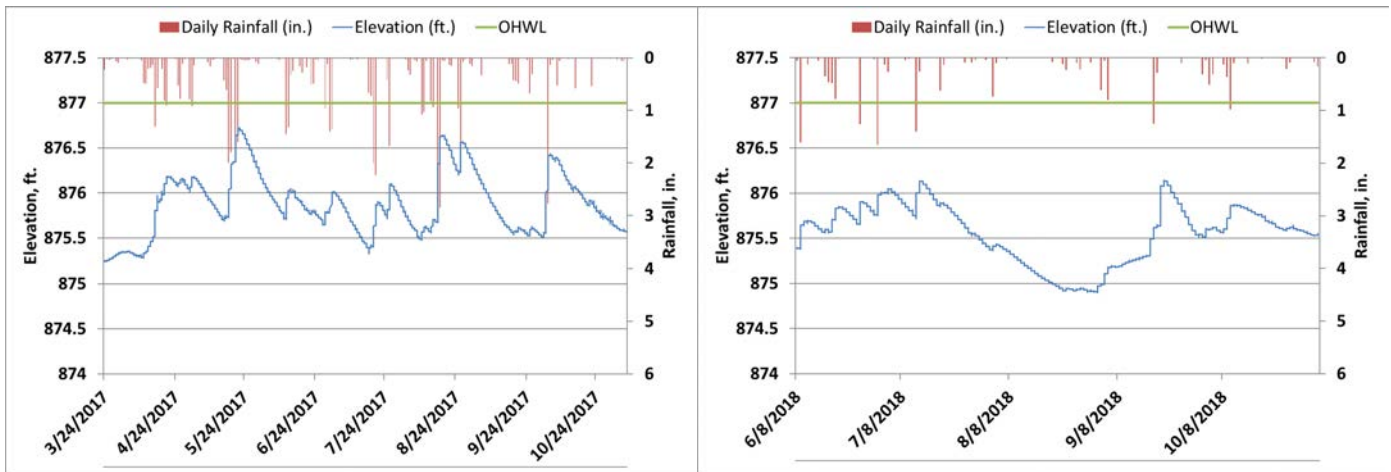
Figure A-9. **Rice Marsh Lake** level elevation data (ft.) for 2017 and 2018 along with the lake's ordinary high-water level (OHWL). Daily rainfall (in.) is displayed along the top of the graph (NOAA).

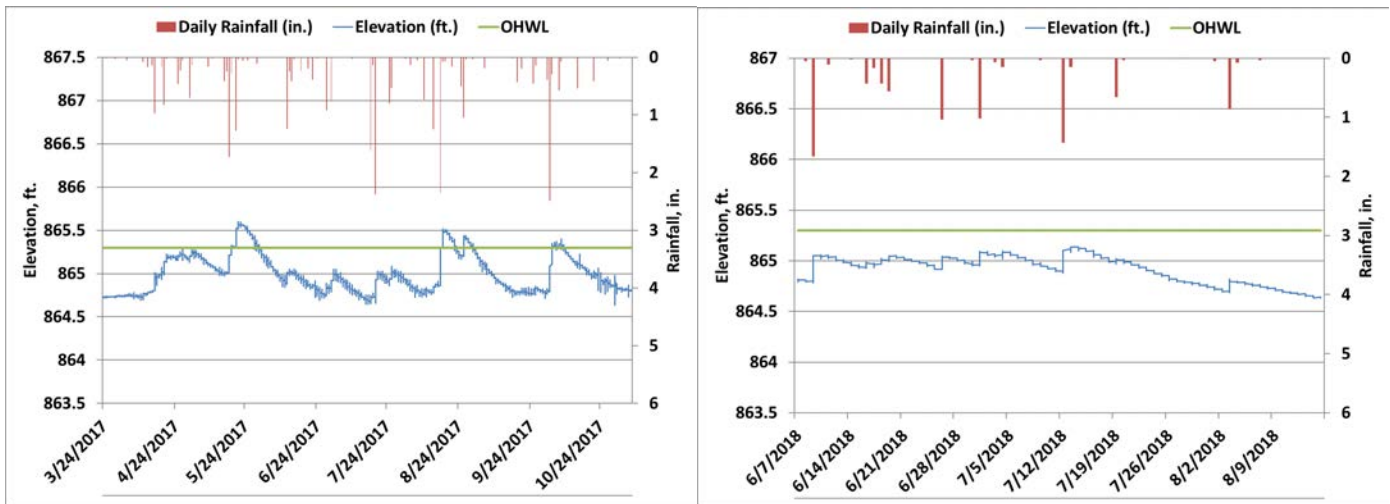
Figure A-10. **Lake Riley** level elevation data (ft.) for 2017 and 2018 along with the lake's ordinary high-water level (OHWL). Daily rainfall (in.) is displayed along the top of the graph (NOAA).

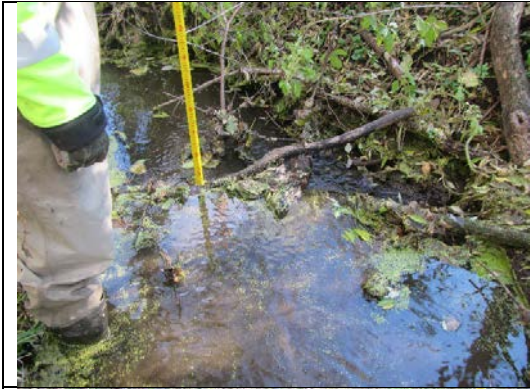
<p>IMG_3597</p> <p>Woody debris dam causing water to pool.</p>

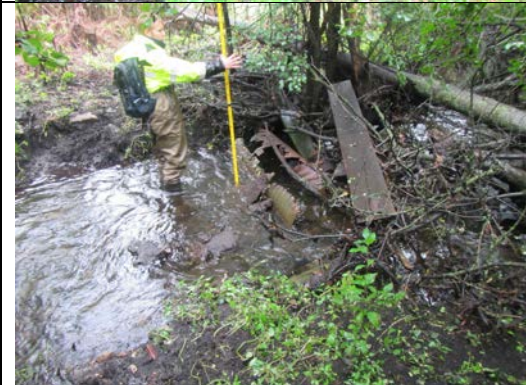
<p>IMG - 3514</p> <p>Rusted metal culvert in debris dam.</p>

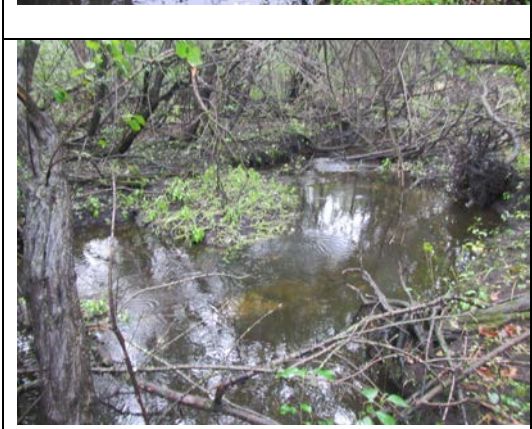
<p>IMG - 3517</p> <p>General stream photo; deposition island.</p>
