Annual Report 2022

Message from the Administrator

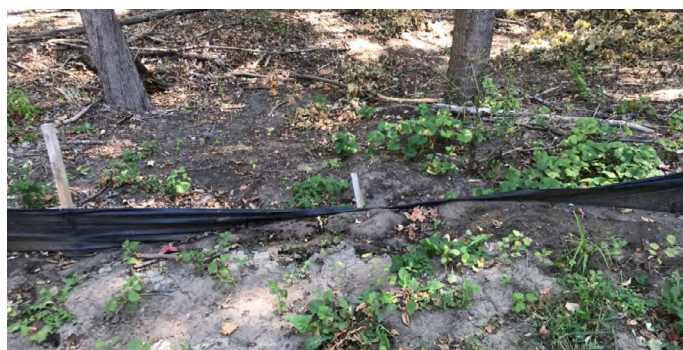
District staff inspect project sites and direct permit holders to take corrective actions as needed to protect water quality. The image above shows a silt fence violation (failure) at a site in 2022.

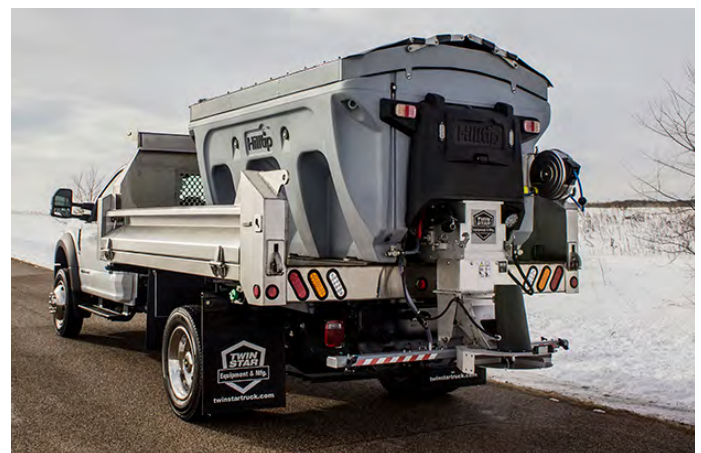
Eden Prairie Independent School District #272 used Chloride Reduction Grant Funds to replace two outdated salt spreaders with more advanced equipment that can be calibrated to conditions and ultimately reduce salt use.

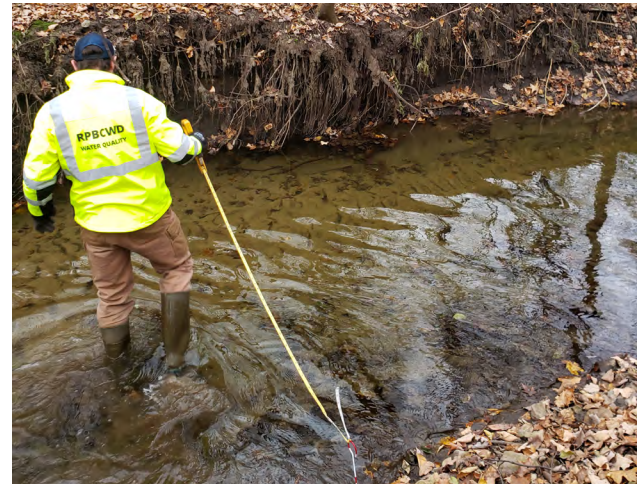
Staff pulls measuring tape across stream to measure width.

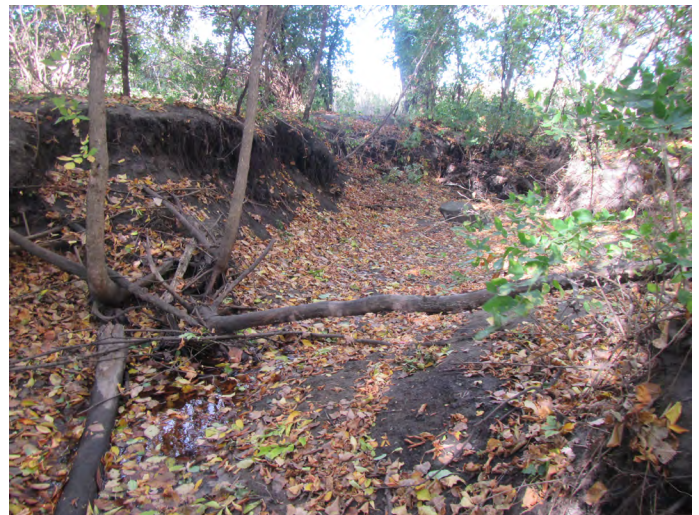
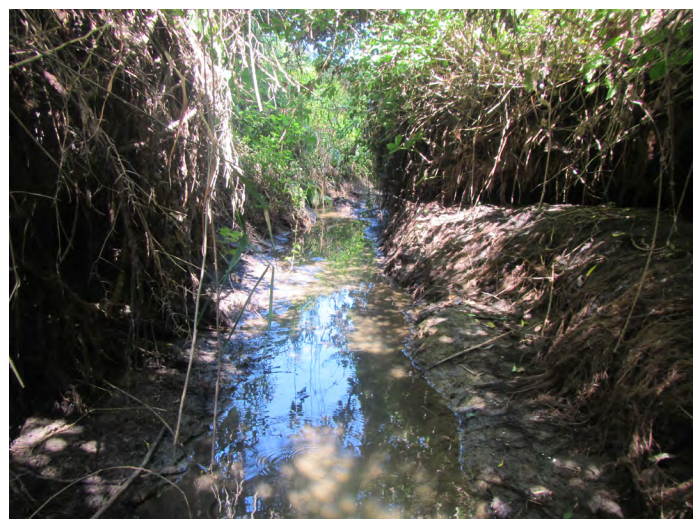
Images of eroding banks and incised channel of Riley Creek - Reach 4 (R4) from 2022.

This reach, known as R4, was analyzed using the Bank Erosion Hazard Index and the Near Bank Stress Ratings. These tools were used to estimate bank erosion rates and were estimated at about 250 tons of total suspended solids (TSS) each year. By stabilizing Reach 4, engineers estimate the project will reduce TSS by 470,000 pounds per year and total phosphorus (TP) by 250 pounds per year. This represents the bank recession rate of 0.10 to 0.25 feet per year.

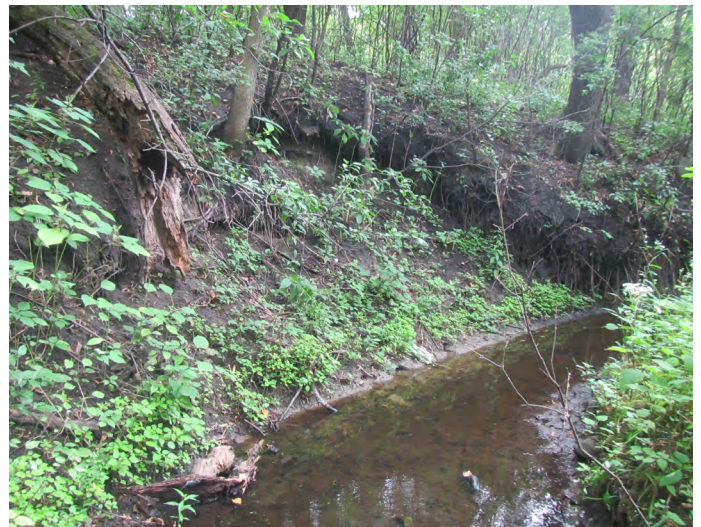
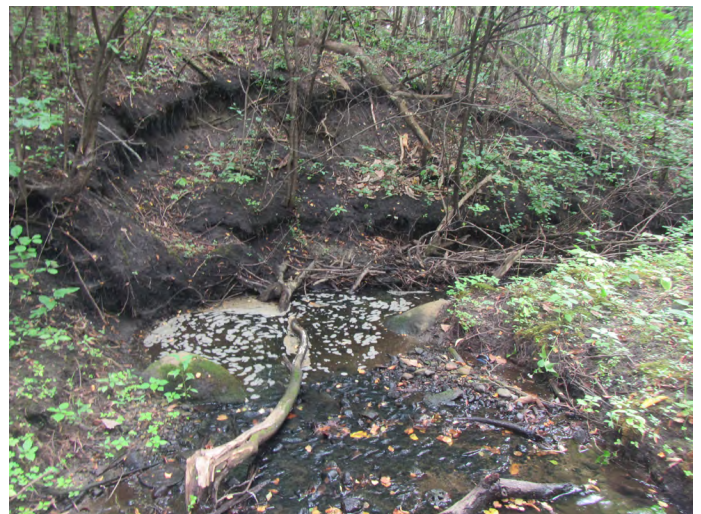
Images of eroding banks and incised channel of Bluff Creek - Reach 5 (B5) from 2022.

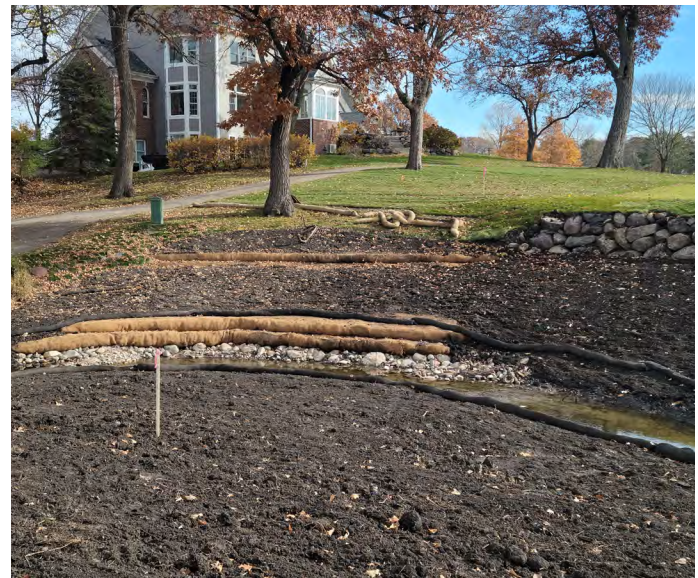
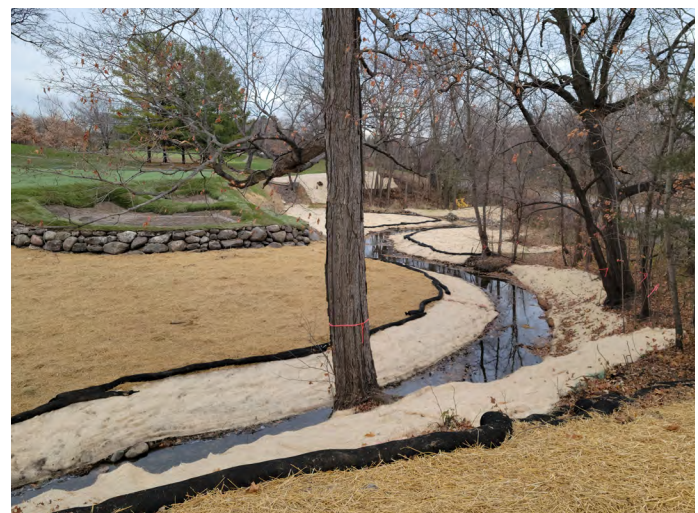
Re-meandering and bank stabilization of Riley Creek within Bearpath Golf and Country Club in November 2021.

At the feasibility stage, the engineer’s opinion of cost for the project ranged from \$504,000 to \$819,000. The awarded bid was for \$439,582. Funding for this project came from the RPBCWD levy and the Bearpath Golf and Country Club. In 2021, the channel was realigned, all stabilization practices such as riffles, root wads, and vegetated reinforced soil slope (VRSS) were installed, and the flood plain area has been temporarily stabilized. The spring of 2022 saw the remainder of the buffer areas planted into native vegetation. Three years of on-going maintenance is left to complete.

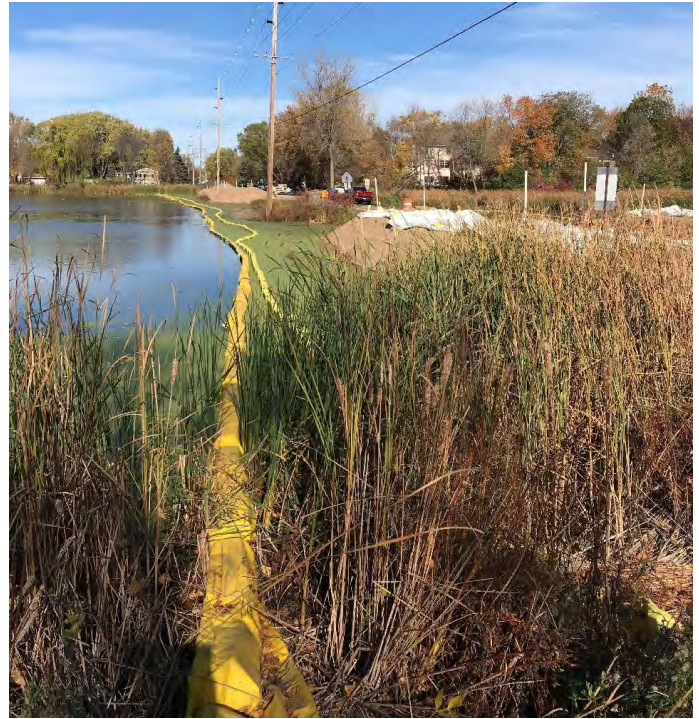
A double row of yellow silt curtains in the water protect the lake from the Duck Lake Road construction zone (fall 2021).

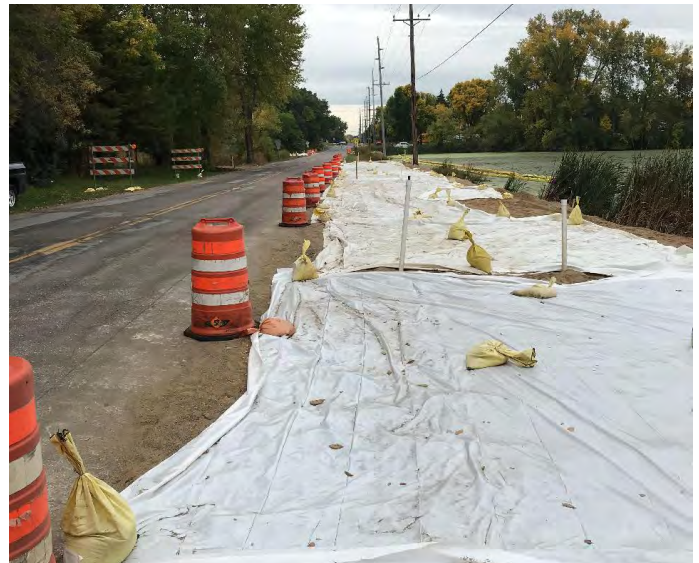
Covering exposed soils during road work reduces the risk of erosion into Duck Lake (fall 2021).
