Feasibility Report

Lotus Lake Water Quality Improvement Project

Prepared for
Riley Purgatory Bluff Creek Watershed District

February 2024 DRAFT

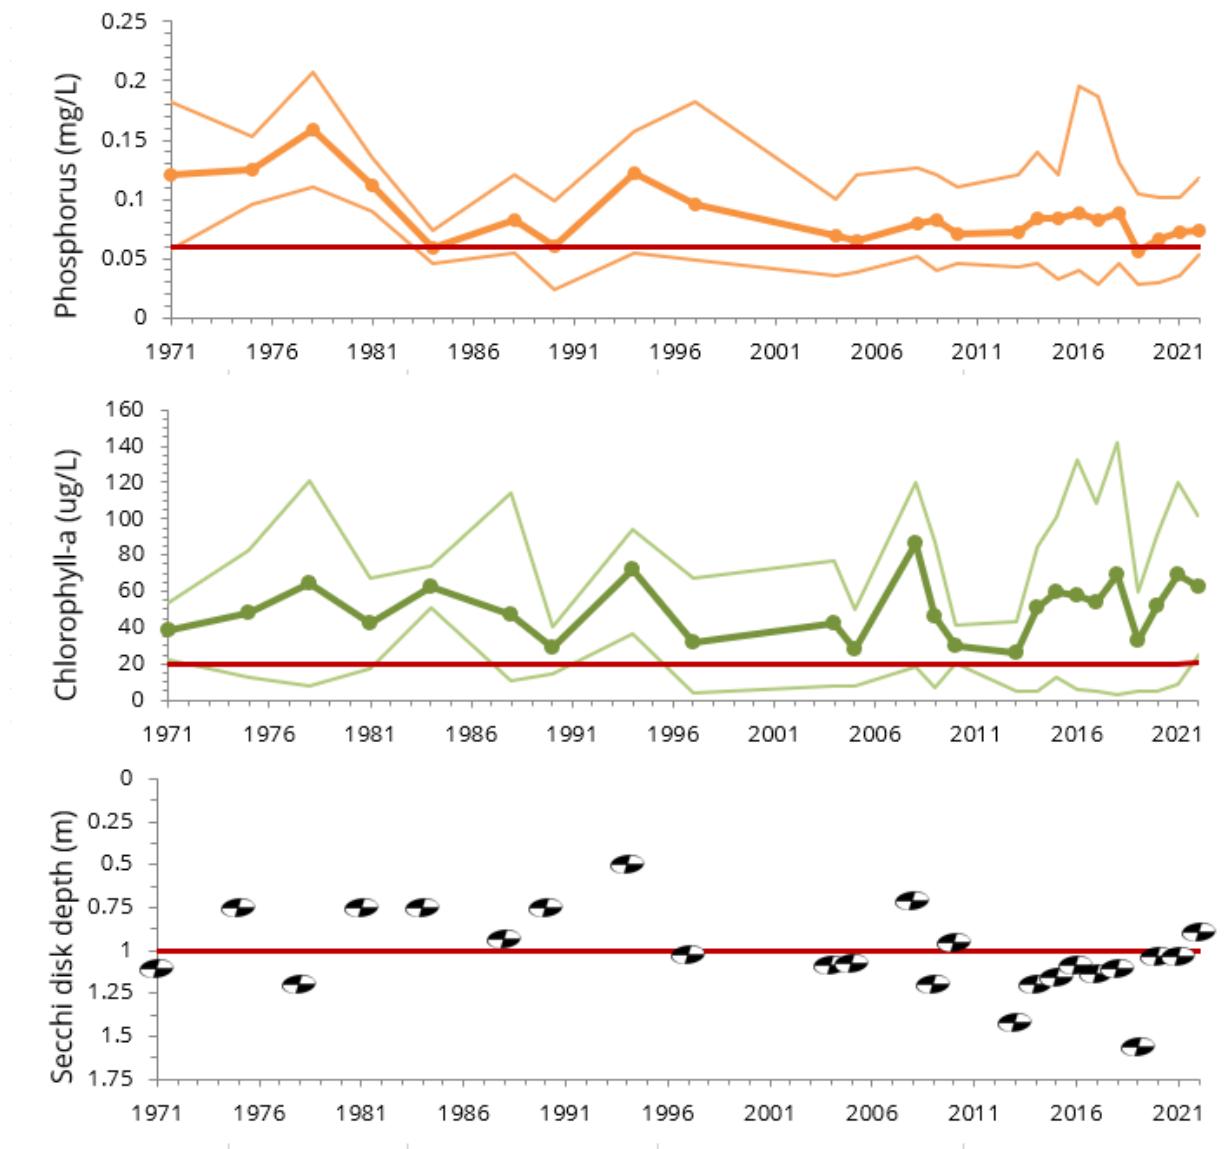
Figure 1-2 Lotus Lake Water Quality

As part of the UAA study and subsequent TMDL study, an in-lake water quality model was used to determine TP load reductions needed to meet the water quality goal for Lotus Lake.

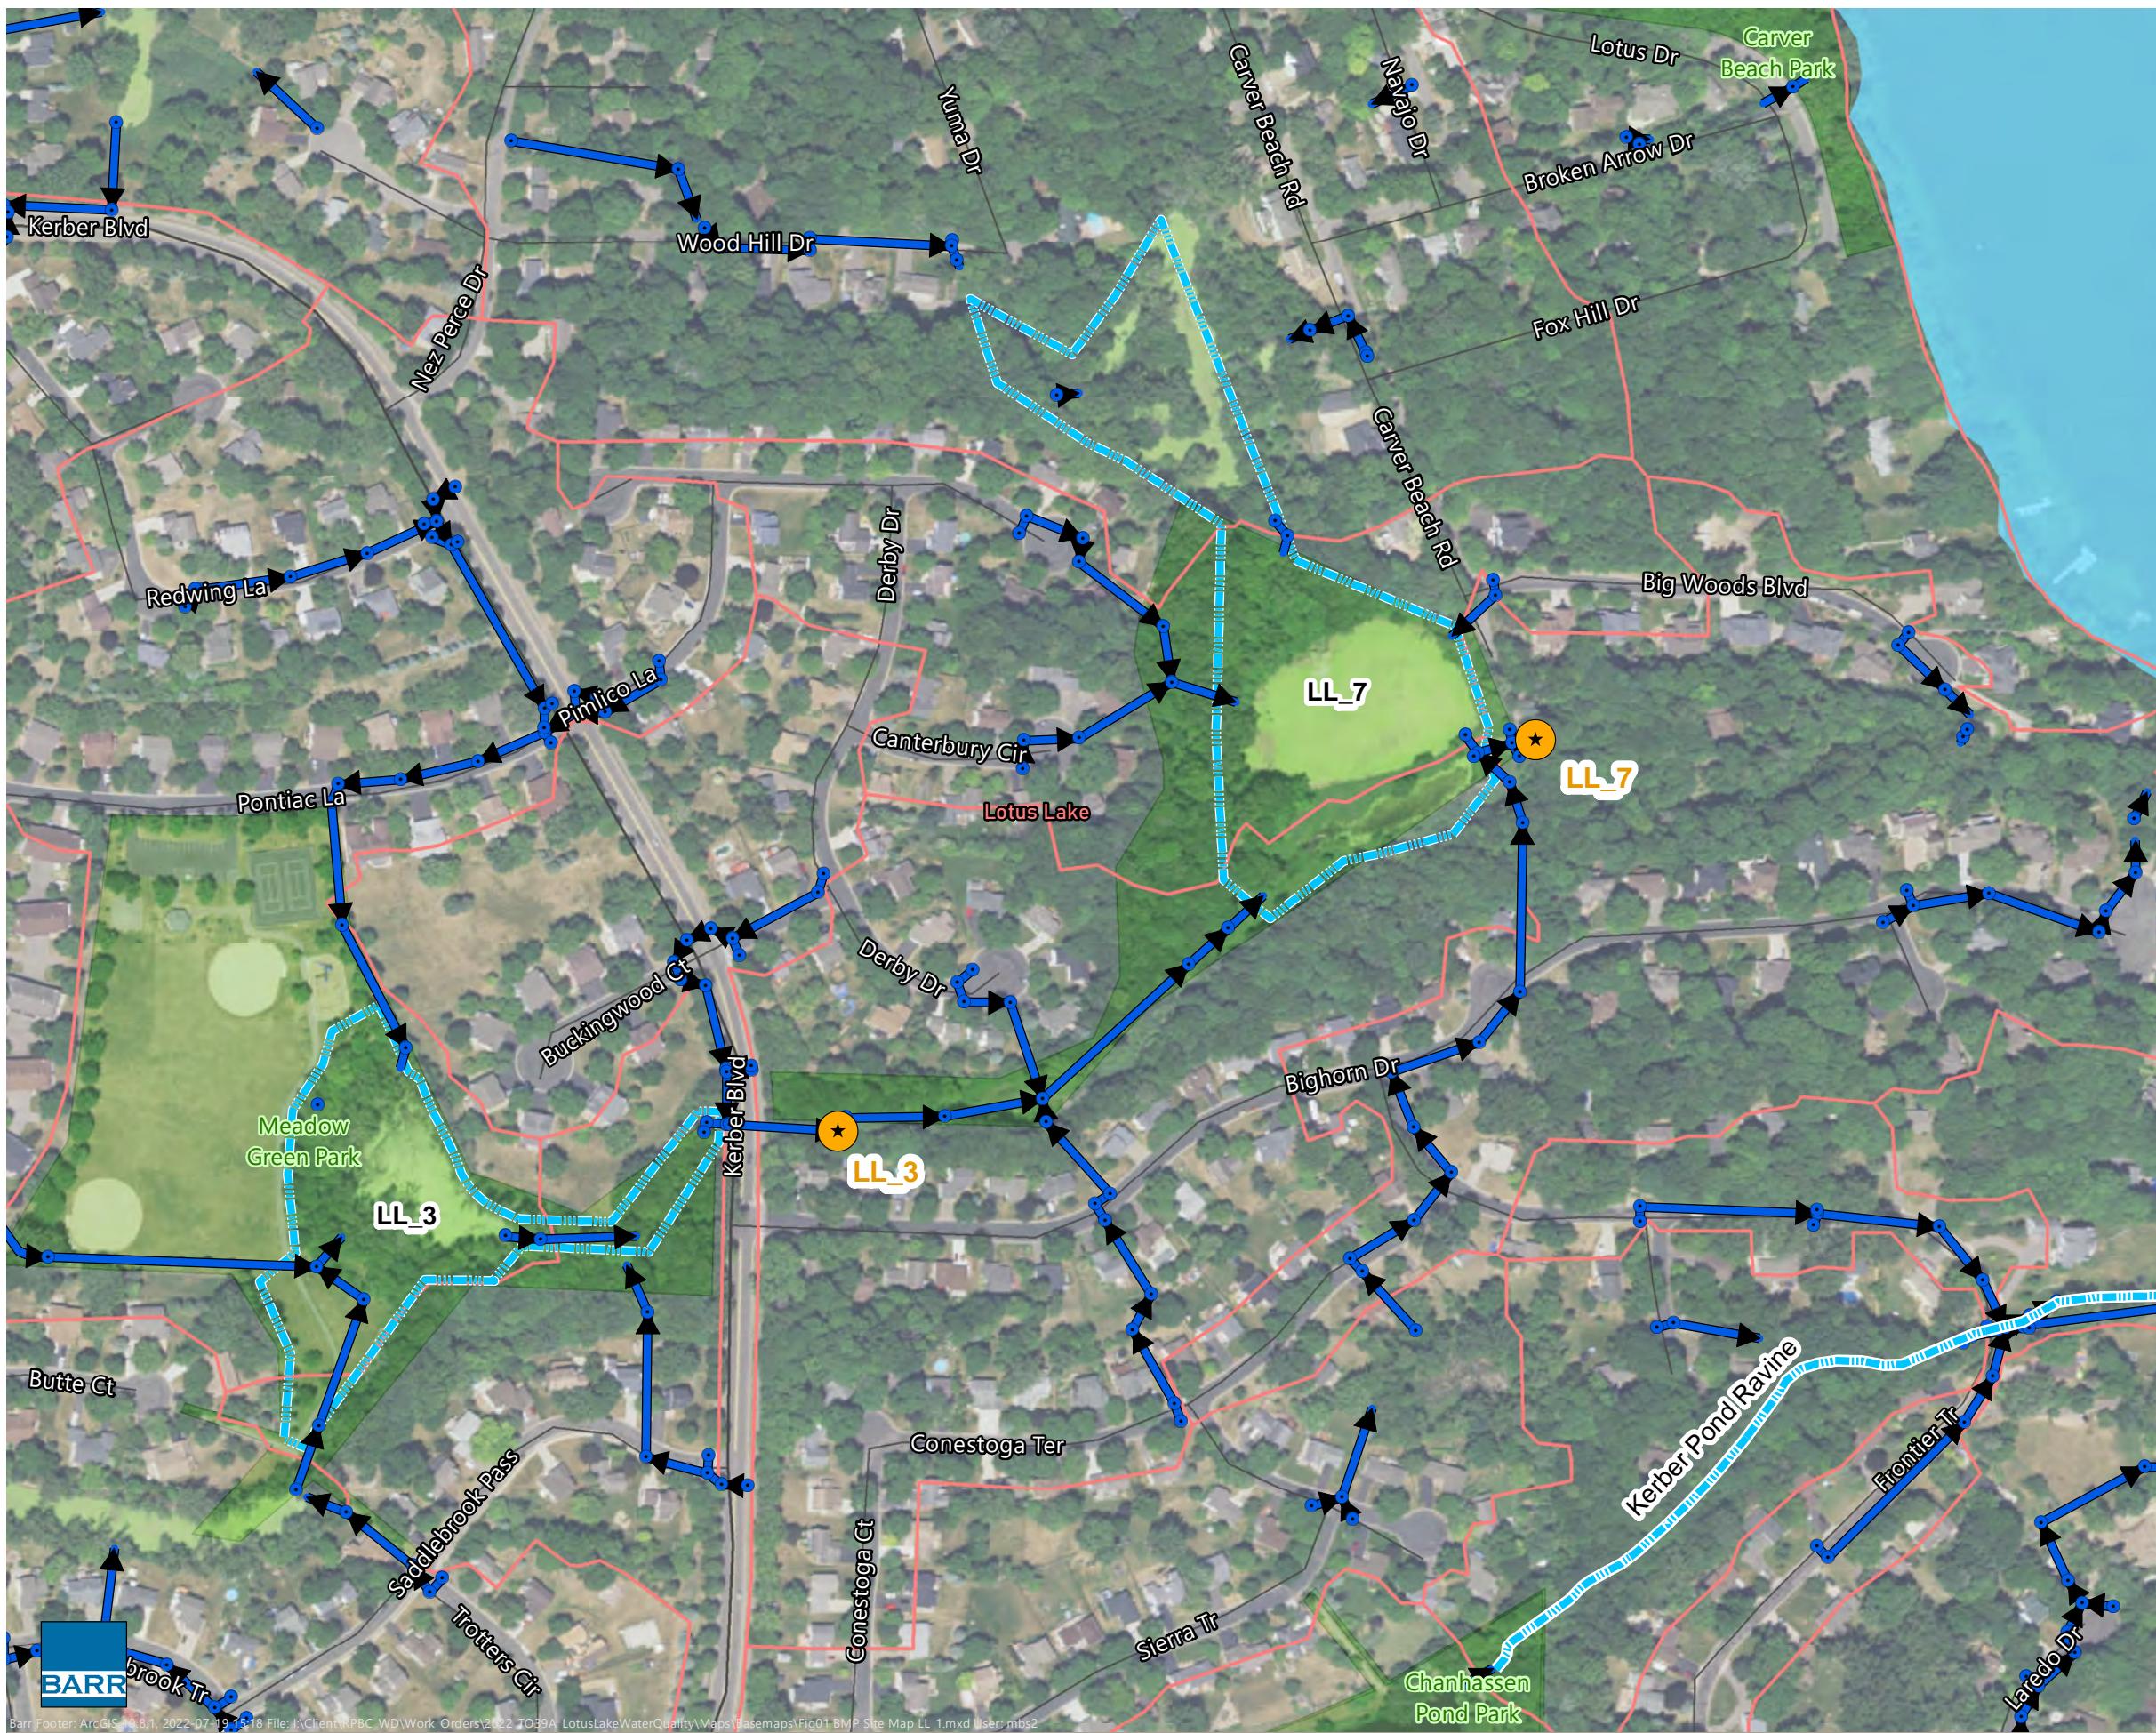
FIGURE 2-4

Figure 2-4 shows the location of the two flow/water quality sensors. The LL_7 unit was installed in 2021 and 2022 and the LL_3 unit was only installed in 2022.

Water Quality Monitoring Locations

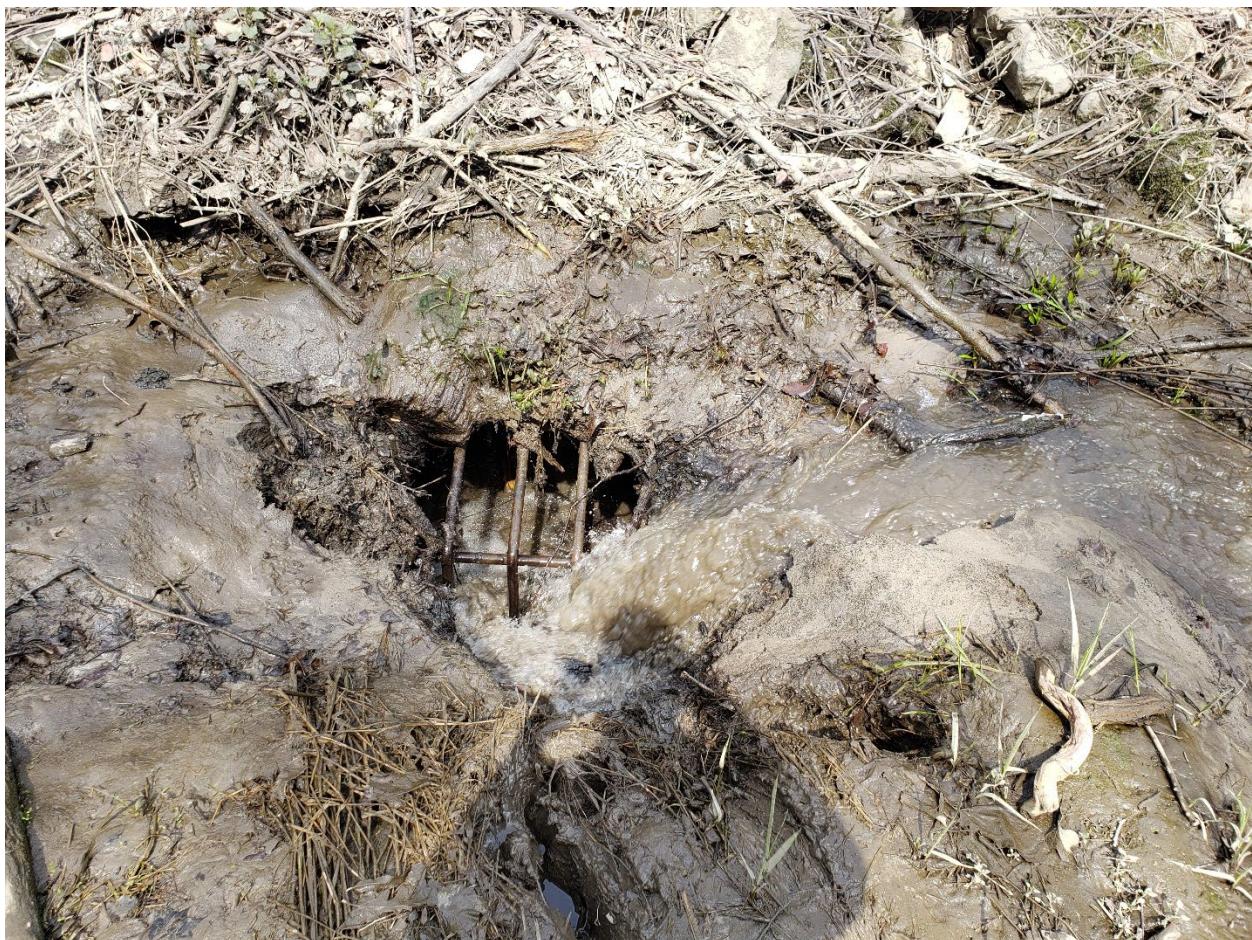
Figure 2-5 Accumulated sediment at the storm sewer pipe inlet on the west side of Kerber Blvd (photo taken by RPBCWD, May 04, 2022)

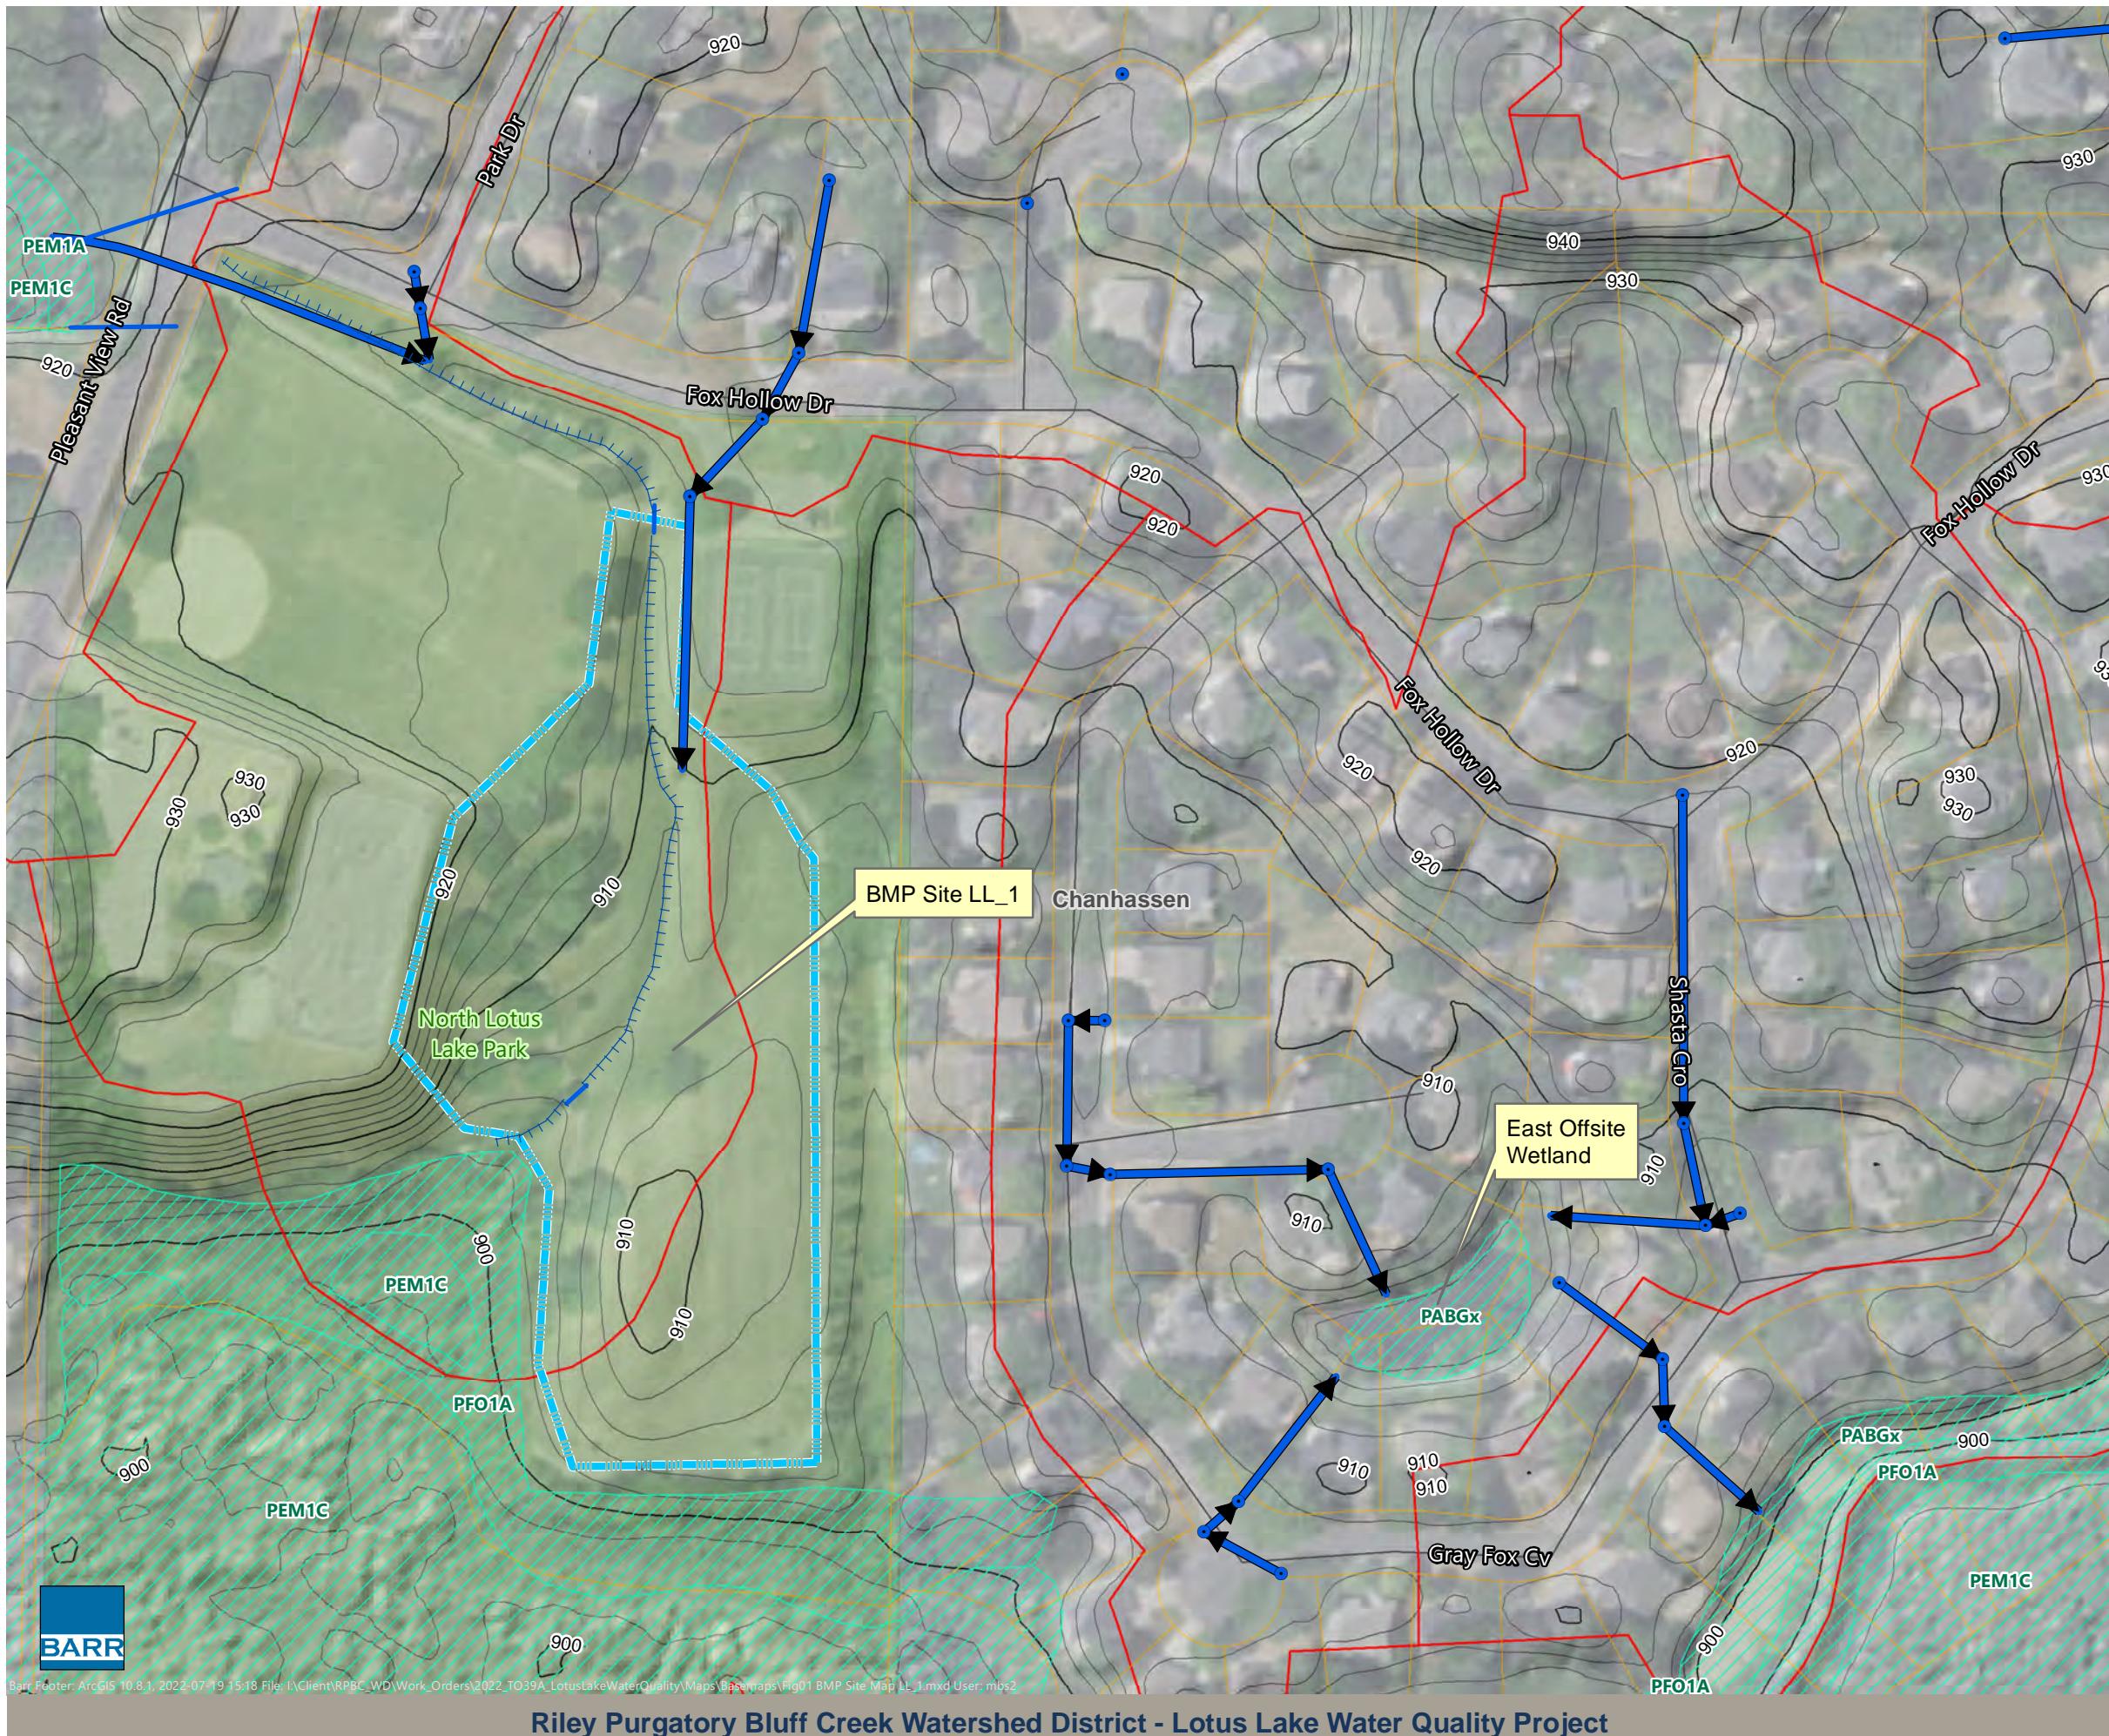
FIGURE 2-7

Existing Site Map: BMP LL_1

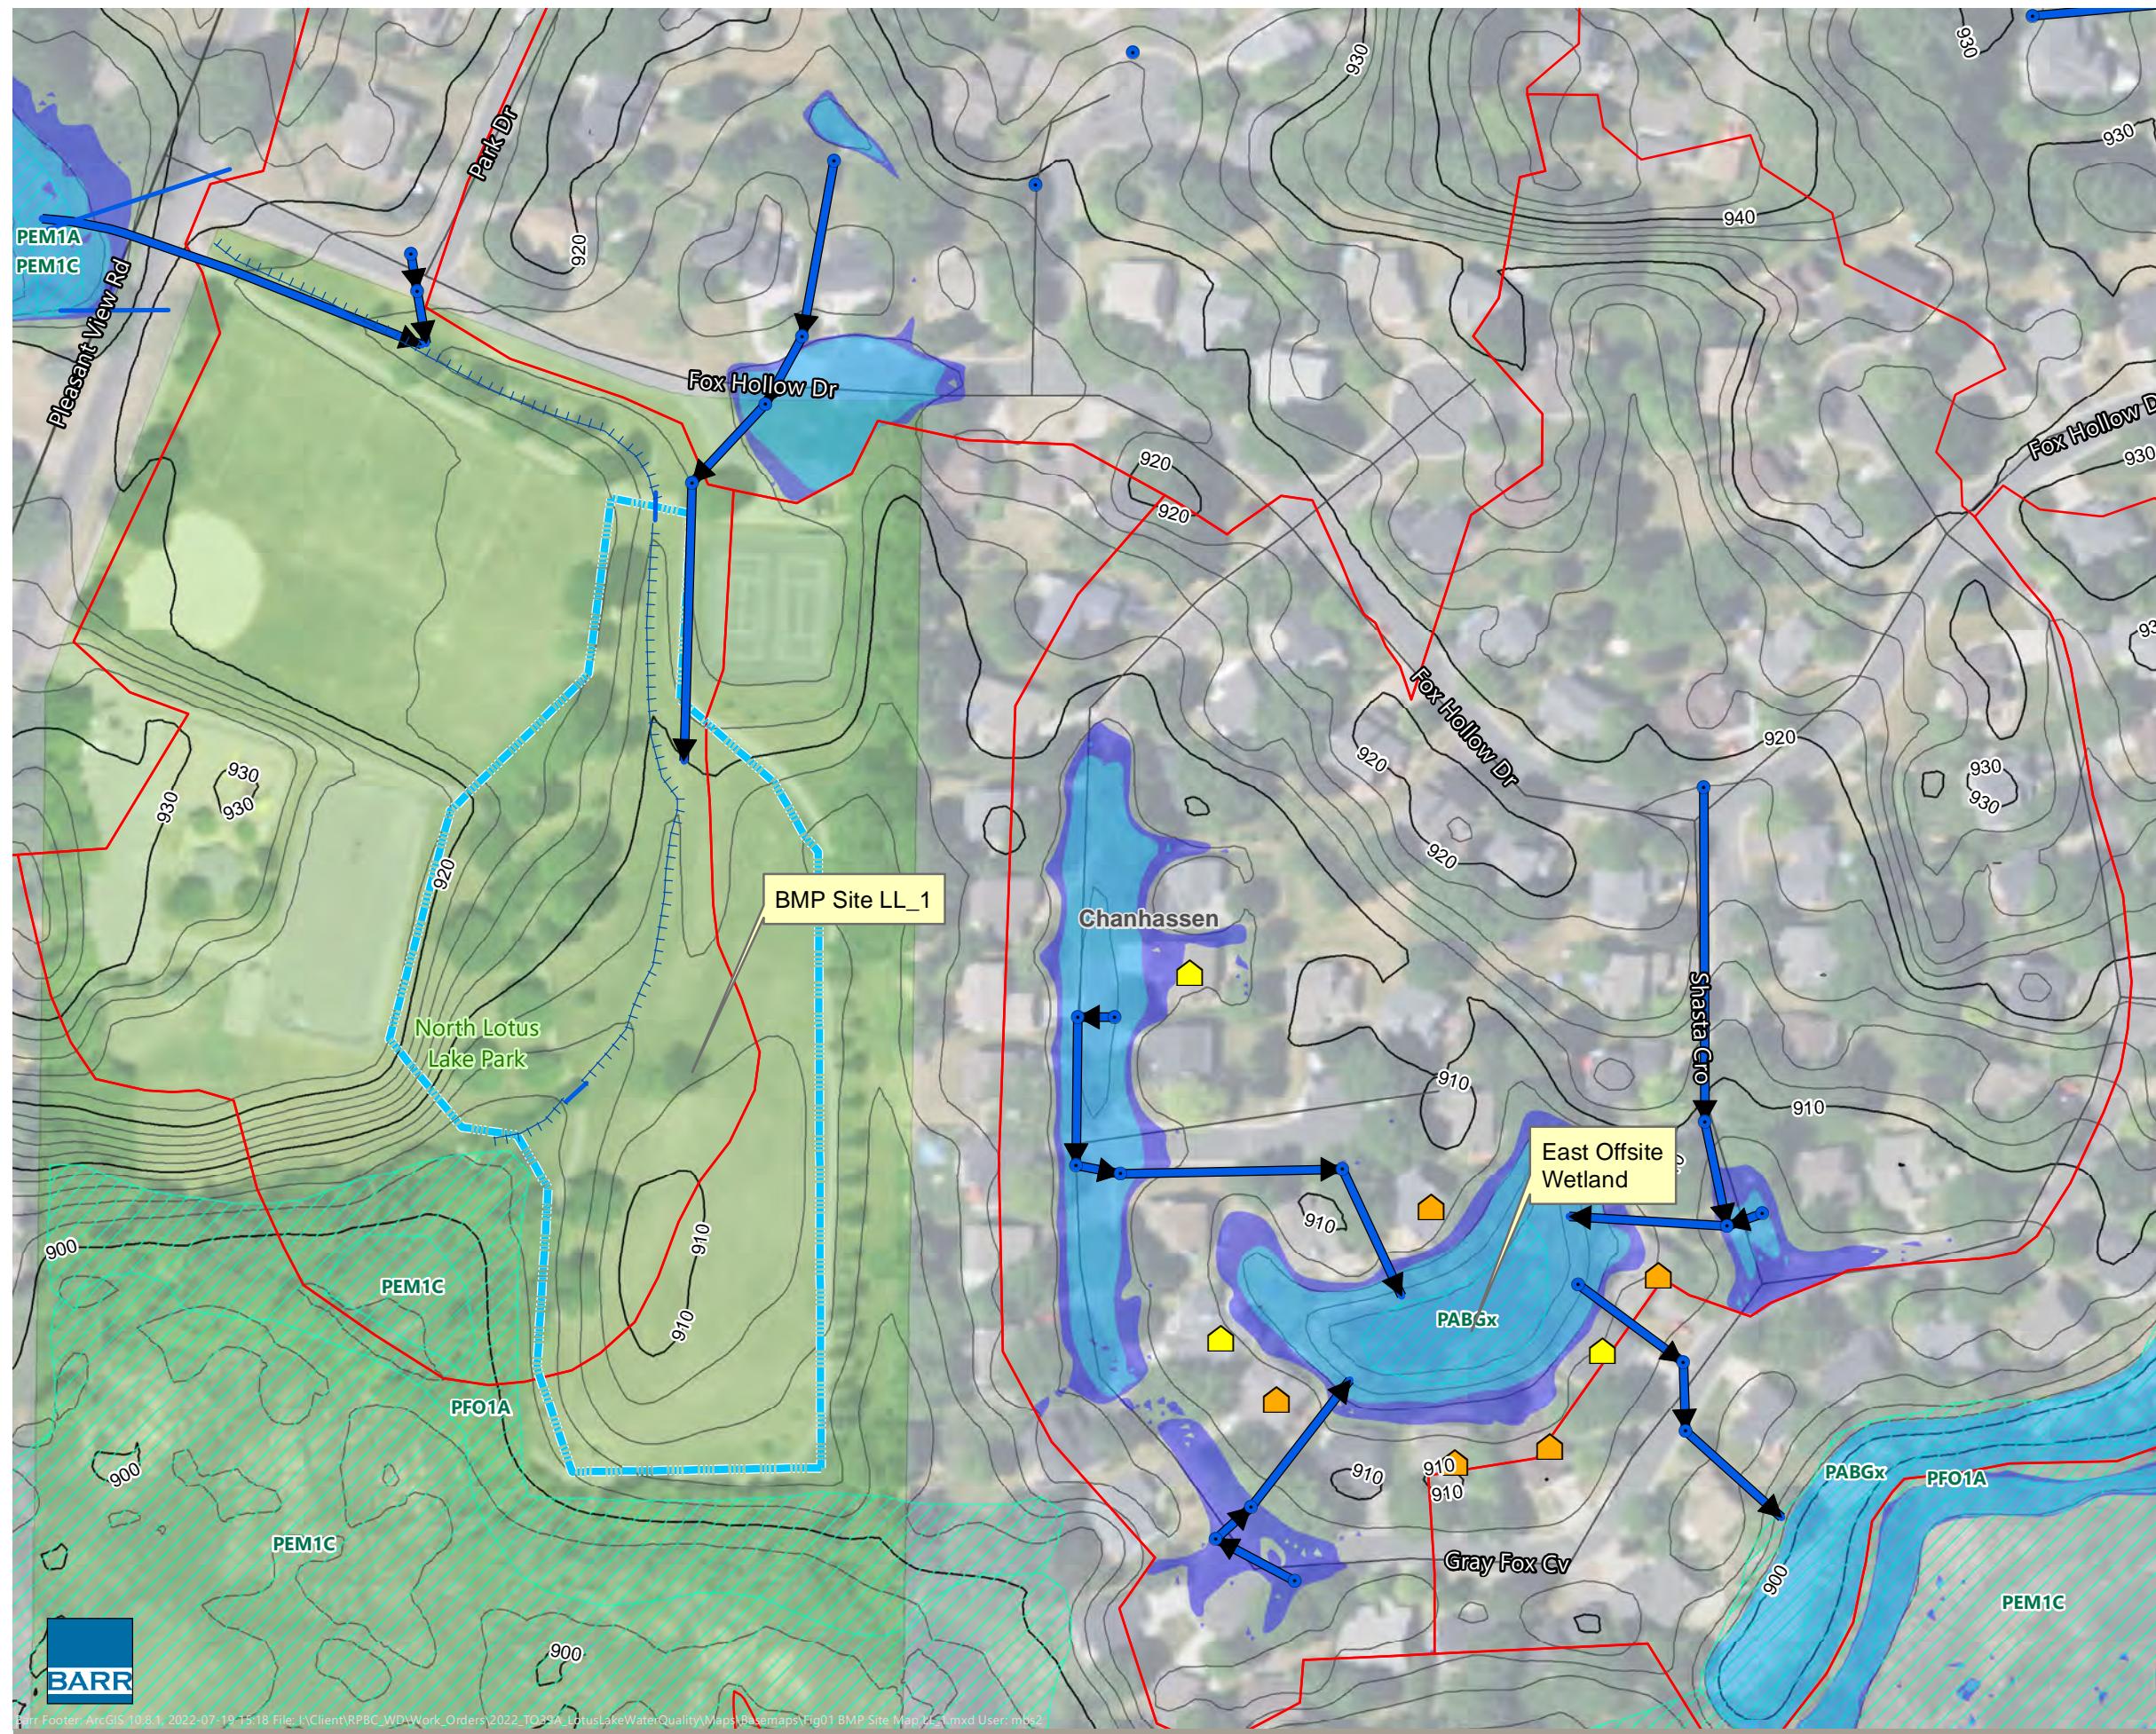
FIGURE 2-8

Potential At-Risk Structures Near LL_1

Adjacent to Site LL_1 in the Fox Hill Drive neighborhood is a freshwater pond wetland (referred to as the east offsite wetland) (See Figure 2-8). The wetland was identified during the study as an overloaded stormwater pond that poses a risk of inundation to surrounding properties during extreme rain events, such as the 100- and 500-year events. The design at site LL_1 included considerations of opportunities to lower the peak water surface elevation at the east wetland.

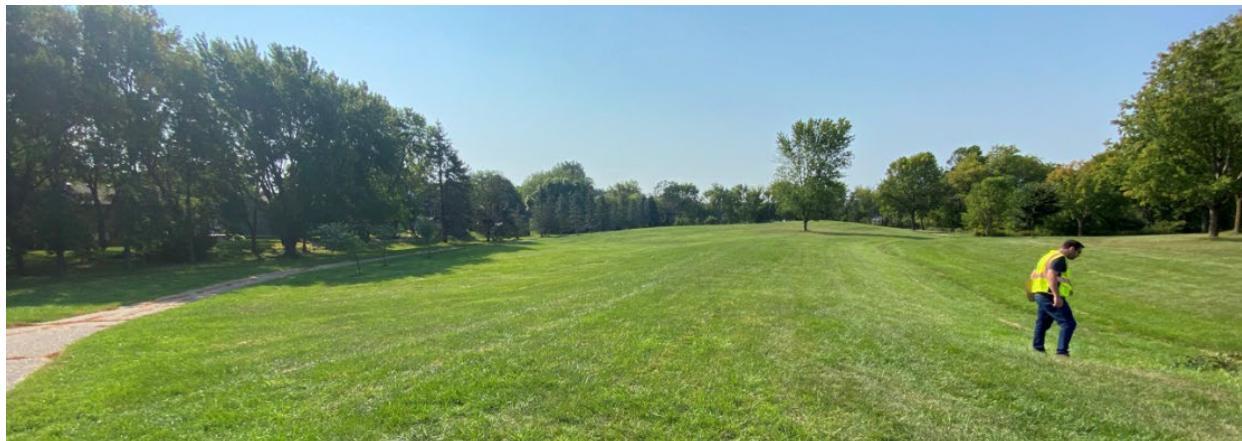
Figure 2-9 Existing Vegetation at Lotus Lake Park

The LL_1 project area within Lotus Lake Park primarily consists of lawn with scattered trees (Figure 2-9). A row of spruce at the southeast border of the park are diseased and declining. The wetland at the south end of the project area is degraded with invasive species such as reed canary grass and common buckthorn. It is surrounded by aspen, green ash, and box elder trees.

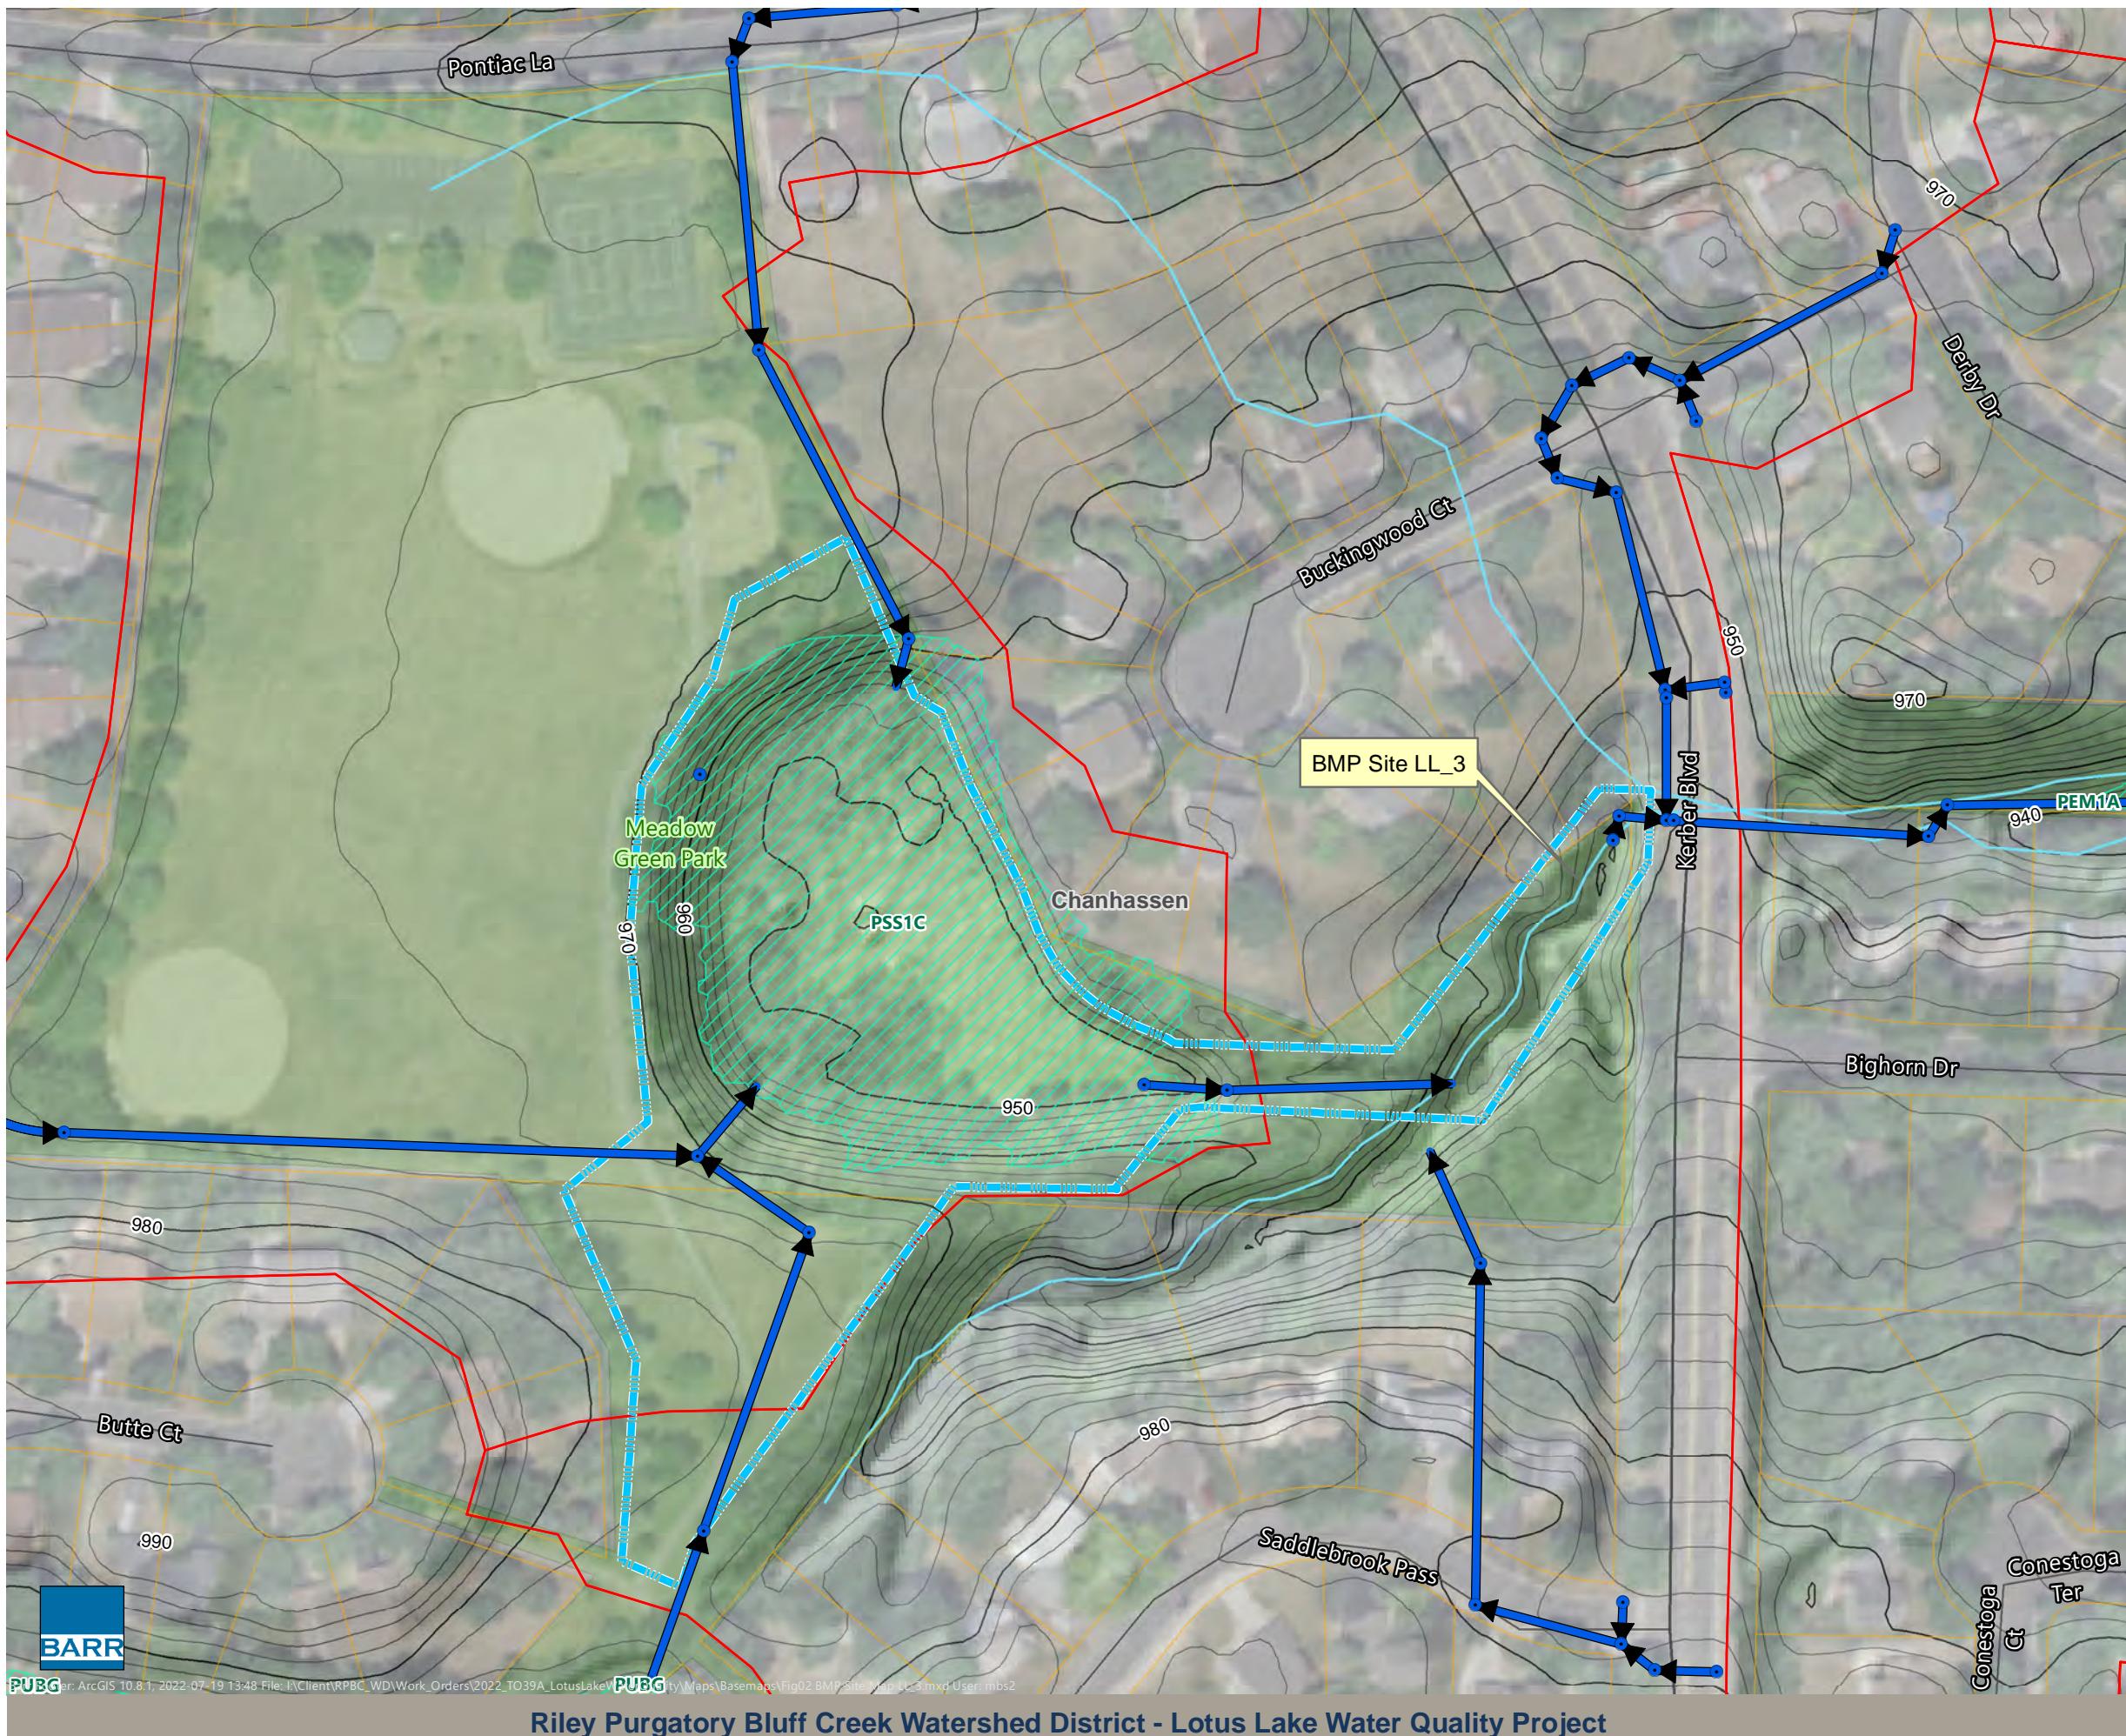
FIGURE 2-10

Existing Site Map: BMP LL_3

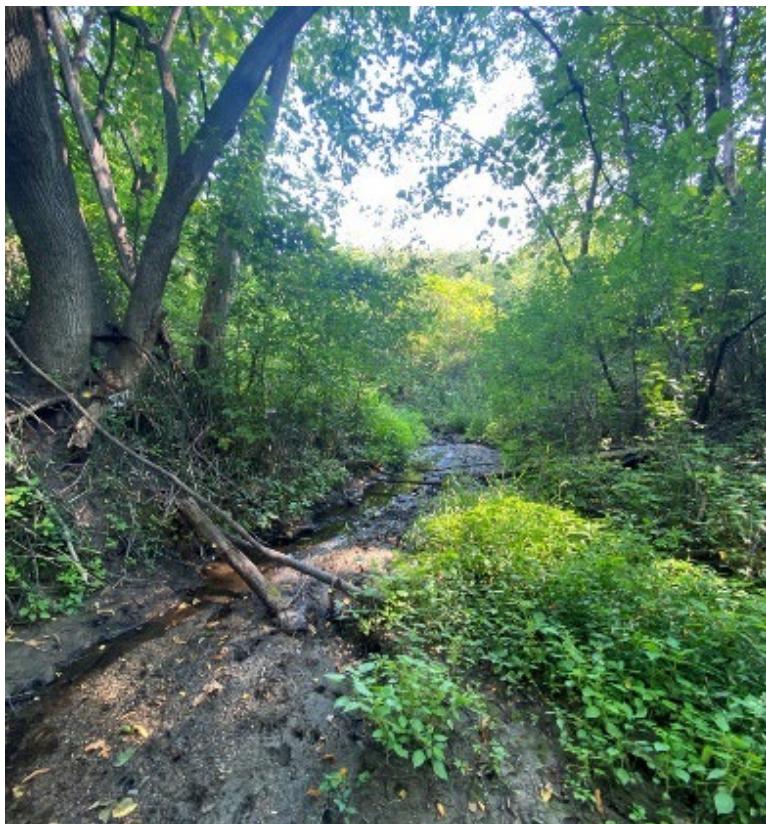
Figure 2-11 Existing vegetation within the channel at site LL_3

The LL_3 project area consists of a channel that serves as the outlet form the wetland in Meadow Green Park. Adjacent to the channel are herbaceous plants including jewelweed and reed canary grass (Figure 2-11). The degraded woodland flanking the channel contains some oaks and sugar maples, and consists of common buckthorn, green ash, and box elder.

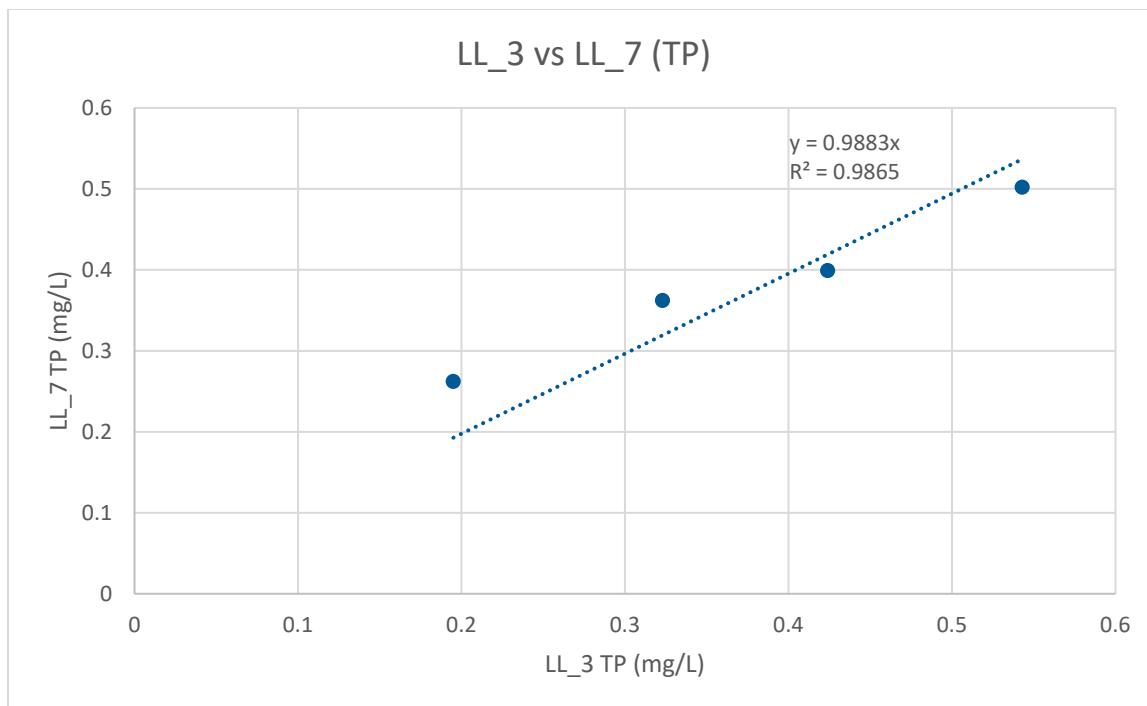
Figure 2-13 Correlation in TP Concentration between Monitoring Stations LL_3 and LL_7

The water quality monitoring data summarized in Table 2-4 and discussed in Section 2.2.7 showed elevations levels of TP and TSS at the LL_7 monitoring location. Figure 2-13 below shows a correlation between the TP concentration at monitoring station LL_3 and the TP concentration at monitoring station LL_7 based on sample events conducted on the same dates in 2022. This strong correlation suggests that the water quality of LL_7 is likely influenced by the water quality at LL_3. This is not surprising as the east wetland upstream of LL_7 is undersized relative to the contributing watershed and the pollutant loads from LL_3 are not fully settled out in the east wetland.

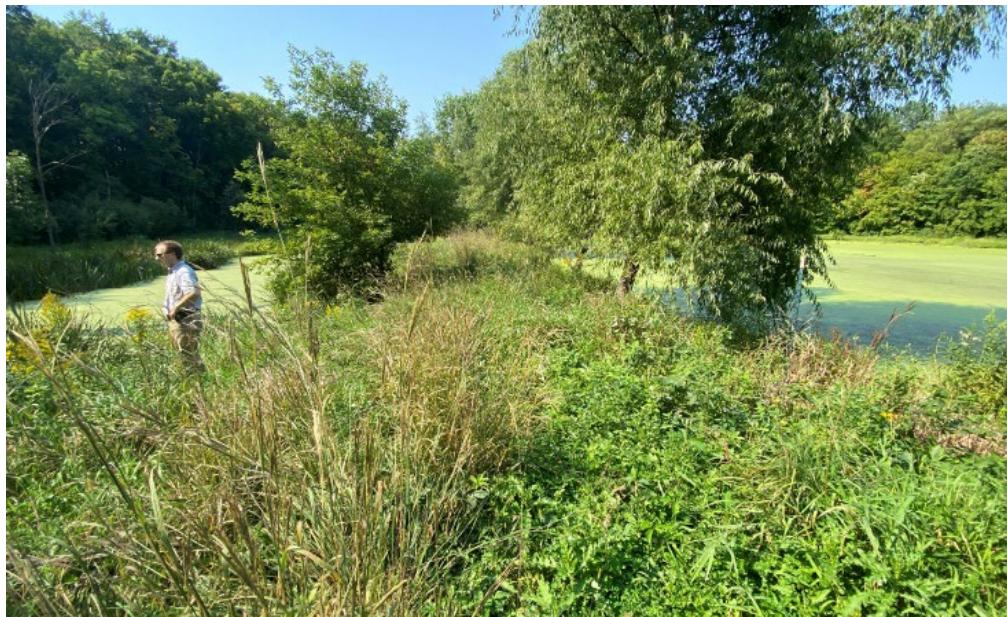
Figure 2-14 Existing vegetation at site LL_7

The LL_7 project area is a wetland that had been previously excavated to accommodate stormwater ponding. The excavation had been seeded with native vegetation but not maintained. Some native herbaceous vegetation such as big bluestem grass persist, but invasive species such as Canada thistle and reed canary grass dominate. The pond supports duck weed and the pond is surrounded with typical wetland edge species such as black willow, box elder, and green ash. See Figure 2-14 for existing site vegetation.
