Feasibility Report

Lotus Lake Water Quality Improvement Project

Prepared for
Riley Purgatory Bluff Creek Watershed District

February 2024 DRAFT

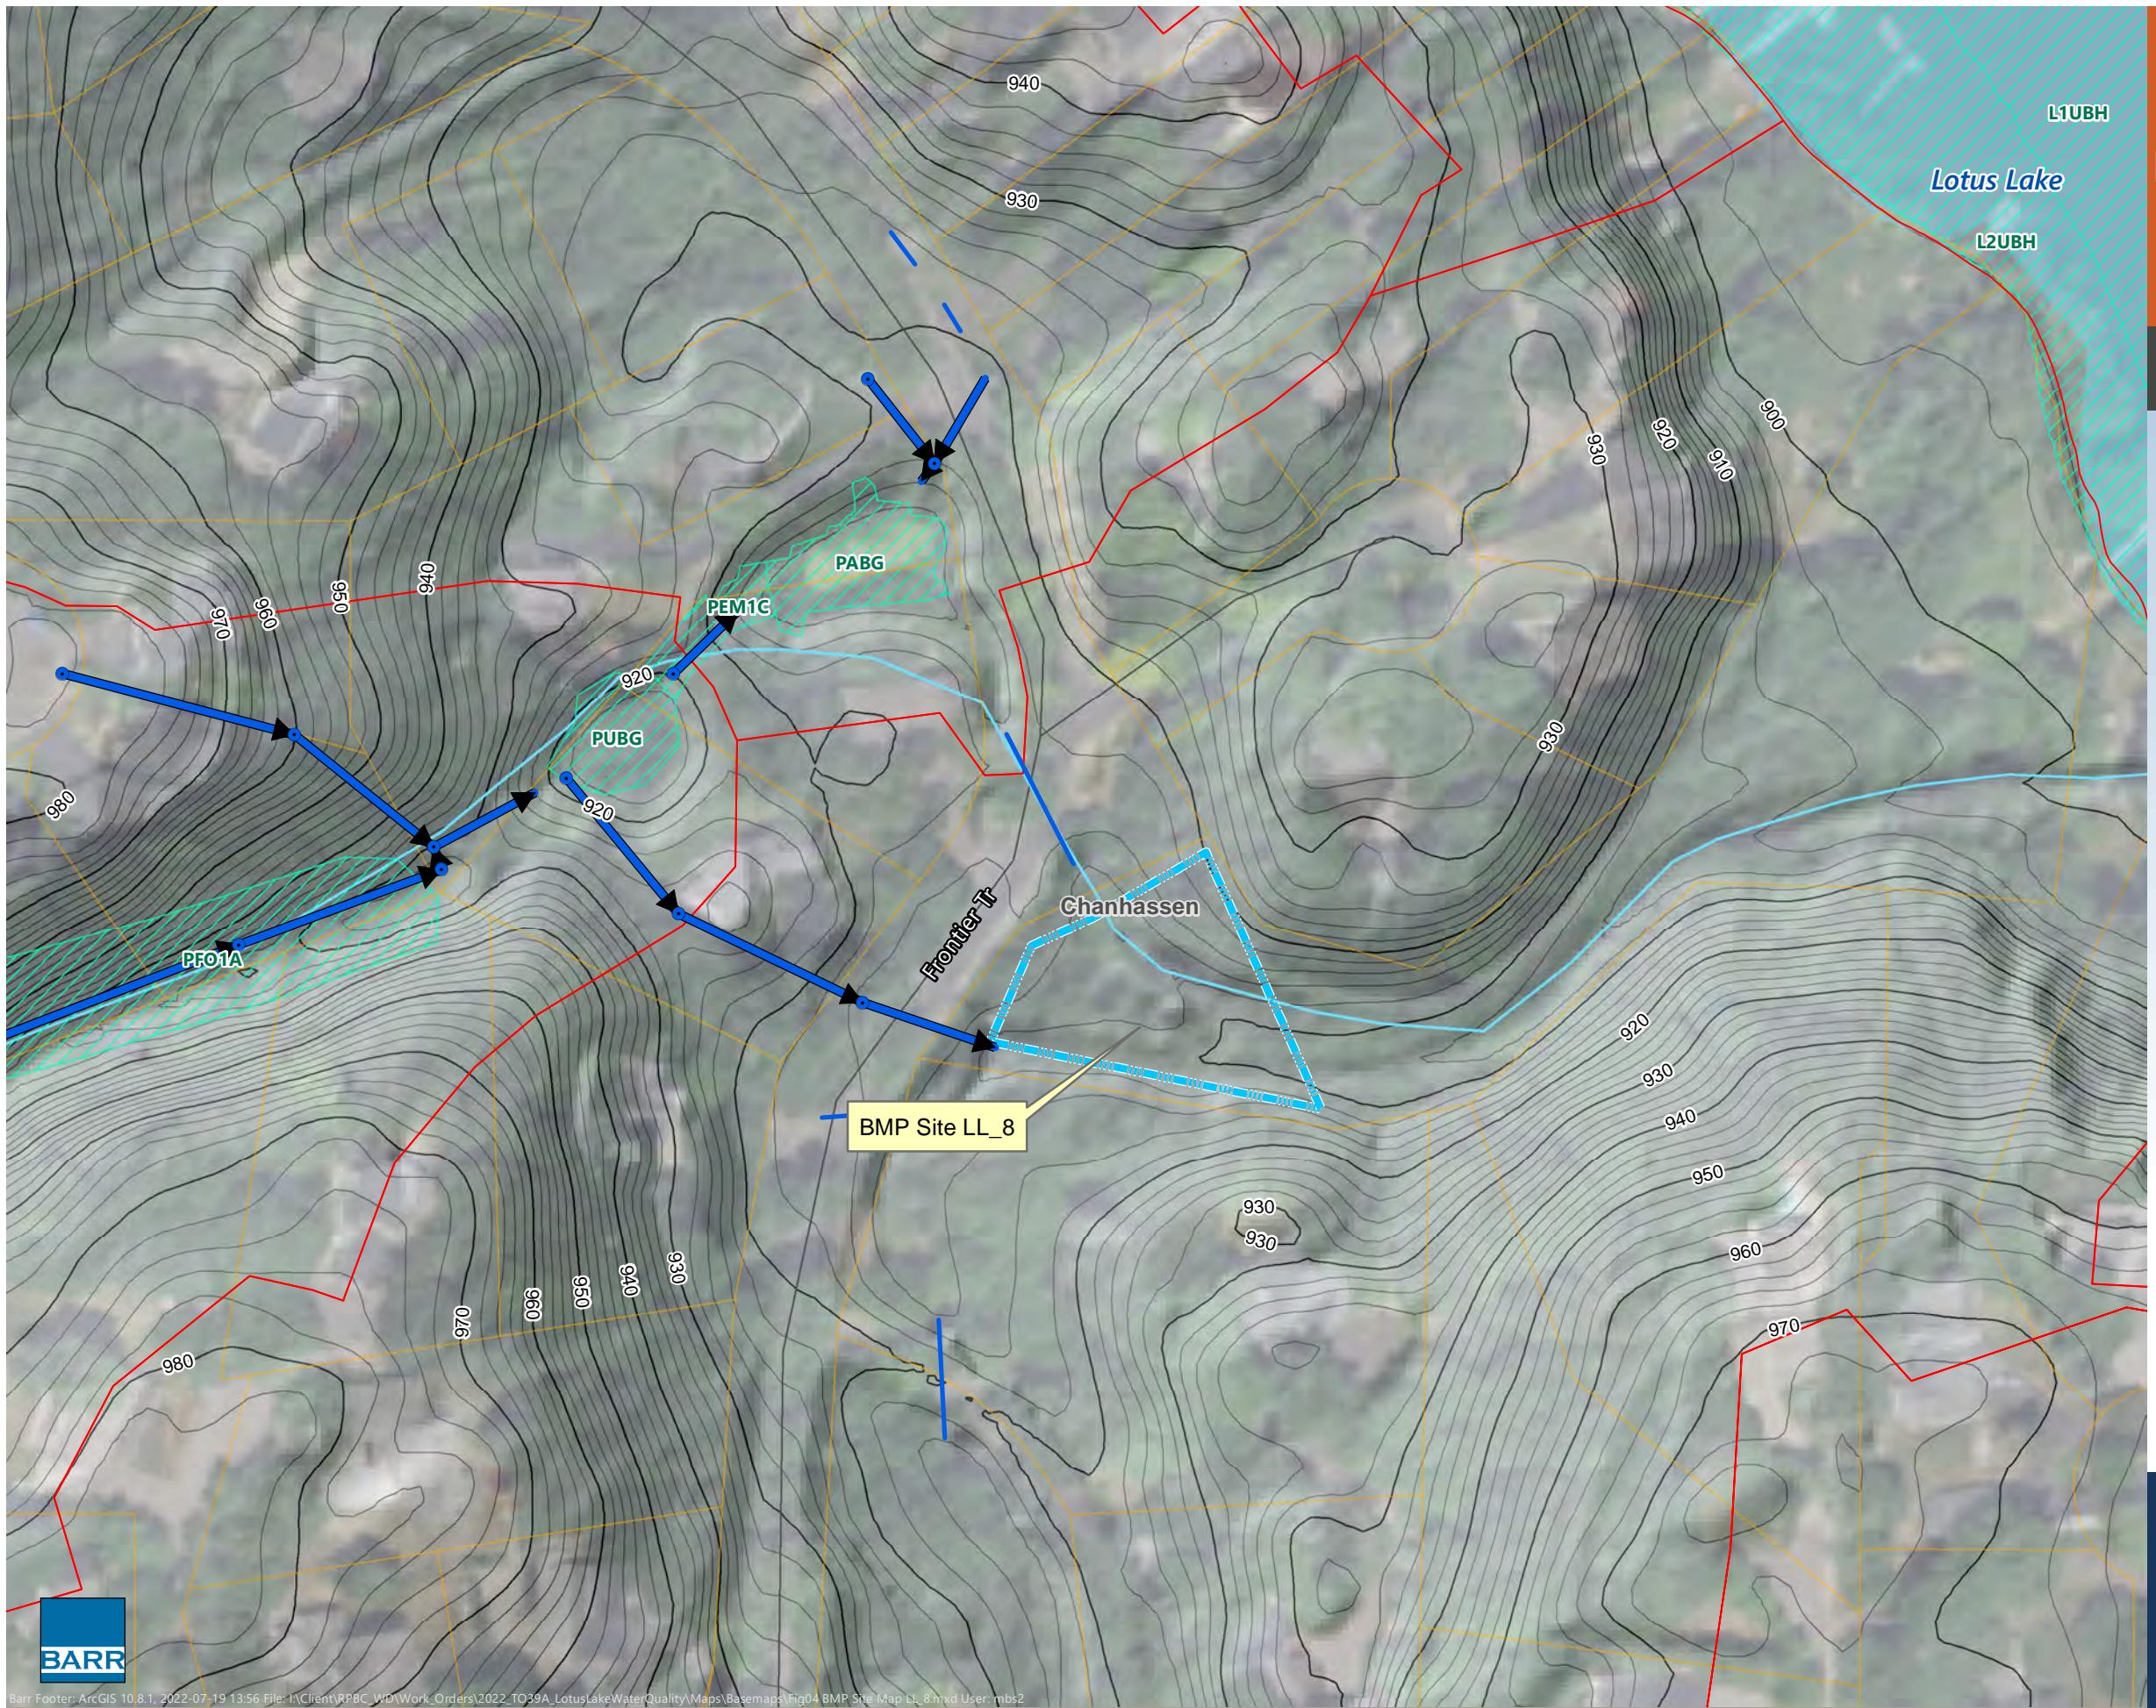
FIGURE 2-15

Existing Site Map: BMP LL_8

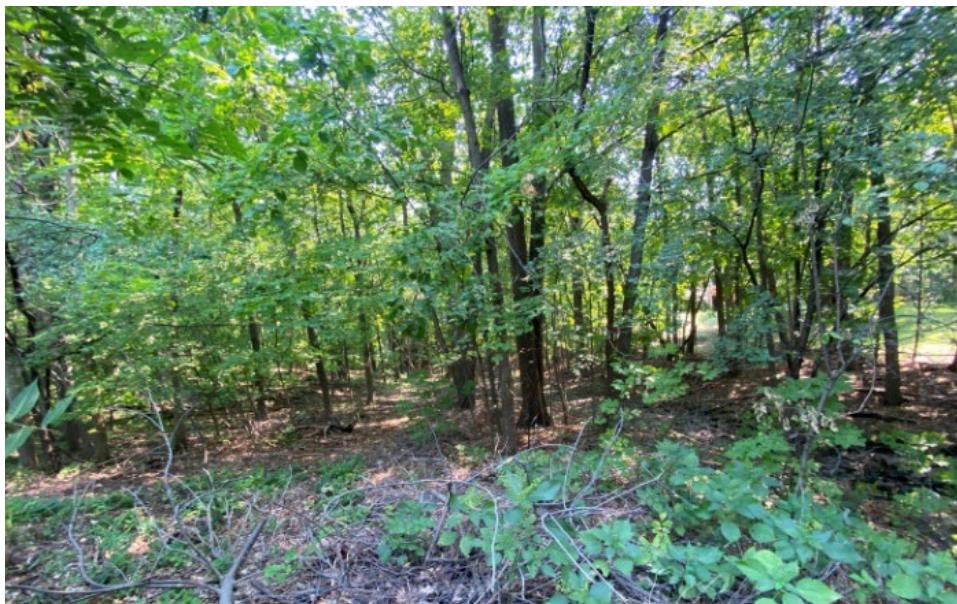
Figure 2-16 Existing Vegetation at Site LL_8

The LL_8 site is a sugar maple woodland. Some invasive species such as reed canary grass and common buckthorn grow, while few native herbaceous species occupy to ground plane. See Figure 2-16 for photo of existing site vegetation.

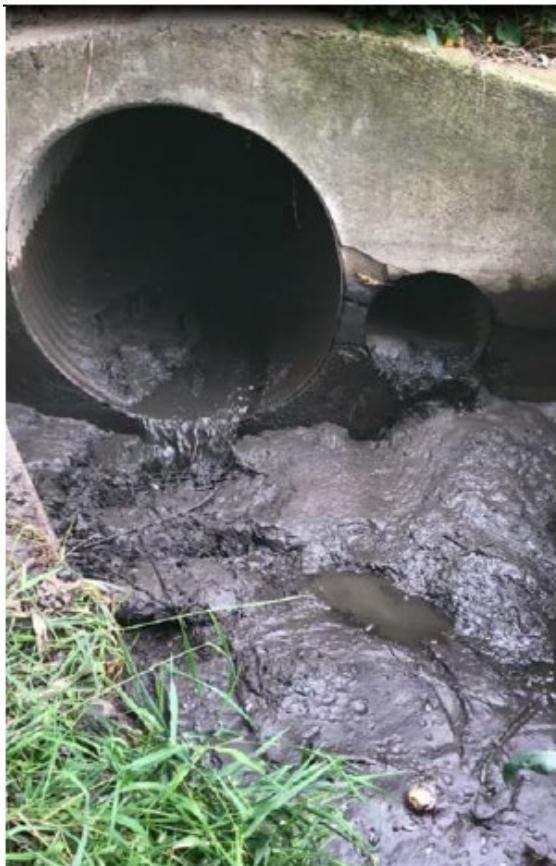
*Screen shot of the city
provided a video showing of
sediment/mud flowing out of
the culvert at Frontier Trail.*

Figure 2-18 Existing Discharge Observed at Kerber Pond Ravine

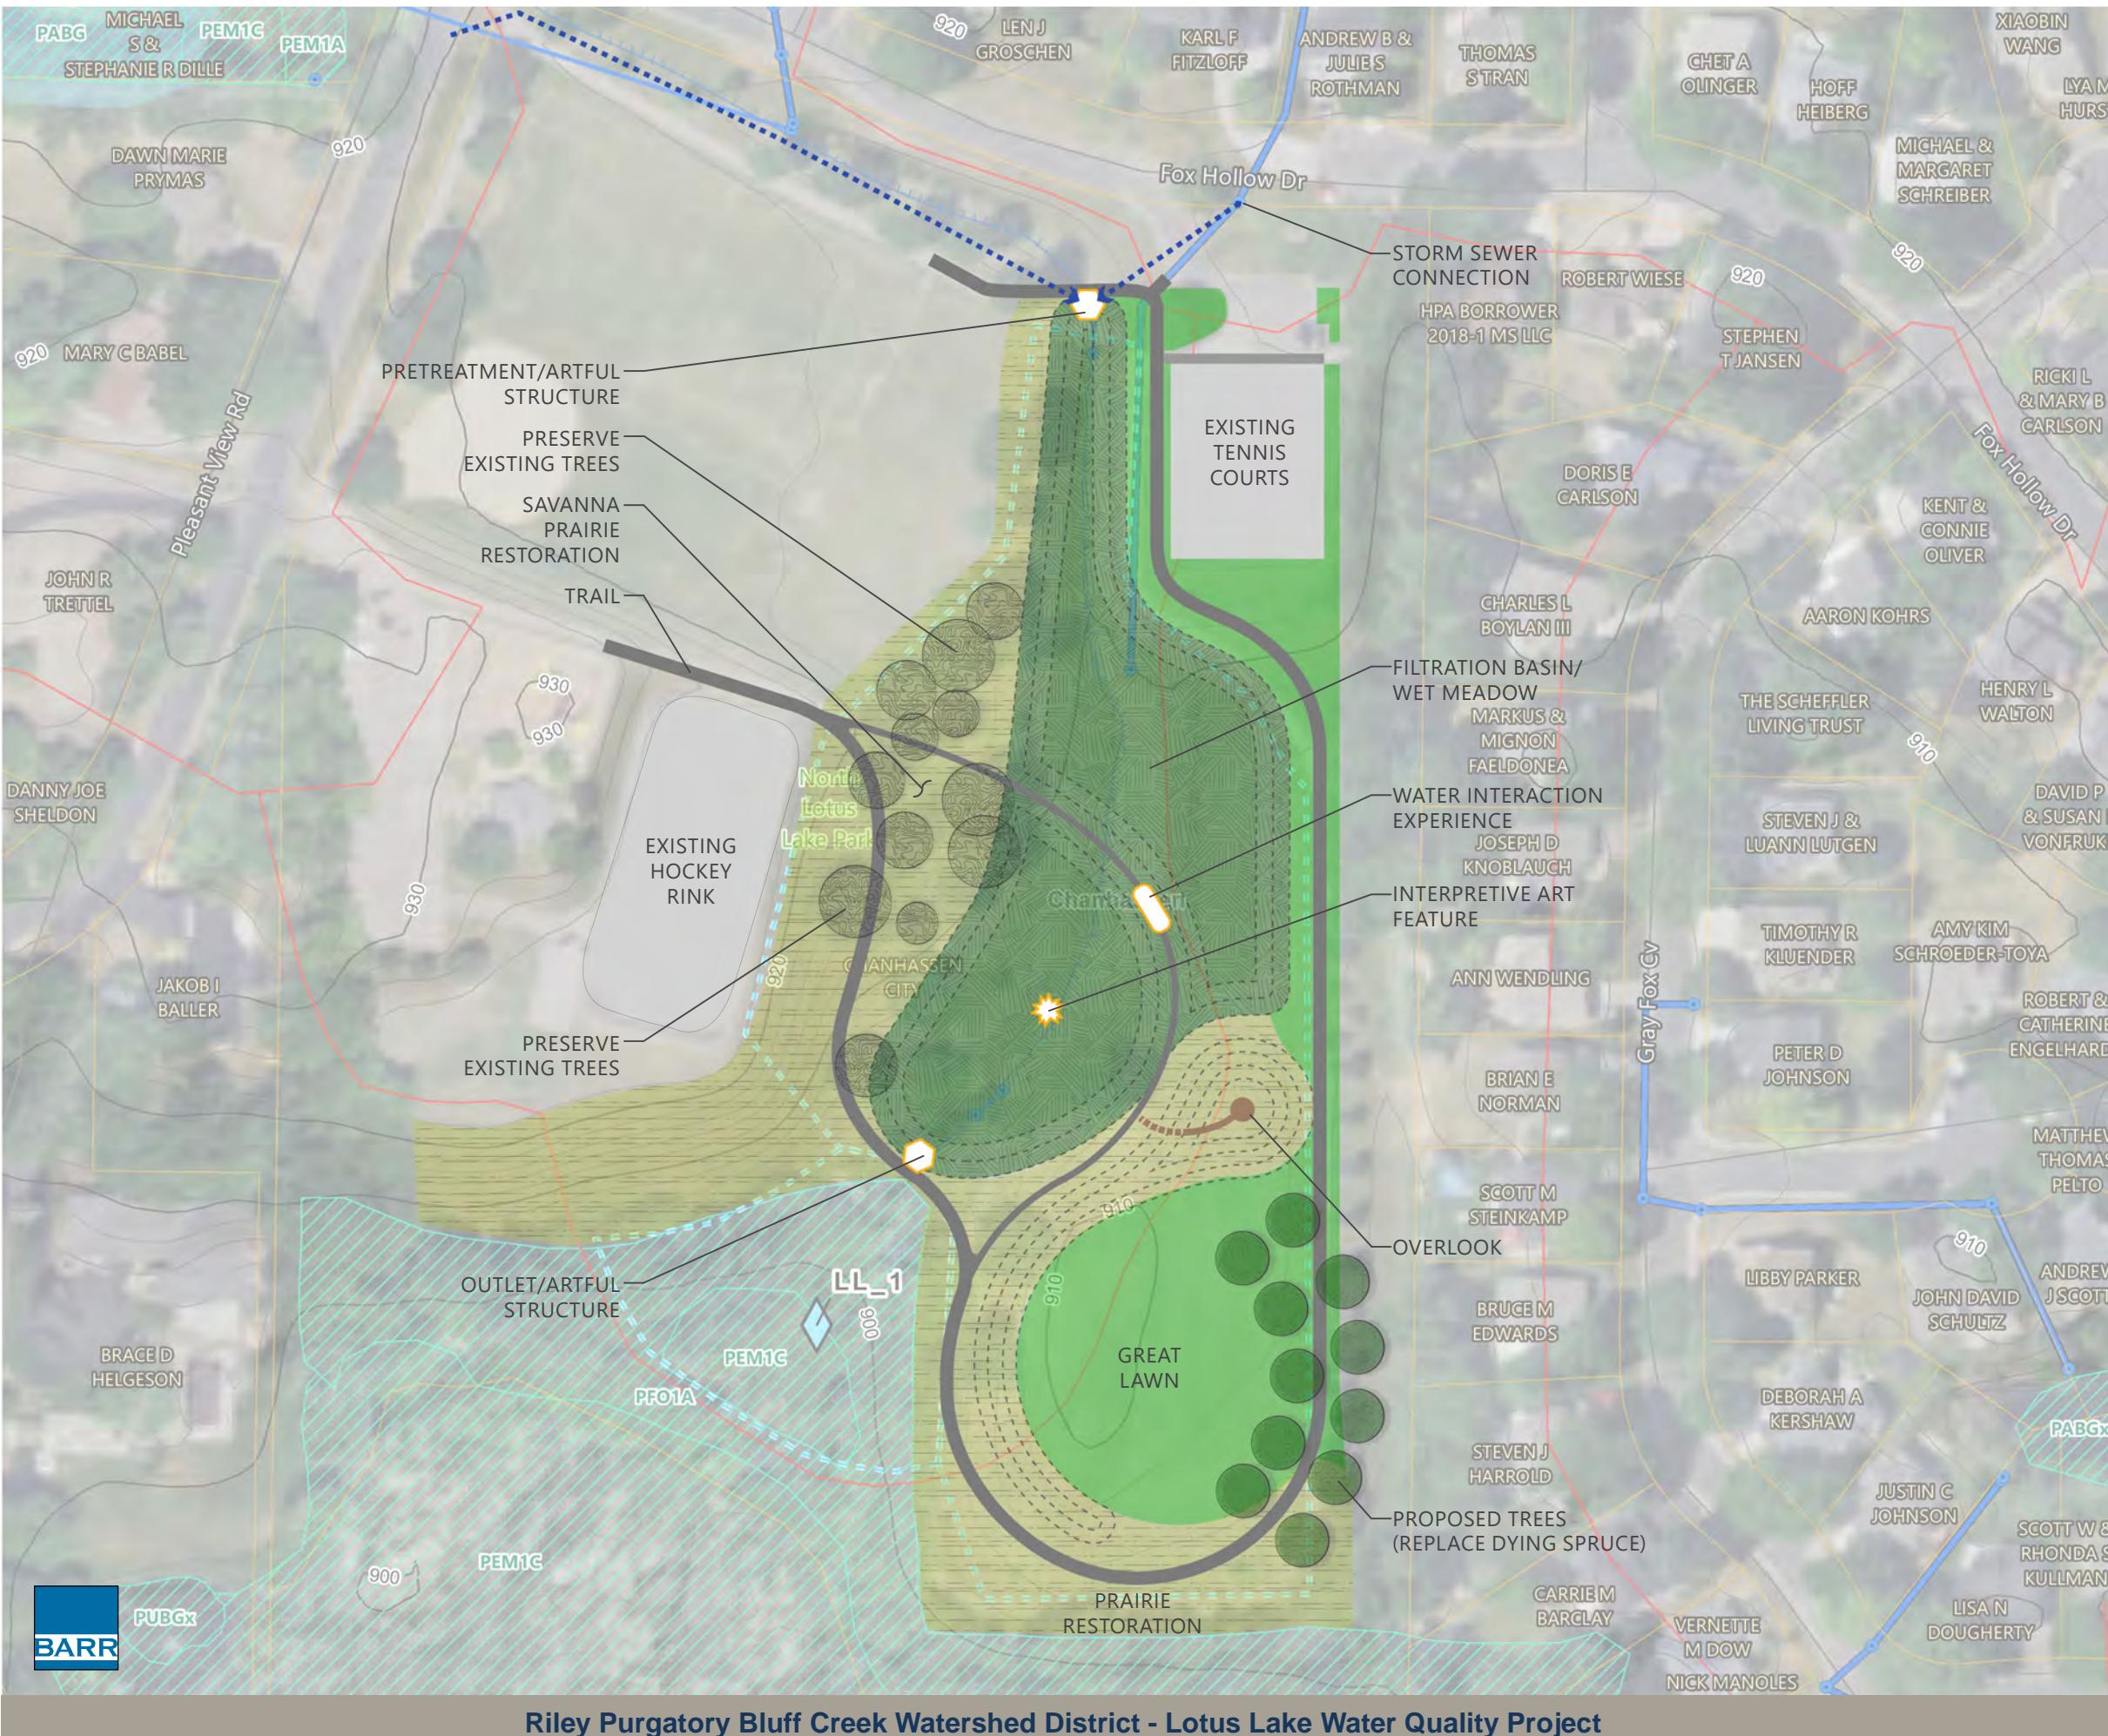
Figure 4-2

Proposed Concept LL_1a

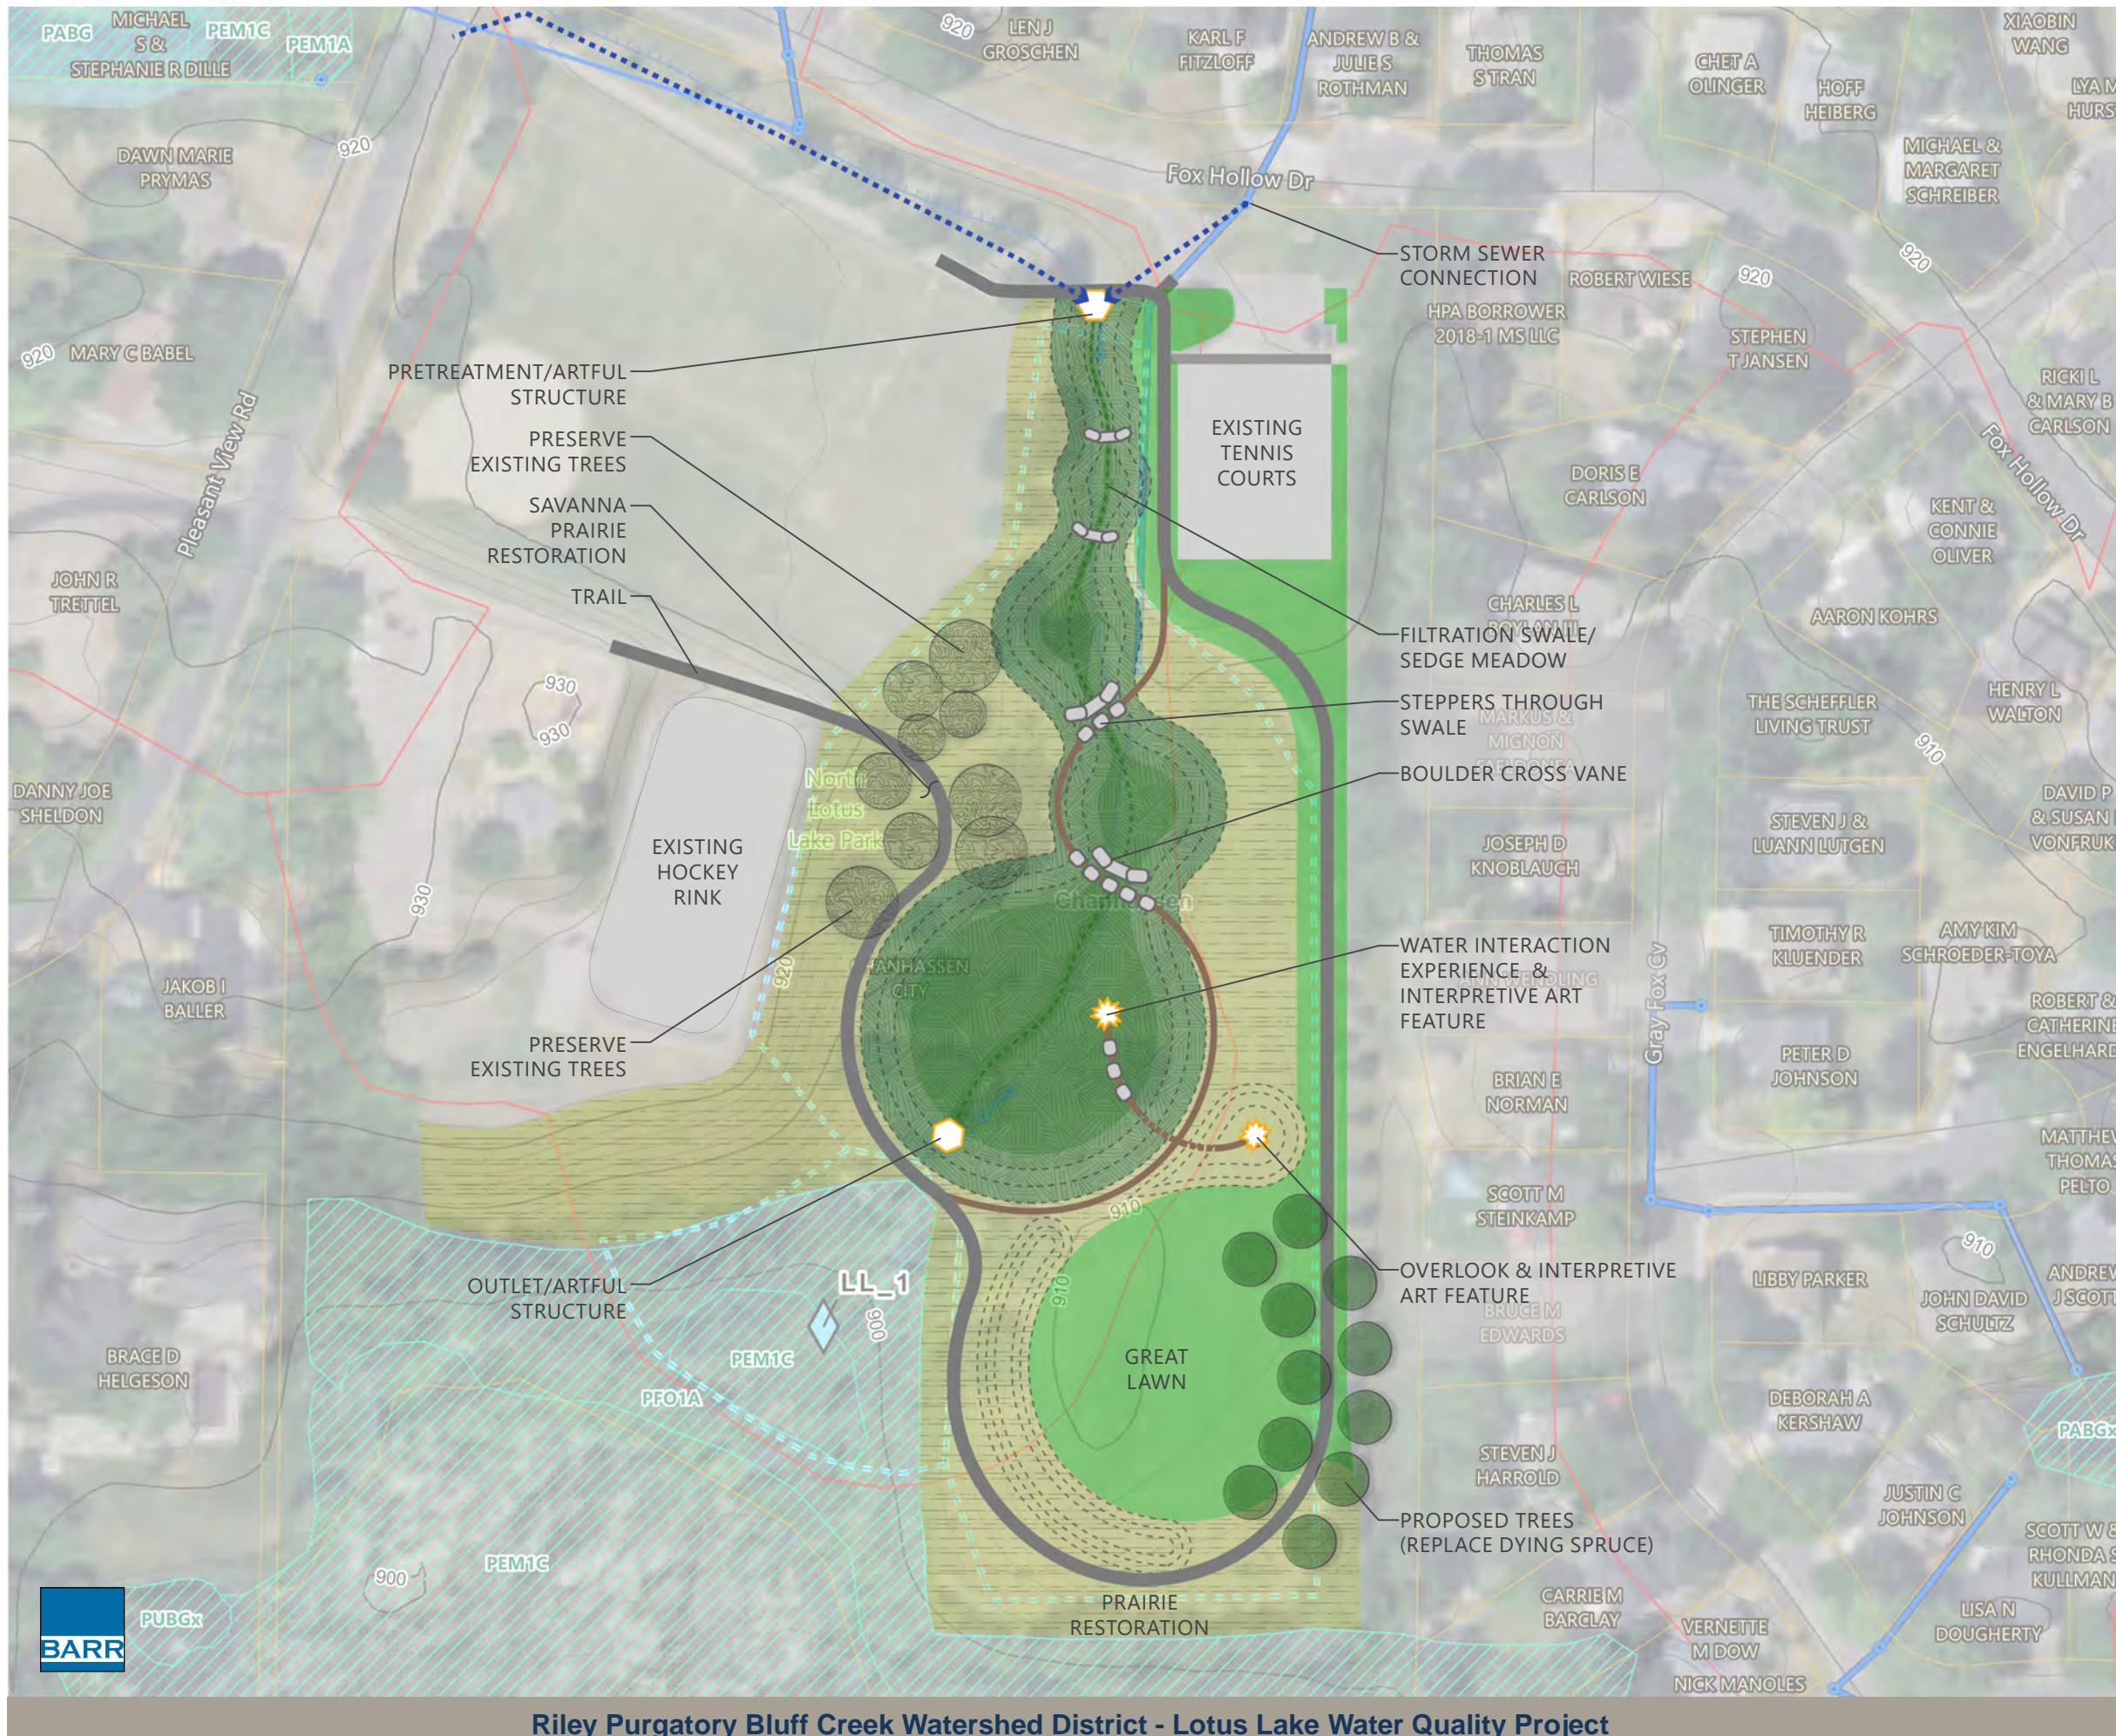
Figure 4-3

Proposed Concept LL_1b

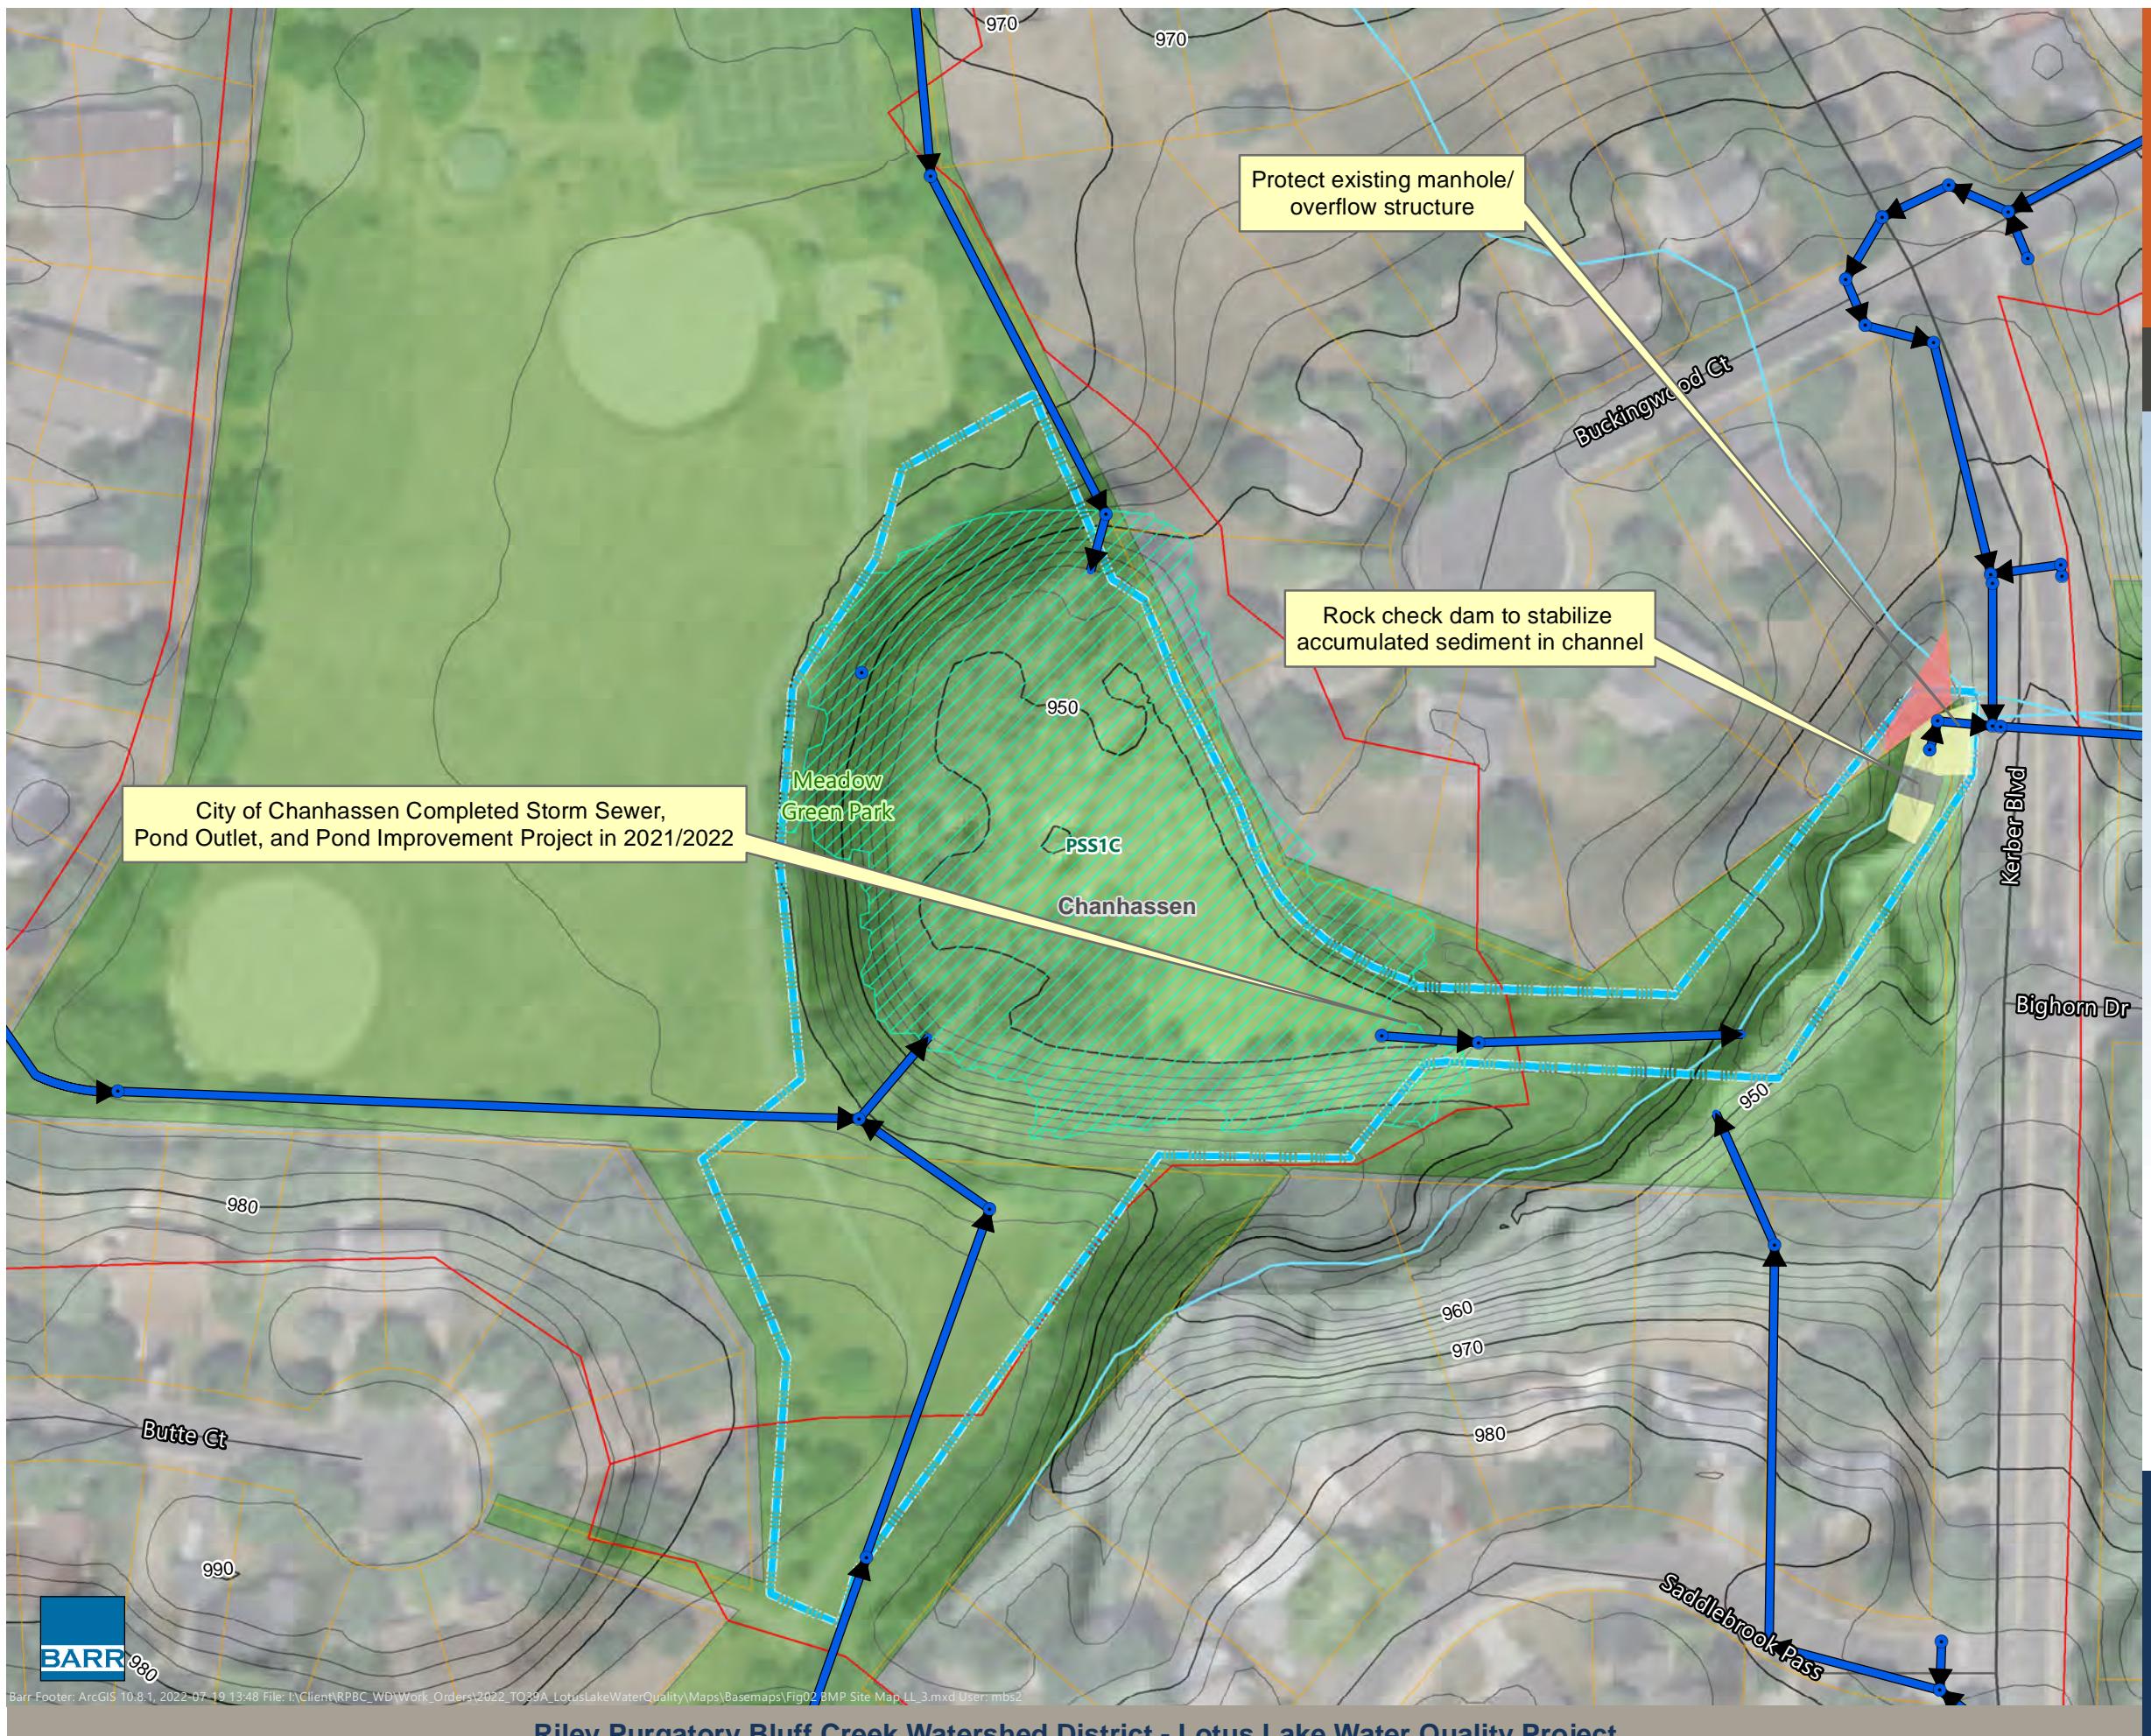
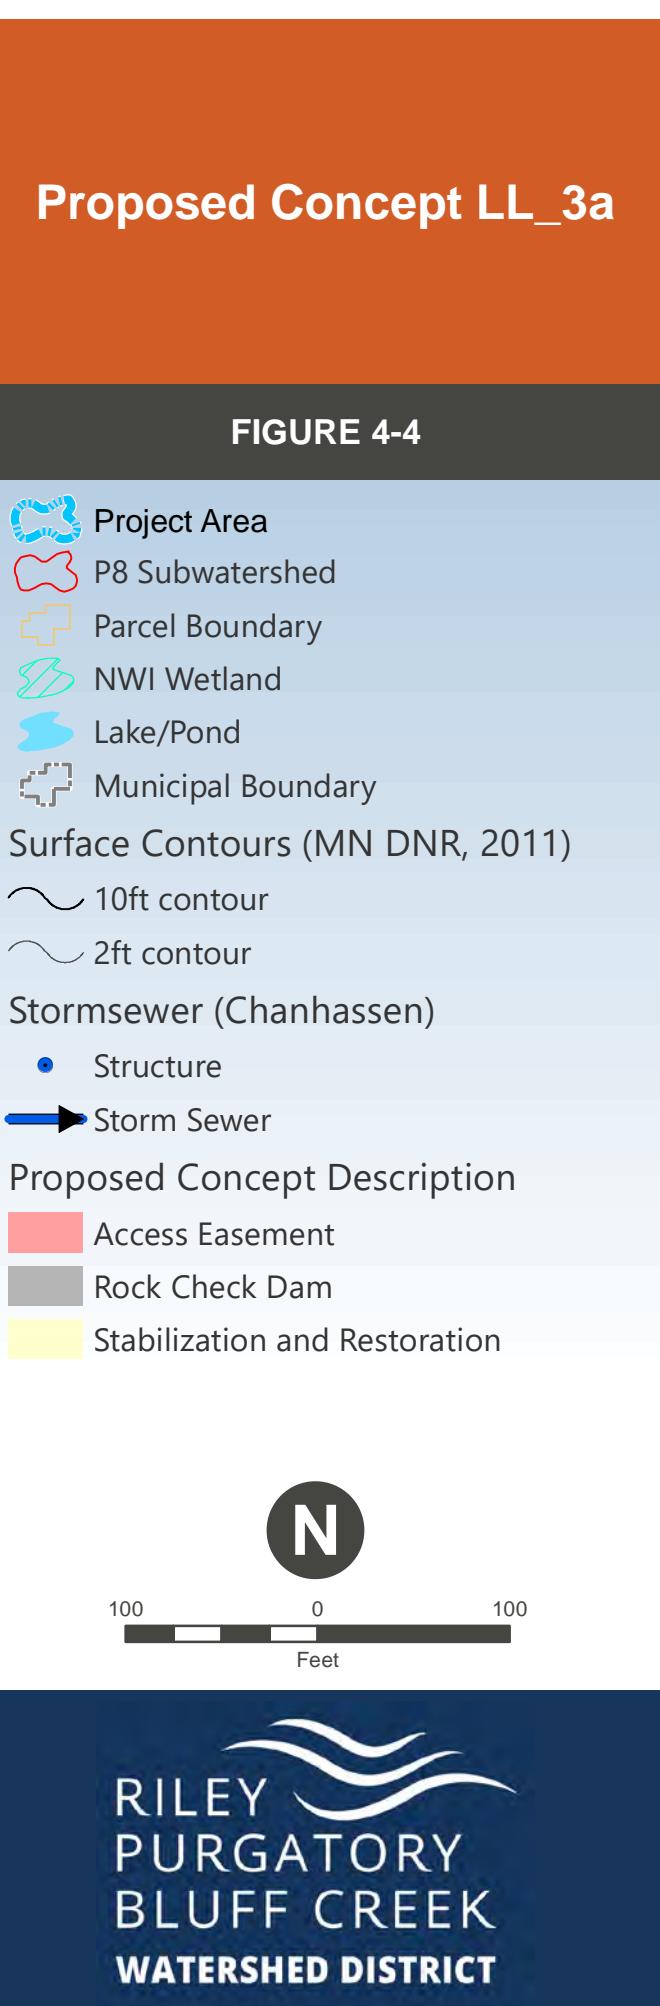
- Construction of Rock Check Dam at elevation 940 ft MSL to stabilize the movement of sediment accumulated in the channel and prevention of further headcutting along the channel bottom
- To improve the infiltration capacity of the woodland soils flanking the channel, removal of invasive species (primarily buckthorn) and seeding of native woodland grasses and wildflowers would improve biodiversity, soil health, and stormwater infiltration.

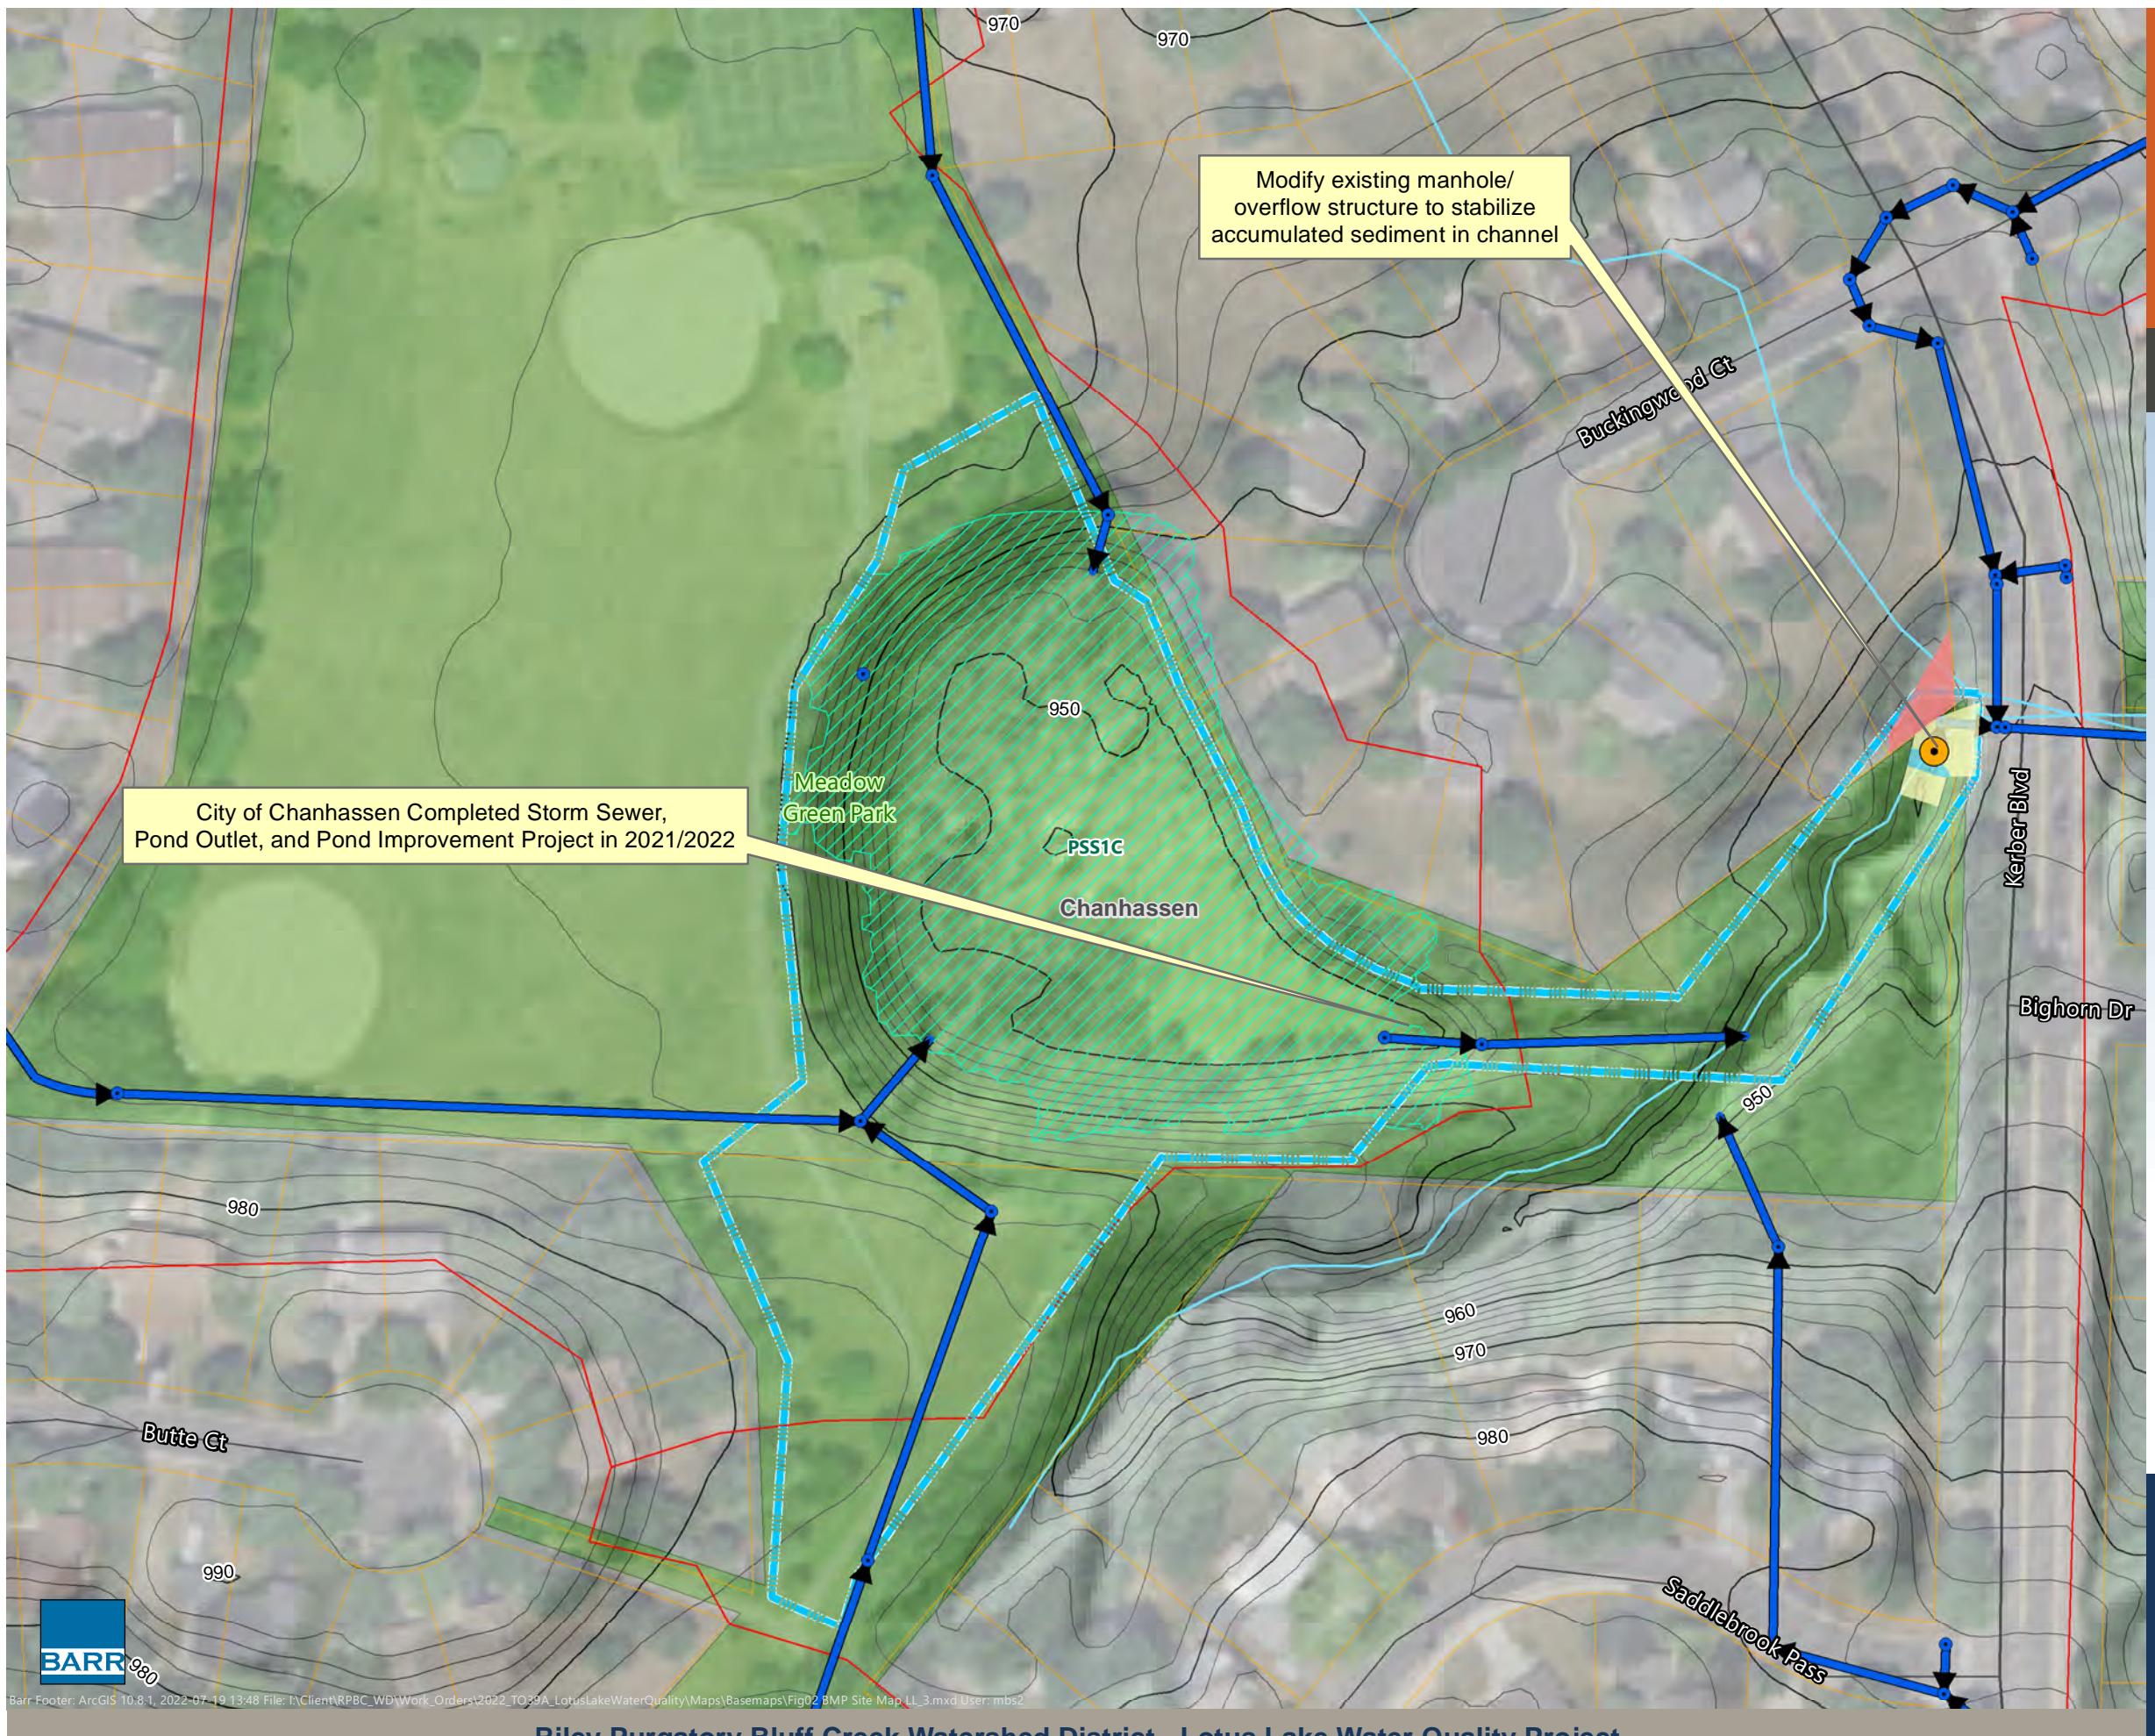
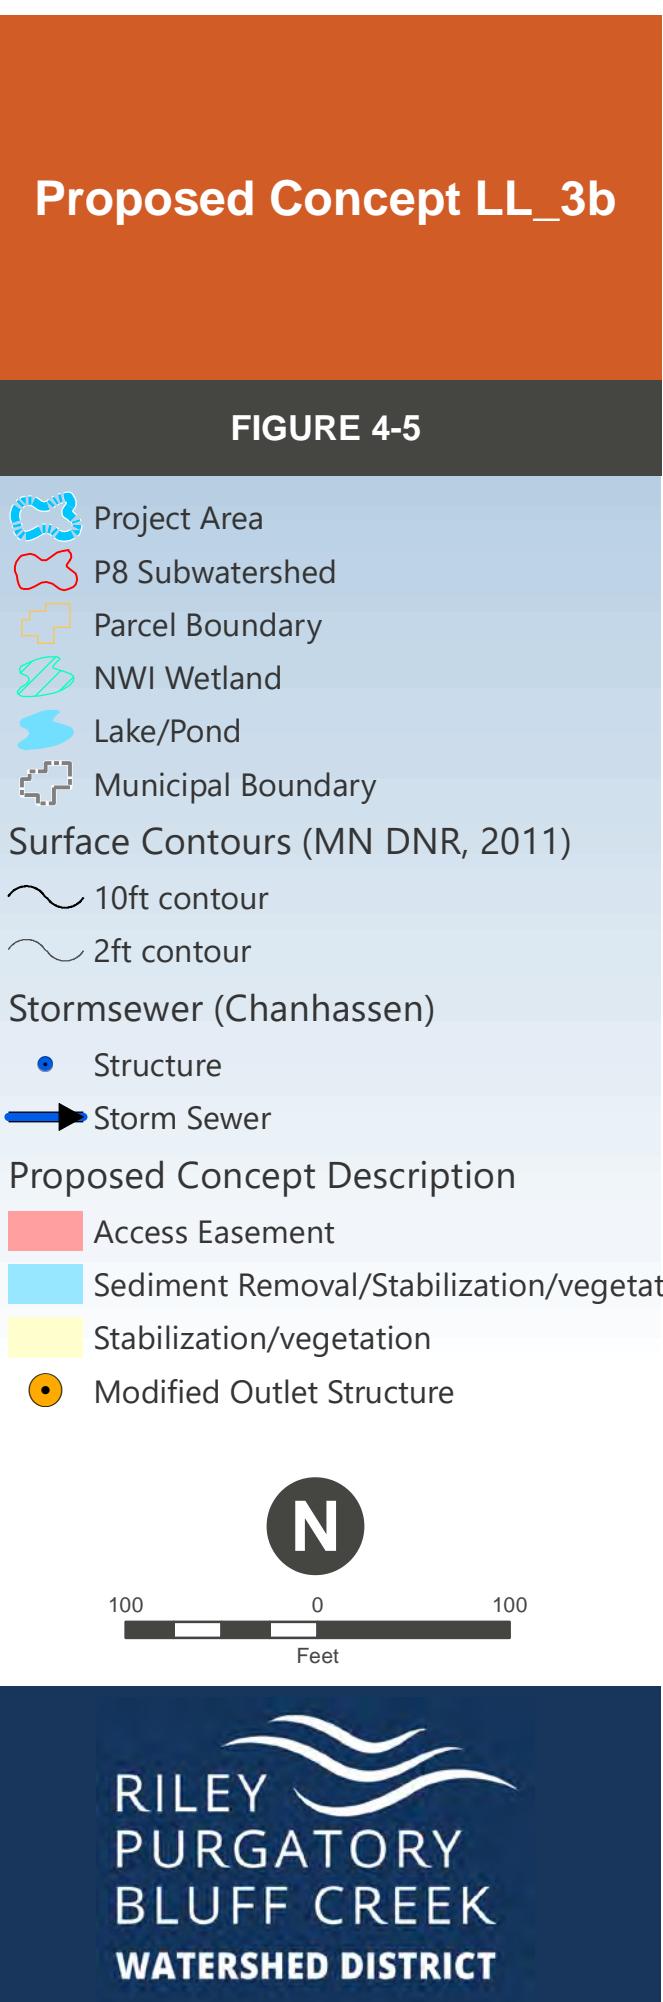
4.2.1.2 LL_3b: Channel Stabilization with Outlet Modification

- Modification of the existing outlet manhole west of Kerber Boulevard to stabilize the movement of sediment accumulated in the channel and prevention of further headcutting along the channel bottom
 - Bulkhead existing outlet pipe at downstream end of ravine
 - Modify manhole to include 10 ft weir at elevation 941 ft MSL (slightly above top of existing sediment accumulation)
- To improve the infiltration capacity of the woodland soils flanking the channel, removal of invasive species (primarily buckthorn) and seeding of native woodland grasses and wildflowers would improve biodiversity, soil health, and stormwater infiltration.
