Feasibility Report

Lotus Lake Water Quality Improvement Project

Prepared for
Riley Purgatory Bluff Creek Watershed District

February 2024 DRAFT

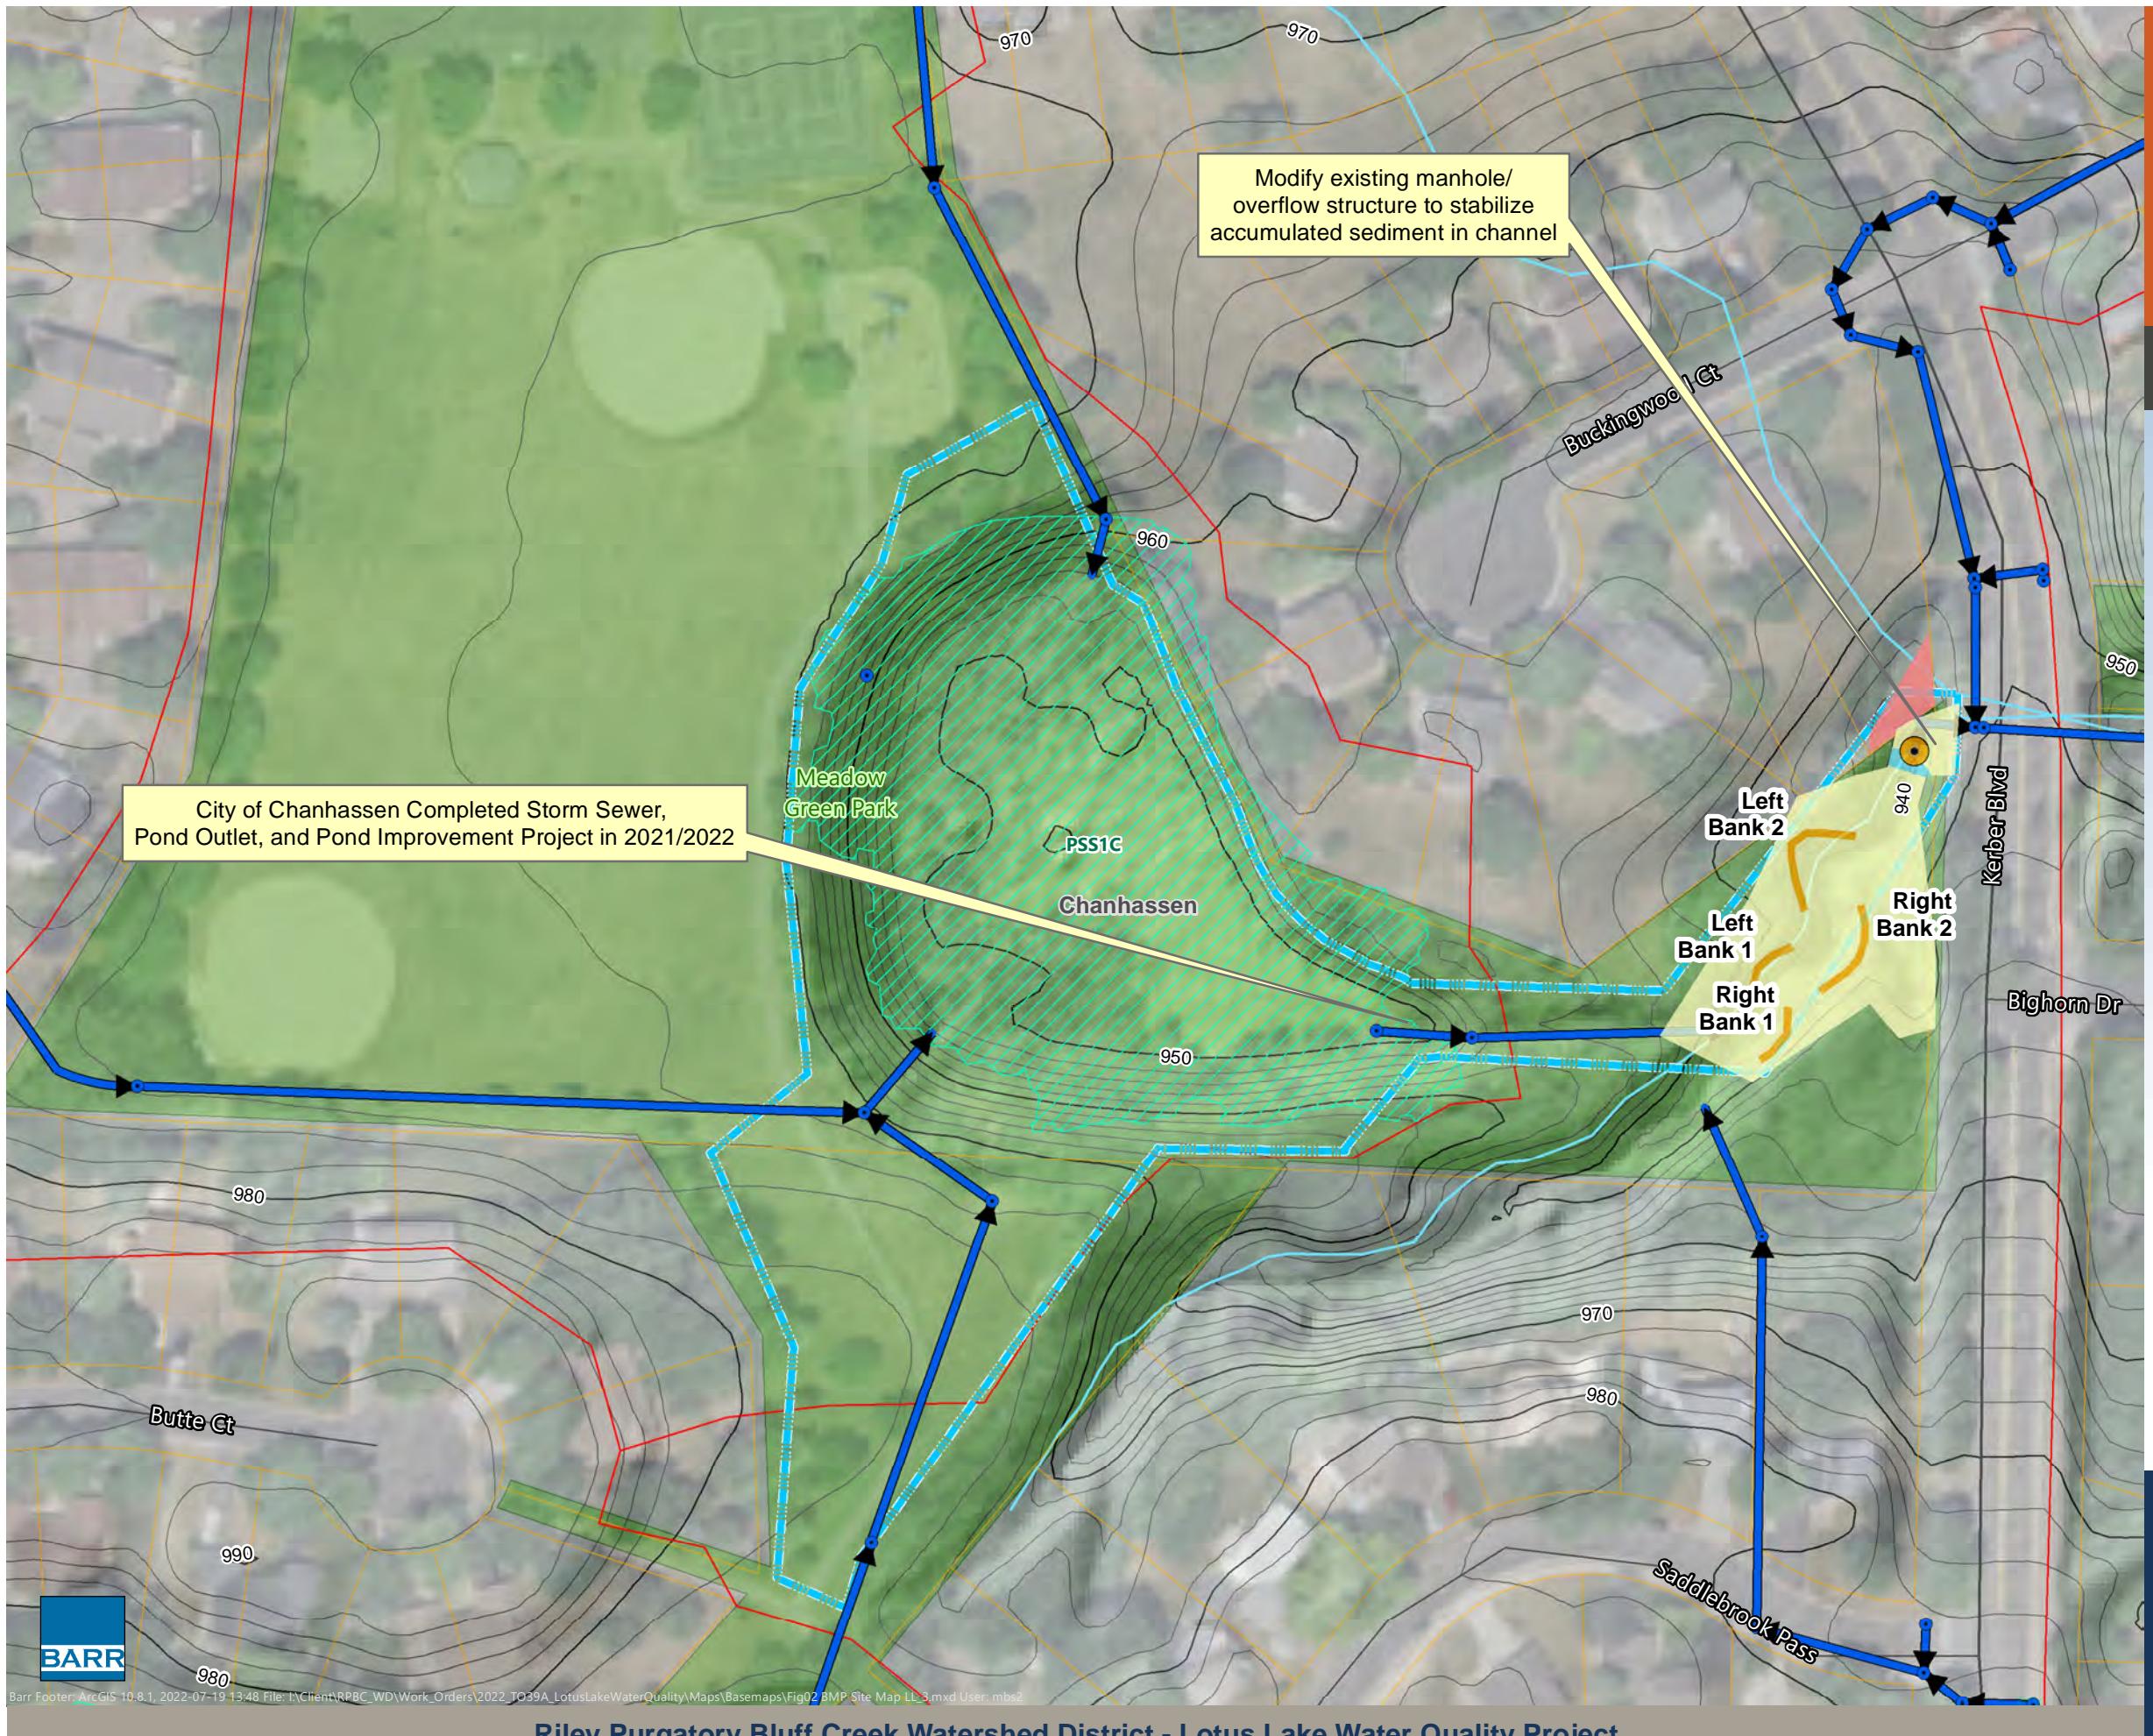
4.2.1.3 LL_3c: Channel Stabilization with Outlet Modification and Upstream Bank Stabilization

- This approach was selected due to narrow channel, steep banks, and minimize disturbance extents and tree removals
- To improve the infiltration capacity of the woodland soils flanking the channel, removal of invasive species (primarily buckthorn) and seeding of native woodland grasses and wildflowers would improve biodiversity, soil health, and stormwater infiltration.

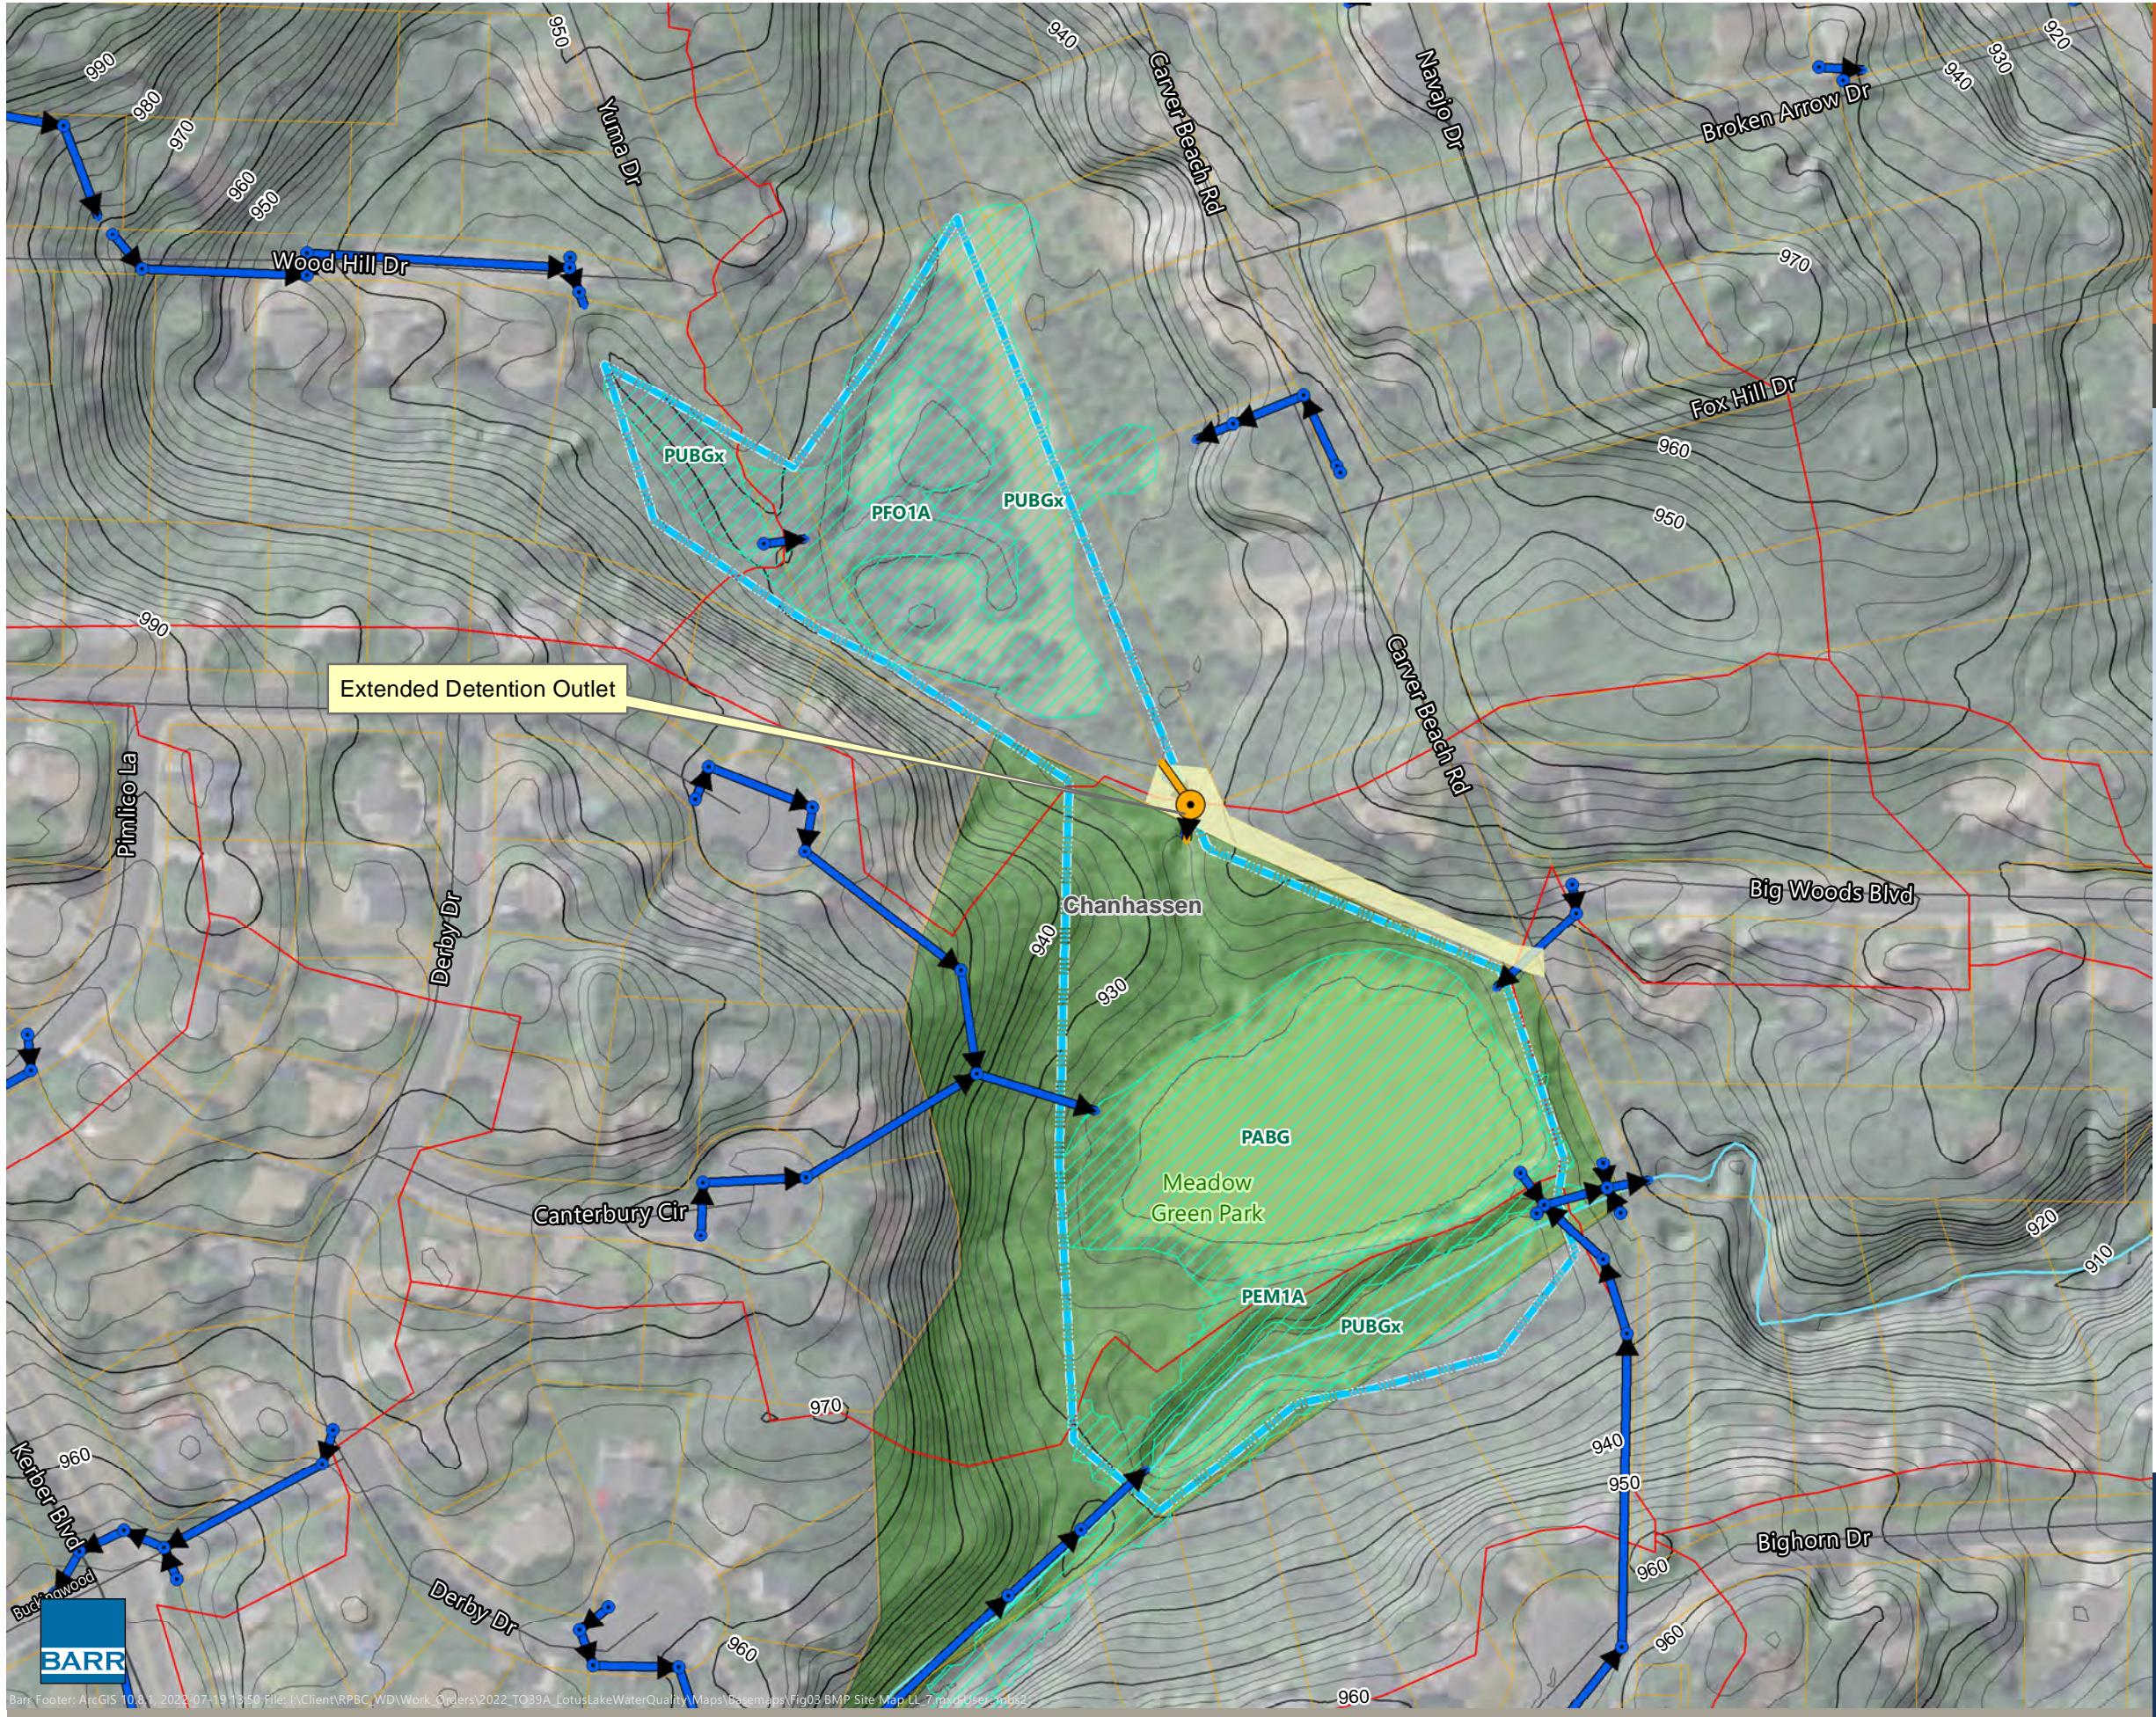
FIGURE 4-7

- Extended detention outlet modification at the Upper Wetland
 - 12" Orifice at elevation 924.71 ft MSL (same elevation as existing outlet pipe)
 - 7' Weir at elevation 926.5 ft MSL
 - Overflow at trail at elevation 927.1 ft MSL (same elevation as existing trail)
- Any disturbed areas are to be improved for soil health (decompacted and amended) and then vegetated in appropriate wet meadow or prairie vegetation.

Proposed Concept LL_7a

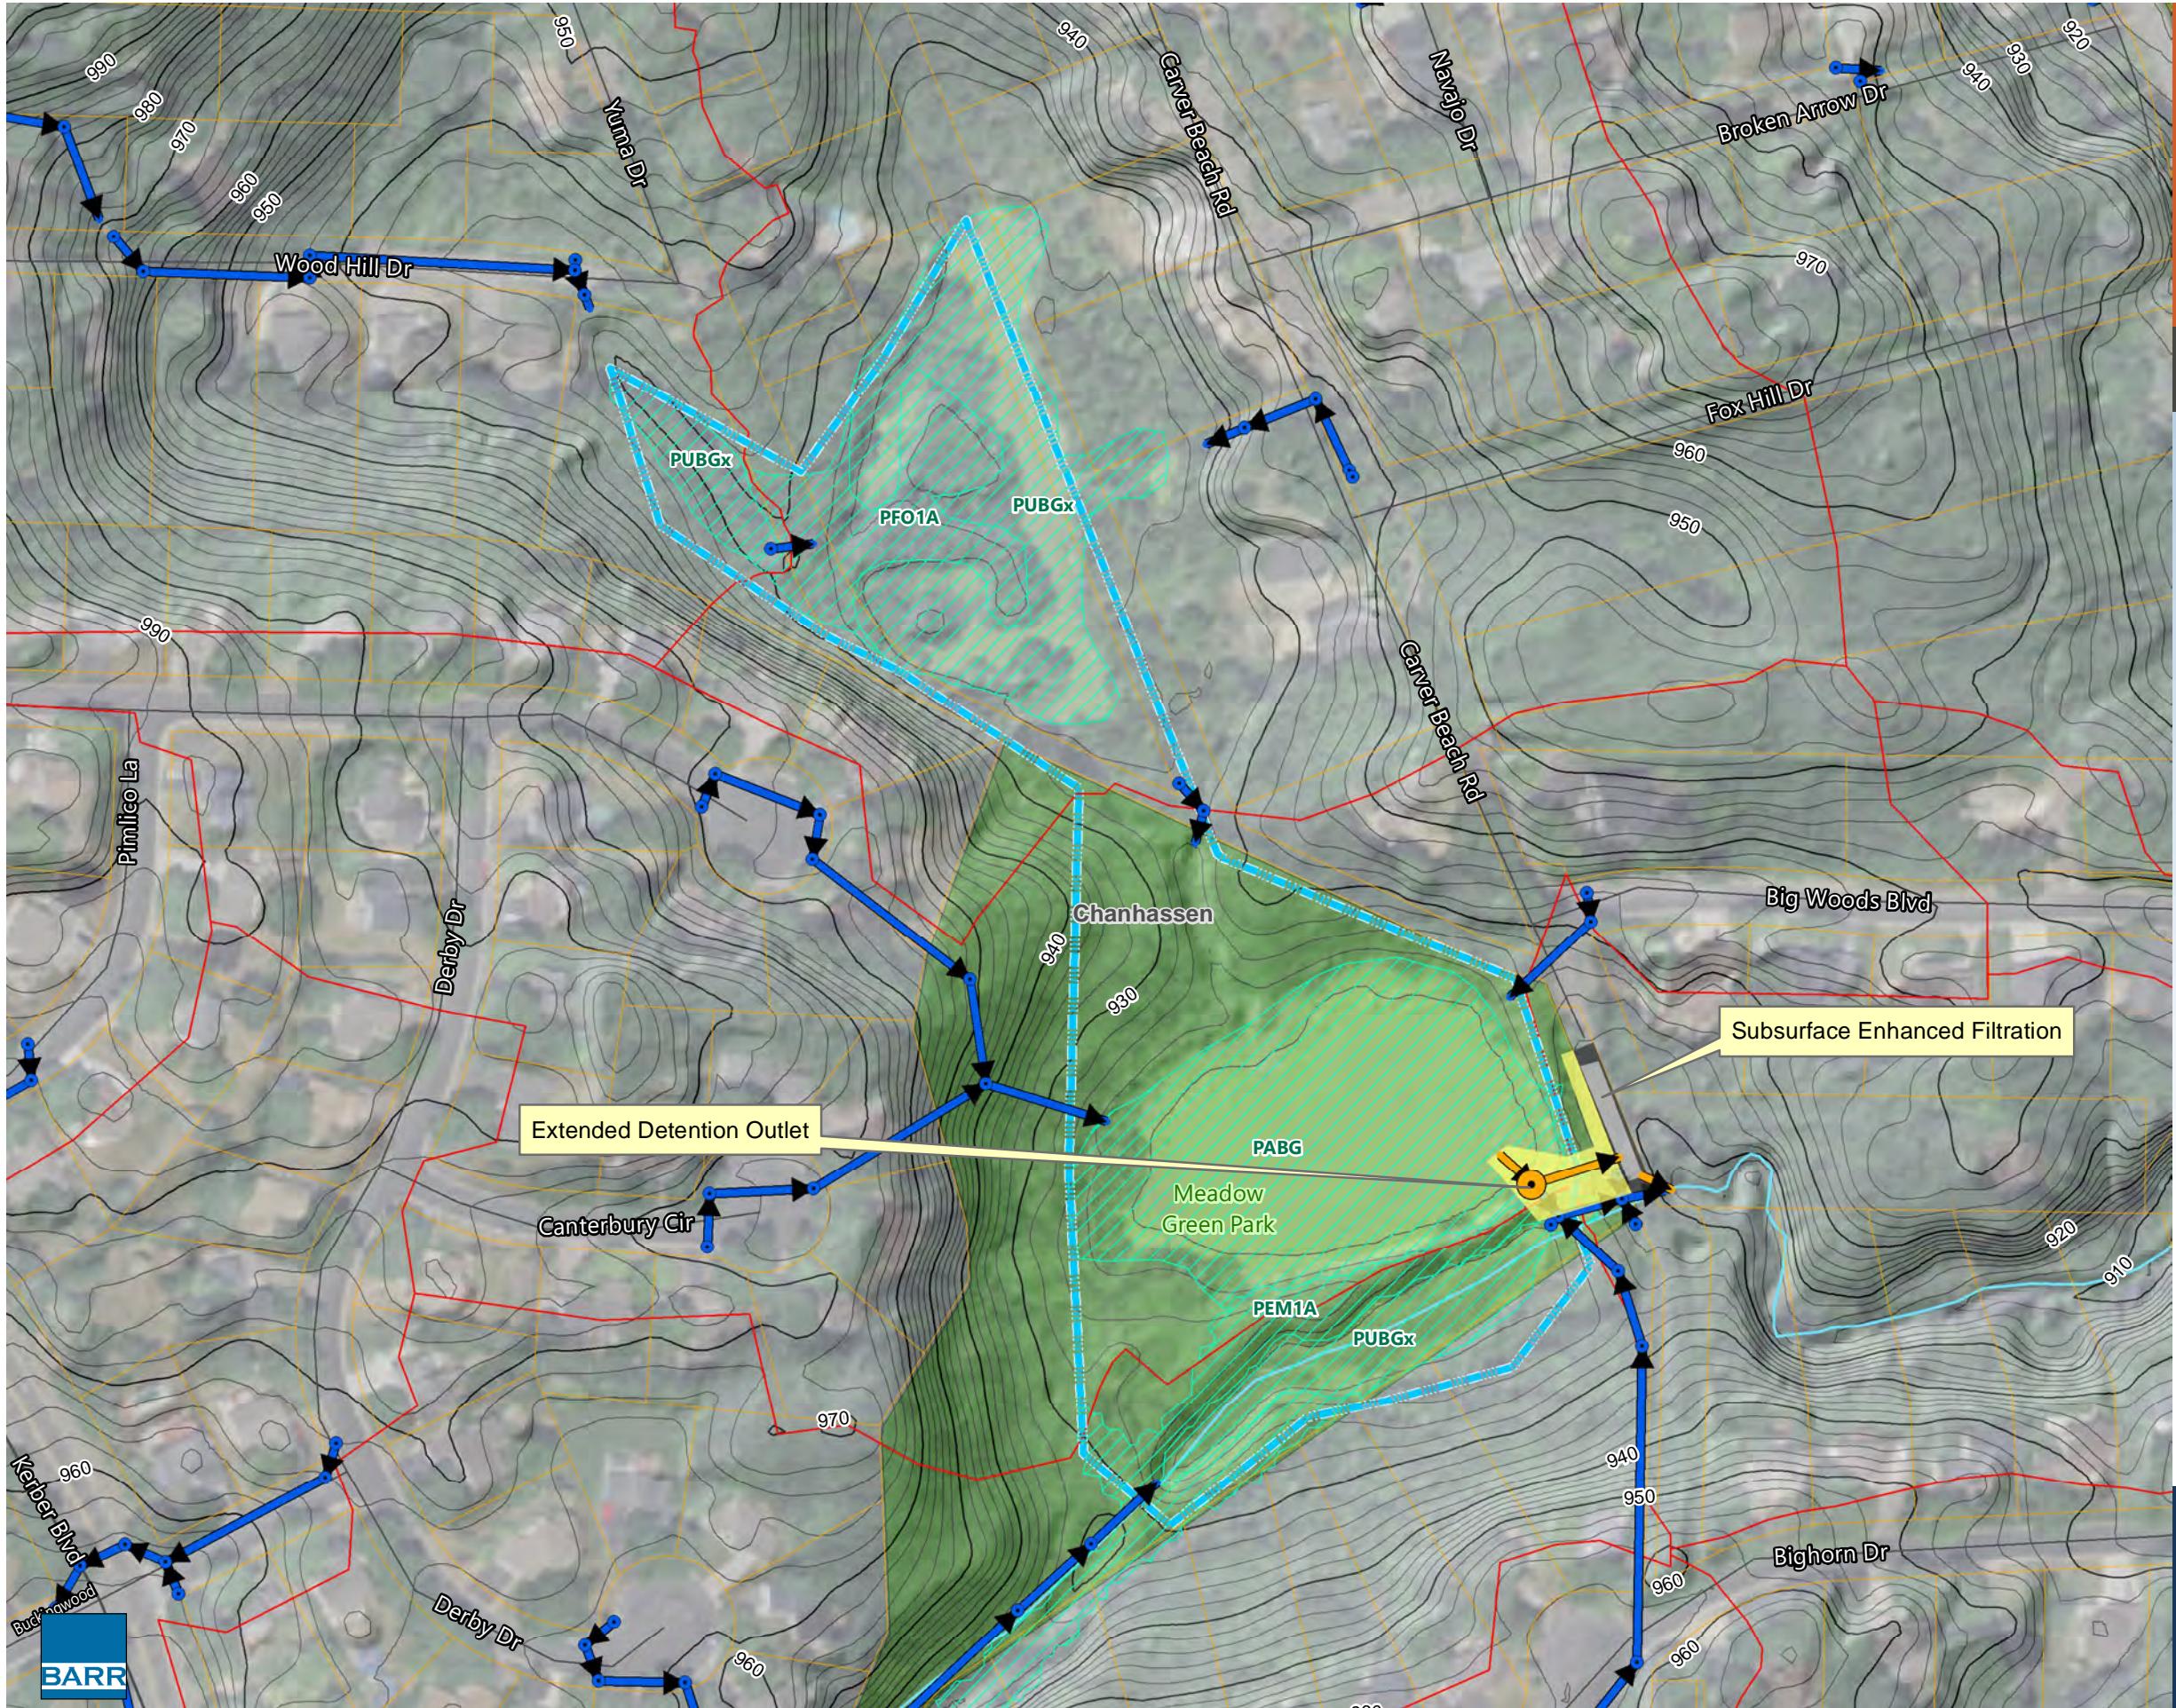
- Extended detention outlet modification at the Lower Wetland (as outlined above)
- Subsurface Iron-Enhanced Sand Filter at outlet from Lower Wetland
 - 1,600 square-foot filter with an assumed 0.15 cfs flow rate
- Modifications (if needed) to berm on south edge of lower wetland
- Any disturbed areas are to be improved for soil health (decompacted and amended) and then vegetated in appropriate wet meadow or prairie vegetation.

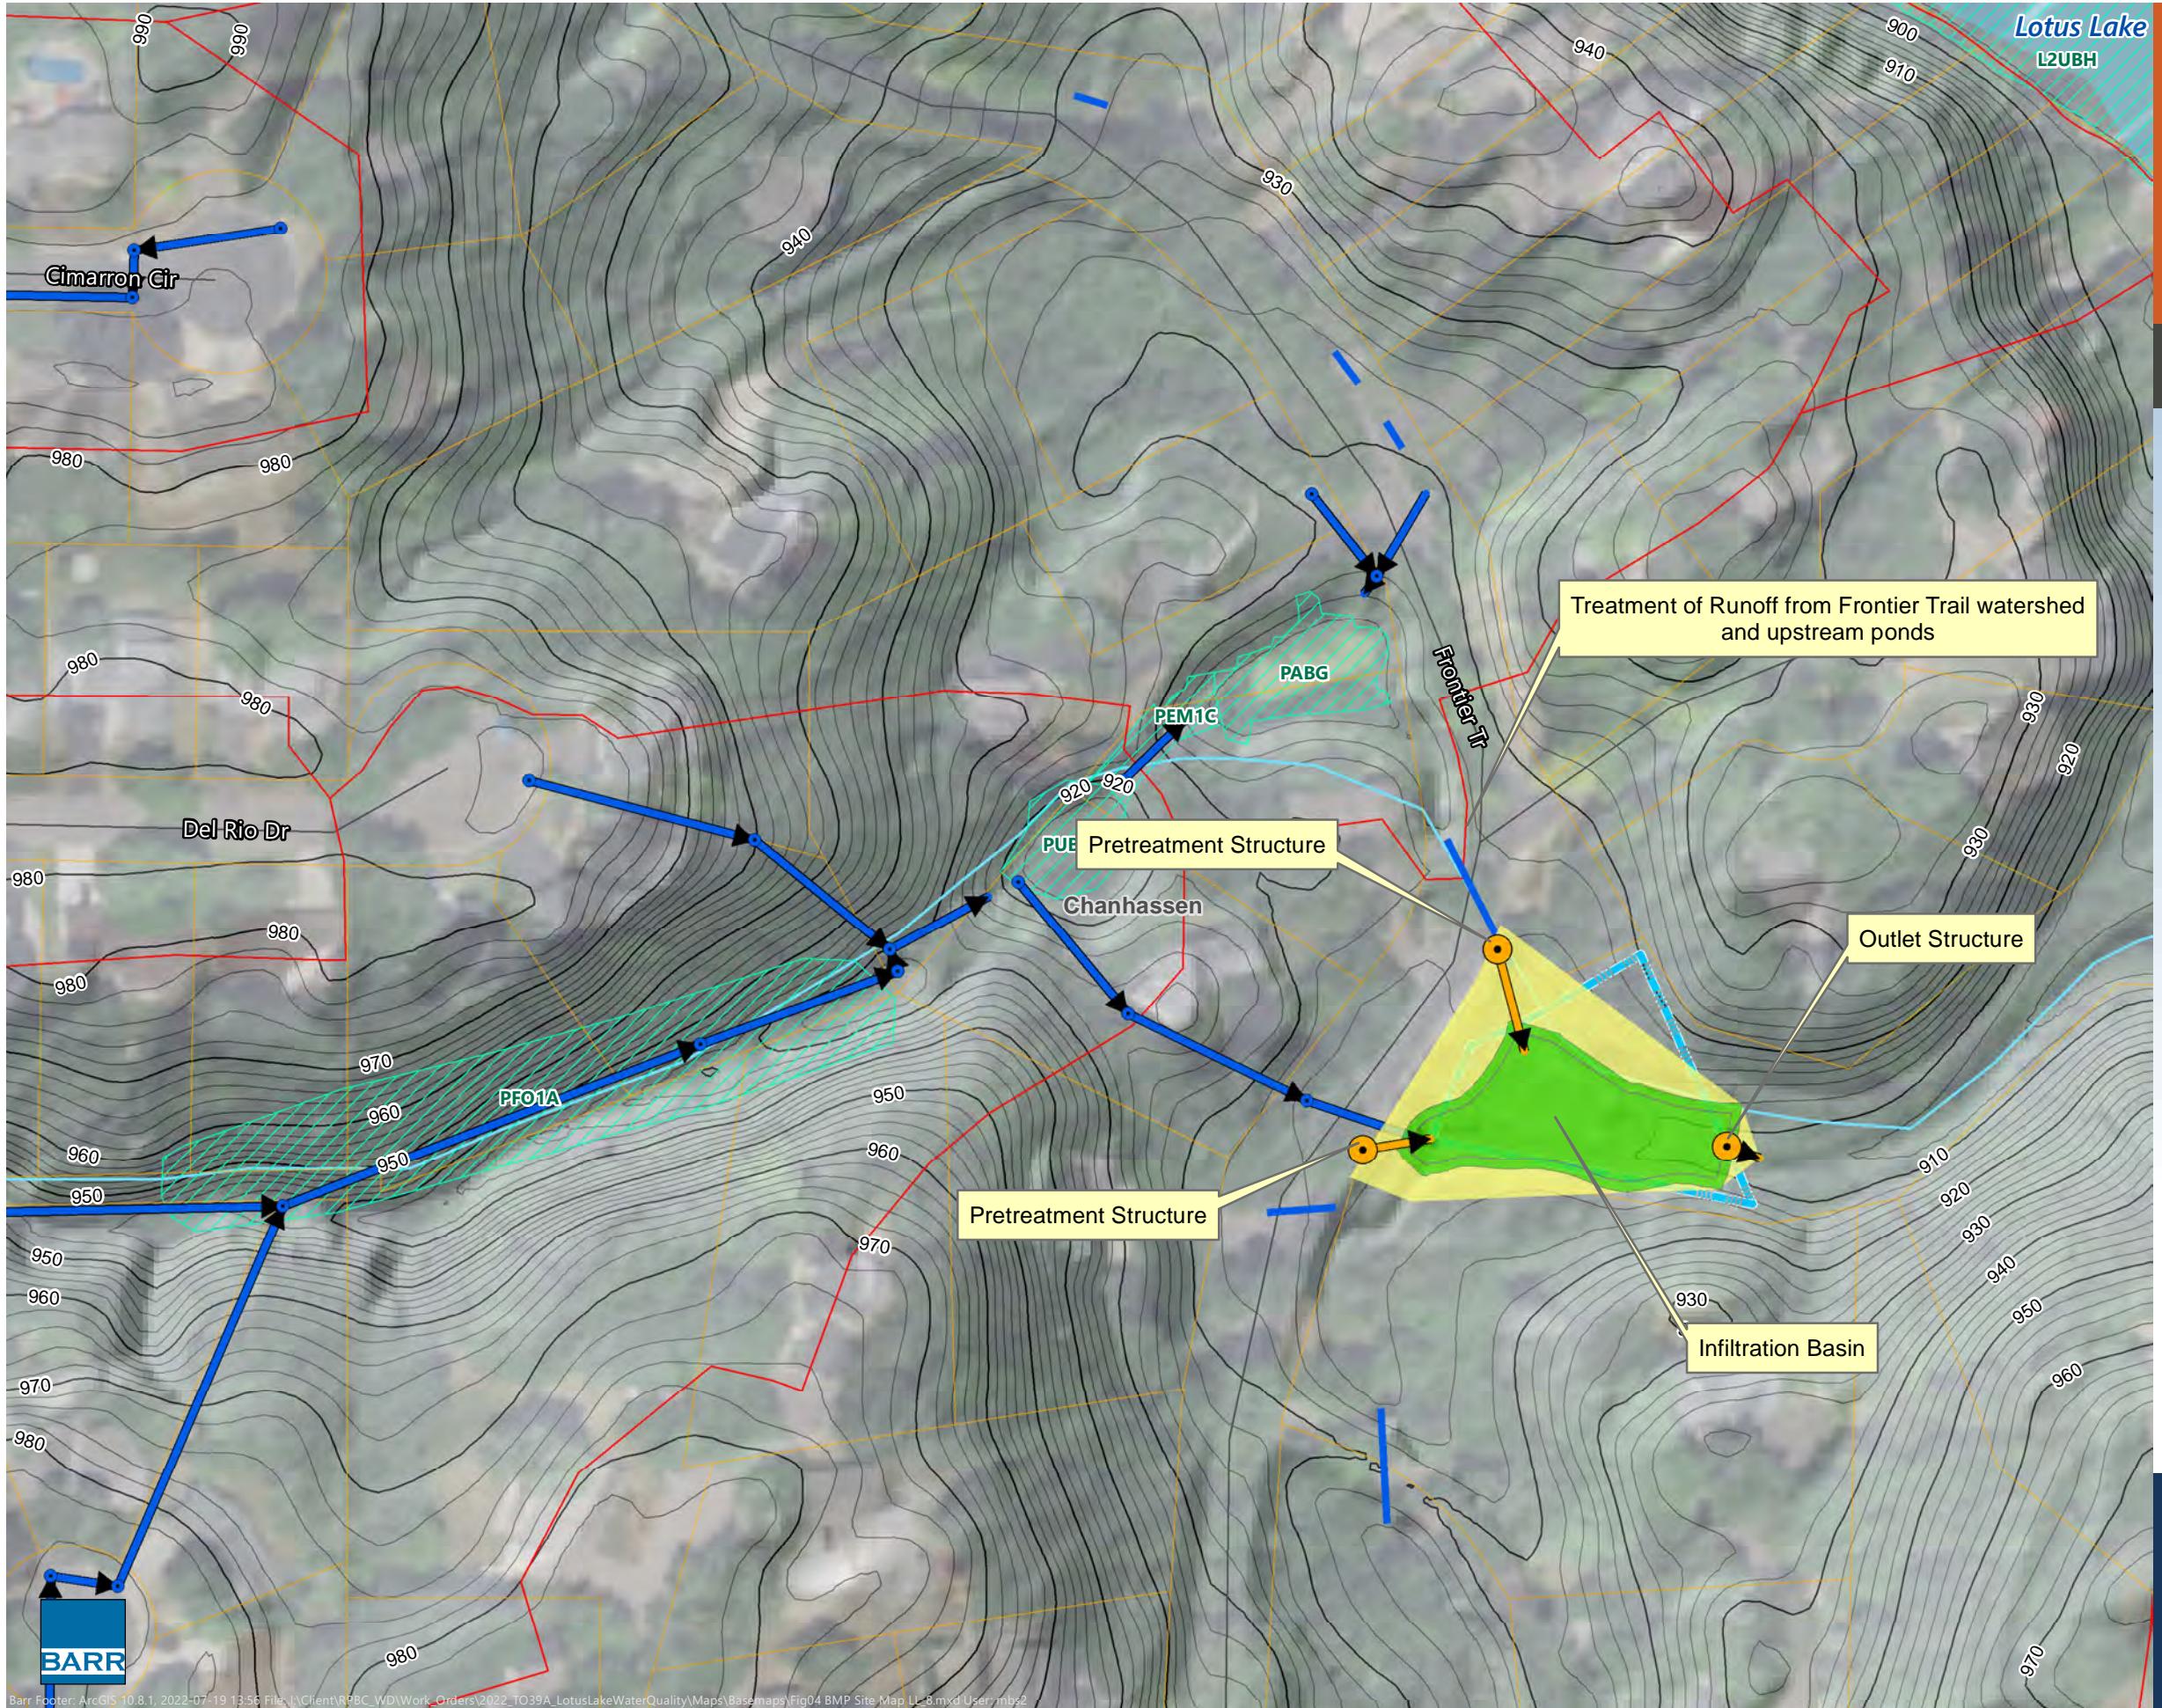
- Site grading to clear and remove many trees in proposed basin area
- Construction of infiltration basin with an invert at 910.0, assuming an infiltration rate of 0.2 inch/hr (HSG C)
- Construction of outlet structure with discharge elevation at 911.5
- Construction of overflow berm at downstream end of basin to elevation 912
- Basin provides water quality volume of 15,238 cf below the outlet structure and additional flood storage of 5,814 cf between the outlet structure and berm overflow
- Construction of associated storm sewer
- Tree planting to occur adjacent to the infiltration basin along with sedge meadow and pollinator vegetation to restore habitat value and improve biodiversity and soil health

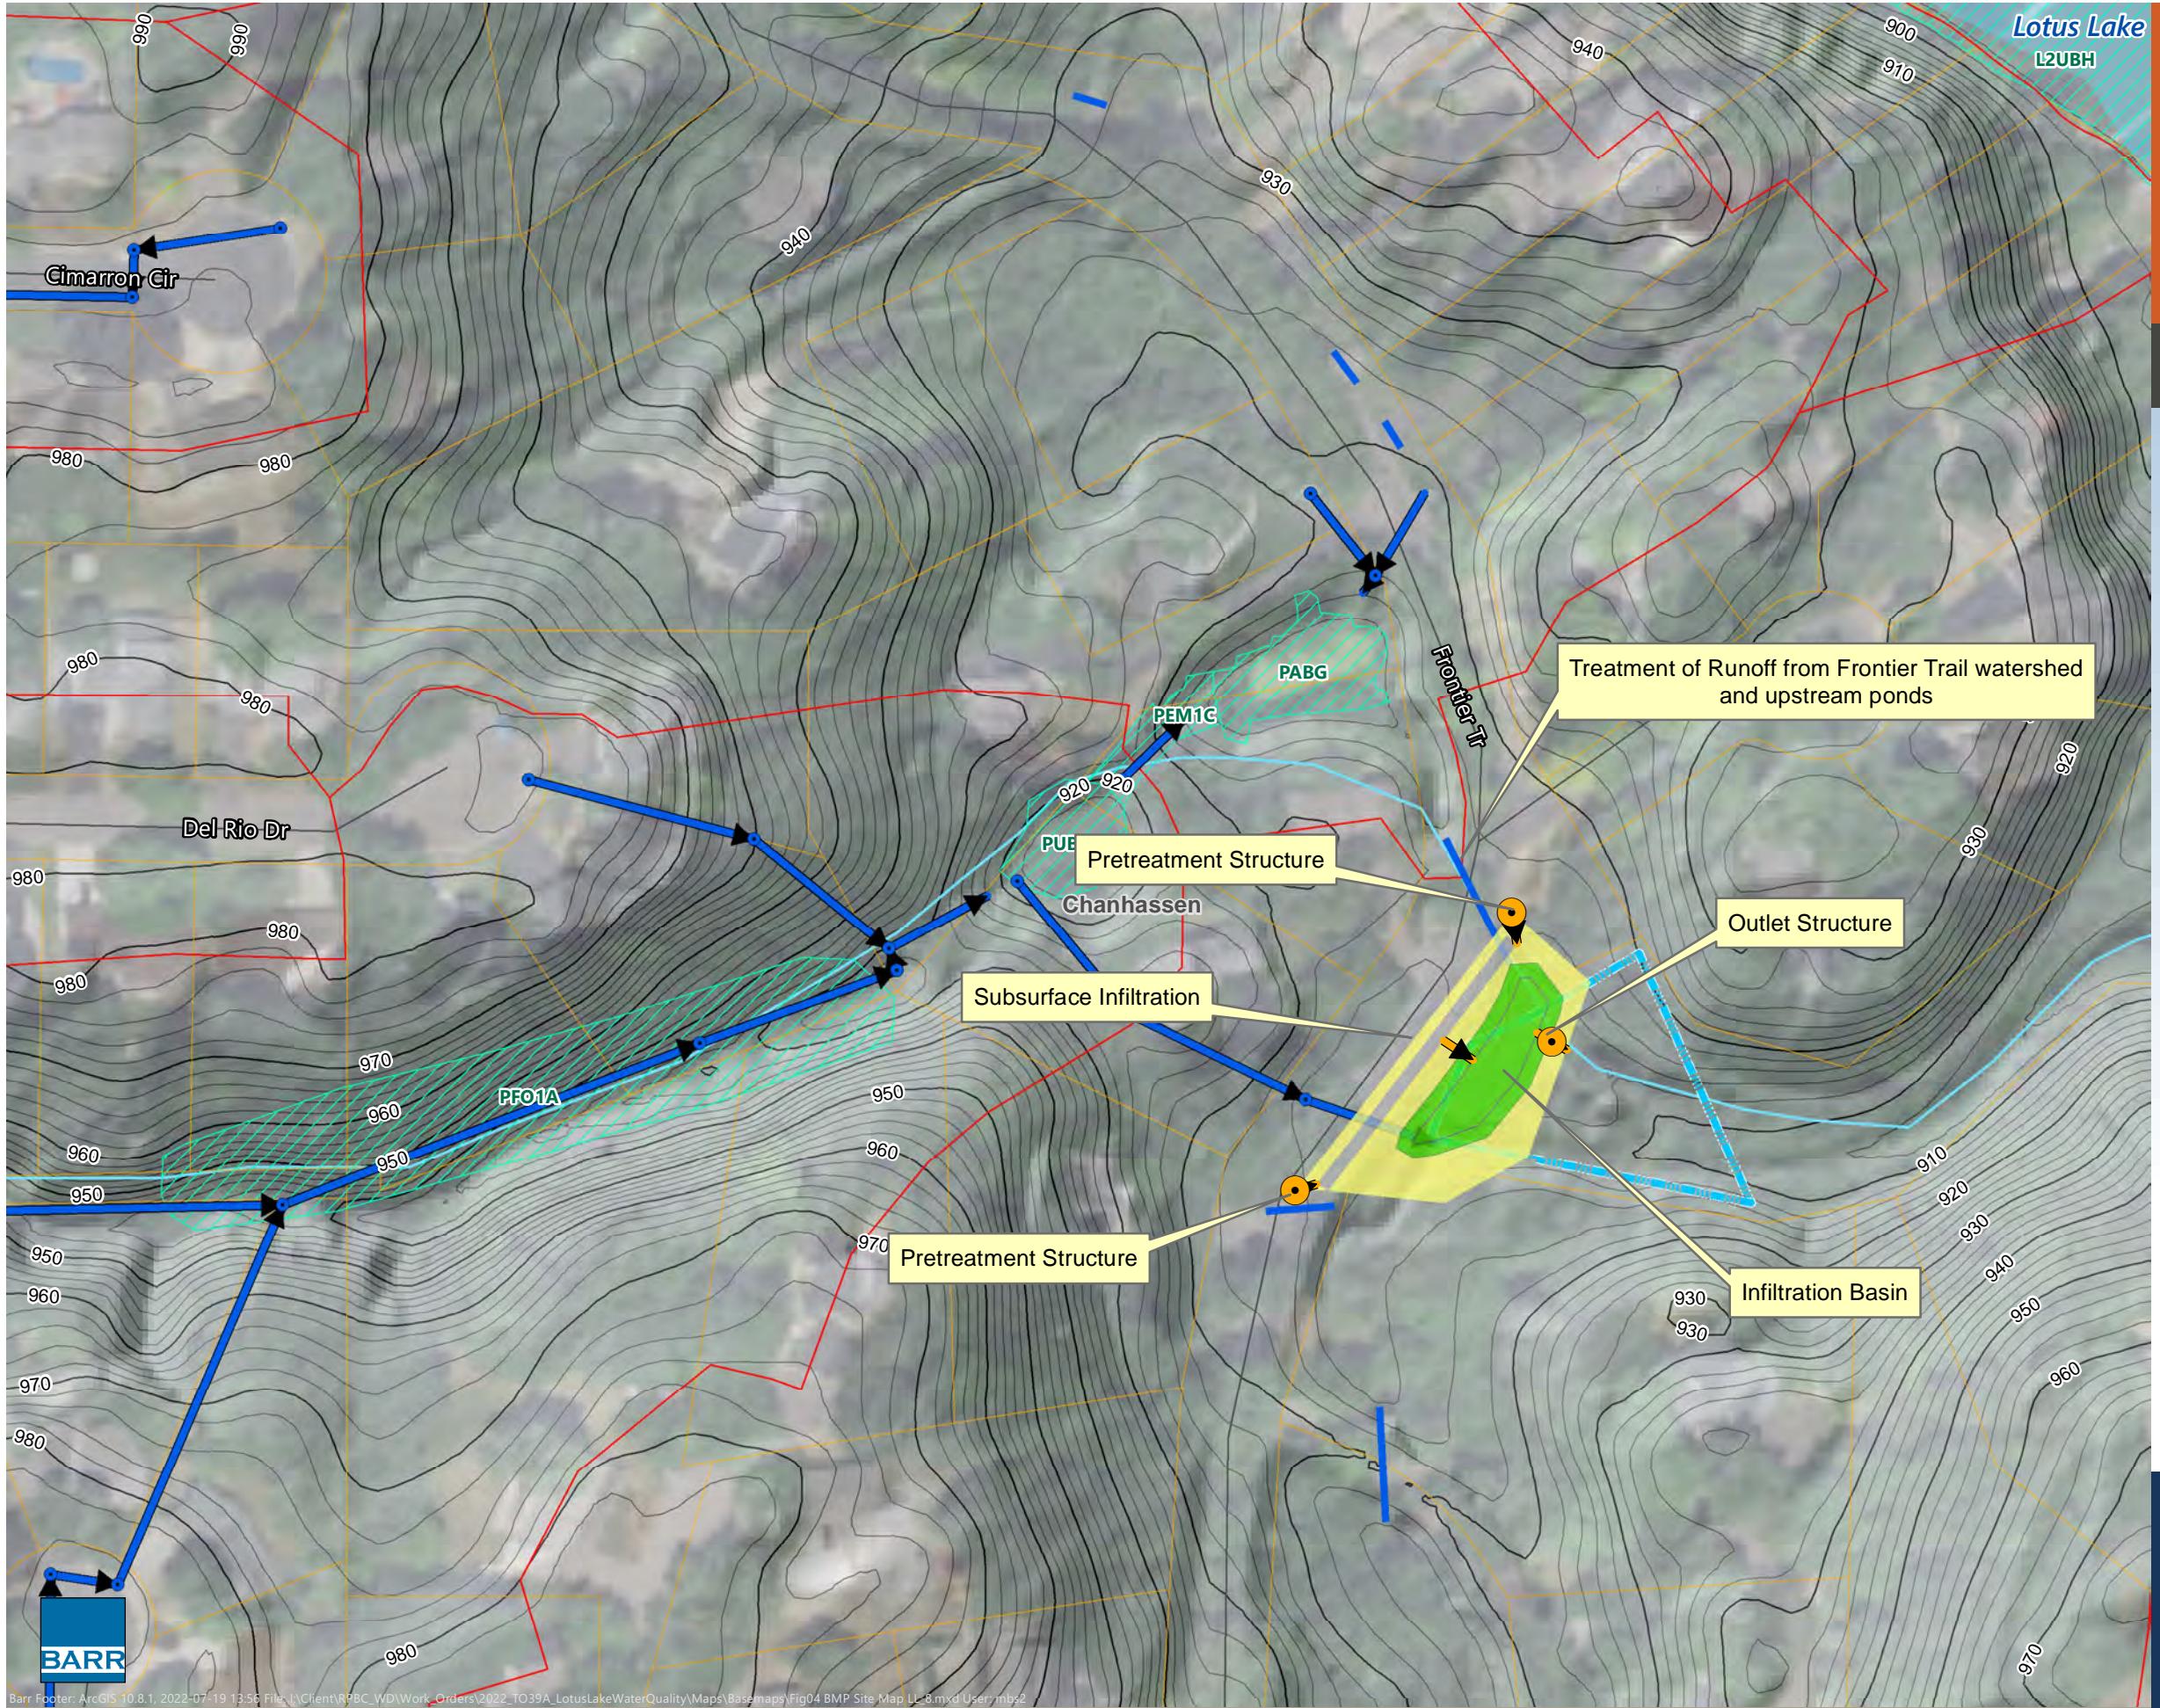
- Site Grading to clear and remove trees (fewer than LL_8a) in the existing channel area closest to the roadway
- Construction of Subsurface Infiltration Chamber with bottom at 909.2, discharge elevation at 910.0, and top height at 912.0, assuming an infiltration rate of 0.2 inch/hr (HSG C)
- Construction of surface infiltration basin with an invert at 909.2, outlet discharge elevation at 910, and overflow berm at 912
- The combined subsurface and surface infiltration basins provide a water quality volume of 3,227 cf below the outlet structures at 910, and additional flood storage of 10,550 cf between the outlet structure and berm overflow
- Tree planting to occur within the infiltration basin along with sedge meadow and pollinator vegetation to restore habitat value and improve biodiversity and soil health
