Feasibility Report

Lotus Lake Water Quality Improvement Project

Prepared for
Riley Purgatory Bluff Creek Watershed District

February 2024 DRAFT

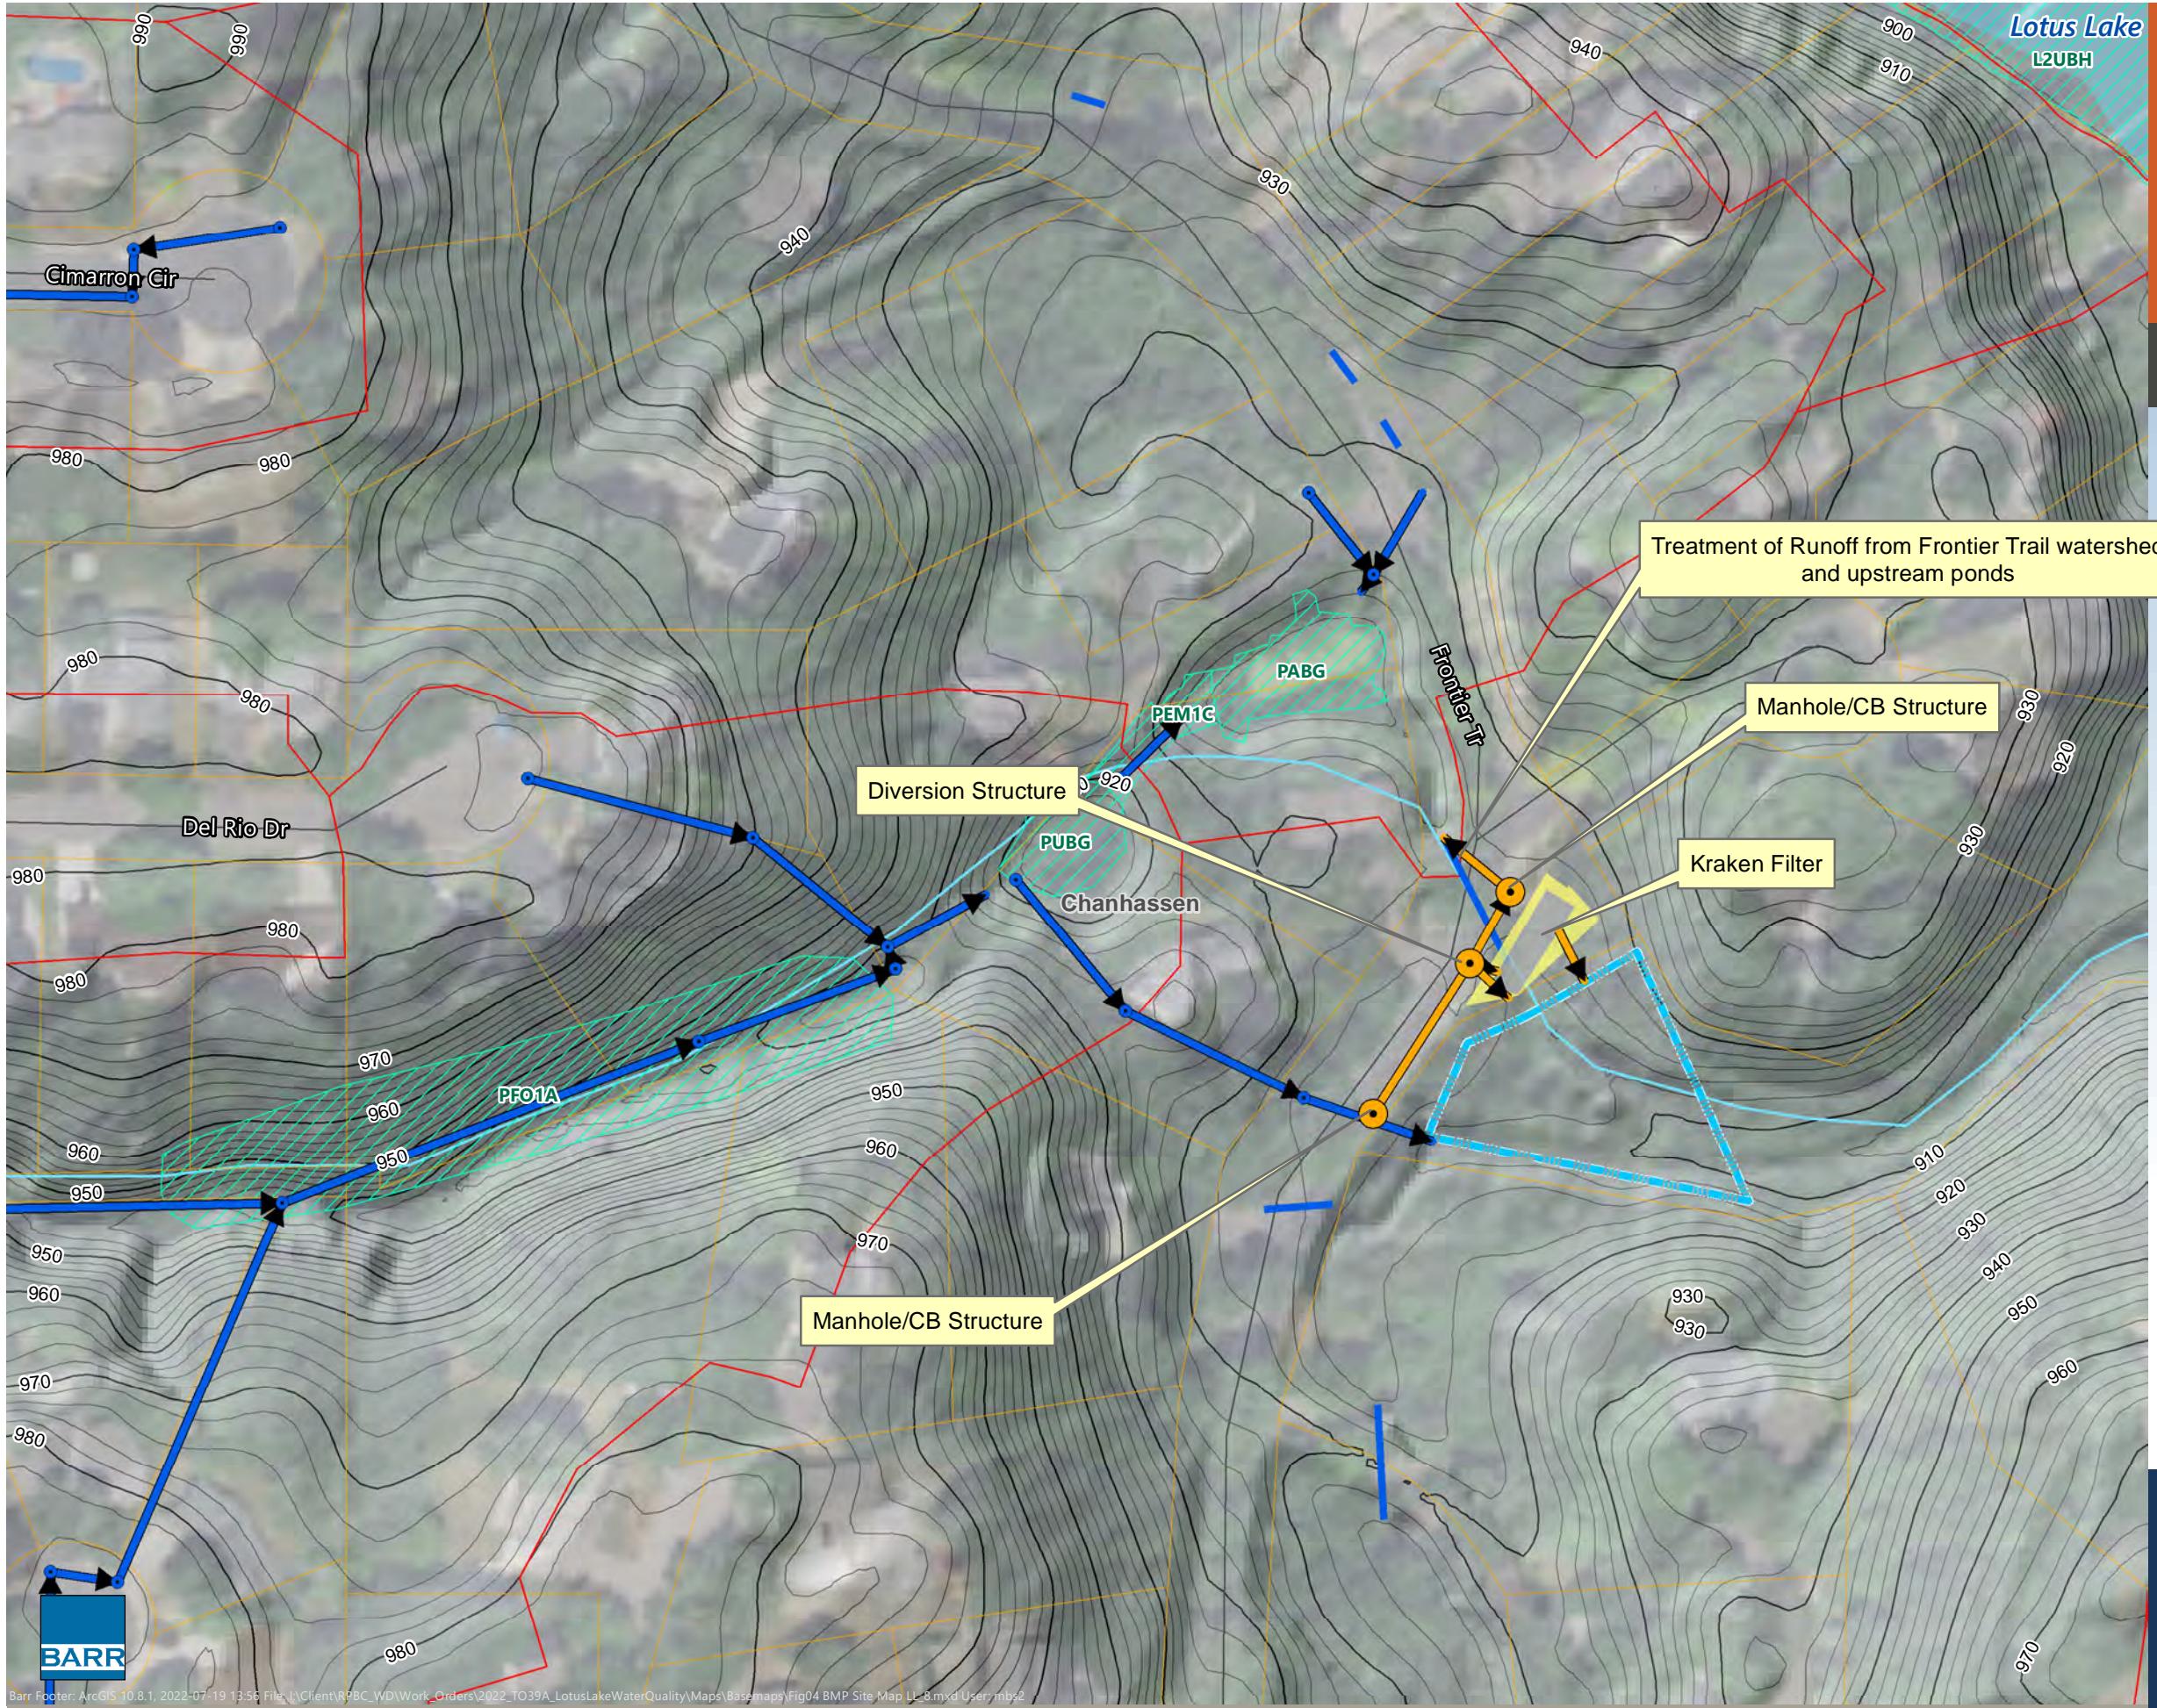
- Evaluation of Kraken Filter, selected to treat able to treat 2.16 cfs. The Kraken filter was selected as it is able to treat a higher flow rate than many other MTDs, with a similar footprint.
- Construction of associated storm sewer to divert low flows through the Kraken Filter, while allowing high flows to bypass.
- Restoration of appropriate native vegetation withing the disturbance extents.

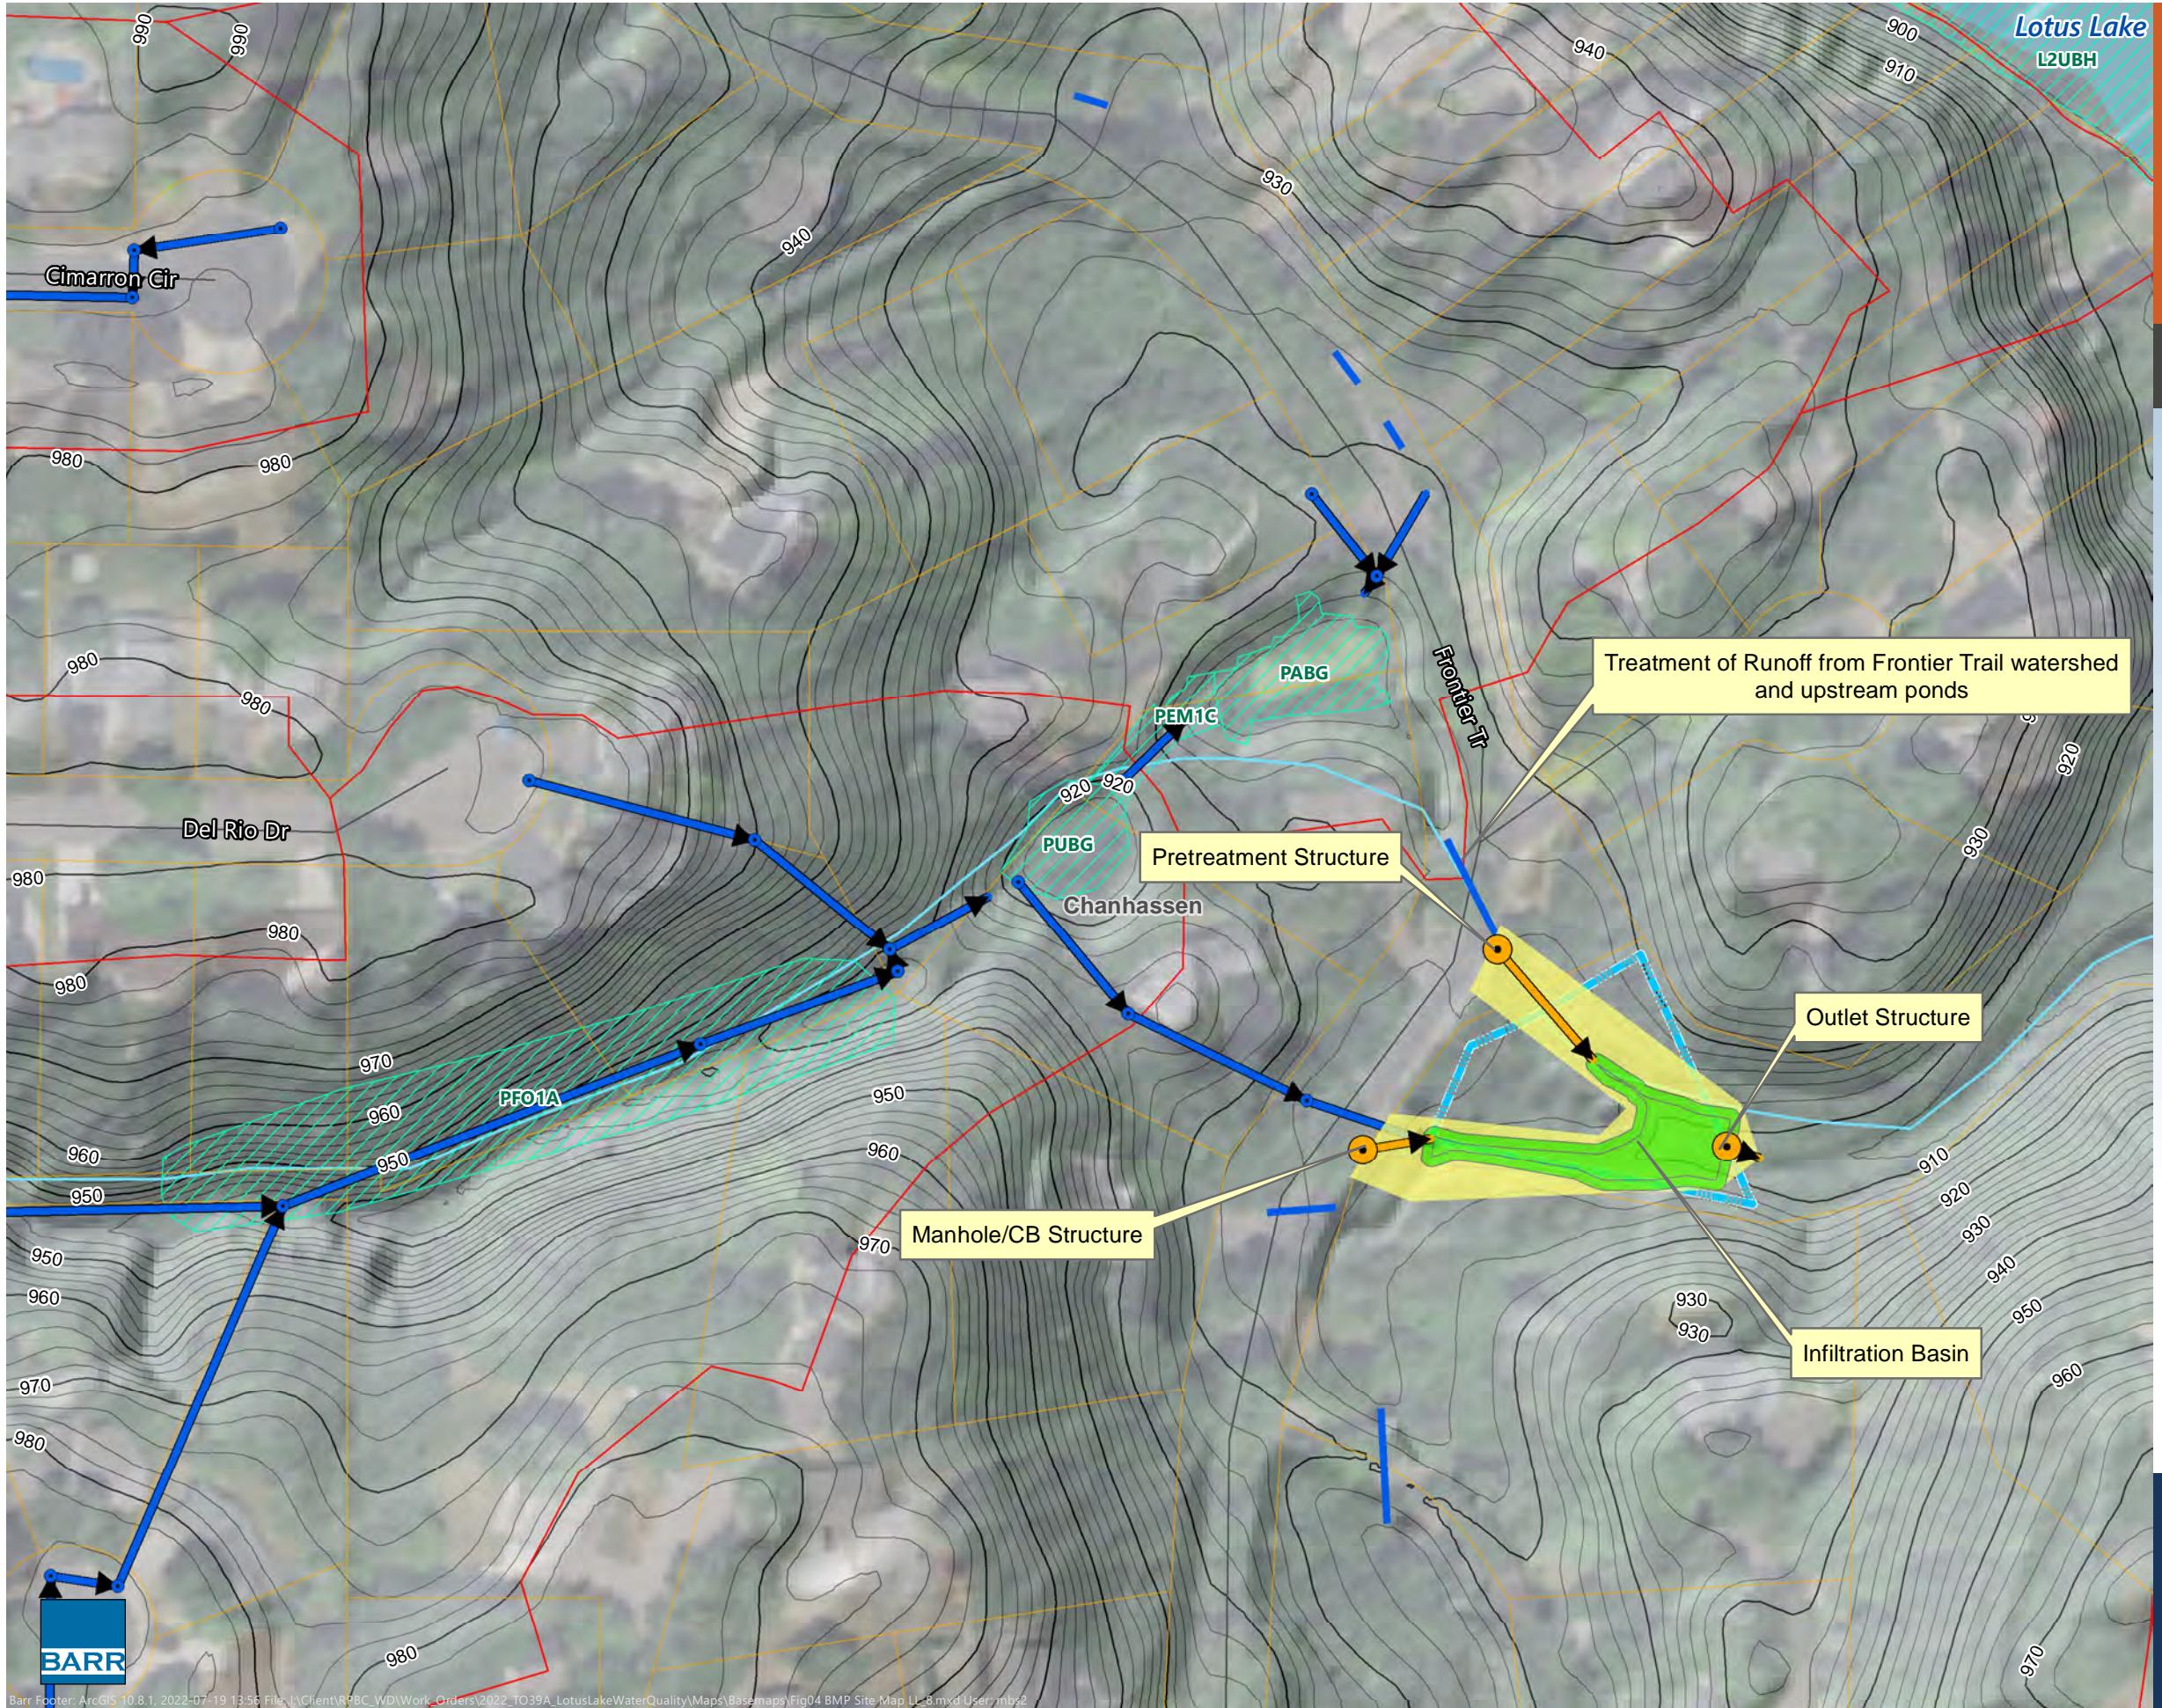
- Site grading to clear and remove trees, however concept attempts to preserve existing trees on the elevated ground within the outlet area between the two inflow channels.
- Construction of infiltration basin with an invert at 909
- Construction of outlet structure with discharge elevation at 910.5
- Construction of overflow berm at downstream end of basin to elevation 912
- Basin provides water quality volume of 6,709 cf below the outlet structure and additional flood storage of 10,864 cf between the outlet structure and berm overflow
- Construction of associated storm sewer
- Restoration of basin with appropriate native vegetation

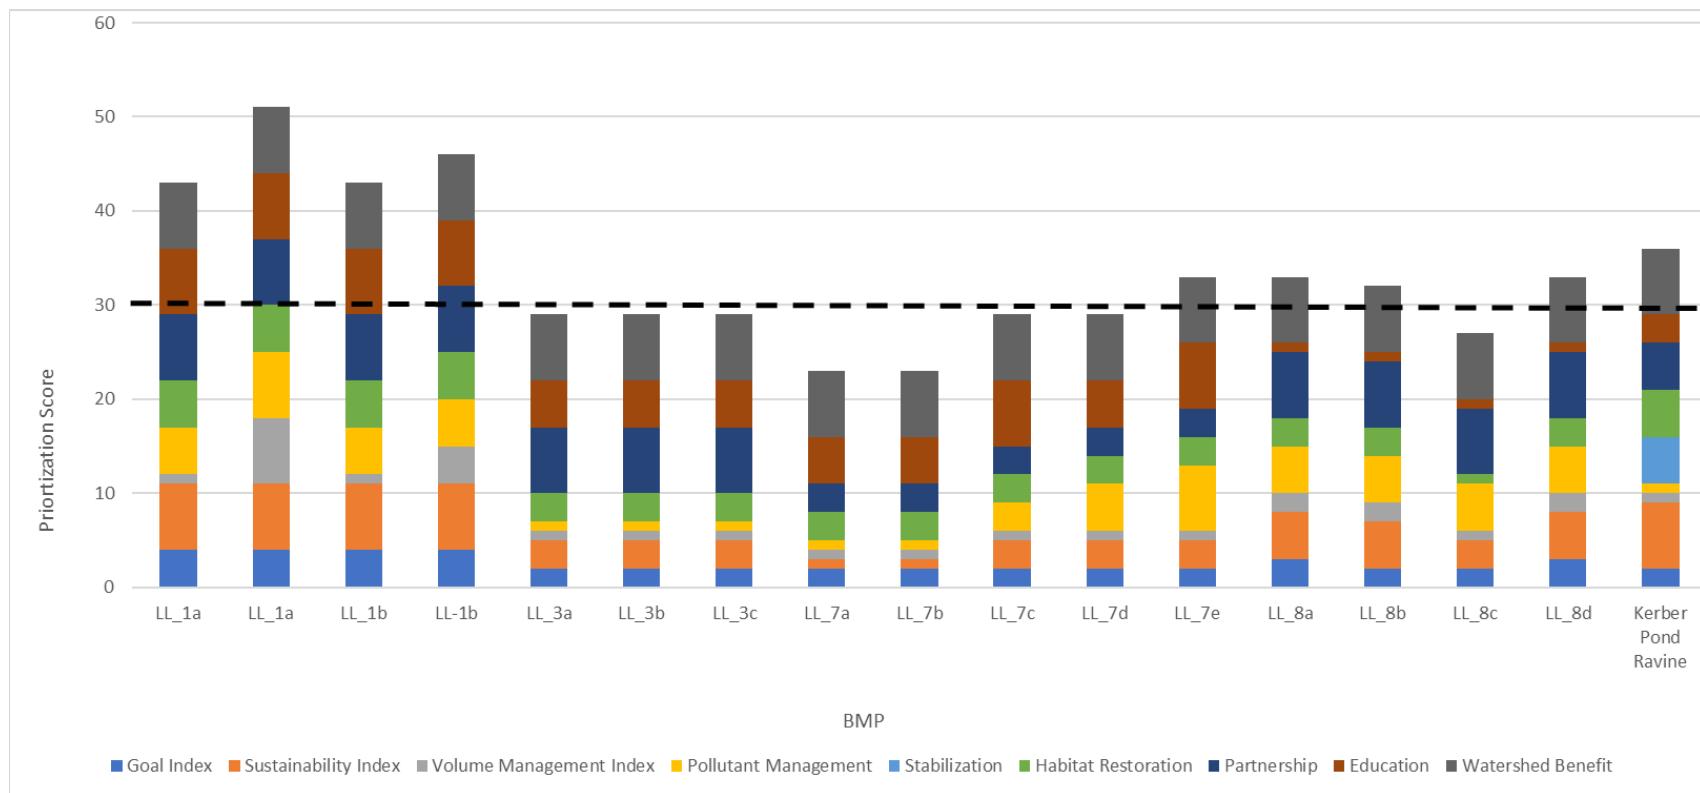
Figure 5-1 Lotus Lake Project Benefit Scores
