# Water Resources Report

RILEY PURGATORY BLUFF CREEK WATERSHED DISTRICT  
2019 ANNUAL REPORT

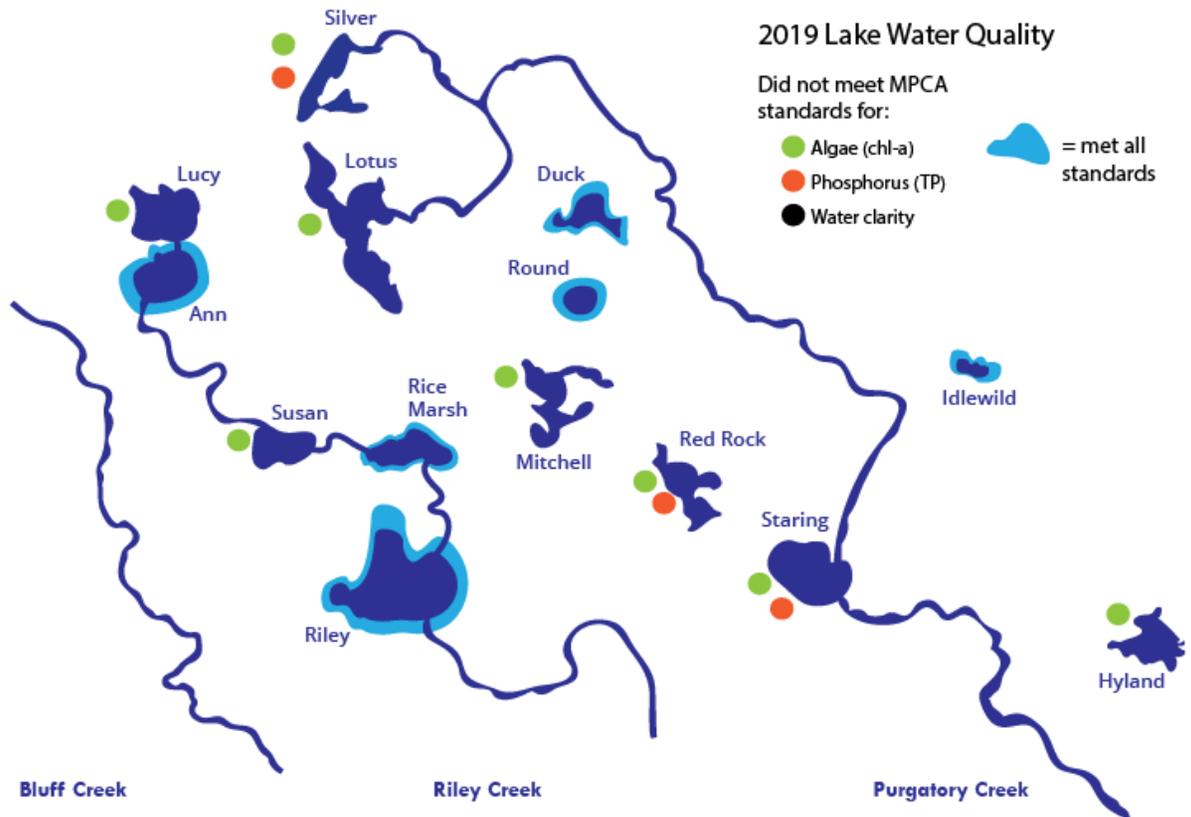
**Figure i 2019 Lake Water Quality**

Summary of the lake water quality data collected in 2019 by the Riley Purgatory Bluff Creek Watershed District as compared to the Minnesota Pollution Control Agency Water Quality Standards. Chlorophyll-a (green), Total Phosphorus (orange), and Secchi Disk depth (black) were assessed during the growing season (June-September) for both 'deep' lakes or lakes >15 ft deep and < 80% littoral area (Lake Ann, Lotus Lake, Lake Riley, and Round Lake), and 'shallow' lakes or lakes <15 ft deep and >80% littoral area (Duck Lake, Hyland Lake, Lake Idlewild, Lake Lucy, Mitchell Lake, Red Rock Lake, Rice Marsh Lake, Staring Lake, Lake Susan, and Silver Lake). The corresponding dots next to each lake indicate which water quality standard was not met and lakes surrounded by blue met all water quality standards.

Surface water samples were collected, analyzed, and compared to standards set by the Minnesota Pollution Control Agency (MPCA) to assess overall lake health. Figure i displays lakes sampled in 2019 that met or exceeded the MPCA lake water quality standards for Chlorophyll-a (Chl-a), Total Phosphorus (TP), and Secchi Disk depth during the growing season (June-September). The MPCA has specific standards for both 'deep' lakes (Lake Ann, Lotus Lake, Lake Riley, and Round Lake) and 'shallow' lakes (Duck Lake, Hyland Lake, Lake Idlewild, Lake Lucy, Mitchell Lake, Red Rock Lake, Rice Marsh Lake, Staring Lake, Lake Susan, and Silver Lake) (MPCA 2016).

Overall lake water quality across the District improved in 2019. This is the first time since data has been collected that all lakes within the watershed district have met the water clarity standard in the same year. Lake Ann, Lake Idlewild, Lake Riley, Rice Marsh Lake, Round Lake, and Duck Lake met all three MPCA standards in 2019; Rice Marsh Lake did not previously meet the Chl-a and TP standards in 2018, but the alum treatment at the end of 2018 cut the concentrations of both in half. Silver Lake met all standards in 2018, but just missed meeting the Chl-a and TP standards in 2019. Red Rock and Staring also all exceeded both the Chl-a and TP standards in 2019. Both Hyland Lake and Mitchell Lake failed to meet any of the standards in 2018 but met

all standards except the Chl-a standard in 2019. Lucy and Susan also did not meet the Chl-a standard 2019. All lakes met the nitrate/nitrite water quality standard and only Lake Idlewild did not meet the chloride standard for lakes.

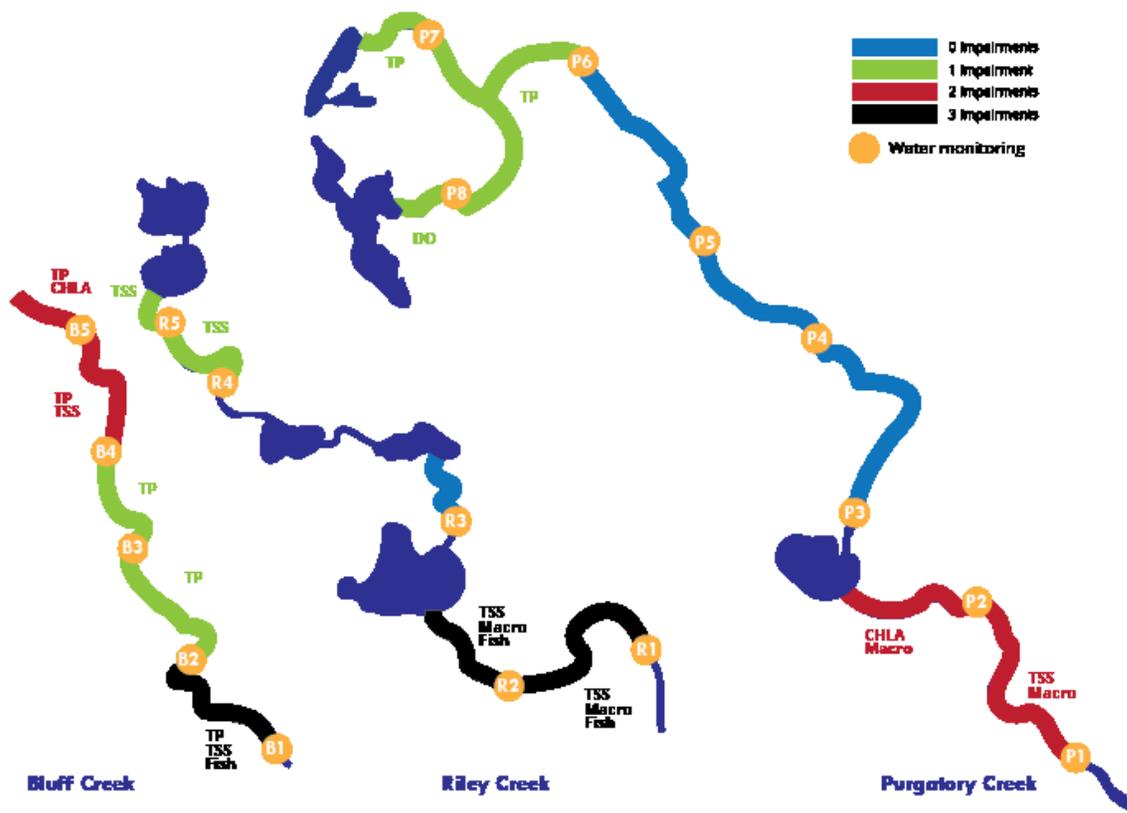
**Figure ii 2019 Stream Water Quality**

Regular creek sampling sites P3, P4, P5 and R3 met all MPCA water quality standards assessed in 2019 (Figure ii). The overall number of water quality standard impairments decreased from 2018 to 2019; Bluff had nine (previously 10), Riley had seven (previously eight), and Purgatory had seven (previously nine). Bluff Creek remained the stream with the most impaired water quality, as previously seen between 2015-2018, with TP impairments at all sites, as well as TSS impairments at two sites, a Chl-a impairment at B5, and a fish impairment at B1. Once again, TP was the water quality standard causing the most impairments in 2019 with seven of the 18 sites not meeting the standard (summer average < 0.1 mg/L). TSS impairments decreased from nine impairments in 2018 to seven 2019. The dissolved oxygen standard (daily minimum of 4mg/L) was impaired at only site P8. All sites met the pH water quality standard (< 9su and > 6su). Similar to 2016-2018, P2 did not meet the Chl-a standard (summer average < 18ug/L). Macroinvertebrate impairments by the MPCA were added to this year's analysis and included lower Purgatory and Riley Creek.

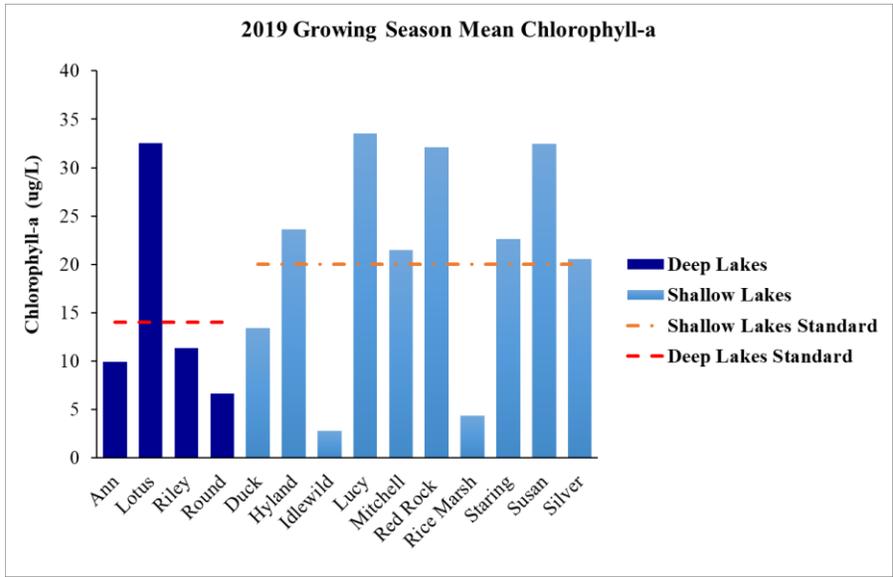
**Figure 2 2019 Lake Growing Season Mean Chlorophyll-a**

Four lakes sampled within the District are categorized as ‘deep’ by the MPCA (>15ft deep, < 80% littoral area): Lake Ann, Lotus Lake, Lake Riley, and Round Lake. The MPCA standard for Chl-a in deep lakes (< 14ug/L) was met by Lake Ann, Lake Riley and Round Lake. Similar to 2018, Lotus Lake did not meet the standard with Chl-a average concentrations were more than twice the MPCA standard at 33ug/l (an increase of 10ug/L from 2018). The remainder of the lakes sampled in 2019 are categorized as ‘shallow’ by the MPCA (<15ft deep, >80% littoral area): Duck Lake, Hyland Lake, Lake Lucy, Mitchell Lake, Red Rock Lake, Rice Marsh Lake, Staring Lake, Lake Susan, and Silver Lake. Water quality metrics on Lake Idlewild, classified as a high-value wetland, were compared to MPCA shallow lake standards. The water quality standard for shallow lakes (< 20ug/L) was met by Duck Lake, Lake Idlewild, and Rice Marsh Lake in 2019. Lake Lucy, Mitchell Lake, Red Rock Lake, Rice Marsh Lake, and Staring Lake did not meet the standard. Hyland Lake and Lake Susan also did not meet the MPCA standard but had significantly reduced chlorophyll levels from 2018.

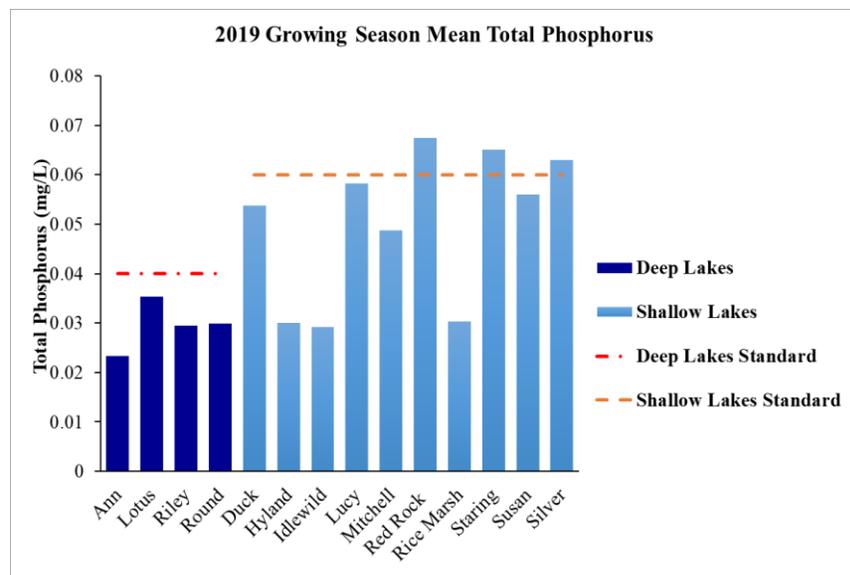
**Figure 3 2019 Lakes Growing Season Mean Total Phosphorus**

The TP growing season averages for all lakes sampled within the District in 2019 are shown in **Figure 3**. The MPCA standard for TP in deep lakes (<0.040mg/L) was met by Lake Ann, Lake Riley, Round Lake, and Lotus Lake. TP concentrations in Lotus Lake, which had failed to meet the standard in 2018, decreased by 20% in 2019. TP levels in both Lake Riley and Lake Ann increased slightly from 2018 (increases of 0.006 mg/L and 0.003 mg/L, respectively). The increase in Lake Riley represents a reversal of a trend of decreasing TP levels year-to-year since the application of the aluminum sulfate treatment in 2016. For shallow lakes, the MPCA TP standard (<0.060mg/L) was met by Duck Lake, Hyland Lake, Lake Idlewild, Lake Lucy, Mitchell Lake, Rice Marsh Lake, and Lake Susan in 2019. Despite having exceeded the standard in 2018, Hyland Lake, Lake Mitchell, Lake Susan and Rice Marsh Lake met the standard in 2019 due to decreases in TP levels (0.05mg/L, 0.03mg/L, 0.03mg/L, and 0.06mg/L, respectively). Red Rock Lake TP levels were down slightly from 2018, but still exceeded the standard. Silver Lake, Duck Lake, and Staring Lake saw increases in TP levels from 2018; Silver and Staring Lake both exceeded the standard despite meeting it 2018.

Overall, 11 of the 14 lakes sampled met the MPCA total phosphorus standard for their lake classification in 2019: Lake Ann, Duck Lake, Lake Idlewild, Lake Lucy, Lake Riley, Round Lake, Lotus Lake, Hyland Lake, Mitchell Lake, Rice Marsh Lake, and Lake Susan. This represents an increase from eight of 14 sampled lakes that met the standard in 2018.

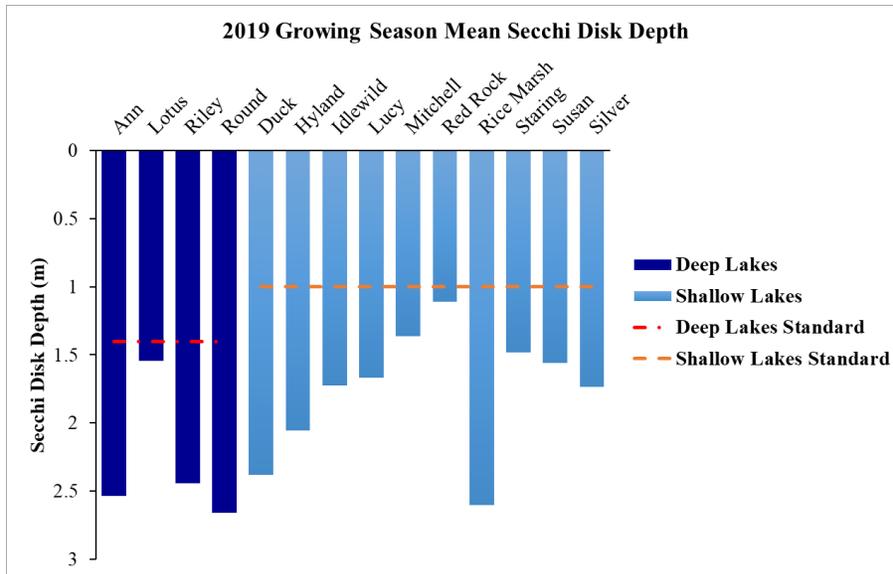
**Figure 4 2019 Lakes Growing Season Mean Secchi Disk Depth**

The 2019 secchi disk growing season means for all District lakes sampled are shown in **Figure 4**. The MPCA standard for secchi disk depth/water clarity for deep lakes (> 1.4m) was met by all deep lakes in the District (Ann, Lotus, Riley, and Round). Ann, Lotus, and Riley all decreased in clarity (1.01m, 0.18m, and 0.98m respectively). Round Lake increased 0.25m in average clarity. For shallow lakes, all ten lakes monitored achieved the MPCA secchi disk depth water quality standard (>1m), an increase from eight of ten lakes monitored in 2018. All the shallow lakes except Duck, Idlewild, and Silver, which experienced minor decreases, showed improvements in water clarity. Particularly notable were large increases in clarity on Hyland (1.965m) and Rice Marsh Lakes (1.012m), which received alum treatments in 2019 and 2018, respectively.

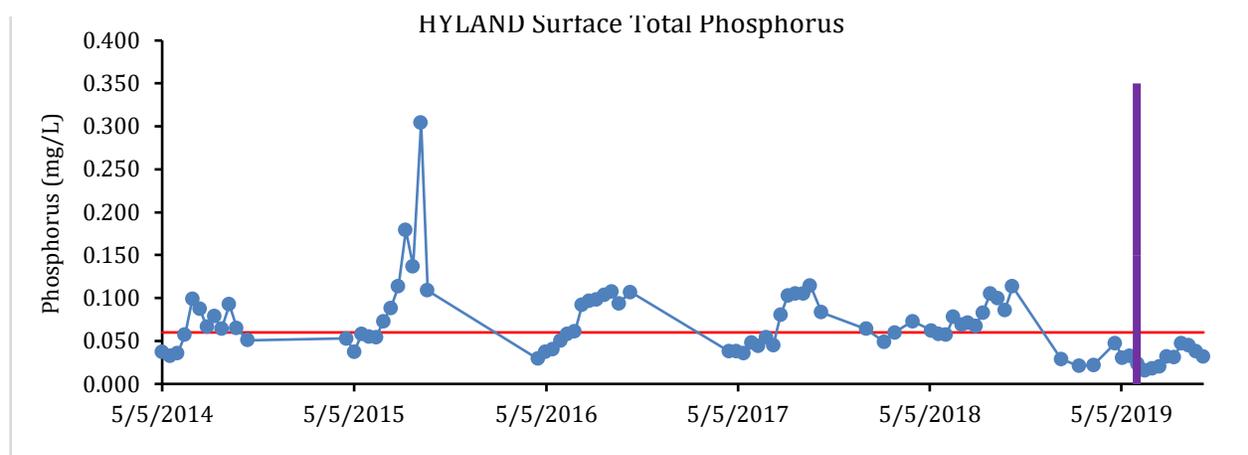
**Figure 5 Hyland Lake Total Phosphorus Levels pre- and post- Alum Treatment**

Total phosphorus levels (TP) in Hyland Lake between May 5, 2014 and October 10, 2019. The aluminum sulfate (Alum) treatment carried out in June 3, 2019 (indicated by vertical bar). The graph displays TP levels (mg/L) measured from 2m composite samples taken at the lake surface and the MPCA water quality standard for TP is represented by the horizontal red line (0.06mg/L).

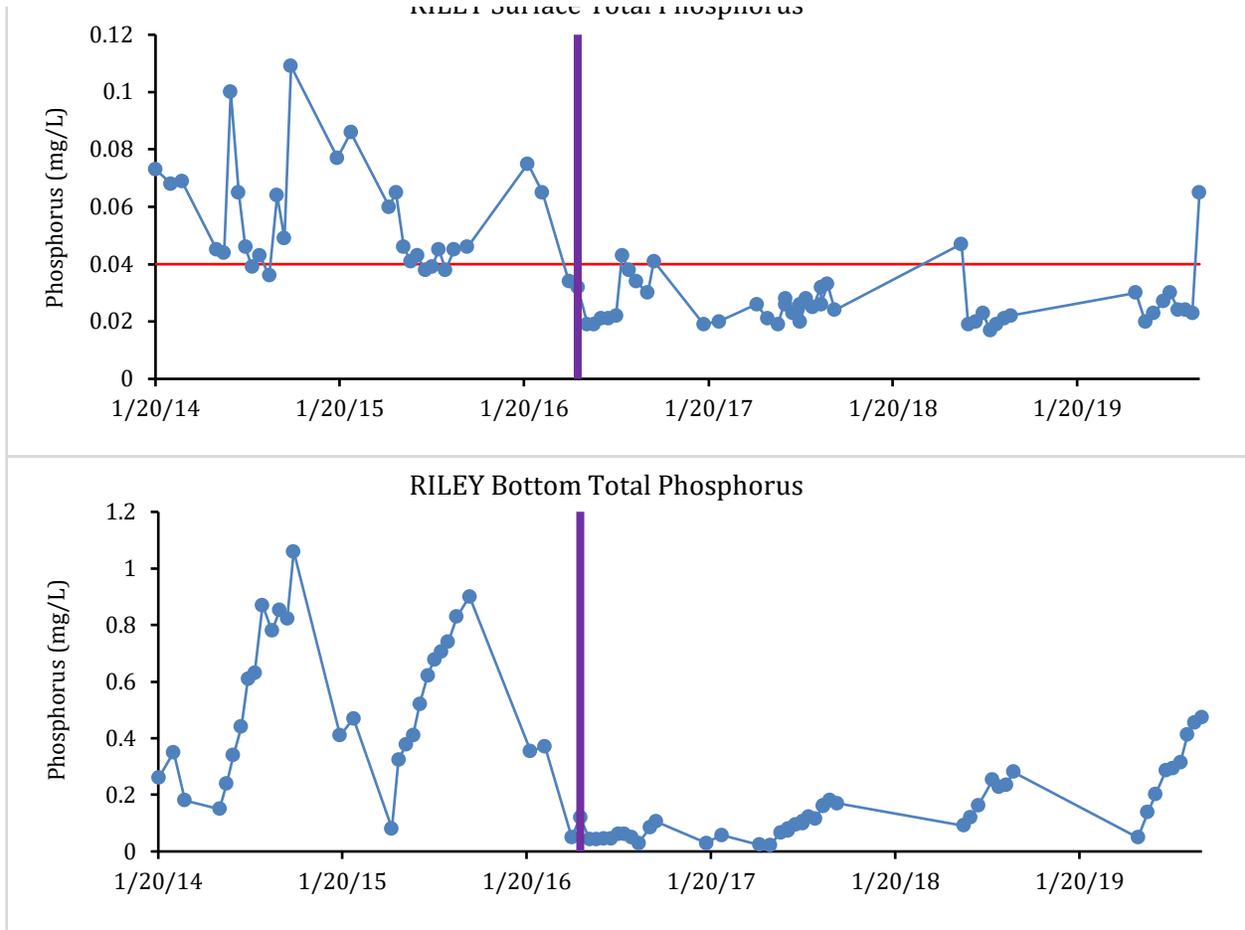
**Figure 6 Lake Riley Total Phosphorus Levels pre- and post- Alum Treatment**

Total phosphorus levels (TP) in Lake Riley between January 20, 2014 and September 19, 2019. The aluminum sulfate (Alum) treatment carried out in May 5, 2016 (indicated by vertical bar). The upper graph displays TP levels (mg/L) measured from 2m composite samples taken at the lake surface and the lower graph displays the TP levels (mg/L) measured from samples taken 0.5-1m above the sediment near the deepest point in the lake. The MPCA water quality standard for TP is represented in the upper graph by the horizontal red line (0.04mg/L).

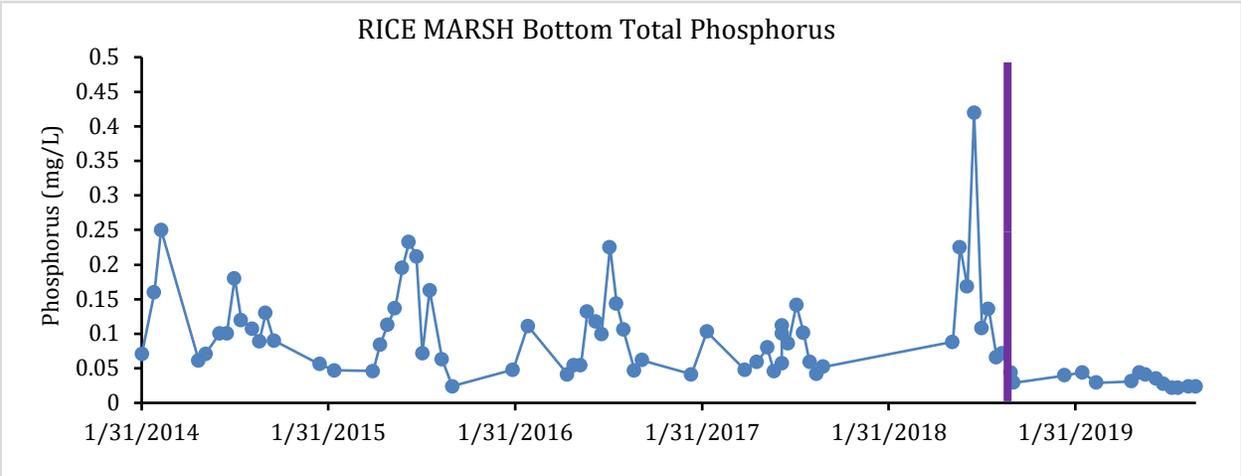
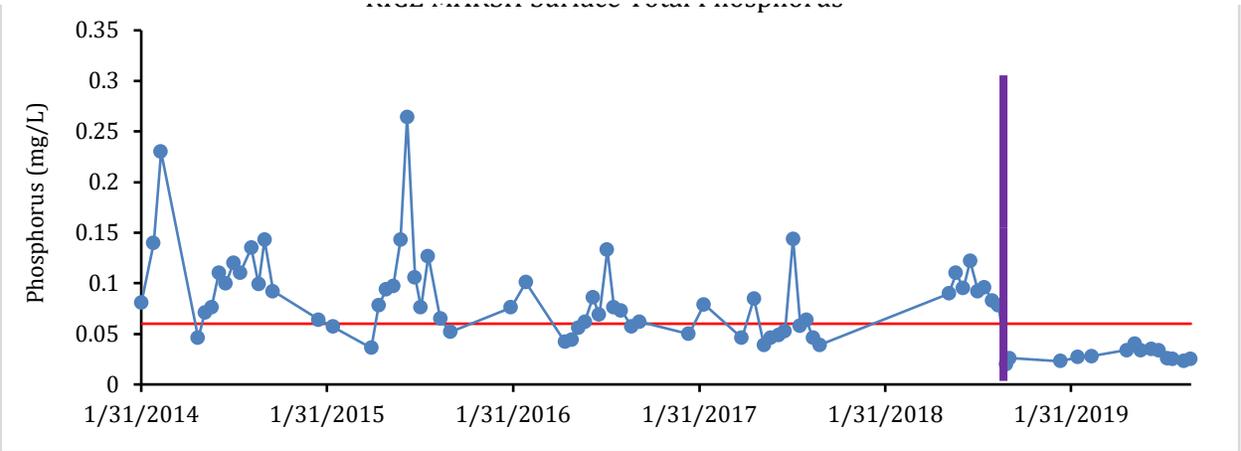
**Figure 7 Rice Marsh Lake Total Phosphorus Levels pre- and post- Alum Treatment**

Total phosphorus levels (TP) in Rice Marsh Lake between January 31, 2014 and September 23, 2019. The aluminum sulfate (Alum) treatment carried out in September 21, 2018 (indicated by vertical bar). The upper graph displays TP levels (mg/L) measured from 2m composite samples taken at the lake surface and the lower graph displays the TP levels (mg/L) measured from samples taken 0.5-1m above the sediment near the deepest point in the lake. The MPCA water quality standard for TP is represented in the upper graph by the horizontal red line (0.06mg/L).

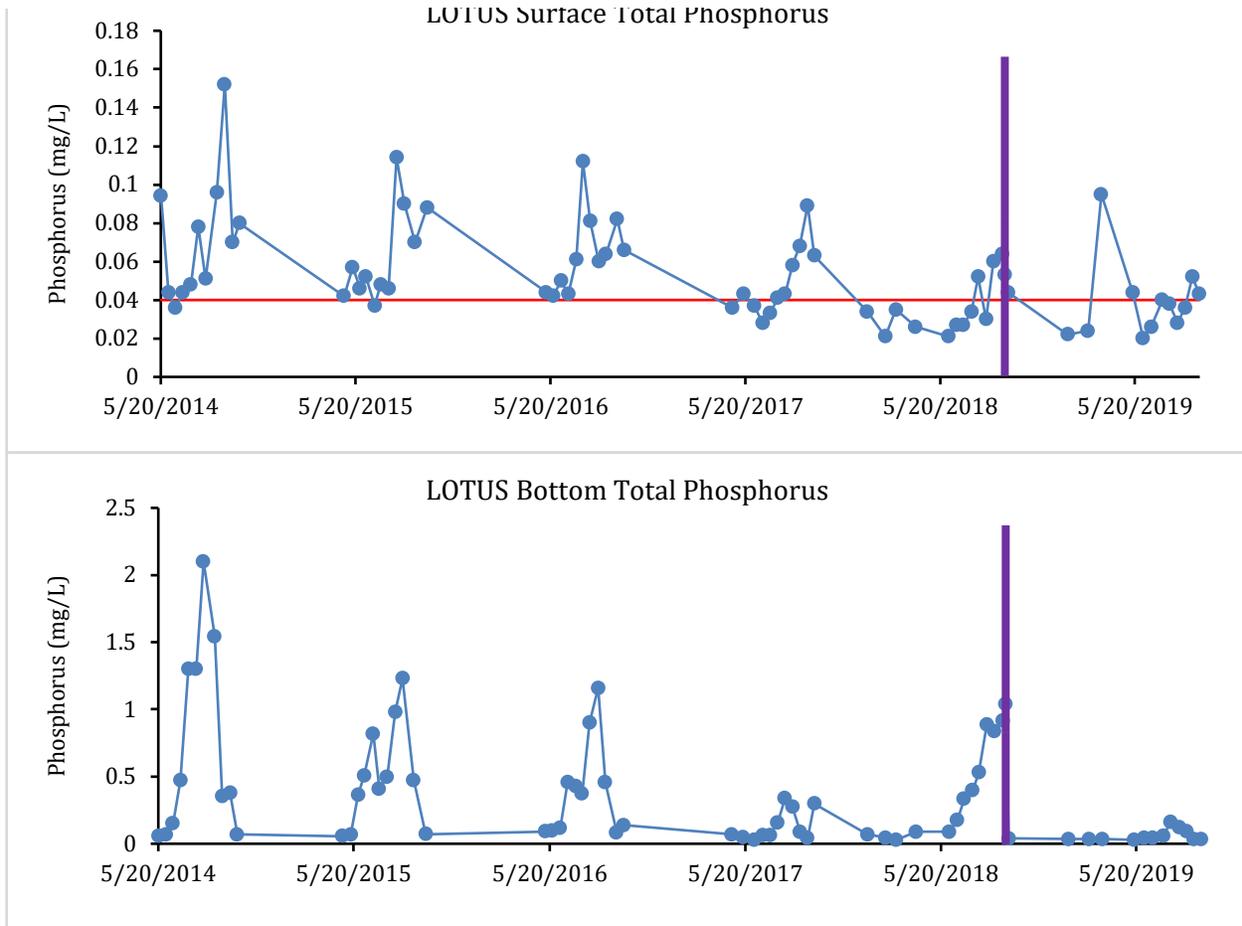
**Figure 8 Lotus Lake Total Phosphorus Levels pre- and post- Alum Treatment**

Total phosphorus levels (TP) in Lotus Lake between May 6, 2014 and September 18, 2019. The aluminum sulfate (Alum) treatment carried out in September 18, 2018 (indicated by vertical bar). The upper graph displays TP levels (mg/L) measured from 2m composite samples taken at the lake surface and the lower graph displays the TP levels (mg/L) measured from samples taken 0.5-1m above the sediment near the deepest point in the lake. The MPCA water quality standard for TP is represented in the upper graph by the horizontal red line (0.04mg/L).

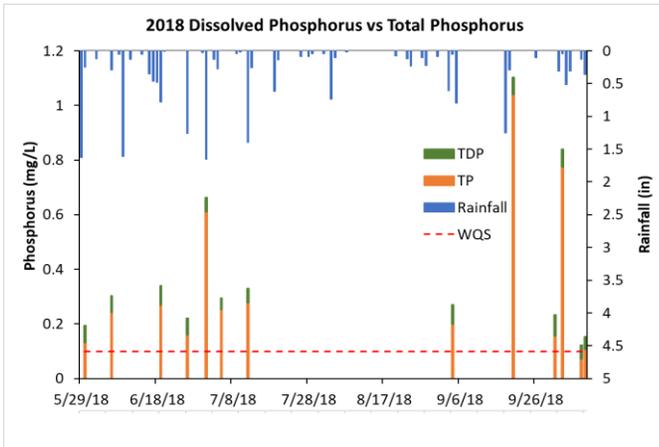
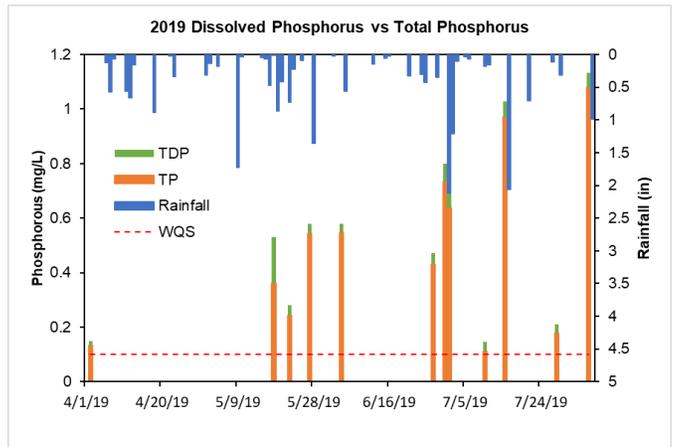
**Figure 11 2018 and 2019 Upper Riley Creek Phosphorus**

The Total Dissolved Phosphorus (TDP) and Total Phosphorus (TP) concentrations (mg/L) from Riley Creek under Powers Blvd from 2018 and 2019 automated, level triggered, flow-paced samples. Dashed line represents the Minnesota Pollution Control Agency standard for TP in class 2B creeks ( $\leq 0.1\text{mg/L}$ ).

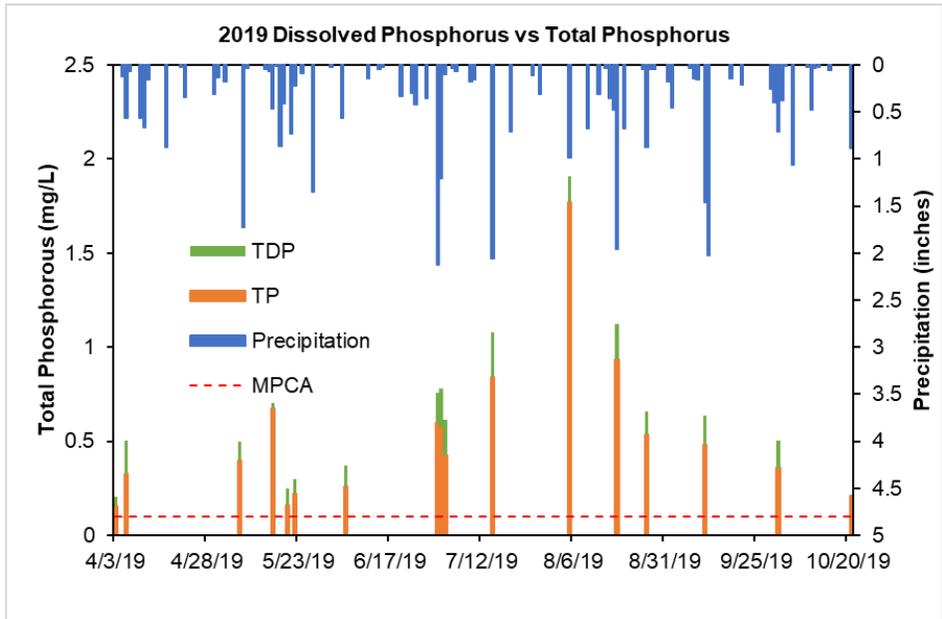
**Figure 12 2019 Upper Bluff Creek Phosphorus**

The Total Dissolved Phosphorus (TDP) and Total Phosphorus (TP) concentrations (mg/L) from Bluff Creek under Galpin Blvd from 2019 automated, level triggered, flow-paced samples. Dashed line represents the Minnesota Pollution Control Agency standard for TP in class 2B creeks ( $\leq 0.1$  mg/L).

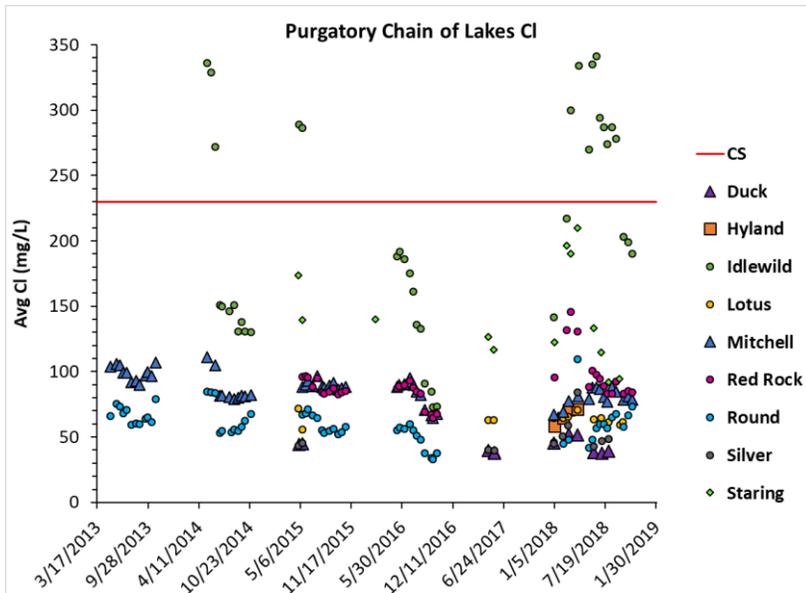
**Figure 14 2013-2019 Chloride Levels within the Purgatory Chain of Lakes**

All chloride sampling results (mg/L) on the Purgatory Chain of Lakes from 2013-2019. The MPCA chloride chronic standard for class 2B waters (230mg/L) is indicated by the red line.

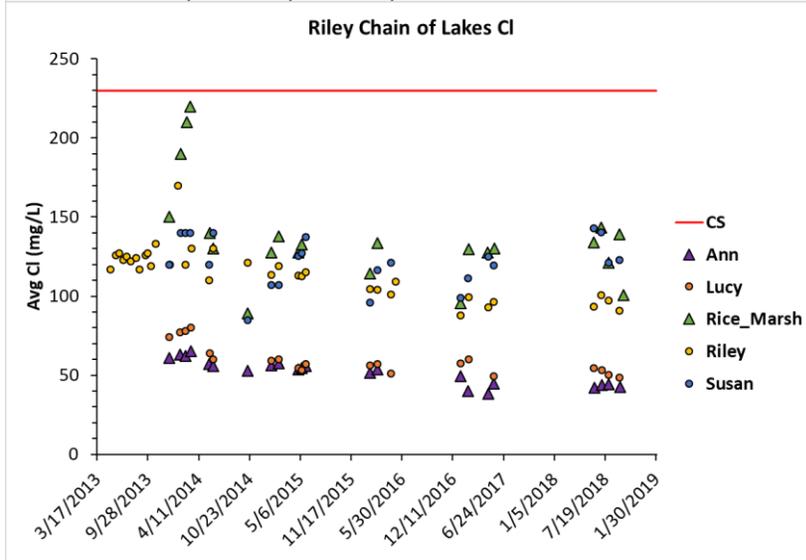
**Figure 15 2013-2019 Chloride Levels within the Riley Chain of Lakes**

All chloride sampling results (mg/L) on the Riley Chain of Lakes from 2013-2019. The MPCA chloride chronic standard for class 2B waters (230mg/L) is indicated by the red line.

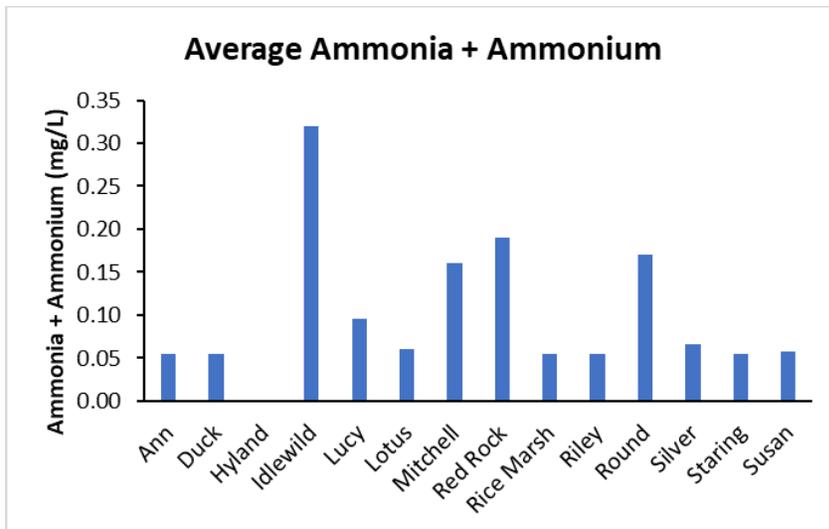
**Figure 18 2019 Lakes Summer Average Ammonia+Ammonium**

Average levels of ammonia+ammonium from samples taken on each lake during regular sampling within the growing season (June-September).

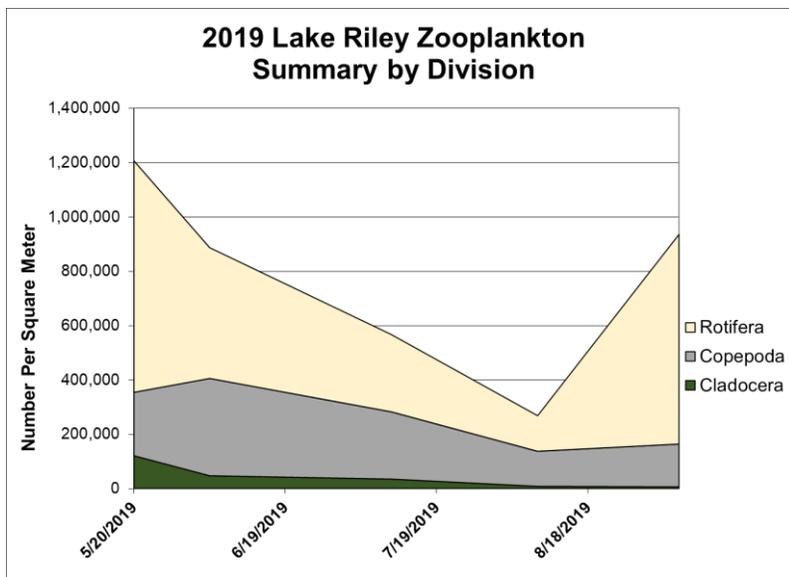
**Figure 19 2019 Lake Riley Zooplankton Counts (#/m<sup>2</sup>)**

In 2019, all three groups of zooplankton were captured in Lake Riley (8 Exhibits C), however only 5.6% of the population was comprised of Cladocera. As expected, rotifers were the most abundant zooplankton sampled (**Figure 19**). The number of rotifers identified in 2019 steadily decreased over sampling events to a low point in August, followed by a sharp increase in September. Copepod numbers increased between the first two sampling events, then followed roughly the same pattern as Rotifera. Cladoceran numbers decreased over the course of the season. Total Cladoceran counts in 2019 were up slightly from 2018, but still less than what was seen in 2016 and 2017 (around 450 thousand). This reduction may be due to the continuing increase in water clarity caused by alum treatment, which leads to increased predation on zooplankton populations. Additionally, zebra mussels were discovered in 2018 which could also be contributing to the increase in water clarity and are removing phytoplankton (Cladoceran food source). The most numerous Cladocera found in Riley was *Chydorus sphaericus*, a species tolerant of widely ranging environmental conditions.

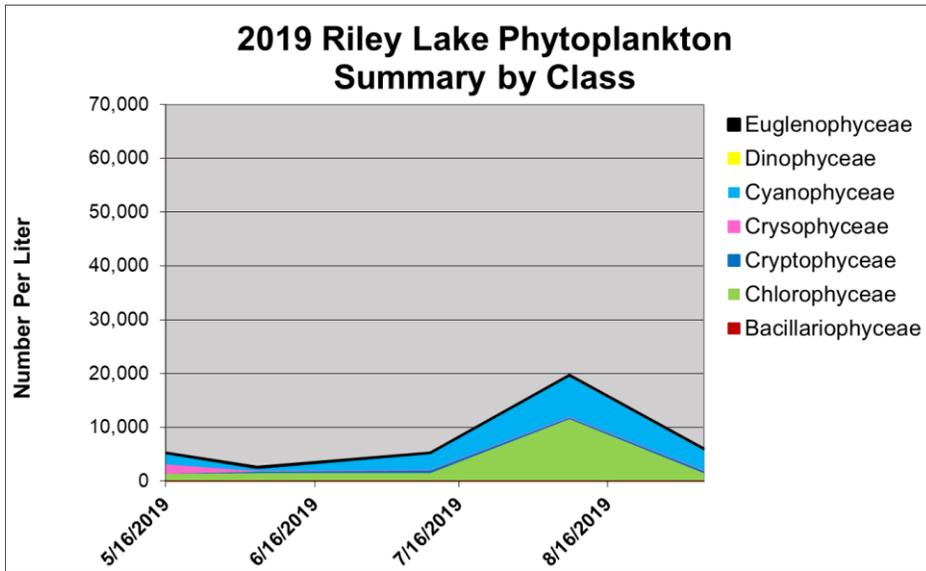
**Figure 20 2019 Lake Riley Phytoplankton Abundance (#/L) by Class.**

During the summer of 2019, staff collected five phytoplankton samples on Lake Riley (8 Exhibits D). The seasonal abundance of phytoplankton is presented in **Figure 20**. The dominant phytoplankton in May, July, and September were Cyanophyceae cells which made up 41%, 59%, and 63% of the total phytoplankton abundance (TPA), respectively. Cyanophytes, also known as cyanobacteria or blue-green algae, are a group of free-living bacteria that obtain energy through photosynthesis. Under favorable conditions large, toxic blooms of cyanobacteria can occur. *Aphanizomenon sp.* was the predominant cyanobacteria found and is known as a possible toxin producer that may potentially produce cylindrospermopsin, anatoxins, and saxitoxins. These toxic compounds have the potential to pose serious threats to human and environmental health via contamination of drinking water, recreational exposure to waterborne toxins and possible accumulation of toxins in the food-web. Chlorophyceae dominated the phytoplankton population in June and August (60% and 59% TPA, respectively).

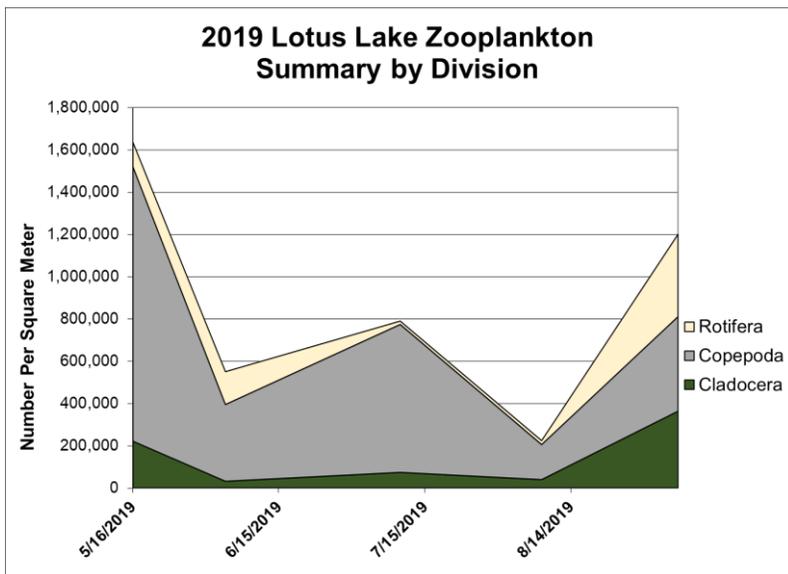
**Figure 21 2019 Lotus Lake Zooplankton Counts (#/m²)**

In 2019, all three groups of zooplankton were present in Lotus Lake (8 Exhibits C). In 2019 Rotifers were the least abundant zooplankton sampled (Figure 21) which is in contrast with 2018 when Rotifers were the most abundant overall. Copepod numbers varied significantly between sampling events throughout 2019. Cladoceran numbers began at 210 thousand in May before decreasing to less than 100 thousand for the June, July, and August. Cladocerans reached their highest numbers in September, at 362 thousand. The spring Cladocera numbers can be attributed to an abundance of *Daphnia galeata*, while *Daphnia retrocurva* was dominant in late fall. *Daphnia retrocurva* is known for its large curved helmet it develops in late spring-to-summer to reduce predation by planktivorous fish and invertebrates.

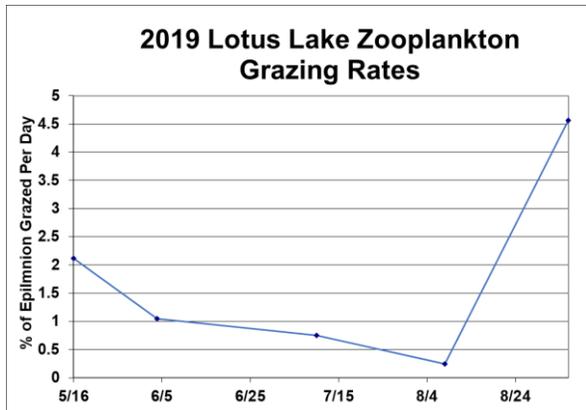
Large Cladocera consume algae and, if enough are present in a lake, they have the potential to improve water quality. The estimated epilimnetic grazing rates observed in 2018 ranged from 6% to 19%. In 2019 the rates were very low ranging from near 0% to under 5% (Figure 22). As expected, grazing rates followed a similar trend to what was seen in the population fluctuations; the largest grazing rate occurred on in September when the spike in *Daphnia retrocurva* numbers occurred.

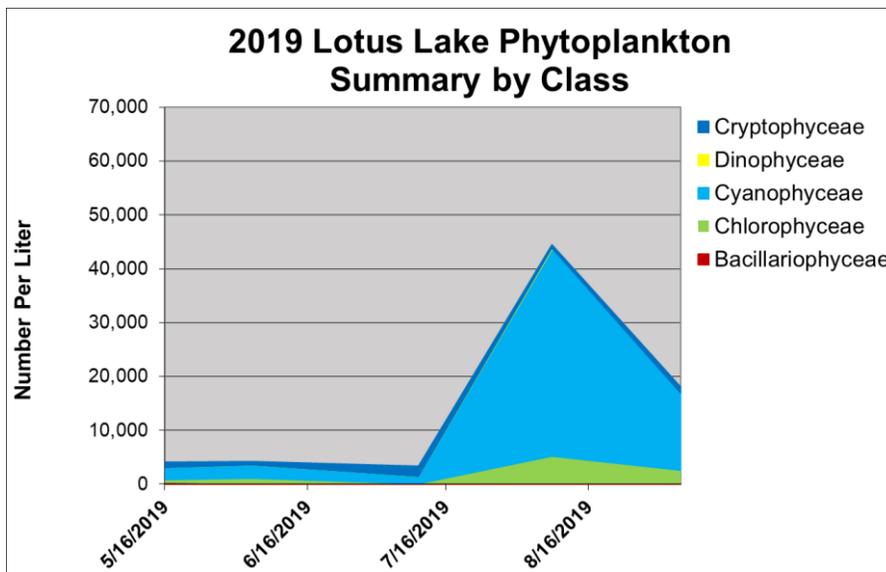
Figure 23 2019 Lotus Lake Phytoplankton Abundance (#/L) by Class.

During the summer of 2019, staff collected five phytoplankton samples on Lotus Lake (8 Exhibits D). The abundance of phytoplankton across all sampling dates is presented in Figure 23. In July *Cryptomonas erosa* was briefly dominant, followed closely by Cyanobacteria (55% and 43% total phytoplankton abundance, respectively). *Cryptomonas* spp. are not known to produce toxins and are an important food source for zooplankton. Cyanobacteria was the dominant species on the May, June, August, and September sampling dates (58%, 59%, 87%, and 72% total phytoplankton abundance by sampling event). *Aphanizomenon* sp. was the dominant species of cyanobacteria in August and September, with a massive spike occurring in early August. *Aphanizomenon* are a potential producer of cylindrospermopsin, anatoxins, and saxitoxins.

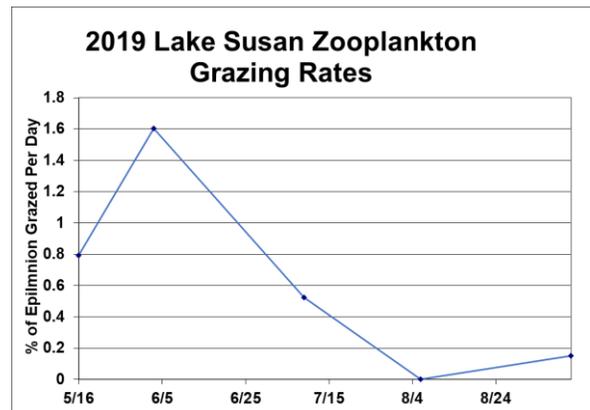
**Figure 25 2019 Lake Susan Epilimnetic Grazing Rates**

The estimated epilimnetic grazing rates upon algae observed in 2018 were, ranging from 0.1% to 11%. However, in 2019, the epilimnetic grazing rate was only around 1% (Figure 25). This is mainly due to the very limited number of Cladocera present in all the samples collected. The highest grazing rate was observed in early June when *Daphnia pulex* were more numerous in the zooplankton community.

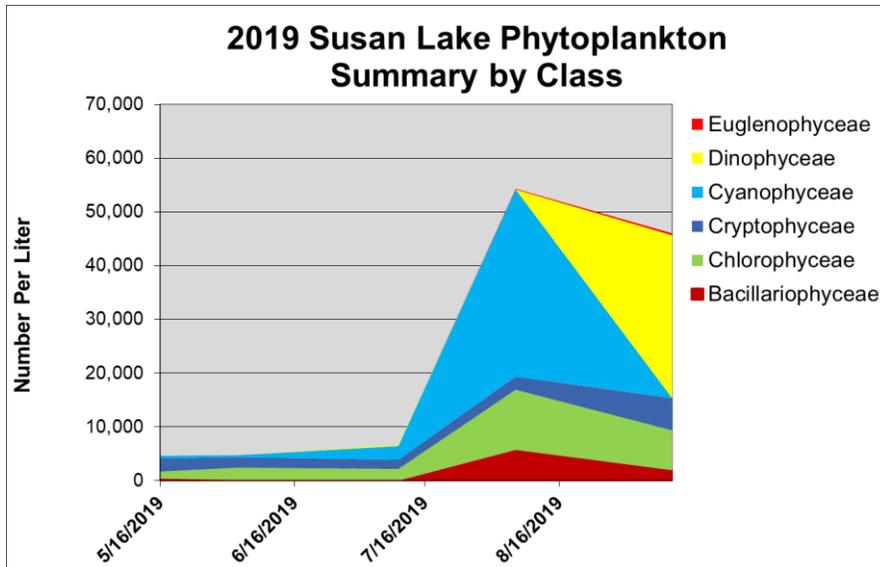
**Figure 26 2019 Lake Susan Phytoplankton Abundance (#/L) by Class.**

During the summer of 2019, staff collected five phytoplankton samples on Lake Susan (8 Exhibits D). The abundance of phytoplankton by Class is presented in Figure 26. From mid-May to mid-July, Cryptophytes and Chlorophytes were the co-dominant phytoplankton groups. Cryptophytes are motile unicellular algae that grow photosynthetically and are broadly distributed in lakes, usually preferring nutrient-rich environments. Chlorophytes, or green algae, are like Cryptophytes, but are non-motile. A large spike in the population of Cyanobacteria caused it to become the dominant phytoplankton species in August with a TPA values 64%. *Pseudanabaena limnetica* was the most common species of cyanobacteria during this event. *Pseudanabaena sp.* are filamentous, bloom forming organisms. They produce compounds that can impart muddy or moldy flavors to drinking water during large blooms. By mid-September the Cyanophytes had disappeared and been replaced as the dominant phytoplankton group by the Dinophyceae species *Ceratium hirundinella*. This unicellular species is known for its spiked shell formed of armored plates. Though generally harmless, blooms of *Ceratium* species can occur under the right conditions. The resulting oxygen depletion caused by these blooms can potentially result in fish kills.

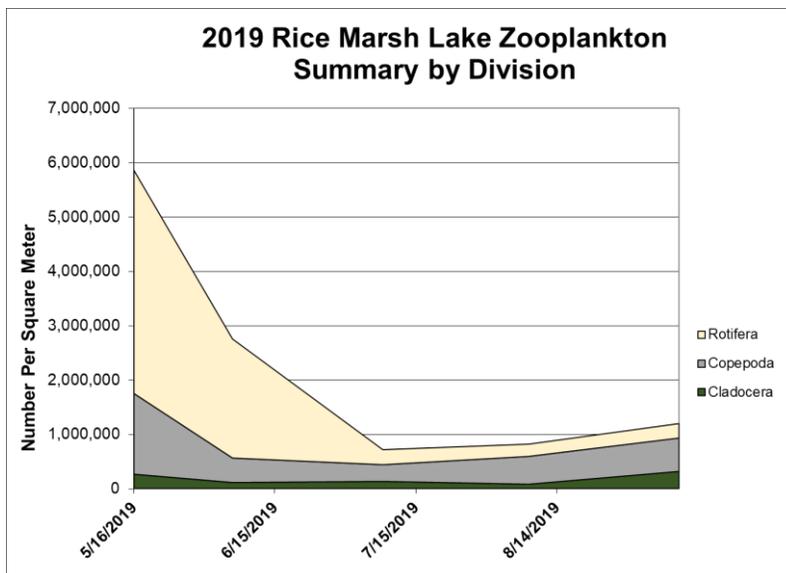
**Figure 27 2019 Rice Marsh Lake Zooplankton Counts (#/m²)**

In 2019, all three groups of zooplankton were captured in Rice Marsh Lake (8 Exhibits C), of which 8% of the population was comprised of Cladocerans, down from 13% in 2018 and 27% in 2017. As expected, rotifers were the most abundant zooplankton sampled in 2019 (**Figure 27**). However, 90% of Rotifers counted were sampled in May and June. Copepod densities were highest in May and remained relatively stable thereafter. Across all sampling dates the Cladoceran community was dominated by small-bodied zooplankton, consisting of mainly *Bosmina longirostris*, *Ceriodaphnia sp.*, and *Chydorus sphaericus*.

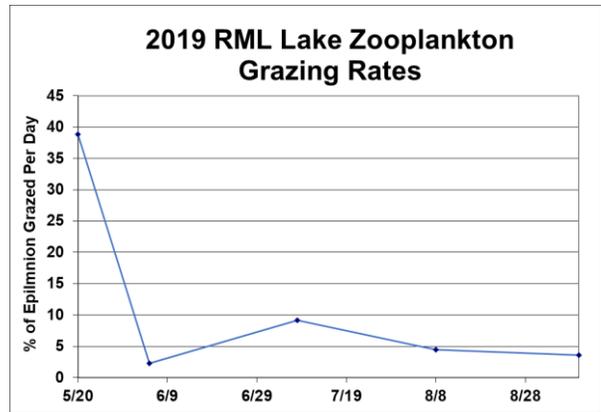
**Figure 28 2019 Rice Marsh Lake Epilimnetic Grazing Rates**

The estimated epilimnetic grazing rates of Cladocera observed in 2018 ranged from near 0% to 23% on Rice Marsh Lake. In 2019, the epilimnetic grazing rate was highest during the May sample at 39% (**Figure 28**). After the first May sampling event, grazing rates averaged near 5% for the remainder of the

year. The highest May grazing rate was linked with the presence of the larger bodied Cladocera *Daphnia pulex*. The most common Cladocera present was *Bosmina longirostris* which are commonly found in bog lakes such as Rice Marsh Lake.

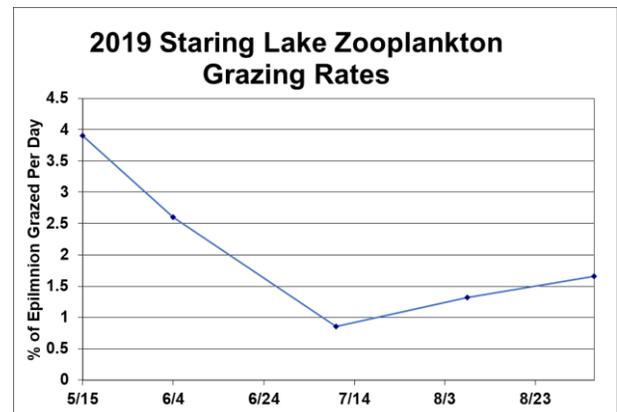
**Figure 31 2019 Staring Lake Grazing Rates**

Large Cladocera consume algae and may have the potential to improve water quality when present in large densities. The estimated epilimnetic grazing rates observed in 2018 ranged from 2% to 24%. The 2019 were much lower at 1-4% (Figure 31). The max grazing rate in May corresponded optimal feeding temperatures near 21 degrees Celsius.

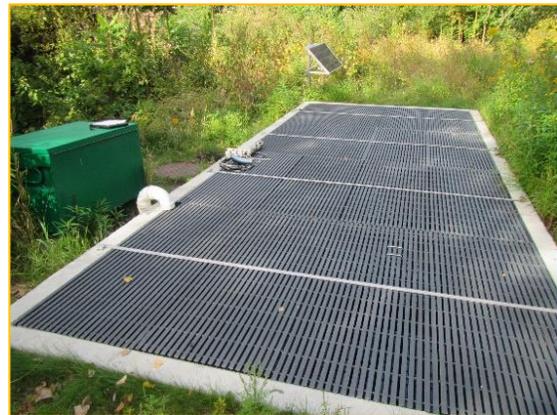
**Figure 34 Spent Lime Treatment System**

In 2016, an innovative spent lime filtration system was constructed along a tributary stream draining a wetland on the south-west corner of Lake Susan (**Figure 34**). Based on system performance of the one other experimental spent lime filter site in the eastern Twin Cities area, modeling simulations based on available water quality measurements suggested the Lake Susan system had the potential to remove up to 45 pounds of phosphorus annually from water entering the lake. This would result in improved water quality and recreational opportunities. Spent lime is calcium carbonate that comes from drinking-water treatment plants as a byproduct of treating water. Instead of disposing of it, spent lime can be used to treat stormwater runoff. When nutrient-rich water flows through the spent lime system, the phosphorus binds to the calcium. The water flows out of the spent lime system, leaving the phosphorus behind.

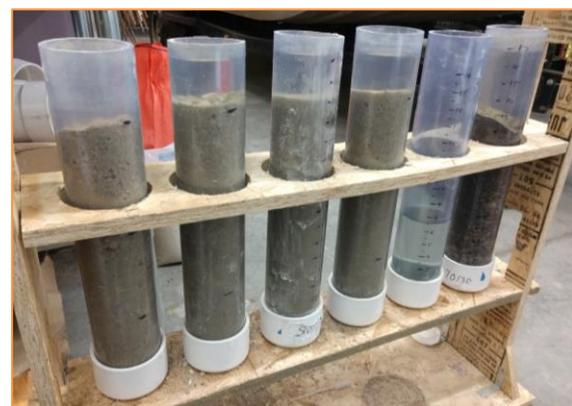
**Figure 35 Spent Lime/Sand Mixture Column Testing**

During the summer of 2019, District staff completed laboratory column testing for mixtures of spent lime and sand. Column testing indicated that mixing spent lime with sand improves the filtration capacity of the media, while still removing phosphorus. **Figure 35** is a photograph of the column testing completed by District staff during 2019. The testing revealed the following key points:

- Filtering water through sand washed to MNDOT standard specifications (washed sand) results in phosphorus export from the test columns.

- Water filtered through the various spent lime/pool sand mixtures elevated the pH in the effluent water, thus supporting the chemical reaction to precipitate phosphorus (i.e. remove phosphorus).
- Filtration rates through the various spent lime/pool sand mixtures appears relatively unchanged after 114 days of inundation and continuous flow for 10 days did not reduce drain times (**Figure 37; Figure 38**).
- Initial testing of plaster sand obtained from a local pit also results in phosphorus export from the material.
- Total phosphorus removals were generally high the larger the content of spent lime in the mixture (**Figure 36**).

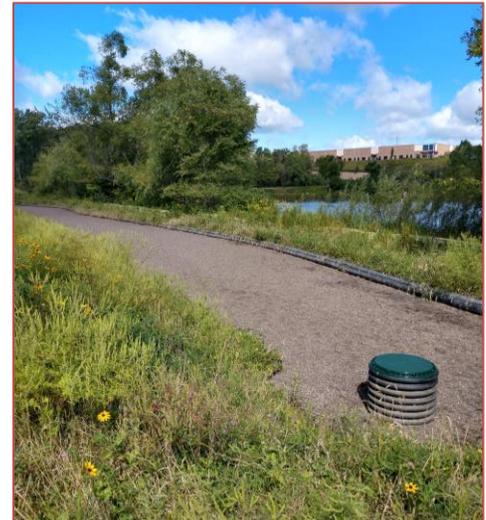
**Figure 39 Lake Susan Park Pond Iron Sand Bench**

In 2013, the Lake Susan Use and Attainability Analysis (UAA) identified Lake Susan Park Pond as a significant contributing source of nutrient pollution to Lake Susan. In 2015 and 2016, staff conducted sampling on Lake Susan Park Pond and at the Lake Susan Park Pond outlet to confirm the UAA findings. Results indicated the pond was contributing nutrient pollution, but at a lesser level than indicated by the UAA (surface water total phosphorous concentrations ranged from 0.043 to 0.084 mg/L). In addition to the goal to improve water quality, the District has been looking at ways to decrease the use of groundwater for irrigation. In 2017, the District proposed actions to improve the water quality in Lake Susan, increase water storage along Riley Creek, and reduce potable water use through implementing the Lake Susan Park Pond Iron Sand Bench and Stormwater Reuse Enhancement Project which was completed in 2019 (**Figure 39**).

Iron-enhanced filtration consists of mixing iron filings with a filtration media (i.e., sand). Filtration through the sand removes the particulate phosphorus, while the iron filings, which form iron oxide when rusted, increase the removal of dissolved phosphorus. When water containing dissolved phosphorus contacts the iron oxide, the dissolved phosphorus is removed from the stormwater through surface sorption. A stormwater harvesting and use system is a constructed system that captures and retains stormwater for beneficial use at a different time or place than when or where the stormwater was generated. To reduce potable water use from which the city of Chanhassen supplies irrigation to the Lake Susan Park ballfield, stormwater already captured in Lake Susan Park Pond was used for irrigation.

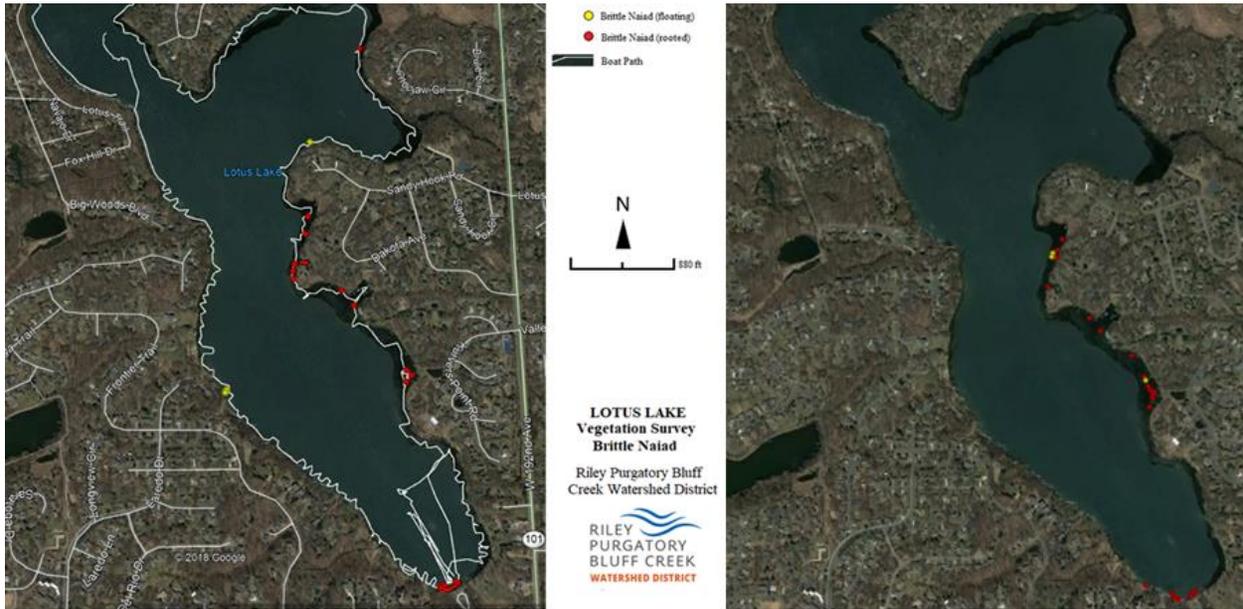
**Figure 43 2018(left) & 2019(right) Brittle Naiad Maps**

District staff again carried out the visual roving survey in 2019, marking each plant discovered. This was done to assess if brittle naiad expanded its range or growing depth due to increased clarity following the fall 2018 alum treatment. The results of the scan can be seen in **Figure 43**. Overall, the 2019 results were very similar to what was seen in 2018. The plant was found in almost all areas where it was found in 2018, however it again appeared to be reduced in density. It has not been determined what would cause reductions in density. Staff will conduct another scan in 2020 to assess brittle naiad population.

On September 24th and 26<sup>th</sup> of 2018, RPBCWD staff conducted brittle naiad surveys to determine the effectiveness of the herbicide and to see if the plant had spread throughout the lake. During the scan staff drove a lap around the lake and every brittle naiad plant found was marked with a handheld GPS device. Results of the survey can be seen in **Figure 43**. Based on the 2018 brittle naiad scan, it appeared the overall plant distribution had been reduced in the treatment areas. Plants were found on both sides of the

public access, similar to where stands of plants were most dense in 2017, however the number and area occupied by the plants was reduced considerably. Additionally, no rooted plants were found on the southwest side of the lake. More plants were found scattered along the south east shoreline and into the east bay which may have been missed during the 2017 survey. Brittle naiad was observed growing between 0.5 to three feet of water. Its absence from deeper water was likely due to limited water clarity in Lotus Lake.
