# Water Resources Report

RILEY PURGATORY BLUFF CREEK WATERSHED DISTRICT  
2019 ANNUAL REPORT

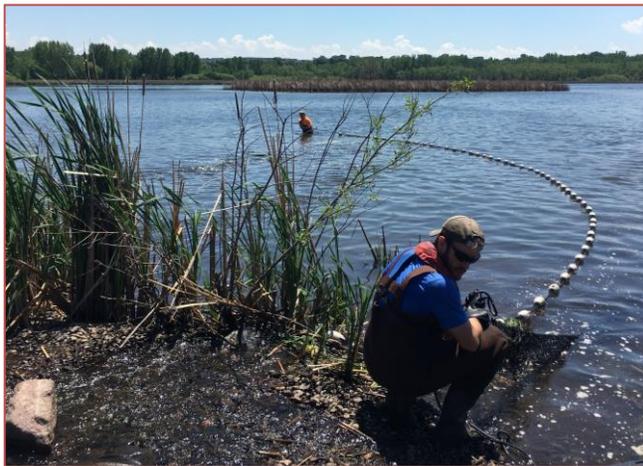
**Figure 49 Common Carp Removal at the PCRA Berm**

In 2019 staff also utilized a backpack electrofishing unit and block nets to remove common carp during the spring spawning run (**Figure 49**). These two gears were deployed in the channel upstream of the barrier to trap carp between the net and at the breach in the berm that separates the Upper and Lower Purgatory Creek Recreational Area. Most of the fish captured via backpack electrofishing were captured at the breached berm site. This breach allows water to short circuit the overflow structure. Water was always flowing at this location which led to carp concentrating in the shallow water near the breach before they tried to move upstream. The sheet piling, combined with the consistent flow, eroded the downstream side of the berm, causing a drop that impeded carp movement. A block net was anchored on one side of the flow at the breach and then stretched around the congregating carp, trapping them against the berm and net. Staff used an electrofishing backpack to easily remove the trapped fish. During the heavy spawning run, staff repeated the process, sometimes up to three times a day, taking about an hour each time from installation of the net to completion of sampling. Utilizing both the trap net and backpack electrofishing, a total of 441 carp were removed in 2019 vs 1,901 carp in 2018. Most of the fish removed were from the 2015 year class, in which approximately 3000 YOY carp had entered Lake Staring from LPCRA and started to grow rapidly (Sorensen et al., 2015). This year class was a result of the last major recruitment event that occurred in the system thus far **Figure 48**. The major removal rate discrepancy between 2018 and 2019 can be attributed to the very high-water levels seen in 2019. This allowed fish to move freely between the two basins without congregating at the

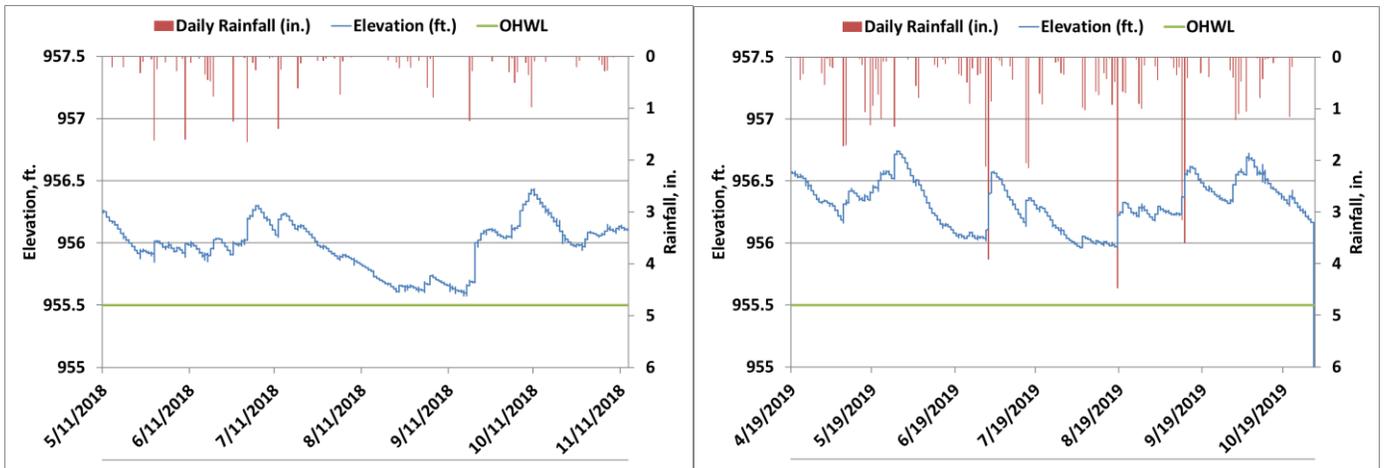
Figure A-1. **Lake Ann** level elevation data (ft.) for 2018 and 2019 along with the lake’s ordinary high-water level (OHWL). Daily rainfall (in.) is displayed along the top of the graph (NOAA).

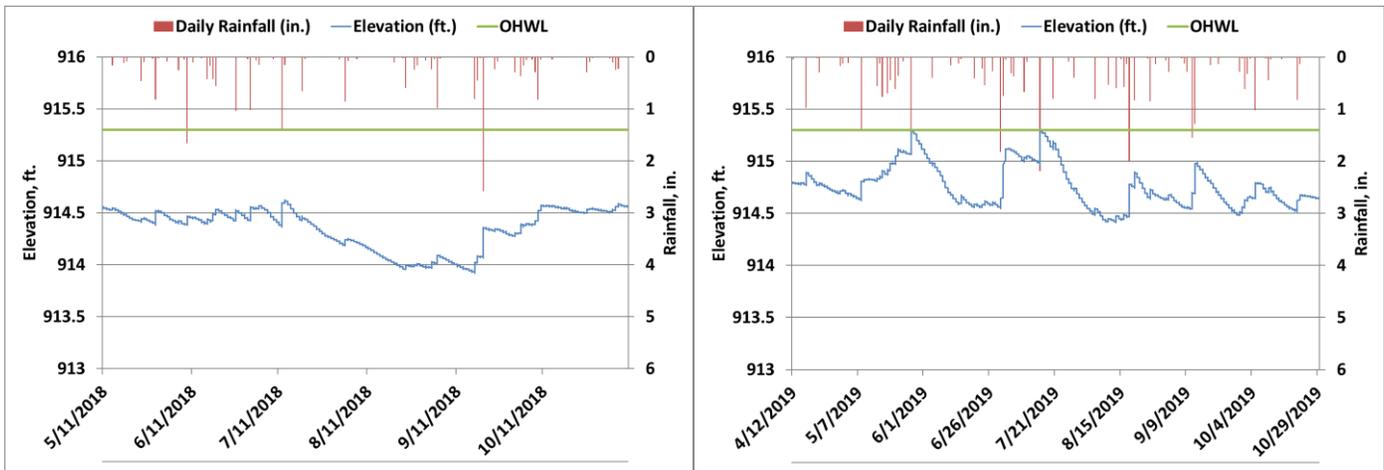
Figure A-2. **Duck Lake** level elevation data (ft.) for 2018 and 2019 along with the lake’s ordinary high-water level (OHWL). Daily rainfall (in.) is displayed along the top of the graph (NOAA).

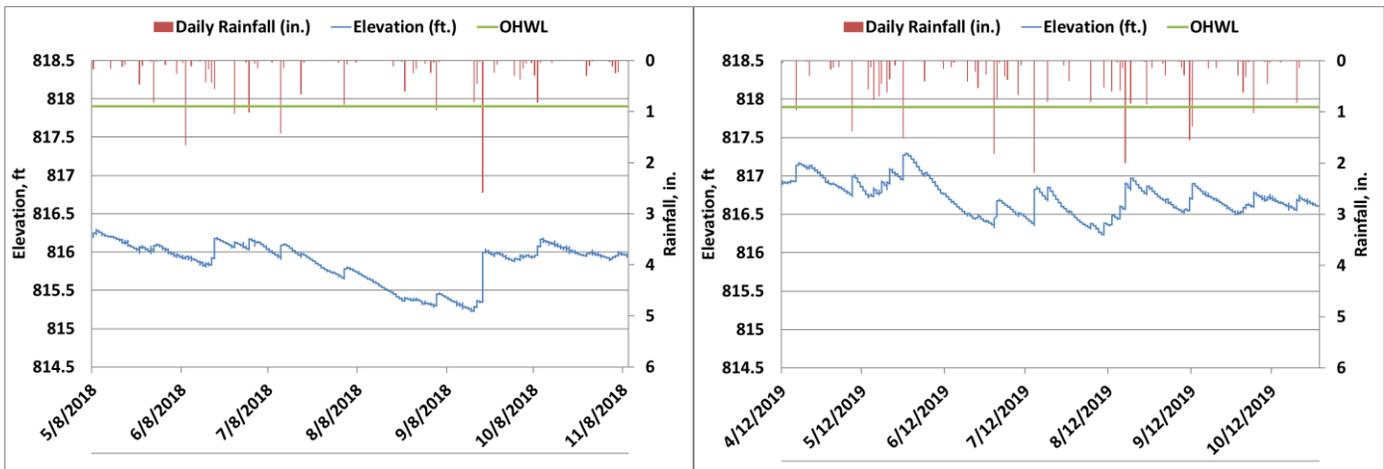
Figure A-3. **Hyland Lake** level elevation data (ft.) for 2018 and 2019 along with the lake’s ordinary high-water level (OHWL). Daily rainfall (in.) is displayed along the top of the graph (NOAA).

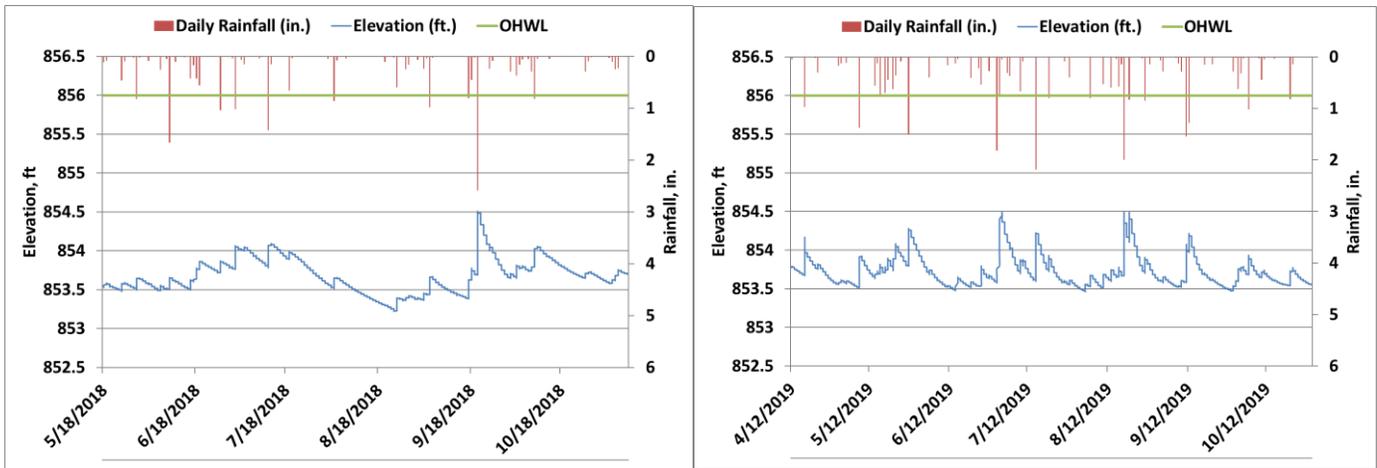
Figure A-4. **Lake Idlewild** level elevation data (ft.) for 2018 and 2019 along with the lake's ordinary high-water level (OHWL). Daily rainfall (in.) is displayed along the top of the graph (NOAA).

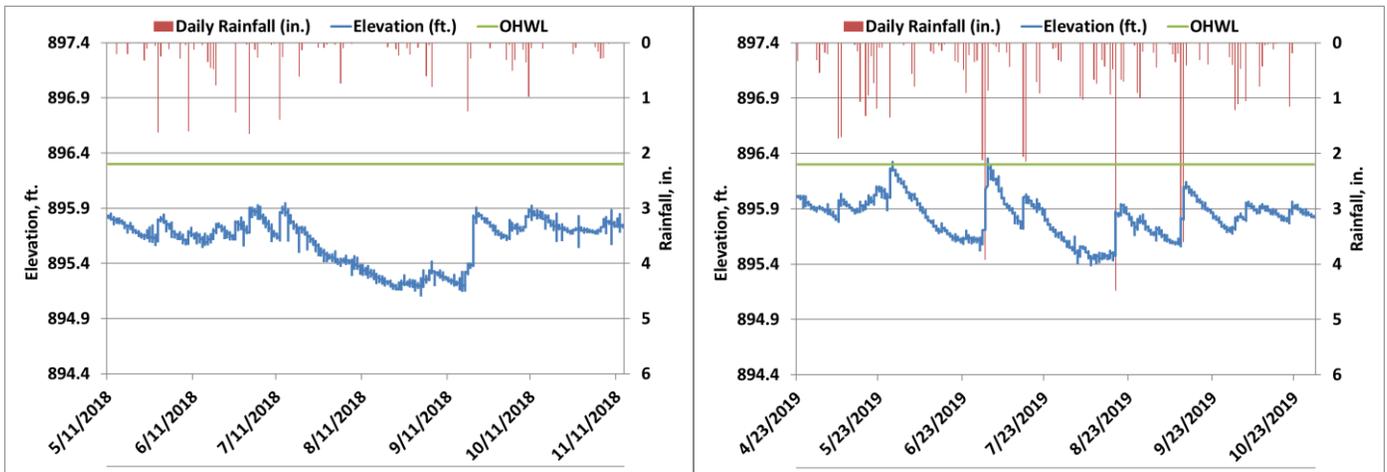
Figure A-5. **Lotus Lake** level elevation data (ft.) for 2018 and 2019 along with the lake's ordinary high-water level (OHWL). Daily rainfall (in.) is displayed along the top of the graph (NOAA).

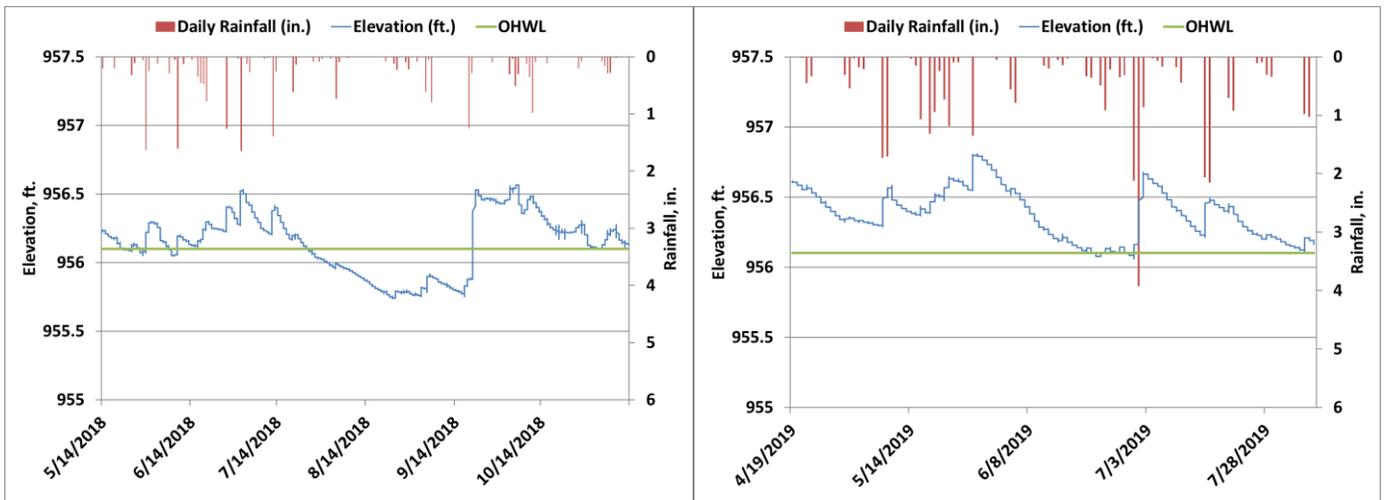
Figure A-6. **Lake Lucy** level elevation data (ft.) for 2018 and 2019 along with the lake's ordinary high-water level (OHWL). Daily rainfall (in.) is displayed along the top of the graph (NOAA).

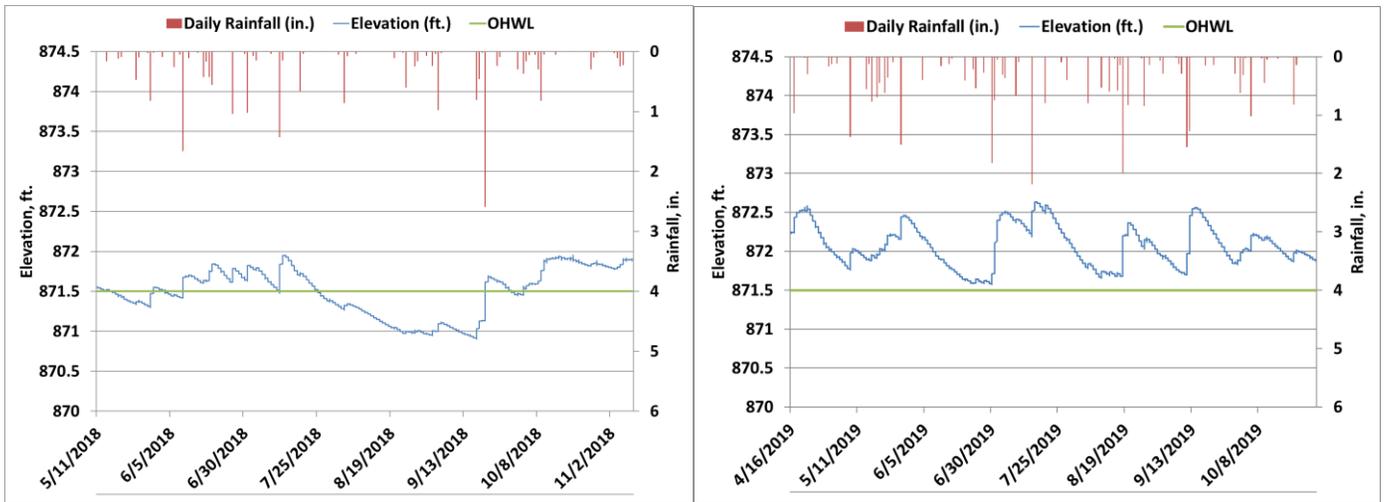
Figure A-7. **Mitchell Lake** level elevation data (ft.) for 2018 and 2019 along with the lake's ordinary high-water level (OHWL). Daily rainfall (in.) is displayed along the top of the graph (NOAA).

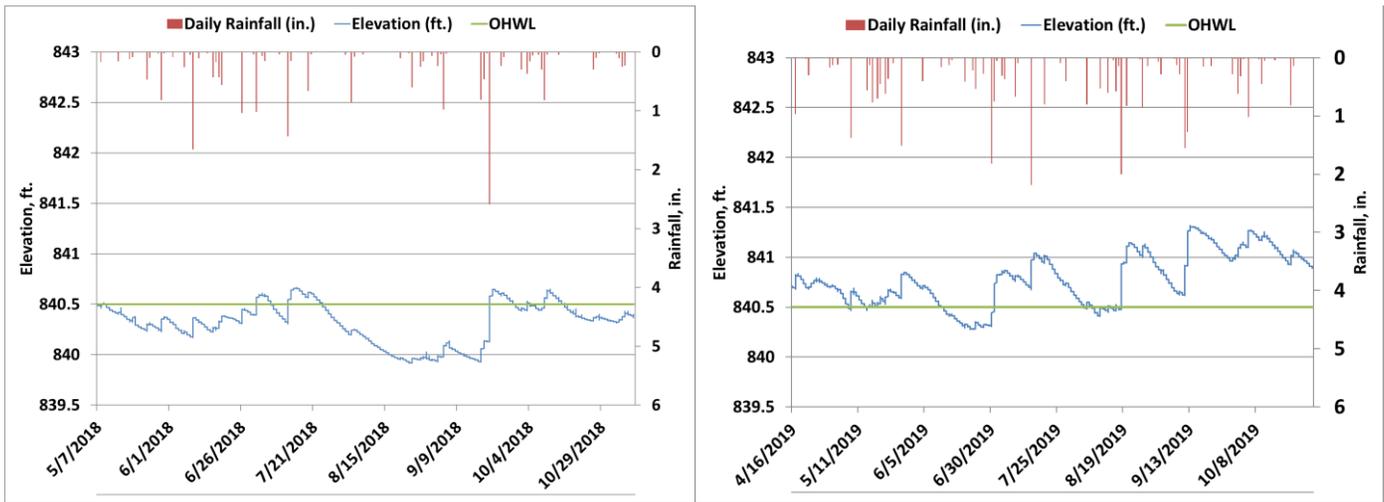
Figure A-8. **Red Rock Lake** level elevation data (ft.) for 2018 and 2019 along with the lake's ordinary high-water level (OHWL). Daily rainfall (in.) is displayed along the top of the graph (NOAA).

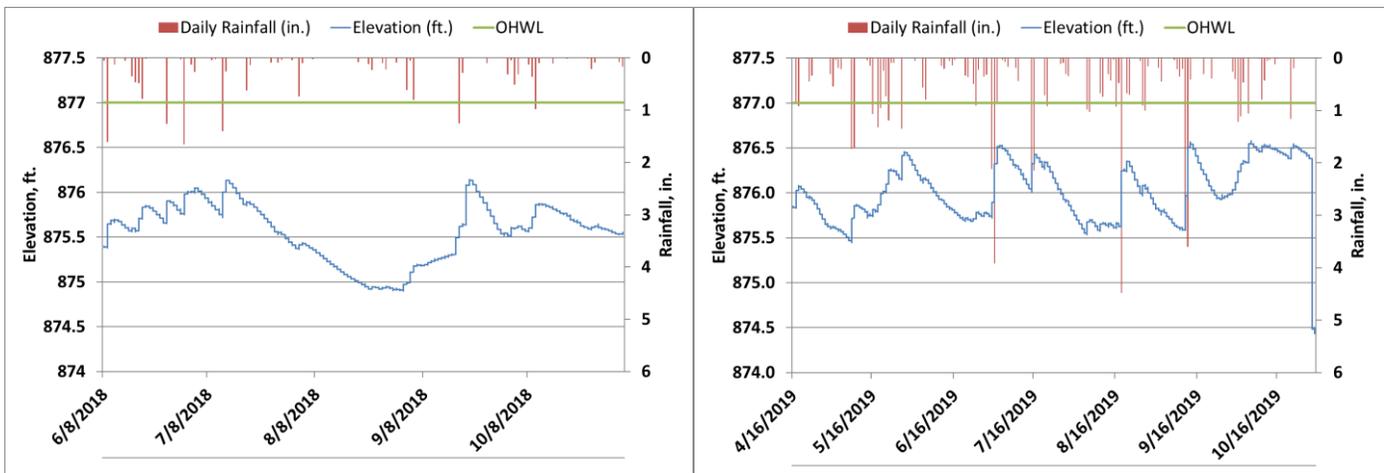
Figure A-9. **Rice Marsh Lake** level elevation data (ft.) for 2018 and 2019 along with the lake's ordinary high-water level (OHWL). Daily rainfall (in.) is displayed along the top of the graph (NOAA).

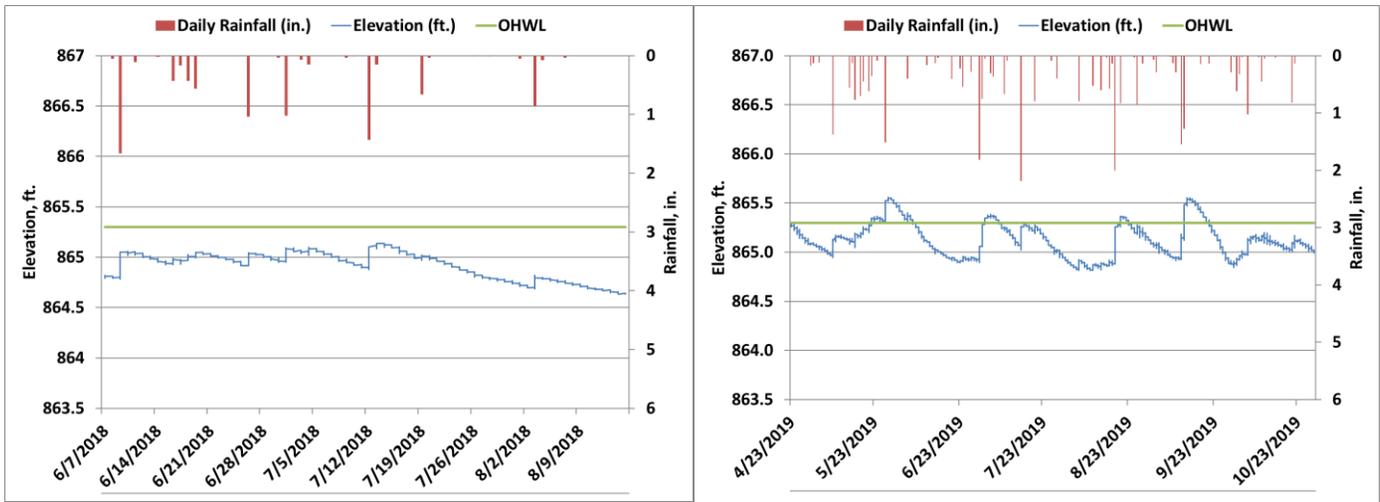
Figure A-10. **Lake Riley** level elevation data (ft.) for 2018 and 2019 along with the lake’s ordinary high-water level (OHWL). Daily rainfall (in.) is displayed along the top of the graph (NOAA).

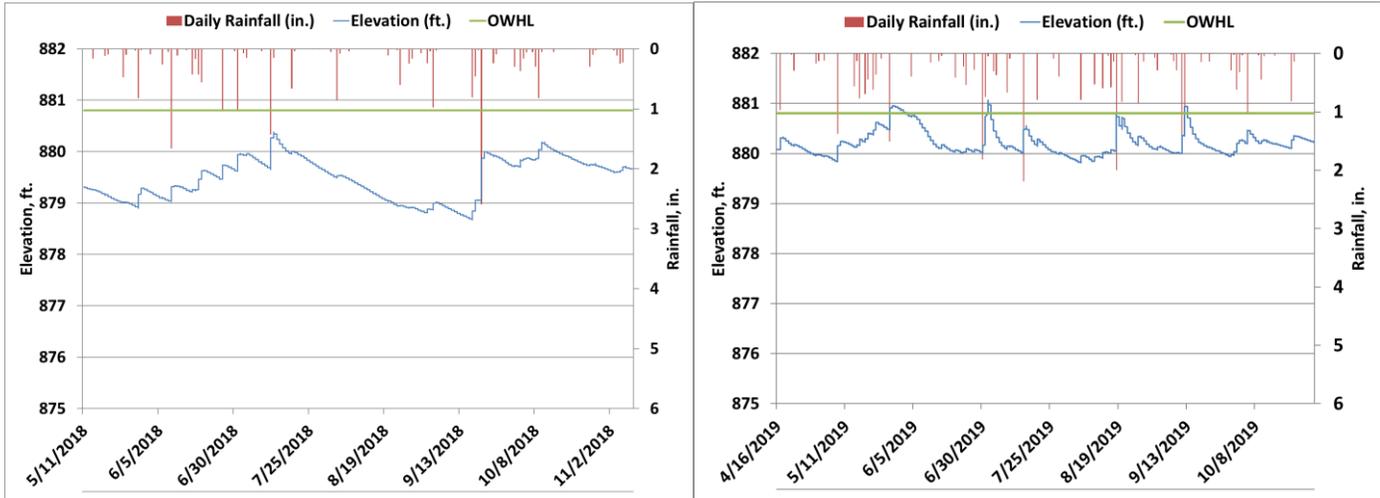
Figure A-11. **Round Lake** level elevation data (ft.) for 2018 and 2019 along with the lake’s ordinary high-water level (OHWL). Daily rainfall (in.) is displayed along the top of the graph (NOAA).

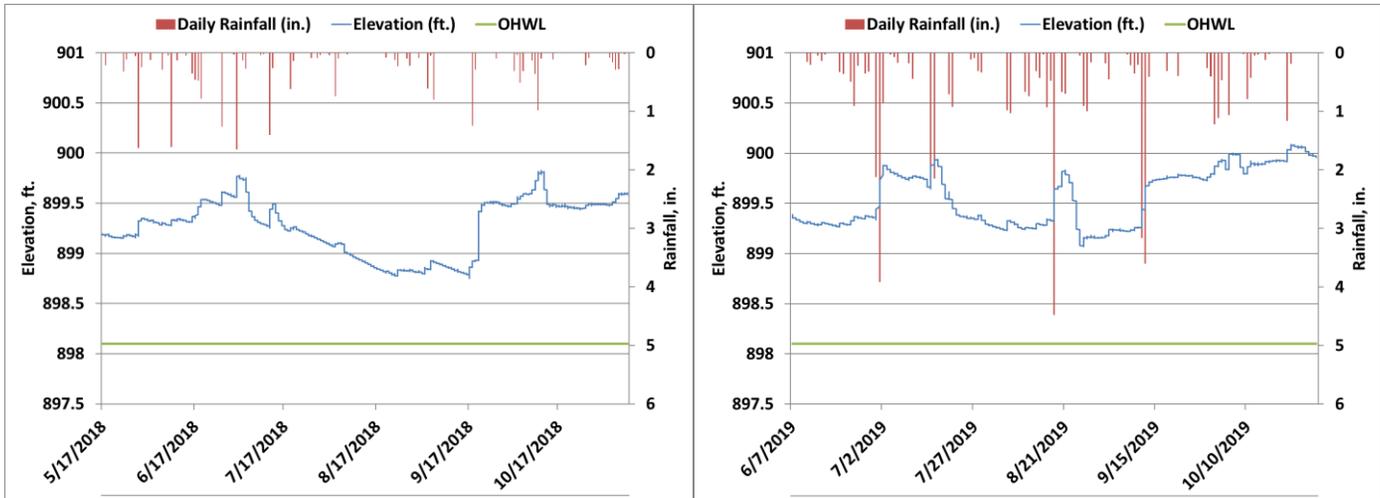
Figure A-12. **Silver Lake** level elevation data (ft.) for 2018 and 2019 along with the lake’s ordinary high-water level (OHWL). Daily rainfall (in.) is displayed along the top of the graph (NOAA).

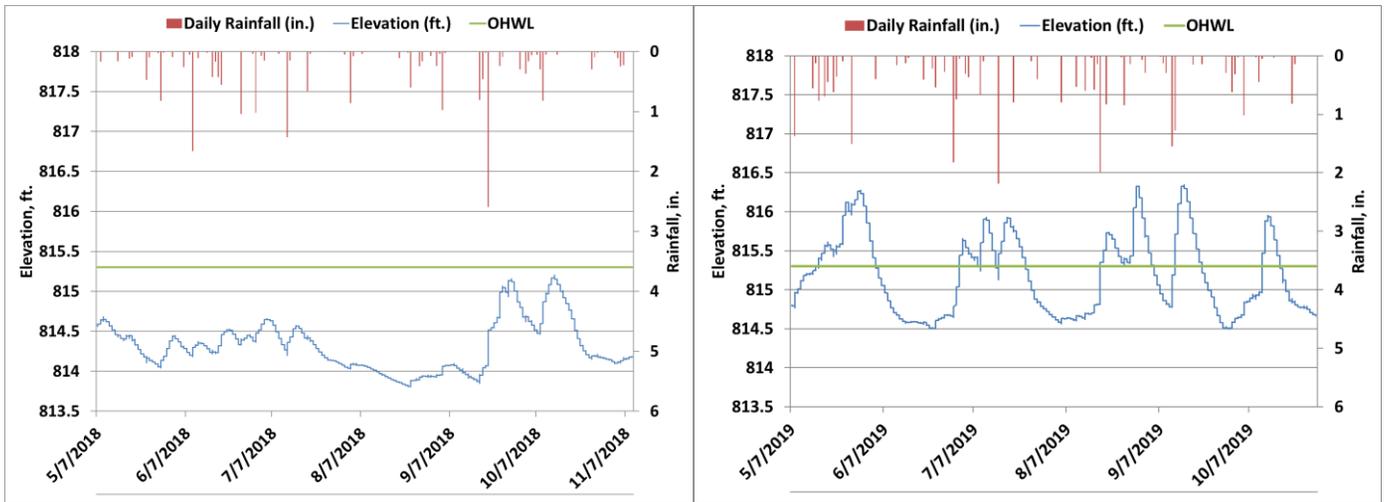
Figure A-13. **Staring Lake** level elevation data (ft.) for 2018 and 2019 along with the lake’s ordinary high-water level (OHWL). Daily rainfall (in.) is displayed along the top of the graph (NOAA).

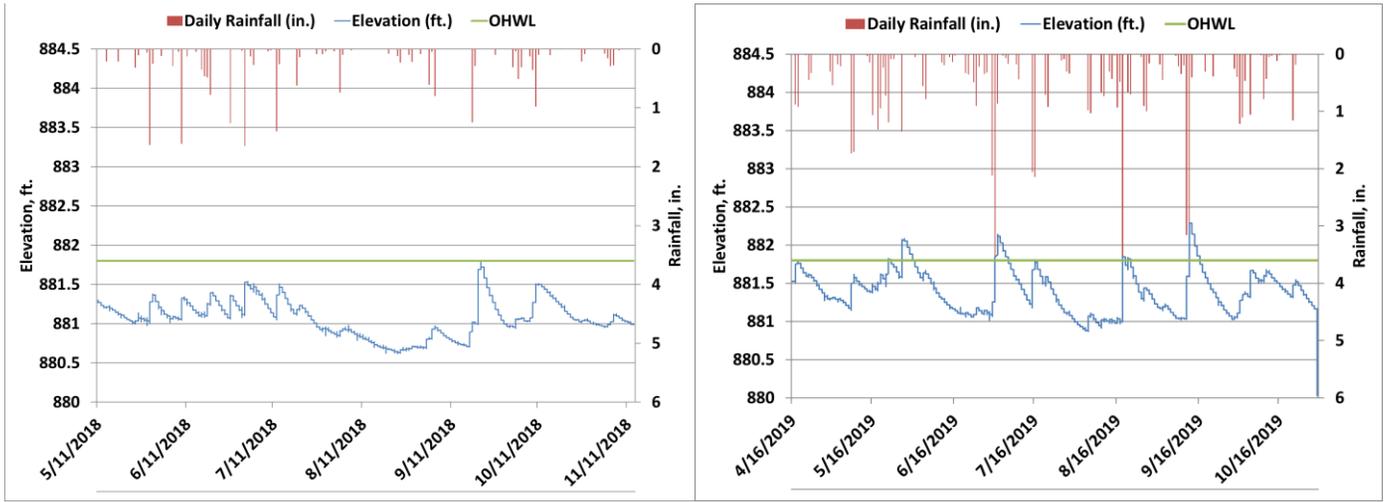
Figure A-14. **Lake Susan** level elevation data (ft.) for 2018 and 2019 along with the lake’s ordinary high-water level (OHWL). Daily rainfall (in.) is displayed along the top of the graph (NOAA).
