**Riley-Purgatory-Bluff Creek Watershed District**  
Board of Managers Workshop and Regular Meeting

**Wednesday, April 5, 2017**  
**5:30pm Board Workshop**  
**7:00pm Regular Board Meeting**  
DISTRICT OFFICE  
18681 Lake Drive East  
Chanhassen

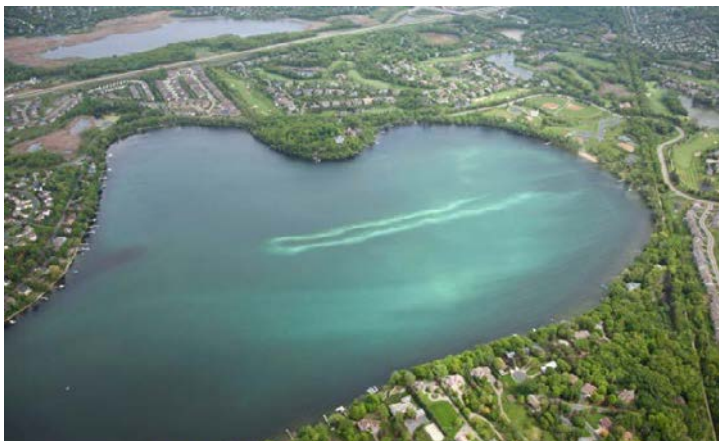
**Photo: Lake Riley, after treatment with aluminum sulfate. The light blue line shows where the alum was placed.**

Phosphorous was also the target of a project on Lake Riley. In May, Riley was treated with a compound called aluminum sulfate (alum). Alum binds with phosphorus and traps it on the lake bottom, preventing algae from using it to grow. Summer water sampling detected improvements in water quality. Continued monitoring will track the long-term performance of the alum treatment.

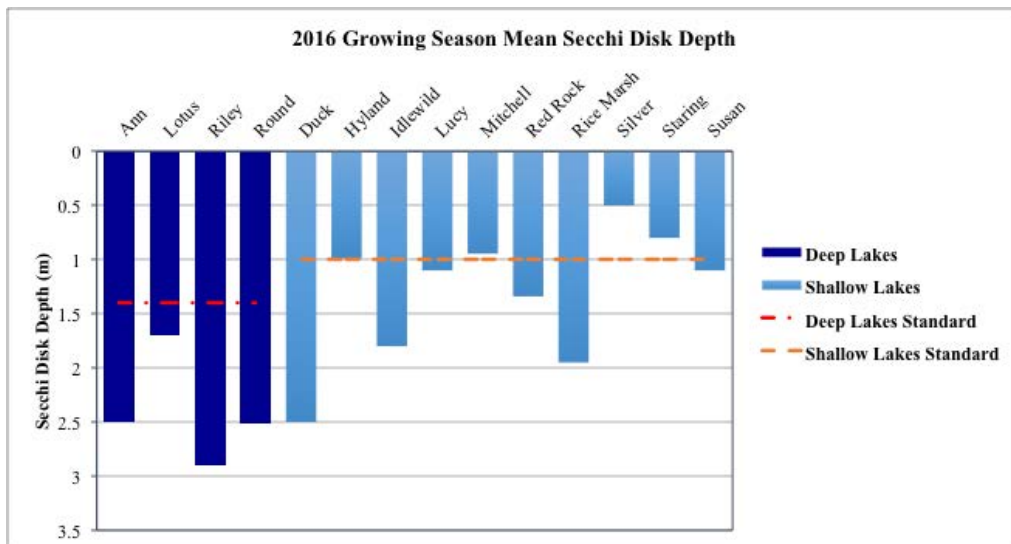
**Figure 4.1-3 2016 Lakes Growing Season Mean Secchi Disk Depth**

The 2016 secchi disk growing season mean for all District lakes sampled is shown in Figure 4.1-3. The MPCA standard for secchi disk depth for deep lakes (> 1.4m) was met by all deep lakes in the District (Ann, Lotus, Riley, and Round). Lake Ann and Lake Riley had the largest changes occur across all deep lakes, with a reduction in water clarity by about 0.5m in Ann and an increase by 1.2m in Riley. The change in Lake Riley can most likely be attributed to the aluminum sulfate treatment that occurred in the spring of 2016 (more information about the treatment can be found in section 4.2). All other deep lakes had clarity readings similar to numbers from 2015. For shallow lakes (>1m), six of 10 lakes monitored achieved the secchi depth water quality standard. Duck Lake, Lake Idlewild, Lake Lucy, Red Rock Lake, Rice Marsh Lake, and Lake Susan met the standard. Hyland and Mitchell Lake were extremely close to meeting the MPCA with a summer averages of 0.99m and 0.95m respectively. Except for Ann, Staring, Susan, and Silver Lake, water clarity improved across all lakes. Lake Riley had the highest average secchi readings at 2.9m, while Silver Lake recorded the worst.

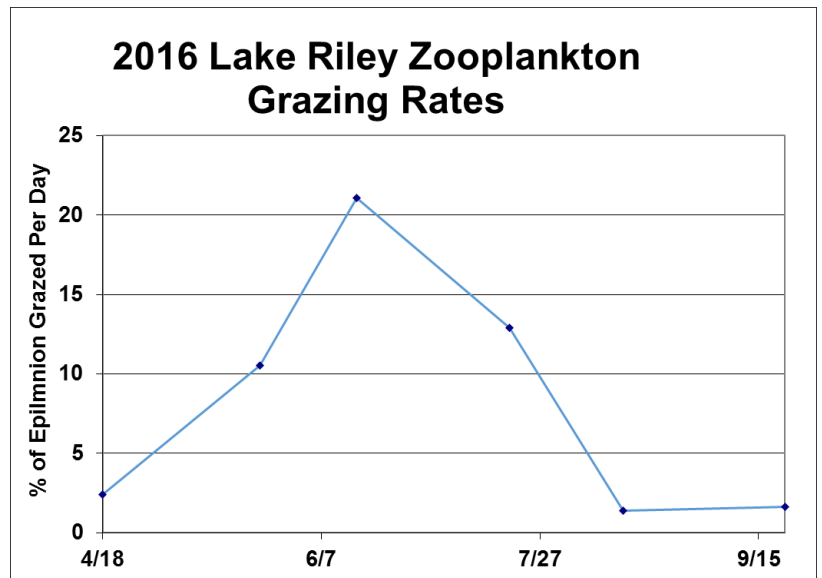
Figure 4.6-1 Lake Riley Zooplankton Counts (#/m<sup>2</sup>)

Cladocera consume algae and have the potential to improve water quality if they are abundant. The estimated epilimnetic grazing rates of Cladocera observed in 2016 were down from rates observed in 2015. In 2016 the estimated epilimnetic grazing rates ranged from 1% to 21% (Figure 4.6-2), down from 1% to 38% in 2015. April grazing rates were very low before peaking at 21% in June and returning to low levels in August and September. The highest June grazing rates were linked with the high number of *Daphnia pulex* present, which declined after the June sample date and were replaced with small bodied Cladocera. The reduction in large bodied zooplankton during the early summer months is often seen in zooplankton communities because of the hatching of young of the year (YOY) fish (fish born in the spring) which consume large/high energy zooplankton. Reductions can also occur because of an increase in cyanobacteria in the phytoplankton community which are inedible to Cladocera.

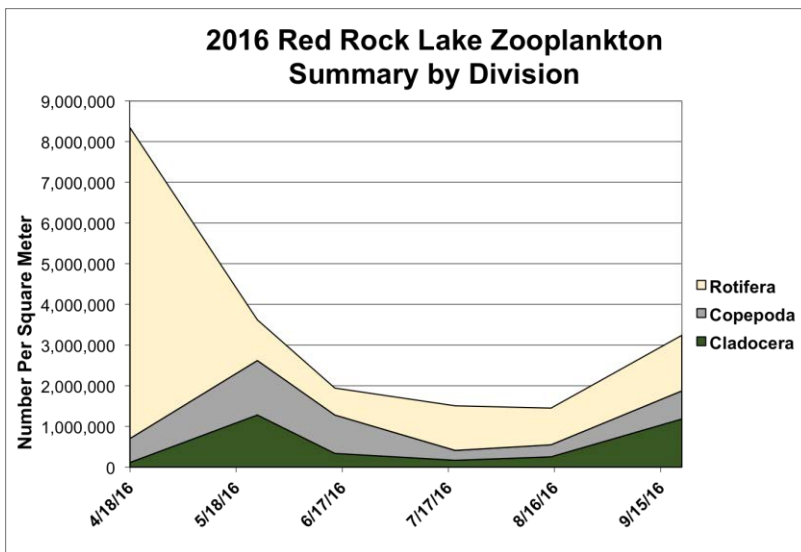
Figure 4.6-3 Red Rock Lake Zooplankton Counts (#/m<sup>2</sup>)

Large Cladocera consume algae and, if enough are present in a lake, they have the potential to improve water quality. The estimated epilimnetic grazing rates observed in 2016 experienced a range from 5% to 36% (Figure 4.6-4). The April epilimnetic grazing rate was the lowest of the season, however it spiked in May and stabilized for the rest of year.

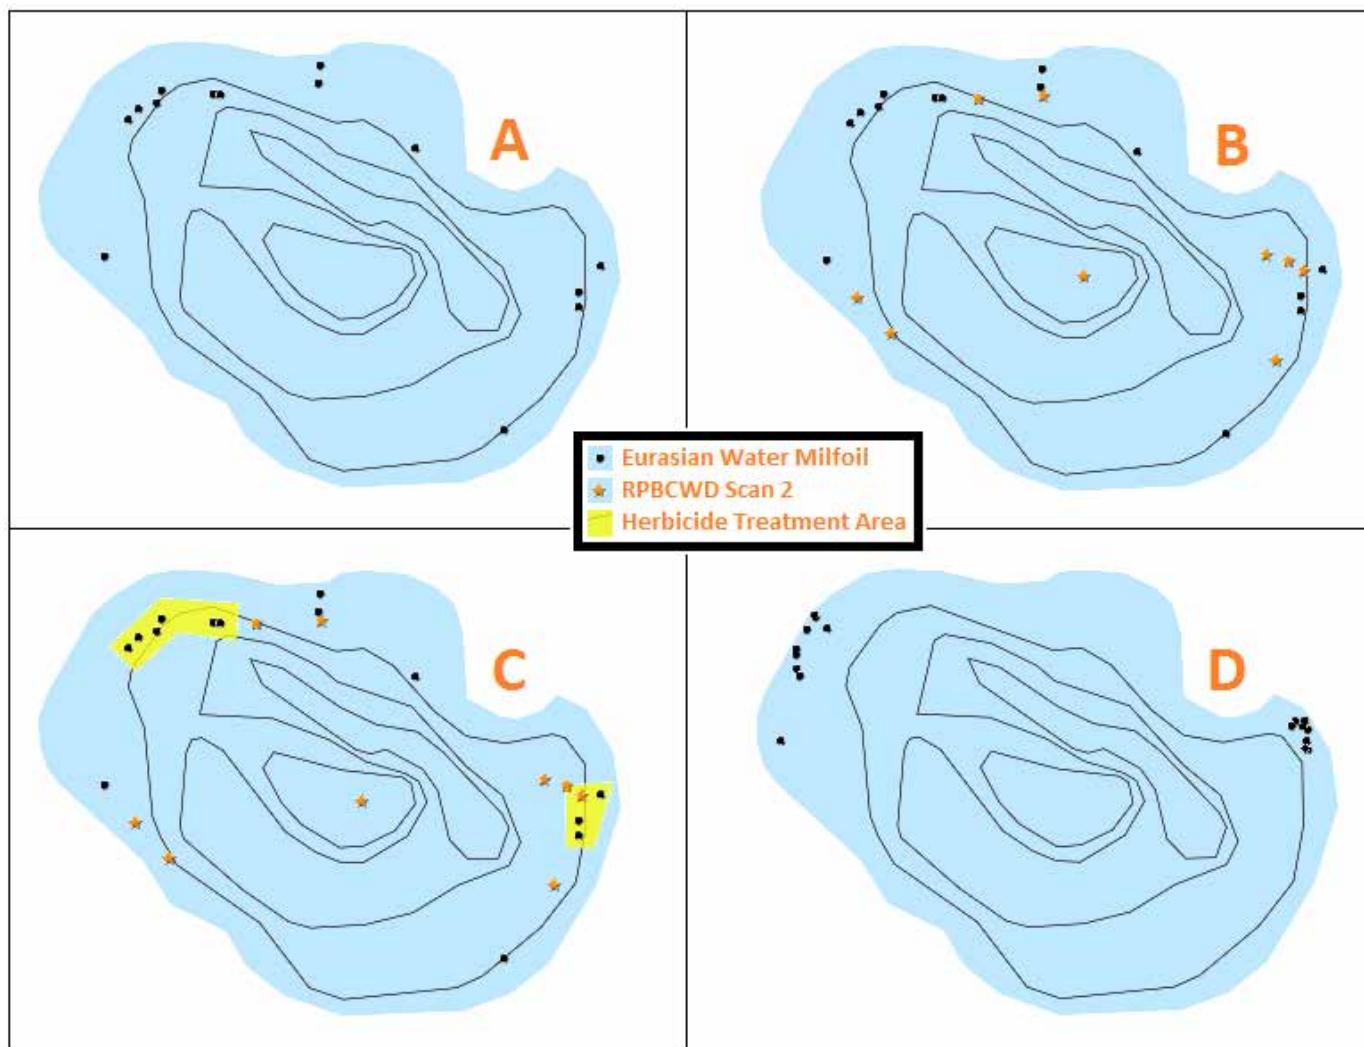
**Figure 5.2-2 2016 Staring Lake Eurasian Watermilfoil Scans and Treatment**

The herbicide treatment in 2015 was successful as no EWM was discovered in the treatment areas in 2016. That said, during the first scan by Johnson in mid-summer, 20 plants were discovered across the lake (Figure 5.2-2– Panel A). RPBCWD staff then went out and conducted an additional scan and found an additional 10 plants. After conducting this scan, RPBCWD staff hand pulled these plants (Figure 5.2-2 – Panel B). The same herbicide was then applied to Staring Lake, treating 6.5ac (one site at the northwest end, and another at the east end of the Lake). This treatment targeted deep plants and plants that were not pulled (Figure 5.2-2 – Panel C). Johnson and RPBCWD staff each performed one last scan in the fall and identified an additional 20 plants (Figure 5.2-2 – Panel D). RPBCWD staff once again mechanically removed all plants except two deep plants that were topped and marked for removal/treatment in 2017. In 2017, aquatic plant surveys will evaluate the success of the combined mechanical and chemical treatment. A combination of mechanical and chemical removal of EWM will continue through 2017.
