Bluff Creek Watershed

Total Maximum Daily Load Implementation Plan: Turbidity and Fish Bioassessment Impairments

**Submitted by:
Barr Engineering Company**

Final Report—July, 2013

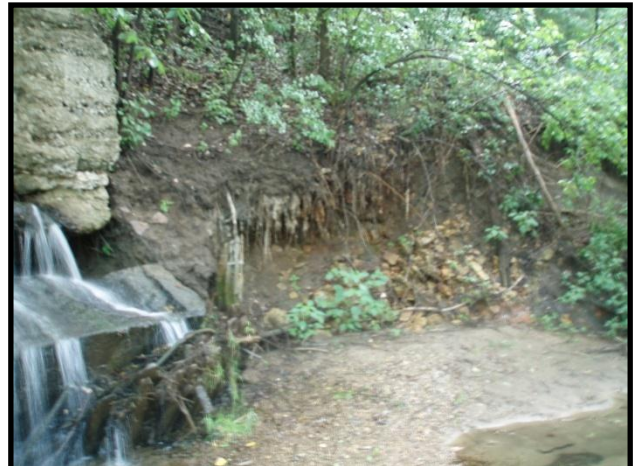
This site includes the downstream end of the regional trail crossing culvert and an eroded bank immediately downstream of the culvert. The stream channel has downcut significantly below the culvert, and the culvert is being undermined. Left unchecked, the culvert may begin to fail. The large drop at the downstream end of the culvert prevents fish passage to upstream reaches (see [Figure 4.2](#) and [Figure 4.3](#)).

Figure 4.3 Large bank failure downstream of culvert outlet on left bank (Site 1)

Evaluate the structural condition of the culvert and make necessary repairs to prevent further undermining, including a rock energy dissipation structure. Evaluate existing vegetation and thin trees where possible to provide greater sunlight to ground vegetation. Grade eroded banks, add toe protection to prevent further undercutting and plant with native plantings.

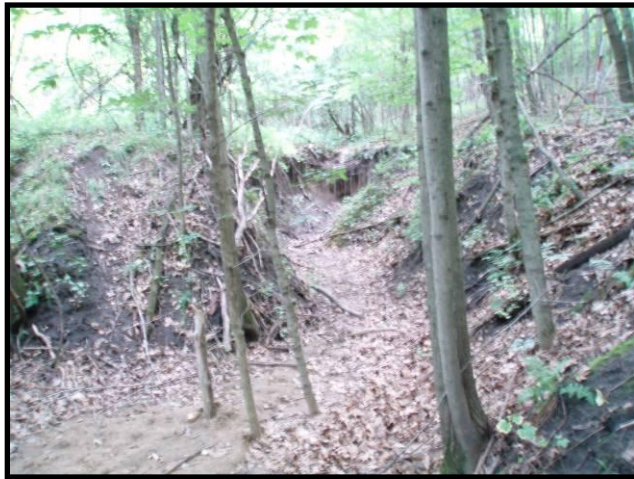
Site 3 consists of an approximately 850-foot long main ravine on the north side of the valley with moderate erosion. The ravine receives drainage from an 18-inch corrugated metal pipe from Creekwood Drive. The pipe conveys discharge from a pond on the north side of Creekwood Drive. There are several headcuts along the ravine, but no severe slope failures. A sand deposit is present at the bottom of the ravine (see [Figure 4.6](#) and [Figure 4.7](#)).

Figure 4.6 Headcut Followed by Sand Deposit in Lower Part of Ravine (Site 3)

Review condition and design of storm sewer pipe from Creekwood Drive. Review design of pond outlet and provide extended detention outlet to reduce the frequency and magnitude of the high flows, if necessary. Provide energy dissipation at pipe outlet and grade control stabilization in the eroded ravine. Evaluate existing vegetation and thin trees where possible to provide greater sunlight to ground vegetation.

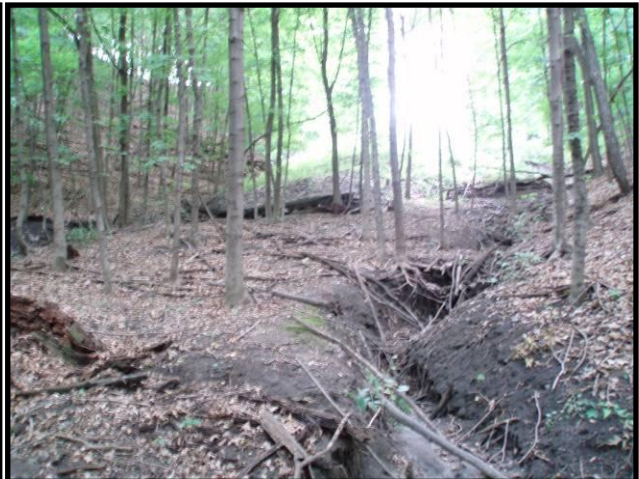
Figure 4.7 Headcutting in the Upper Part of the Ravine (Site 3)

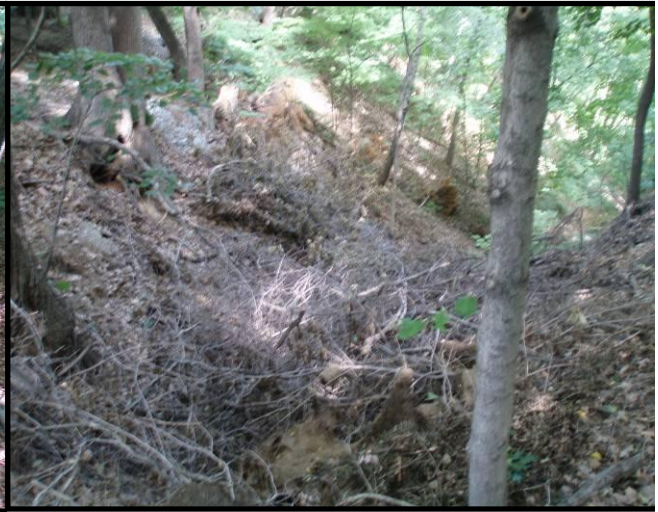
Site 9 consists of an approximately 400-foot long ravine on the south side of the valley with minor erosion. The ravine originates about 30-feet north of Hesse Farm Road and has a small tributary watershed. Although it is very steep, there is only minor erosion evident in this ravine (see [Figure 4.18](#) and [Figure 4.19](#)).

Figure 4.19 Yard waste dumping in ravine (Site 9)

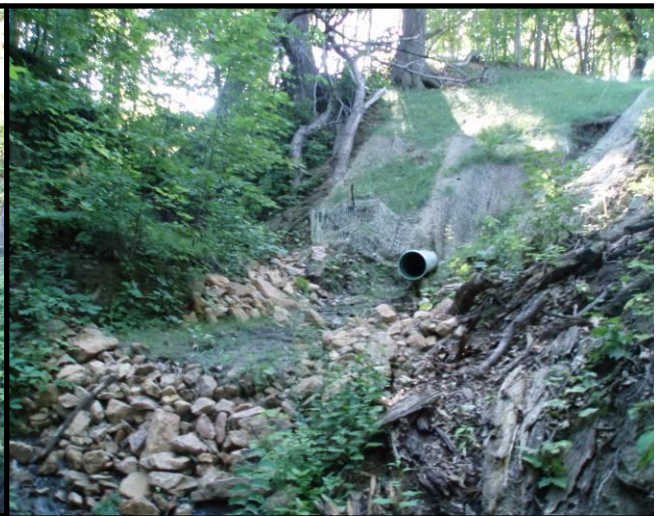
Site 15 consists of an approximately 1,000-foot long ravine on the east side of the valley with severe erosion in the form of slope failures along the ravine. The ravine originates at the southwest perimeter of the Bluff Creek golf course and conveys local drainage from the golf course. The head of the ravine is split, and each side is advancing into the golf course. A new 12-inch plastic drain pipe has been installed in the east branch of the split in an attempt to curb the erosion, with fill and geotextile placed in the eroded ravine. A gully has formed in the fill material, however. A path crosses the ravine with a bridge, but the bridge abutments will soon be affected by the erosion. The lower part of the ravine is older and more stable, with a well-developed channel carrying flow to Bluff Creek (see [Figure 4.30](#) and [Figure 4.31](#)).

Figure 4.31 New pipe outlet from golf course (Site 15)

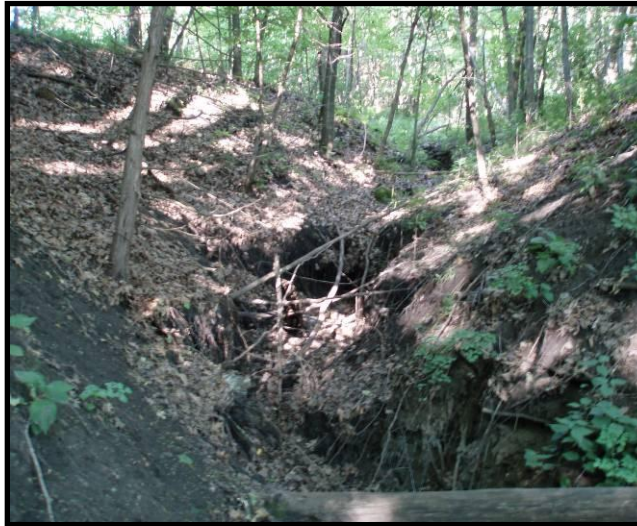
Site 17 consists of an approximately 380-foot long ravine on the east side of the valley with moderate erosion. The head of the ravine originates at the same hobby farm as site 13, with yard waste present. Some headcutting is evident, especially near the top and bottom of the ravine. The middle portion is relatively stable (see [Figure 4.34](#) and [Figure 4.35](#)).

Figure 4.34 Some headcutting present at the head of the ravine (Site 17)

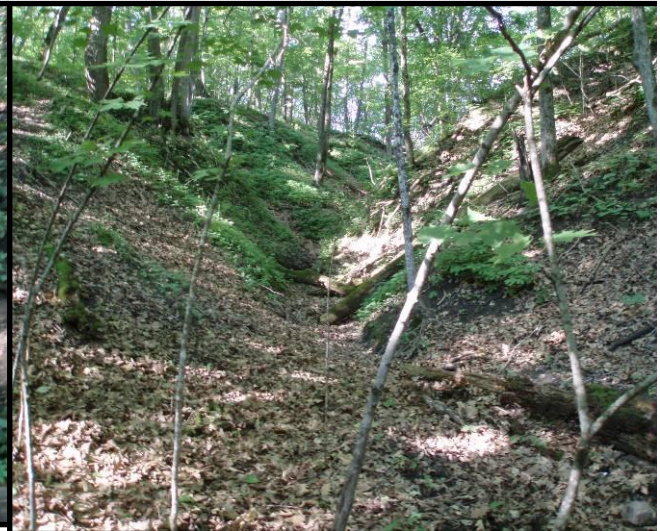
Figure 4.35 Stable middle portion of ravine (Site 17)

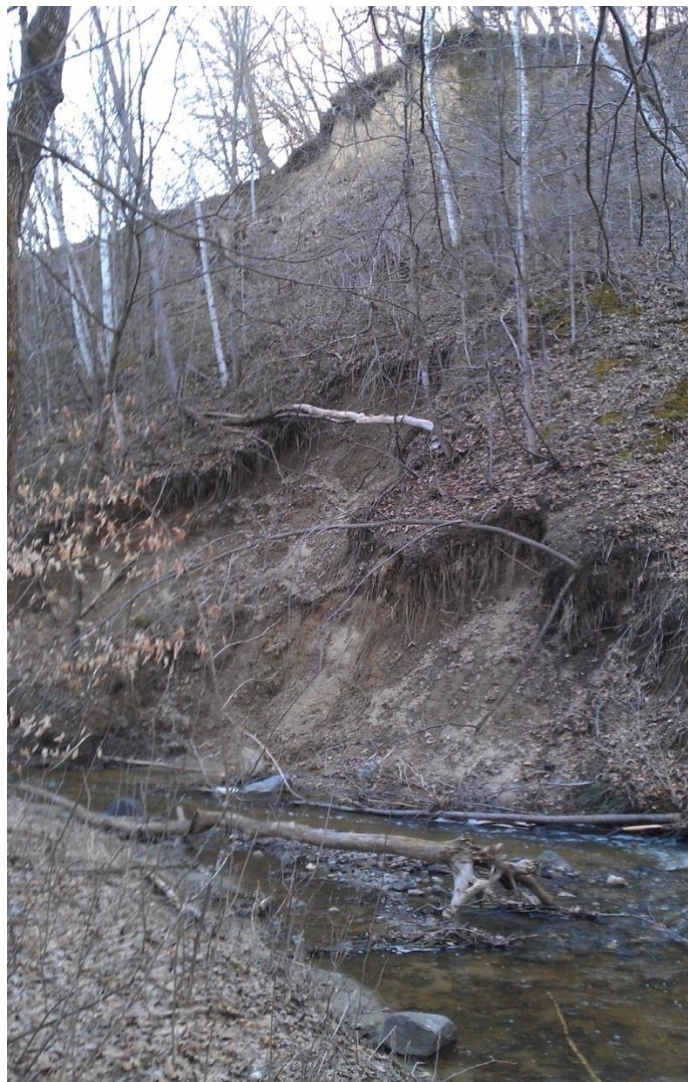
The Bluff Creek stream channel itself was re-examined for unstable areas during the spring of 2013. Much of the lower reach of the stream was observed to be stable, although some segments of downcutting and bank erosion were observed, including 18 main channel scarps were that were identified (and indicated by site number 23 on Figure 4.1). Main channel scarps (such as the example site shown in Figure 4.43) represent a significant source of sediment since the Bluff Creek flow is actively eroding higher banks (typically between 10 to 40 feet high) located outside of the natural floodplain (where bank heights are typically less than 10 feet).

Figure 4.43 Example of main channel scarp along Bluff Creek

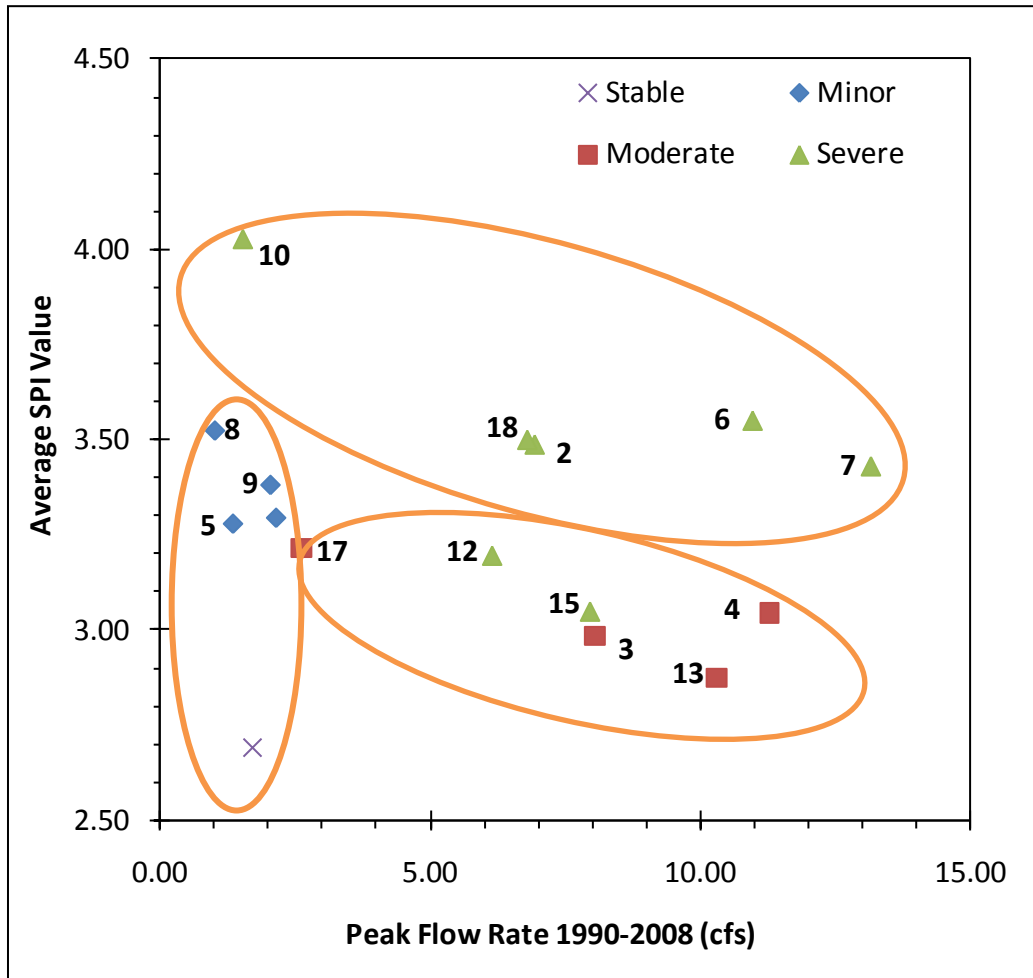
modeled peak flow rates with comparable SPI values than both ravines with minor or stable erosion. On average, ravines surveyed as having severe erosion had both higher SPI values and modeled peak flow rates than the ravines surveyed with minor or stable erosion and higher SPI values than those surveyed as having moderate erosion. The results show the importance of minimizing flow volume and runoff rates within the areas tributary to each ravine. It is expected that peak flow rates will need to be comparable to those observed in the stable channels or channels with minor erosion to ensure that stabilized ravine channels will not contribute excess sediment to Bluff Creek.

Figure 4.45 Ravine stability comparison between the modeled peak flow rates in each ravine and the average of the top 5% SPI values shown in Table 4.1.
