Appendix B

Variability in the 100-year 24-hour Inundation Areas

100-YEAR INUNDATION EXTENTS
 Purgatory Creek Watershed
 Riley Purgatory Bluff Creek
 Watershed District

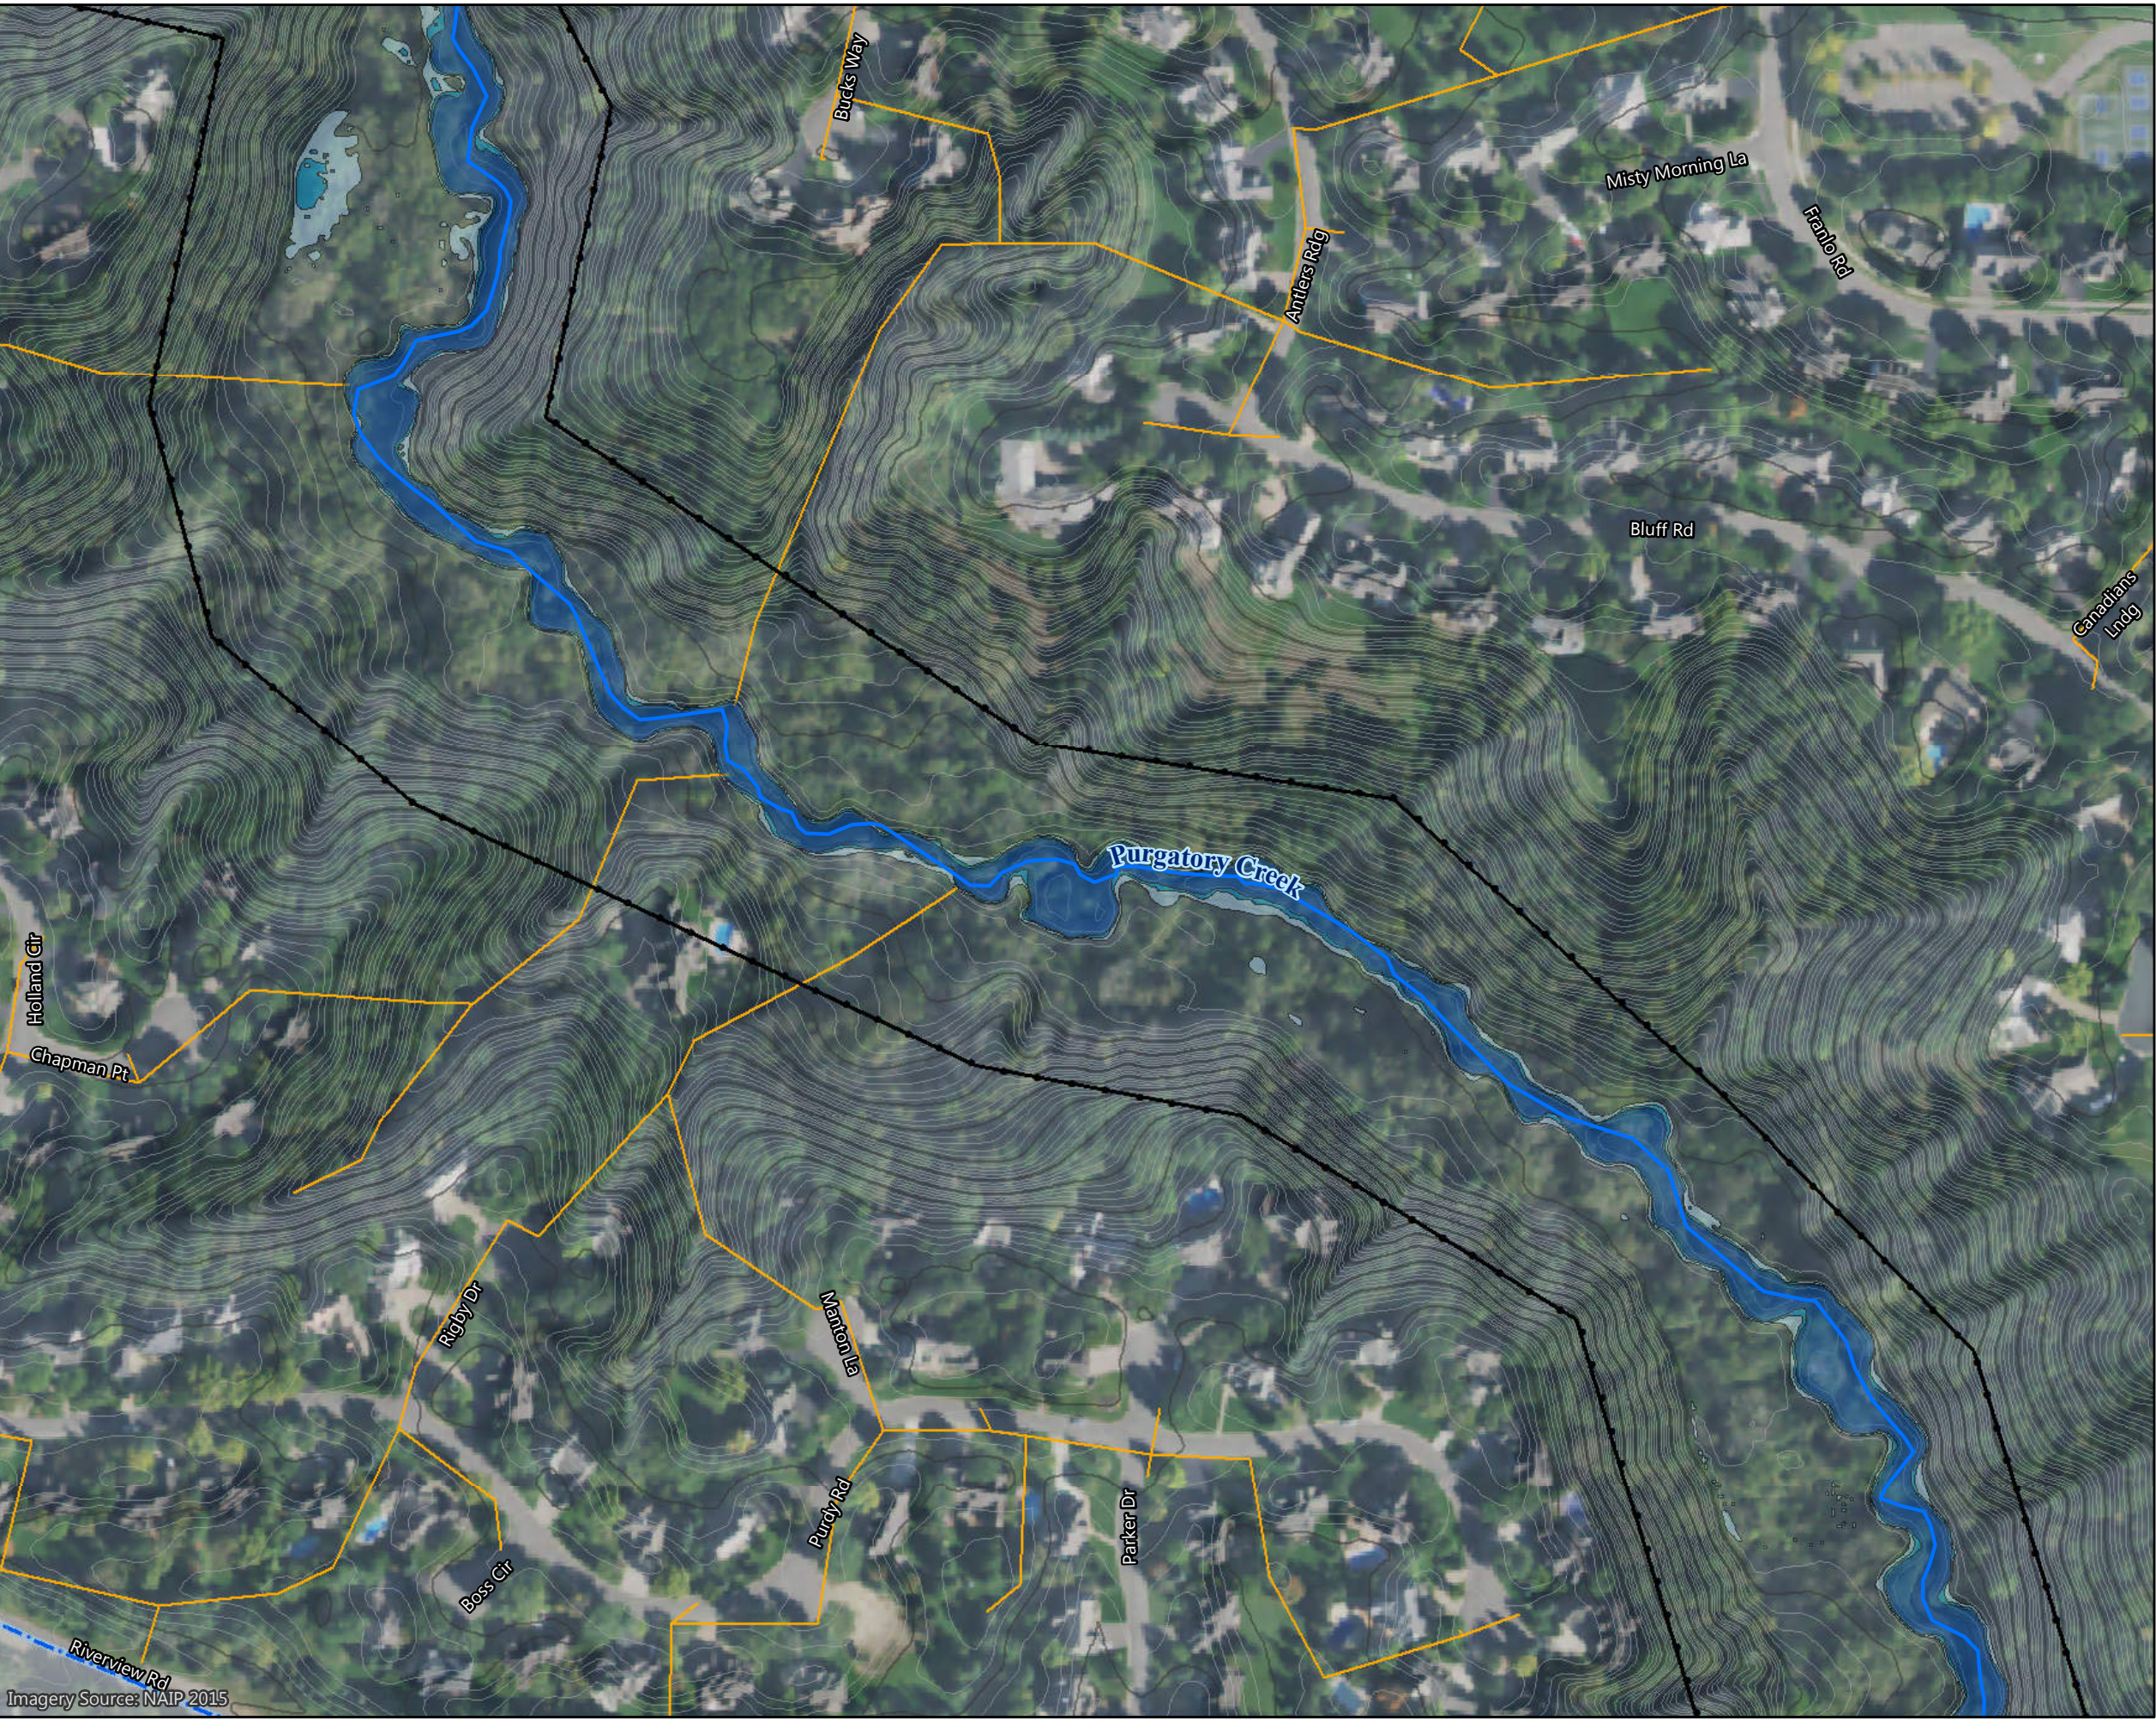
Figure B-P2

- Structure Potentially Inundated During a:**
- 5.5-inch rainfall event¹
 - 7.4-inch rainfall event²
 - 10.0-inch rainfall event³
- Creek Crossing Potentially Overtopped During a:**
- 5.5-inch rainfall event¹
 - 7.4-inch rainfall event²
 - 10.0-inch rainfall event³
 - No Impact
- Modeled Inundation Extents Resulting from:**
- 5.5-inch rainfall event¹
 - 7.4-inch rainfall event²
 - 10.0-inch rainfall event³
 - ⊕ Extent of Inundation Mapping
 - ~ Creek
 - ⊕ Creek Watershed Boundary
 - ~ Storm Sewer
- Surface Contours**
- ~ 10-Foot Contour
 - ~ 2-Foot Contour
- ¹Atlas 14 100-year 24-hour 5% confidence limit
²Atlas 14 100-year 24-hour 50% confidence limit
³Atlas 14 100-year 24-hour 95% confidence limit

100-YEAR INUNDATION EXTENTS
 Purgatory Creek Watershed
 Riley Purgatory Bluff Creek
 Watershed District

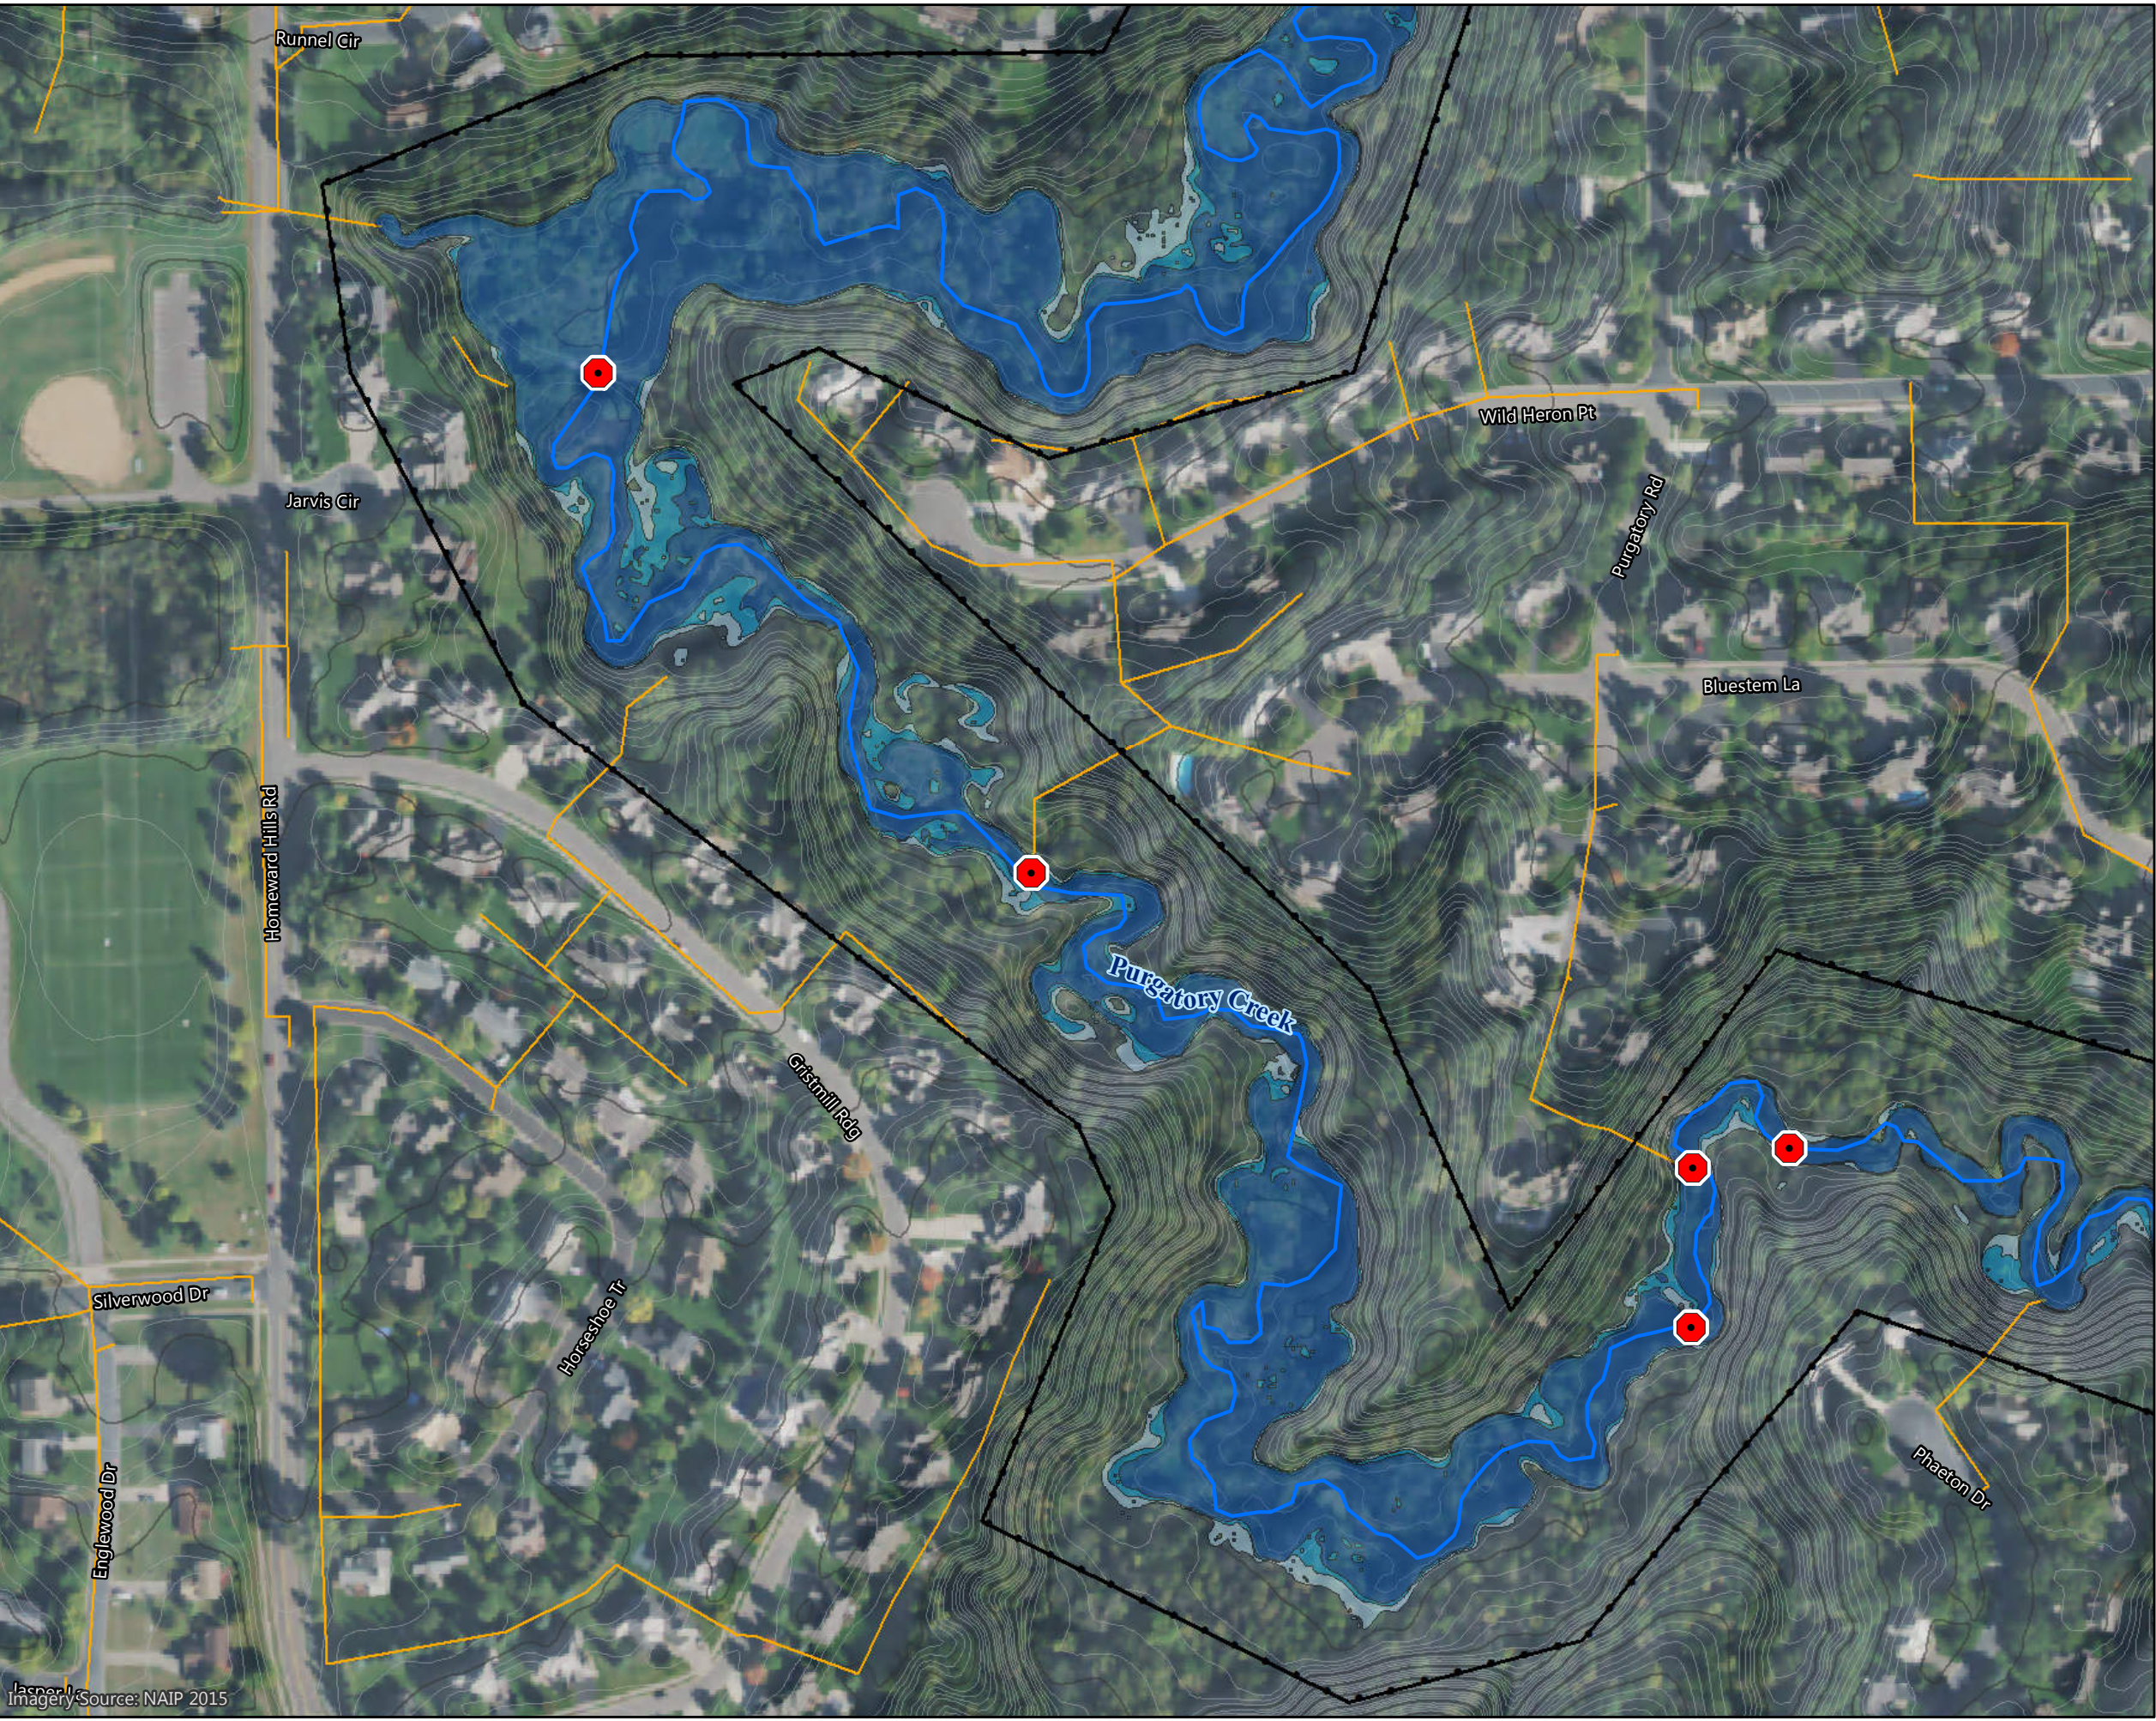
Figure B-P4

- Structure Potentially Inundated During a:
- 5.5-inch rainfall event¹
 - 7.4-inch rainfall event²
 - 10.0-inch rainfall event³
- Creek Crossing Potentially Overtopped During a:
- 5.5-inch rainfall event¹
 - 7.4-inch rainfall event²
 - 10.0-inch rainfall event³
 - NoImpact
- Modeled Inundation Extents Resulting from:
- 5.5-inch rainfall event¹
 - 7.4-inch rainfall event²
 - 10.0-inch rainfall event³
 - Extent of Inundation Mapping
 - Creek
 - Creek Watershed Boundary
 - Storm Sewer
- Surface Contours
- 10-Foot Contour
 - 2-Foot Contour
- ¹Atlas 14 100-year 24-hour 5% confidence limit
²Atlas 14 100-year 24-hour 50% confidence limit
³Atlas 14 100-year 24-hour 95% confidence limit

100-YEAR INUNDATION EXTENTS
 Purgatory Creek Watershed
 Riley Purgatory Bluff Creek
 Watershed District

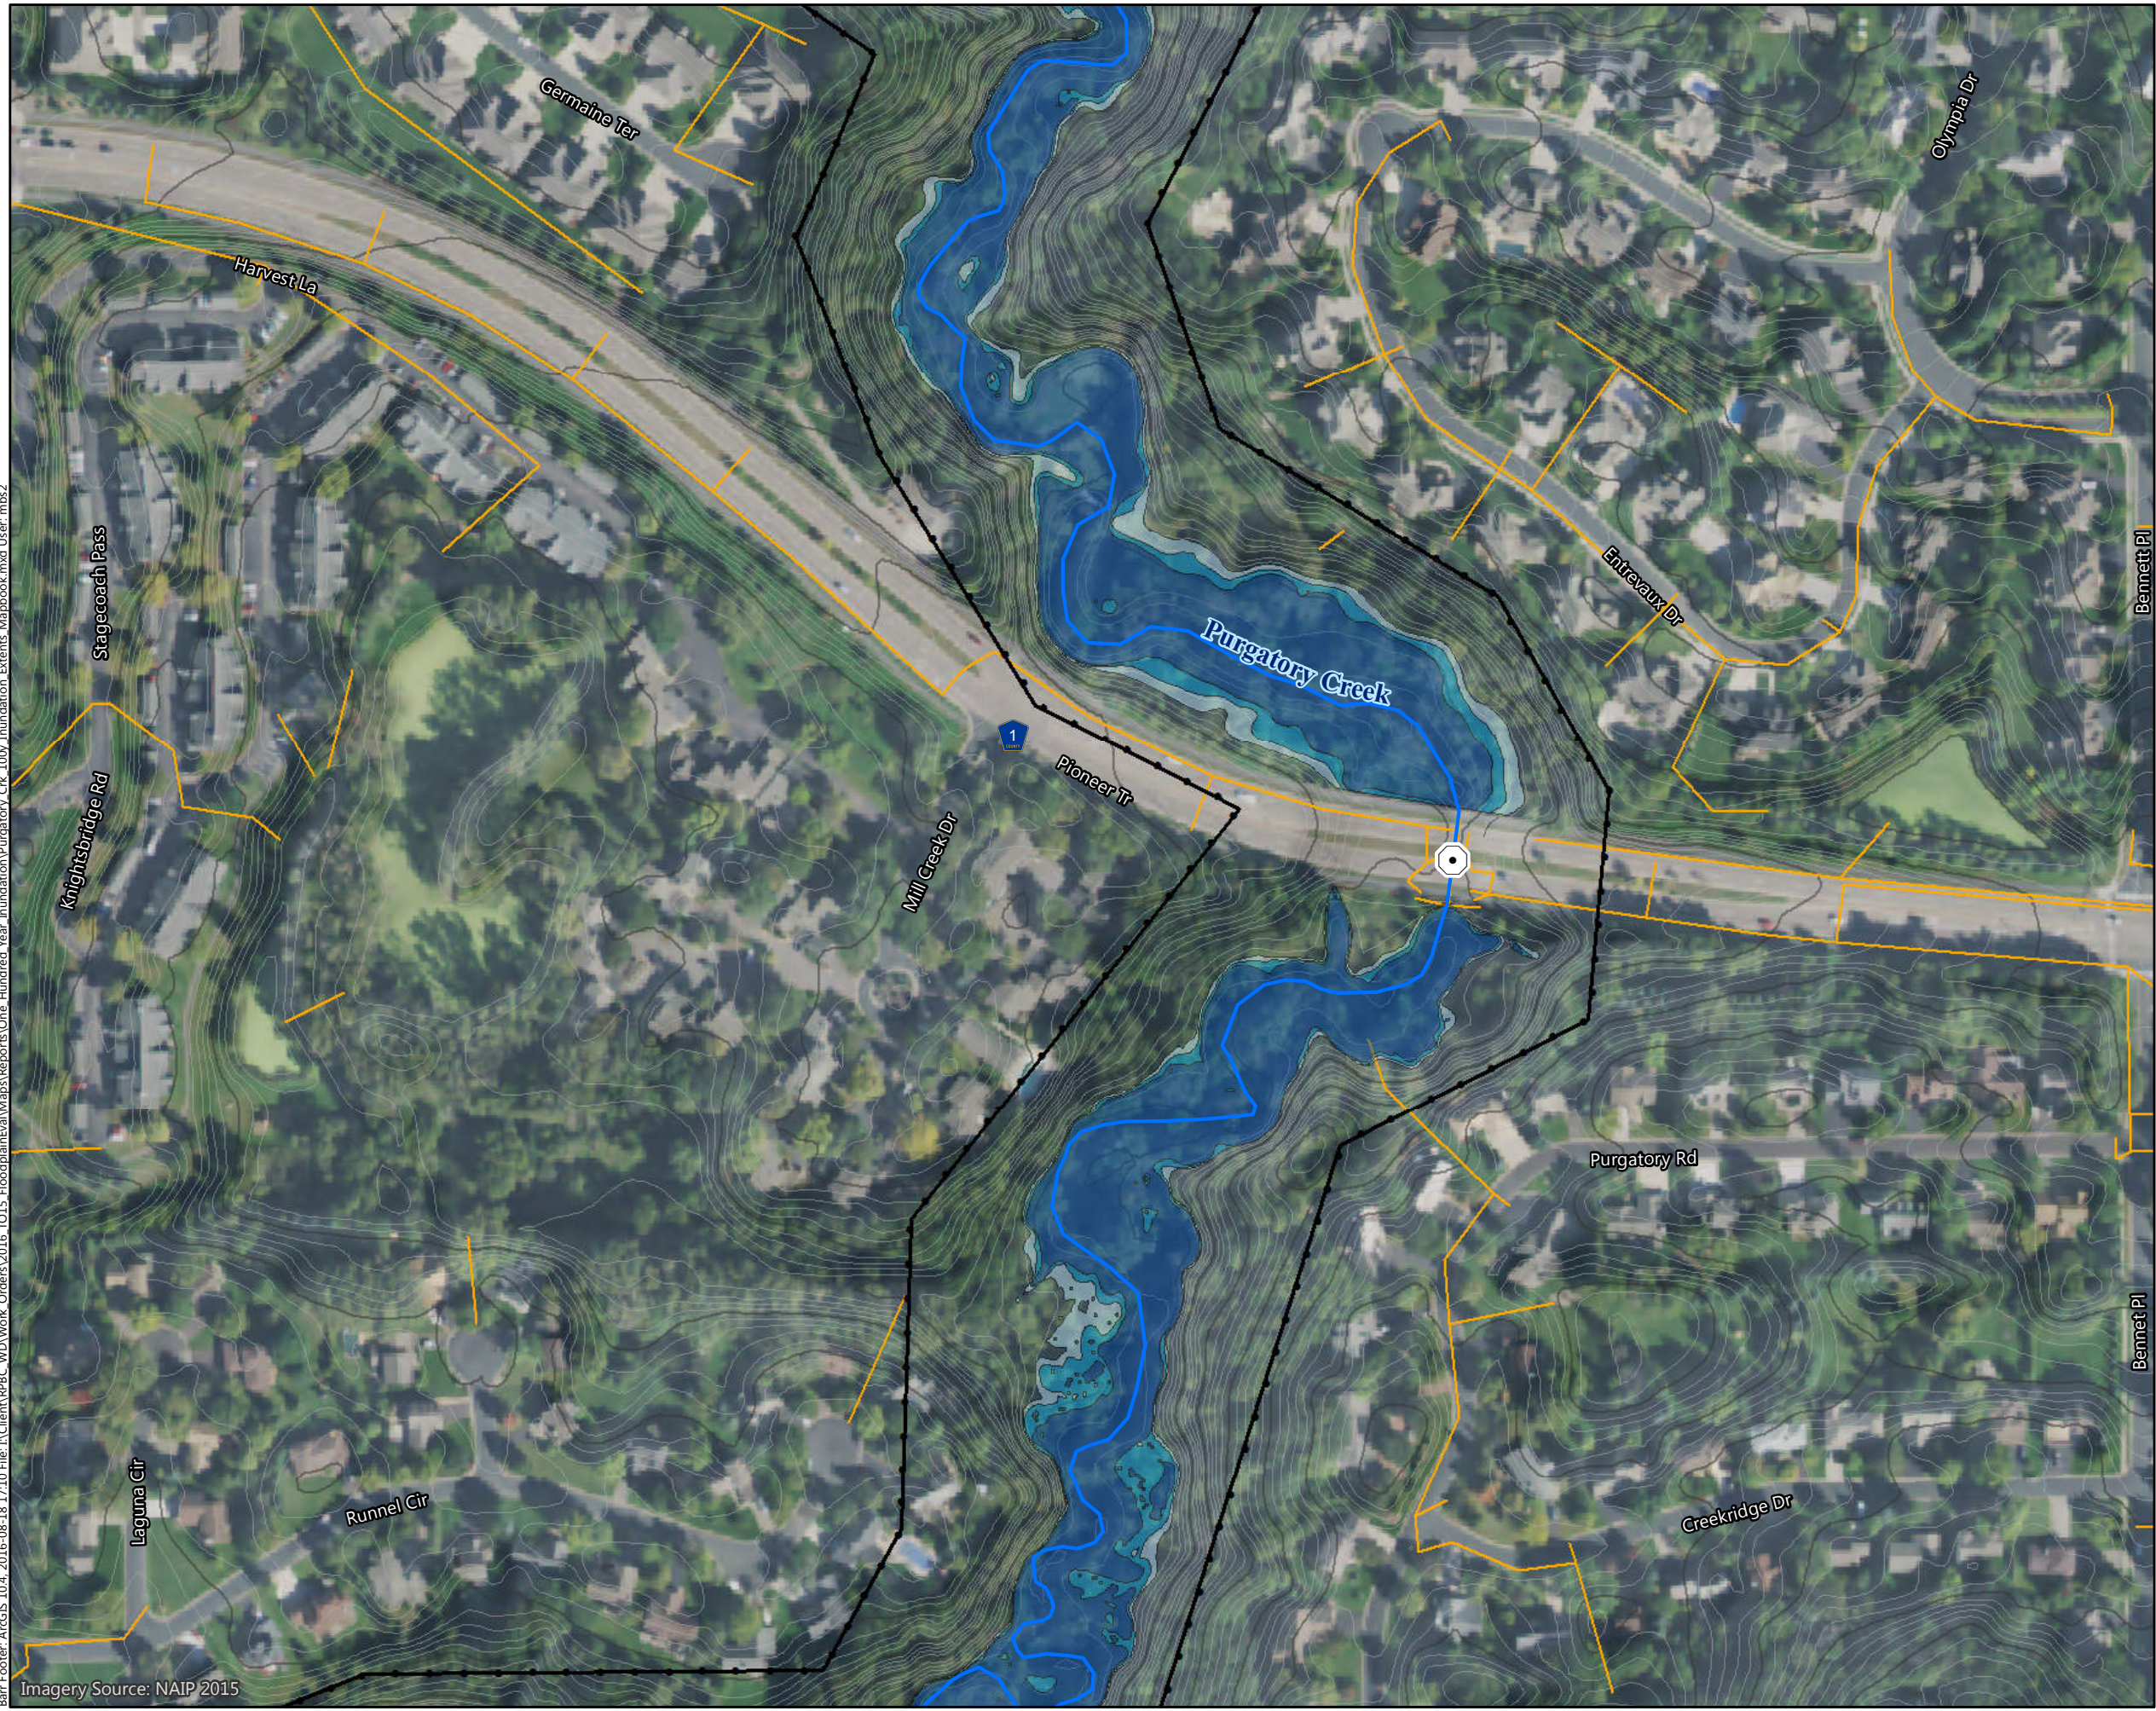
Figure B-P5

- Structure Potentially Inundated During a:
- 5.5-inch rainfall event¹
 - 7.4-inch rainfall event²
 - 10.0-inch rainfall event³
- Creek Crossing Potentially Overtopped During a:
- 5.5-inch rainfall event¹
 - 7.4-inch rainfall event²
 - 10.0-inch rainfall event³
 - No Impact
- Modeled Inundation Extents Resulting from:
- 5.5-inch rainfall event¹
 - 7.4-inch rainfall event²
 - 10.0-inch rainfall event³
 - ⊕ Extent of Inundation Mapping
 - ~ Creek
 - ⊕ Creek Watershed Boundary
 - ~ Storm Sewer
- Surface Contours
- ~ 10-Foot Contour
 - ~ 2-Foot Contour

100-YEAR INUNDATION EXTENTS
Purgatory Creek Watershed
Riley Purgatory Bluff Creek
Watershed District

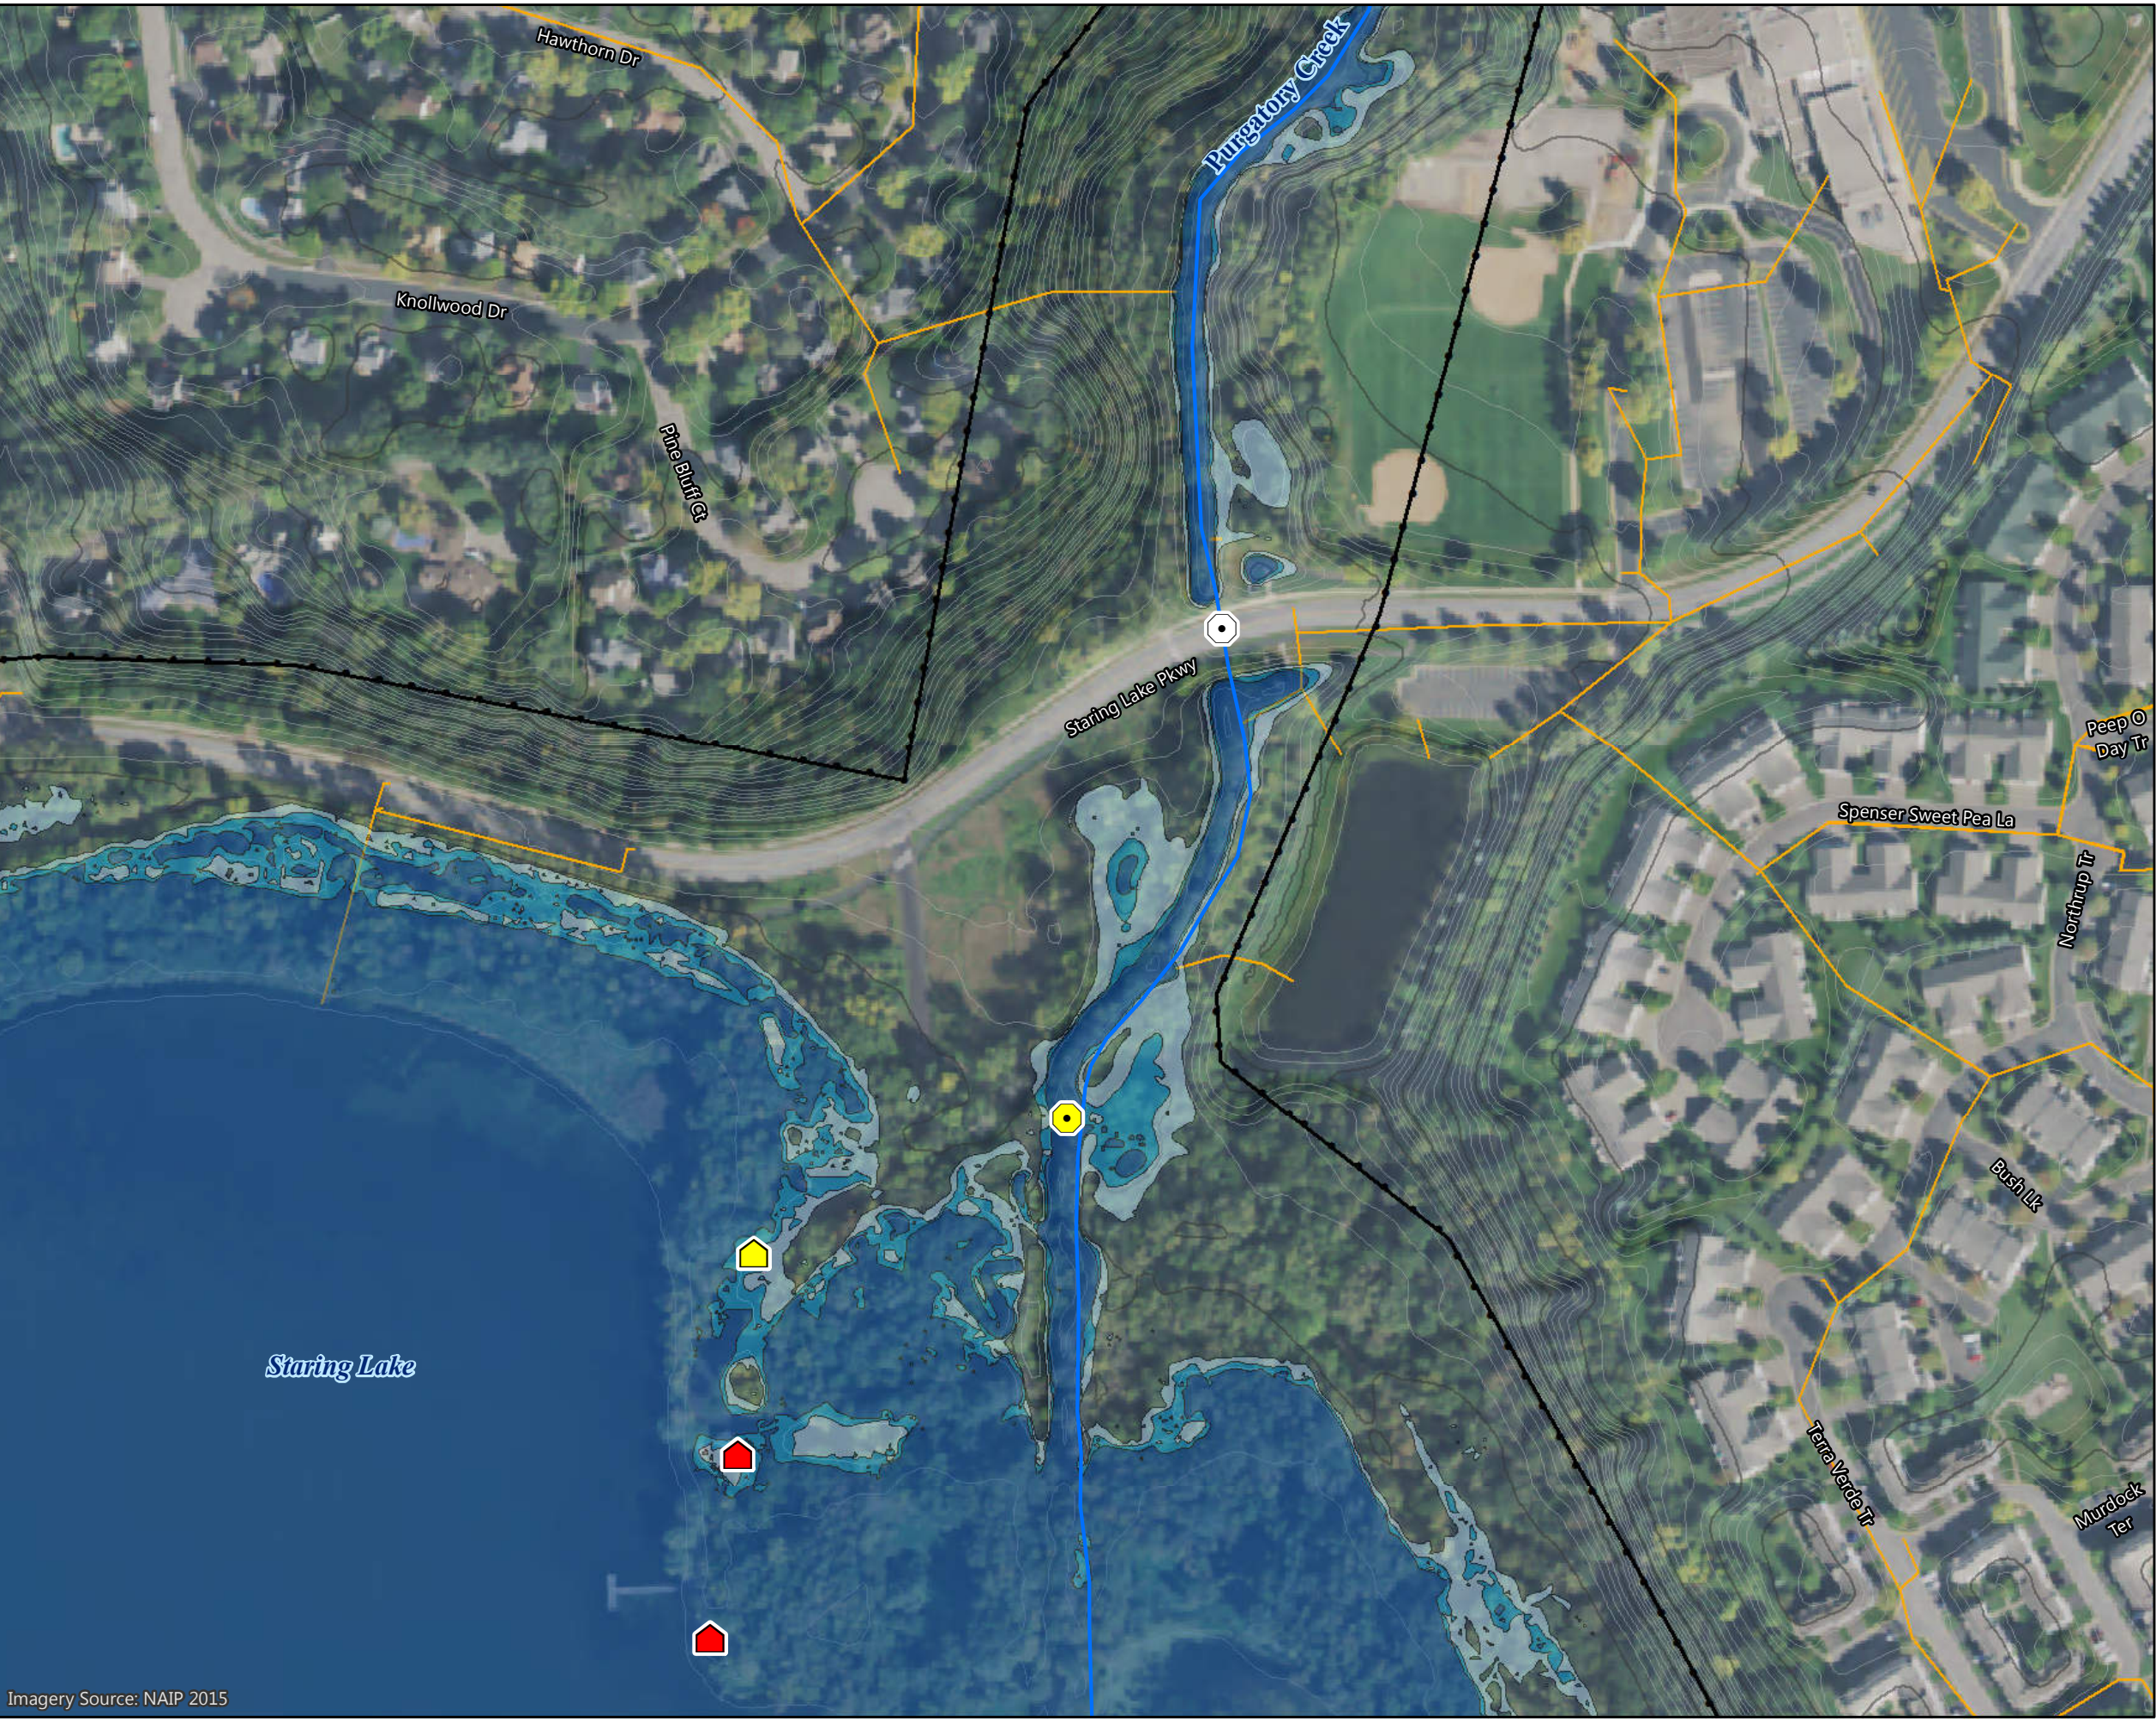
Figure B-P10

- Structure Potentially Inundated During a:
- 5.5-inch rainfall event¹
 - 7.4-inch rainfall event²
 - 10.0-inch rainfall event³
- Creek Crossing Potentially Overtopped During a:
- 5.5-inch rainfall event¹
 - 7.4-inch rainfall event²
 - 10.0-inch rainfall event³
 - No Impact
- Modeled Inundation Extents Resulting from:
- 5.5-inch rainfall event¹
 - 7.4-inch rainfall event²
 - 10.0-inch rainfall event³
 - Extent of Inundation Mapping
 - Creek
 - Creek Watershed Boundary
 - Storm Sewer
- Surface Contours
- 10-Foot Contour
 - 2-Foot Contour
- ¹Atlas 14 100-year 24-hour 5% confidence limit
²Atlas 14 100-year 24-hour 50% confidence limit
³Atlas 14 100-year 24-hour 95% confidence limit

100-YEAR INUNDATION EXTENTS
Purgatory Creek Watershed
Riley Purgatory Bluff Creek
Watershed District

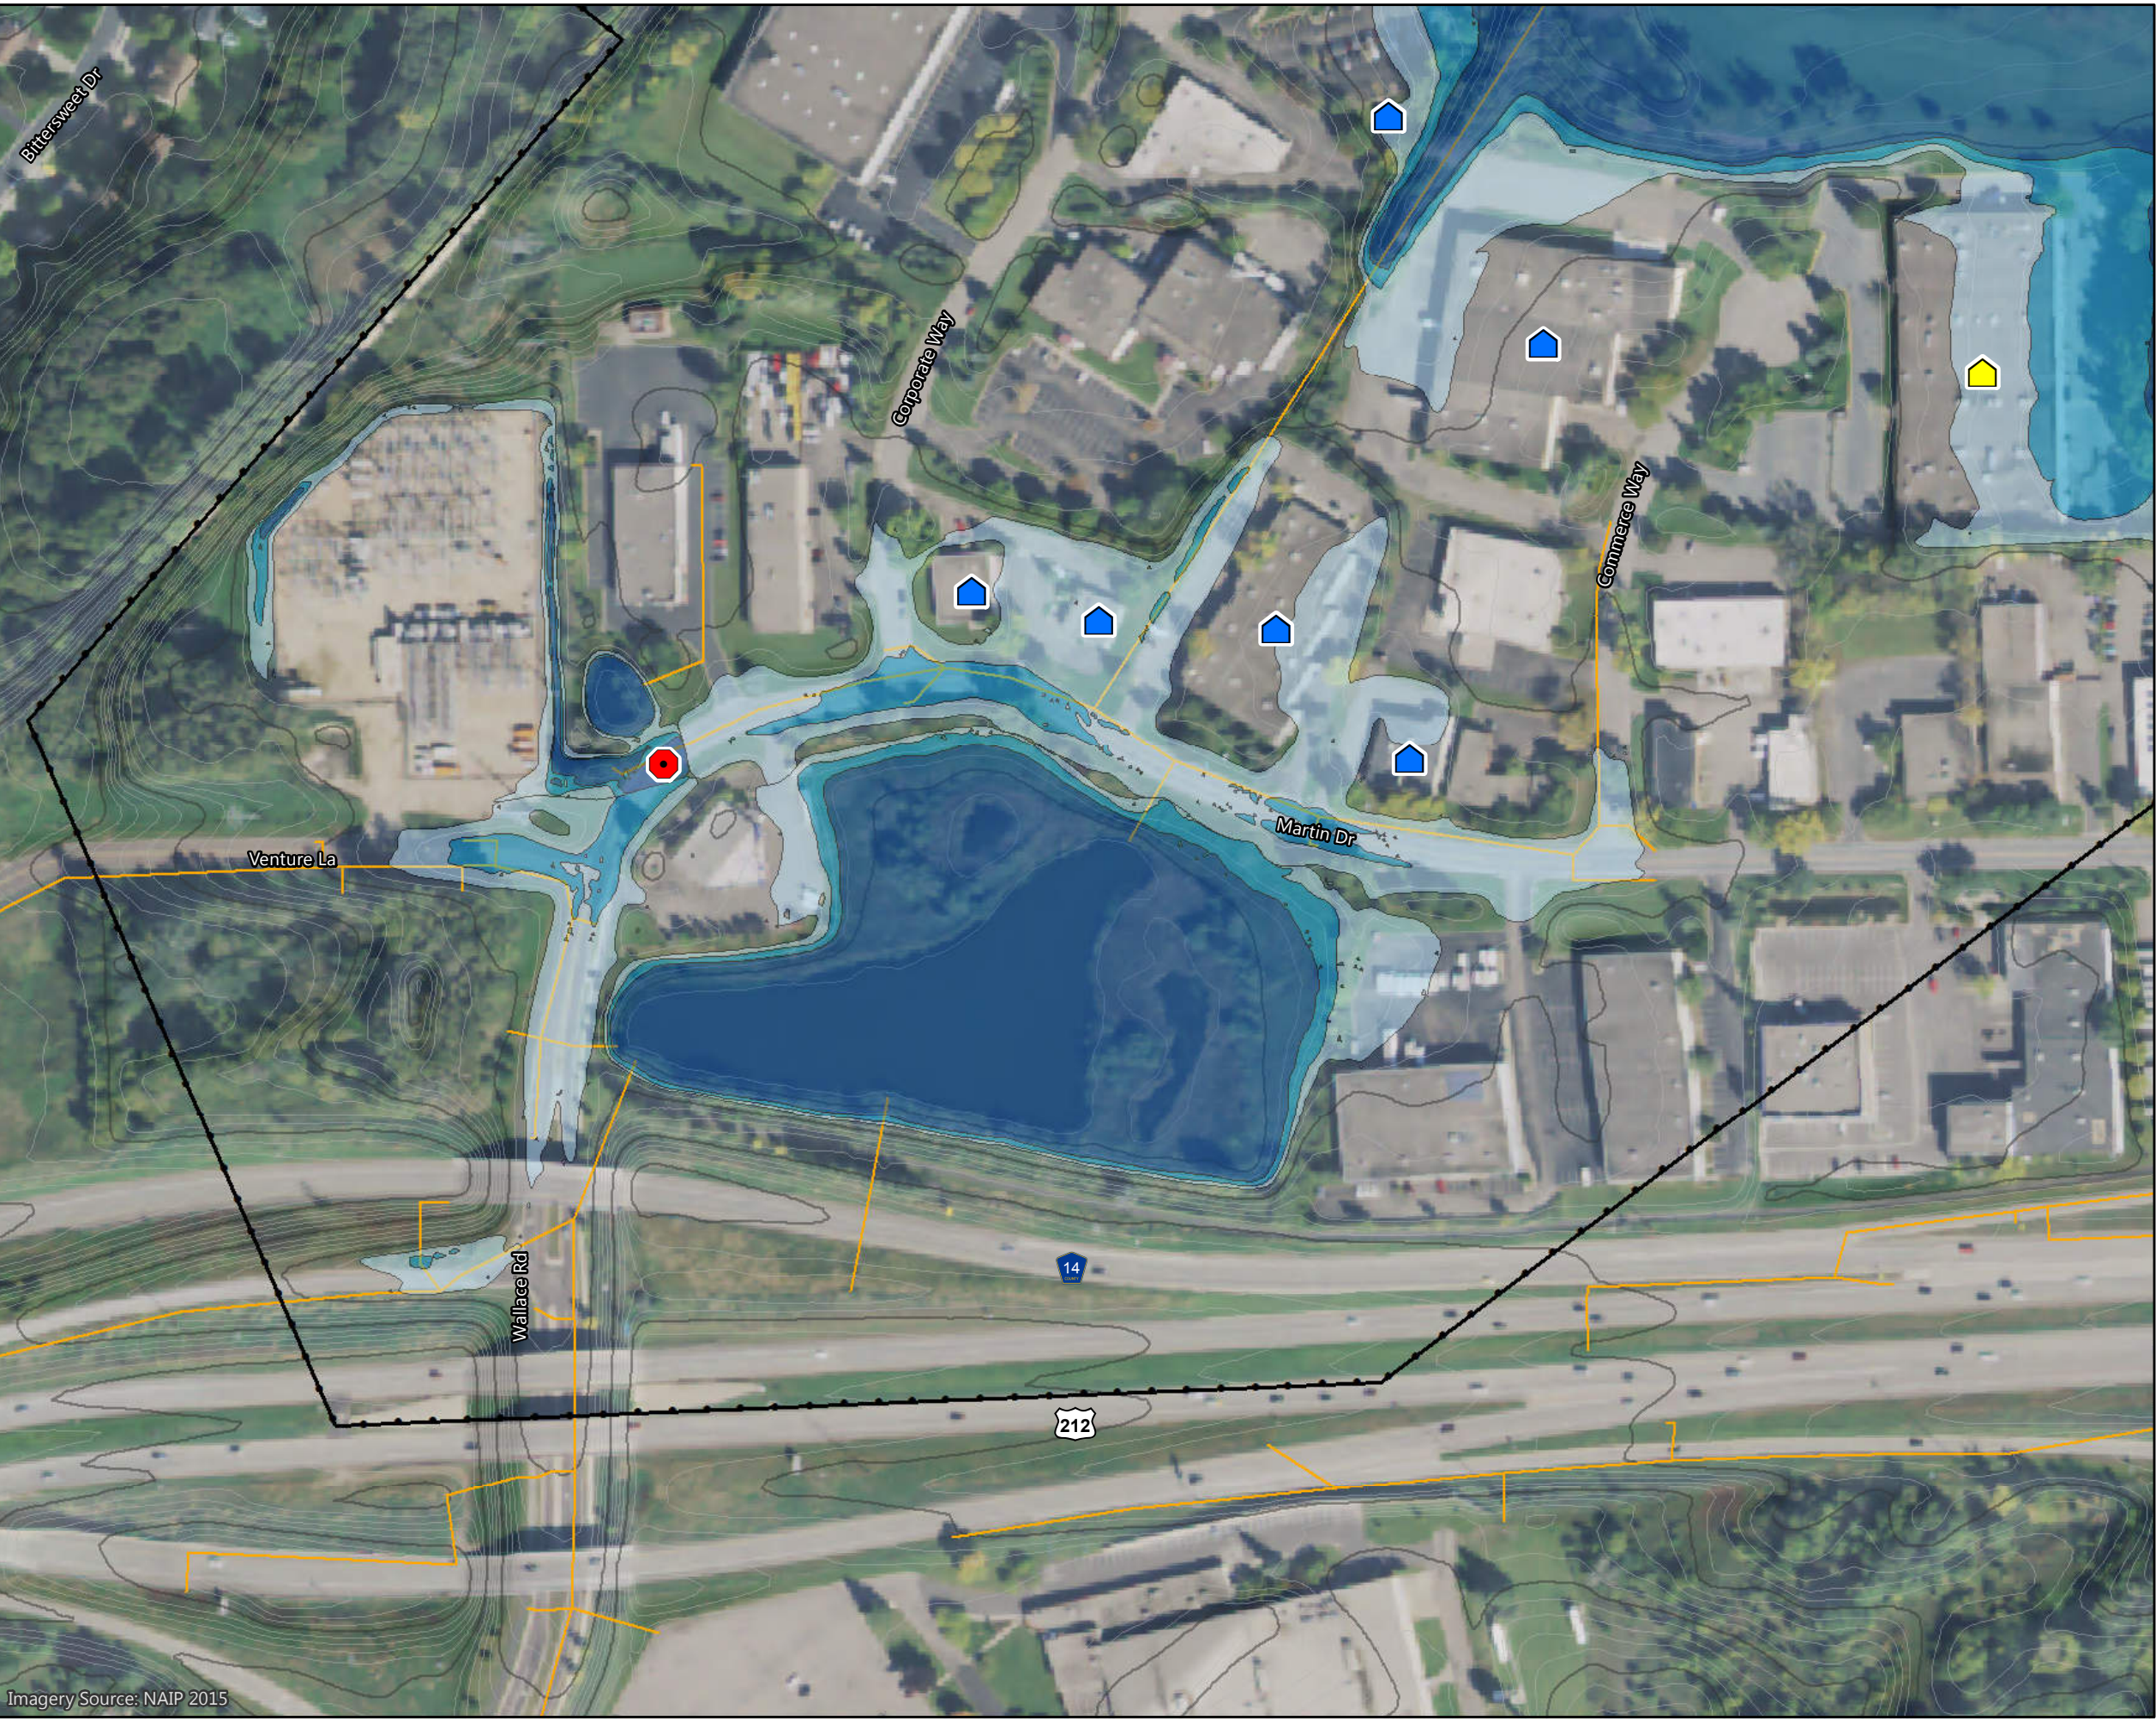
Figure B-P16

- Structure Potentially Inundated During a:
- 5.5-inch rainfall event¹
 - 7.4-inch rainfall event²
 - 10.0-inch rainfall event³
- Creek Crossing Potentially Overtopped During a:
- 5.5-inch rainfall event¹
 - 7.4-inch rainfall event²
 - 10.0-inch rainfall event³
 - No Impact
- Modeled Inundation Extents Resulting from:
- 5.5-inch rainfall event¹
 - 7.4-inch rainfall event²
 - 10.0-inch rainfall event³
 - ⊕ Extent of Inundation Mapping
 - ~ Creek
 - ⊕ Creek Watershed Boundary
 - Storm Sewer
- Surface Contours
- ~ 10-Foot Contour
 - ~ 2-Foot Contour
- ¹Atlas 14 100-year 24-hour 5% confidence limit
²Atlas 14 100-year 24-hour 50% confidence limit
³Atlas 14 100-year 24-hour 95% confidence limit

100-YEAR INUNDATION EXTENTS
 Purgatory Creek Watershed
 Riley Purgatory Bluff Creek
 Watershed District
