# Annual Report 2022

The Riley Purgatory Bluff Creek Watershed District (RPBCWD or the District) is a local government unit established on July 31, 1969, to protect, manage, and restore water resources. It encompasses some 50 square miles of land that drains into any of the three creeks in its name. The District includes parts of seven cities (Bloomington, Chanhassen, Chaska, Deephaven, Eden Prairie, Minnetonka, and Shorewood) and two counties (Carver and Hennepin).

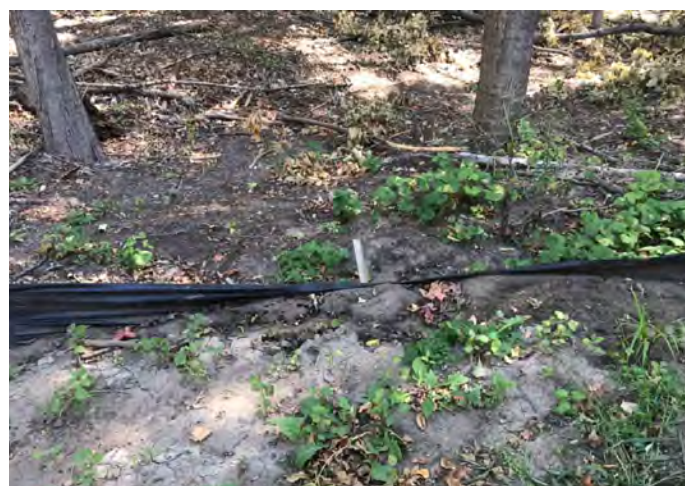
*District staff inspect project sites and direct permit holders to take corrective actions as needed to protect water quality. The image above shows a silt fence violation (failure) at a site in 2022.*

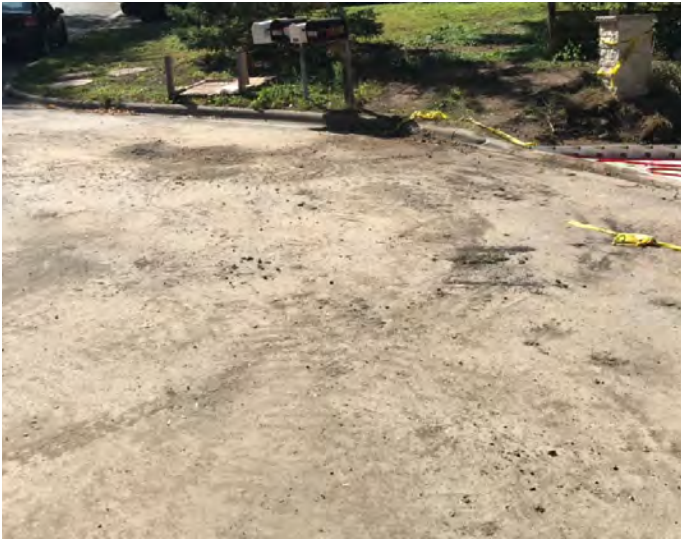
*The image above shows tracking of sediment onto a street from a 2022 construction site, which violates District permit rules.*

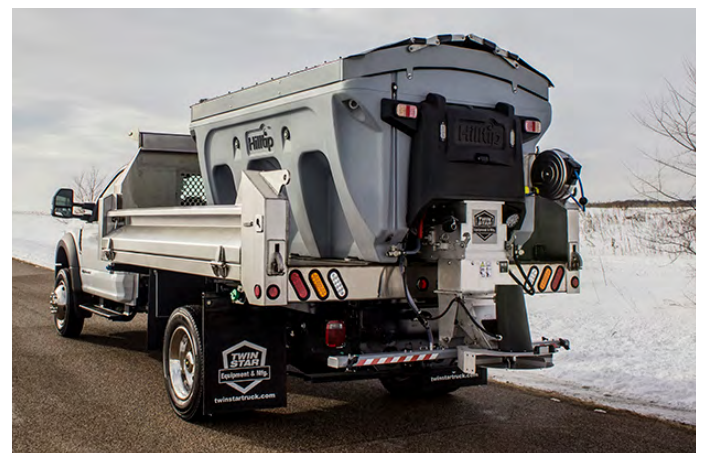
Eden Prairie Independent School District #272 used Chloride Reduction Grant Funds to replace two outdated salt spreaders with more advanced equipment that can be calibrated to conditions and ultimately reduce salt use.

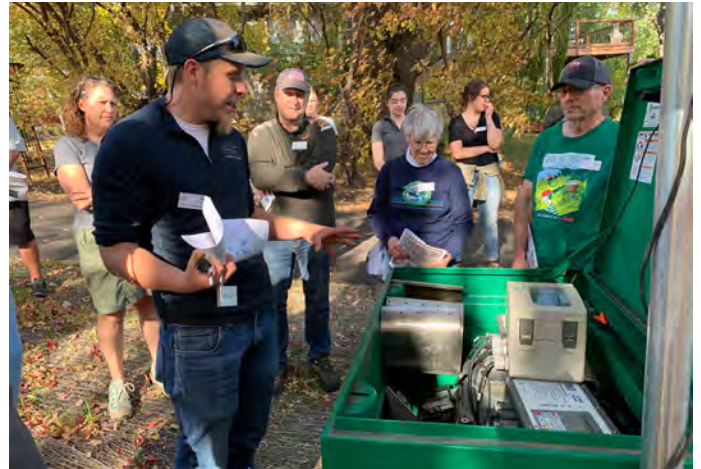
Josh Maxwell, Water Resources Coordinator, explains operation of the automated sampling unit for the Kraken filtration units for the Rice Marsh Lake Stormwater Management Project (Stop 3).

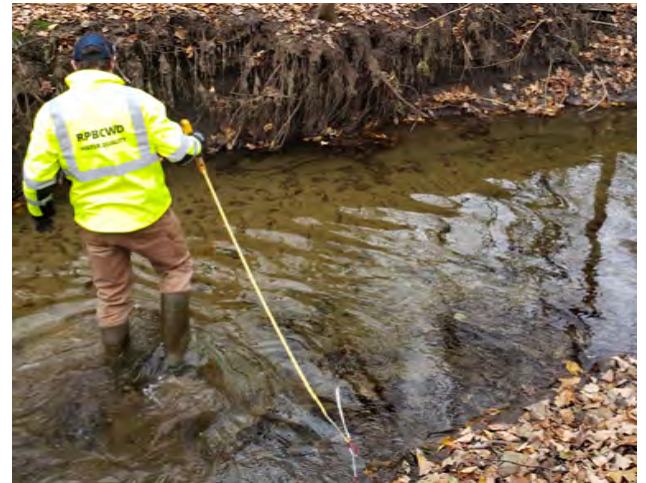
Staff pulls measuring tape across stream to measure width.

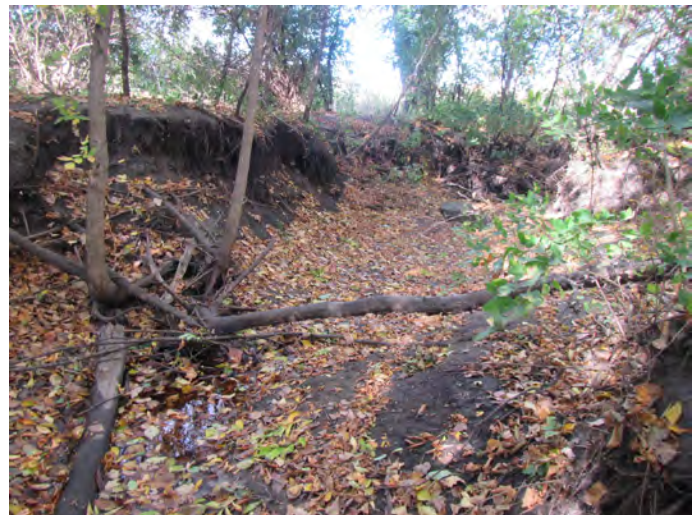
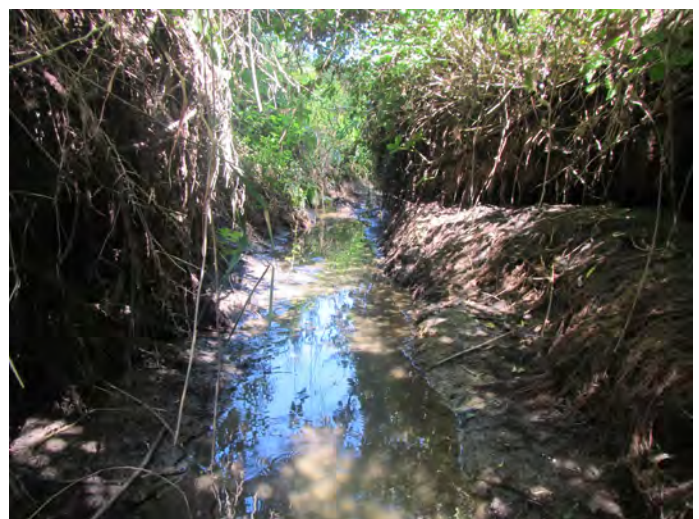
Images of eroding banks and incised channel of Riley Creek - Reach 4 (R4) from 2022.

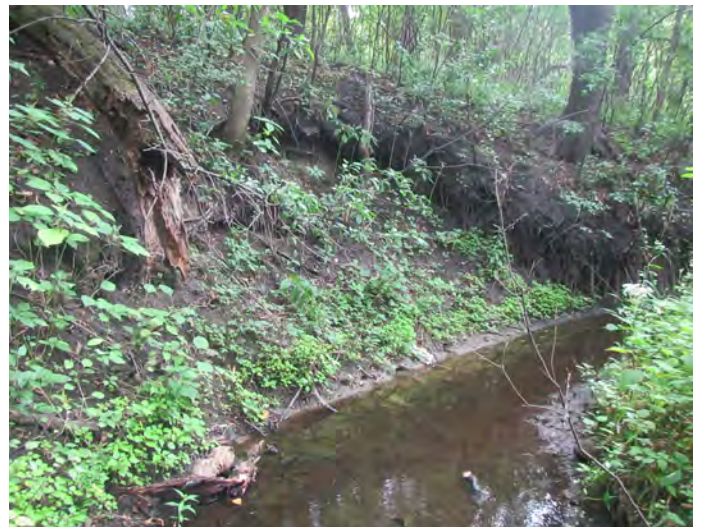
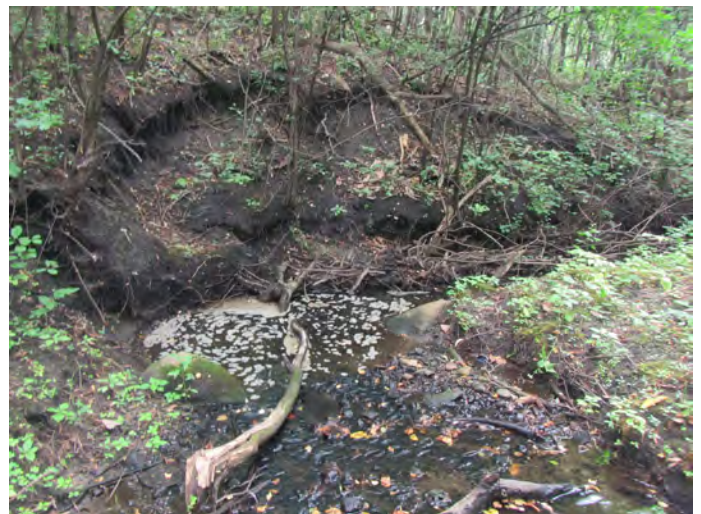
Images of eroding banks and incised channel of Bluff Creek - Reach 5 (B5) from 2022.

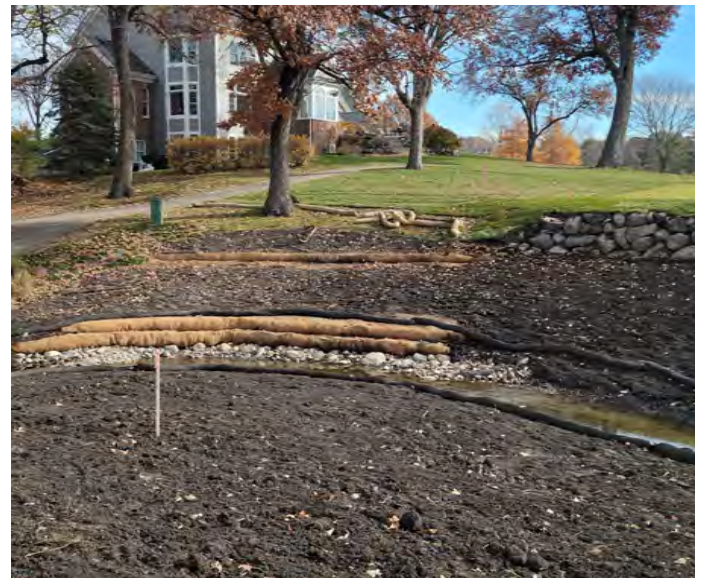
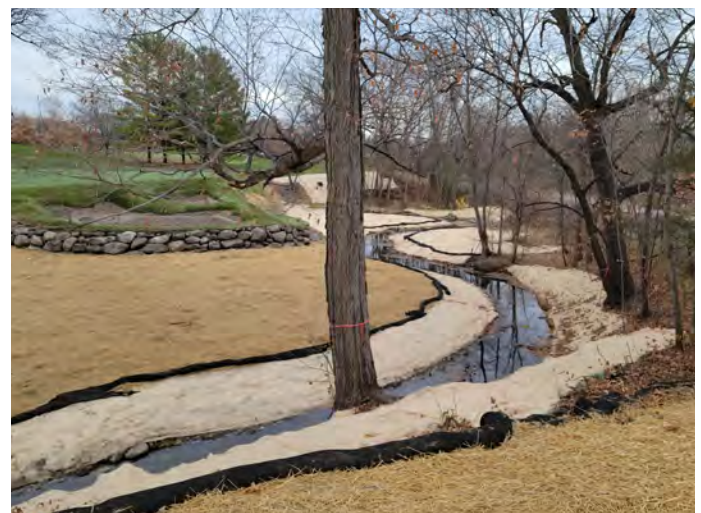
Re-meandering and bank stabilization of Riley Creek within Bearpath Golf and Country Club in November 2021.

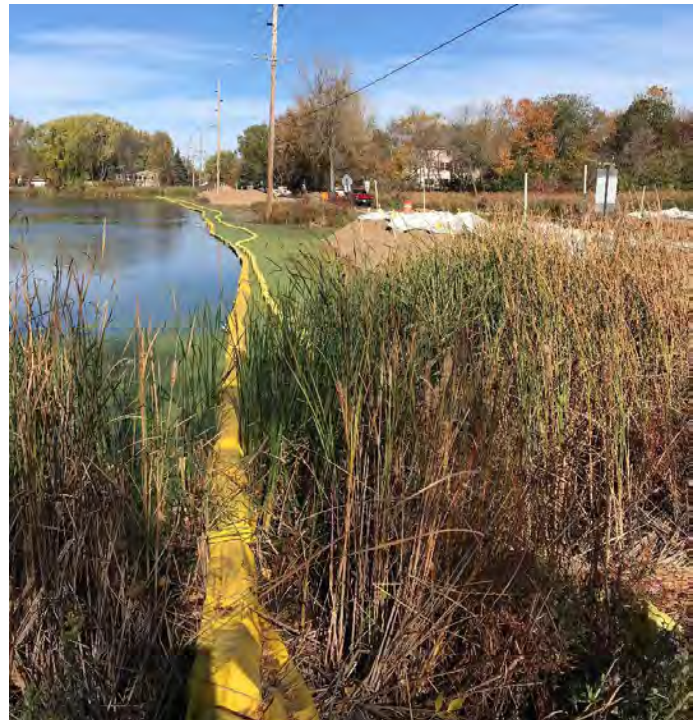
*A double row of yellow silt curtains in the water protect the lake from the Duck Lake Road construction zone (fall 2021).*

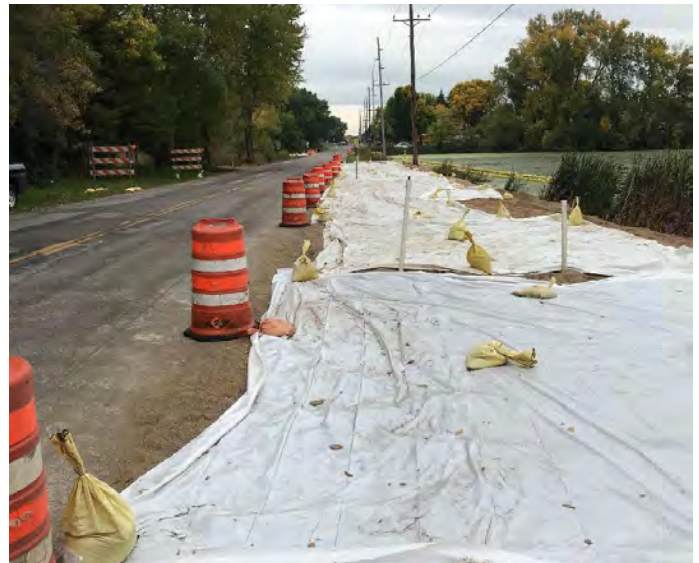
*Covering exposed soils during road work reduces the risk of erosion into Duck Lake (fall 2021).*

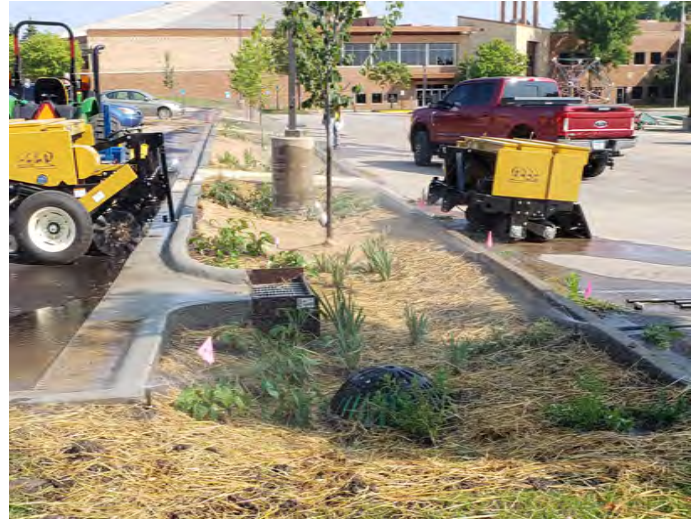
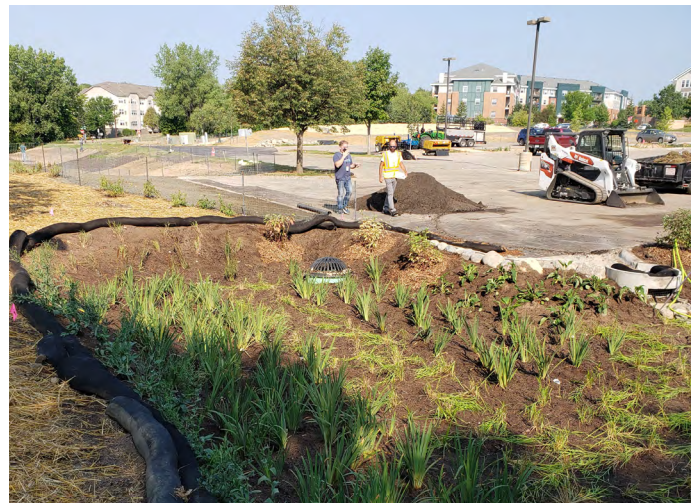
Photos taken during the installation of the St. Hubert Opportunity Project.
