Creek Restoration Action Strategy – Upper Riley Creek Sediment Source Assessment

Chanhassen, MN

Prepared for
Riley Purgatory Bluff Creek Watershed District

April 2017

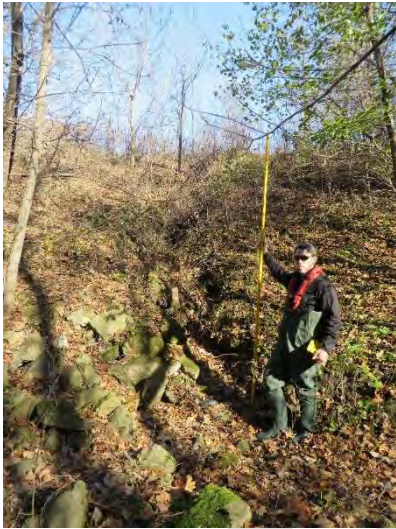
IMG-0185
Drainage
from road
causing small
ravine
erosion

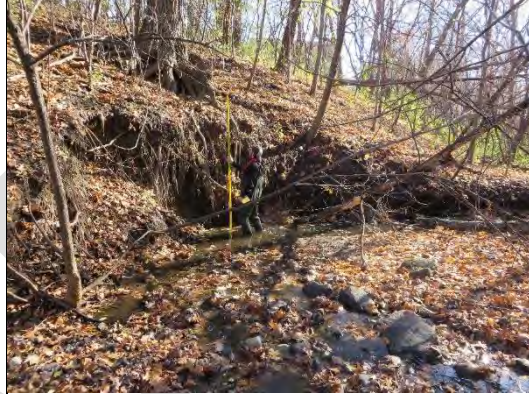
IMG-0186
Outside bend
erosion on
left bank,
2.2m by 8m

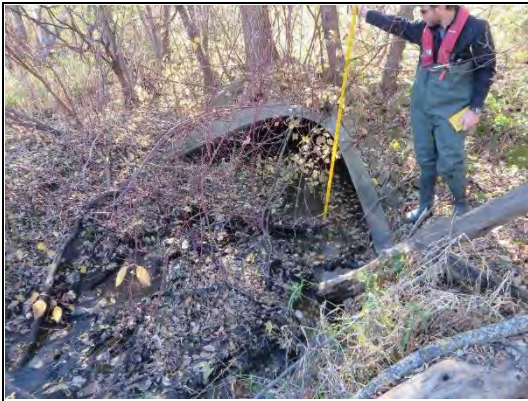
At the start of Reach 4, subreach B, the culvert under Park Drive was approximately 40% filled with sediment (IMG_0204). Facing downstream from Park Drive the banks are densely covered with herbaceous vegetation and graminoids with very sparse woody debris present (IMG_0205). Additionally, some of the surrounding vegetation was comprised of cattails and minor ponding was seen within the riparian zone (IMG_0206). The surrounding slopes were very low with the small businesses and stormwater ponds set back approximately 20m from the right bank and 50m from the left. No overhead canopy cover was present; however, the overhanging grasses did provide some shade over the stream. Substrate near the beginning of the subreach was sand/silt, but shortly after shifted to a clay/marl material. Continuing downstream, a tributary/drainage from the business park about 25m away entered the main stream channel on the left bank (IMG_0207). The banks in this subreach were characteristic of a small prairie stream, having steep banks (vertical in places) with dimensions measuring approximately 0.9m deep by 1m wide. There was evidence of a shifting channel present in the riparian zone and some bank sloughing was occurring which was caused by uncut bank failures (IMG_0208, IMG_0209, IMG_0211).

IMG-0204
Facing upstream, culvert under Park Drive, culvert 40% filled

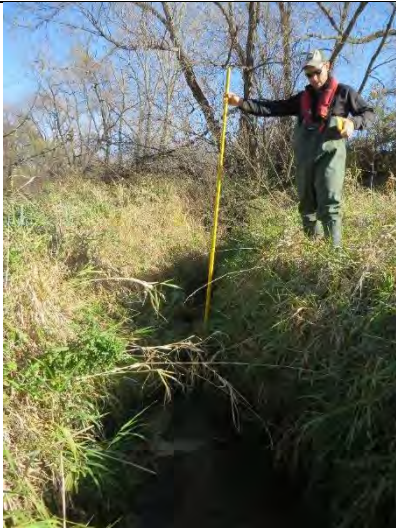
IMG-0208
Evidence of bank sloughing

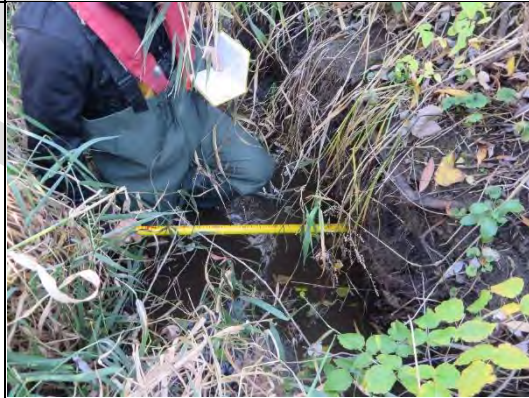
IMG-0209
Bank undercut on both sides by about 0.4m

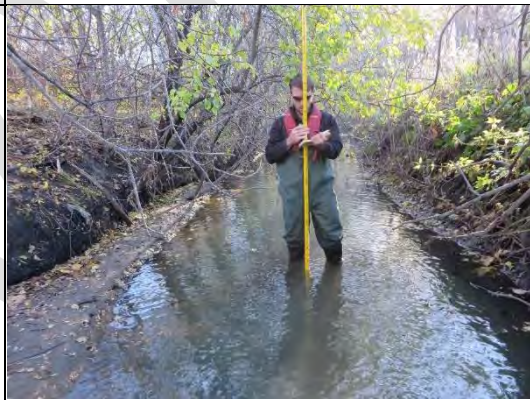
IMG-0228
Channel widens and forms long glide: 2.7m x 0.3m.

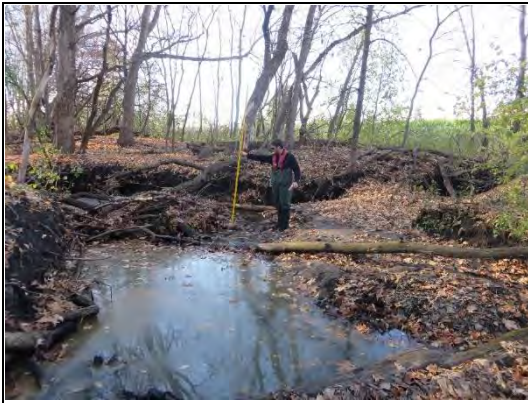
IMG-0231
Large woody debris dam

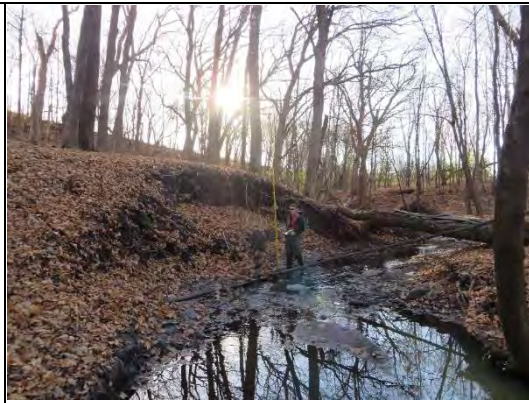
IMG-0232
Erosion on left bank measuring 2.7m by 6m wide; downed tree with wood plank bridge

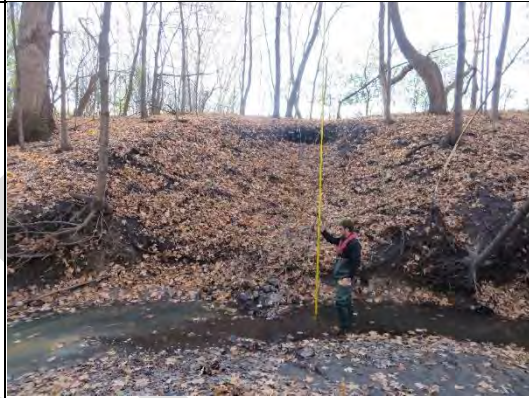
IMG-0234
Possible groundwater seepage area; causing erosion measuring 3.8m by 5m wide

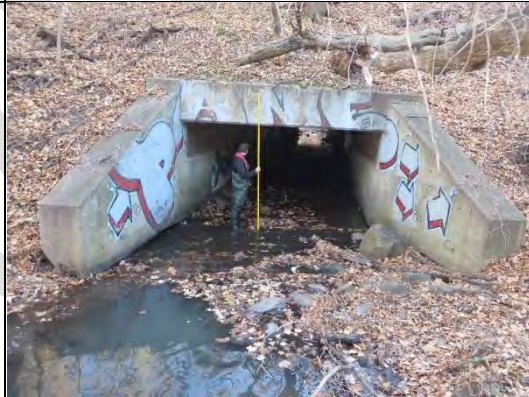
IMG-0236
Box culvert underneath the railroad bridge

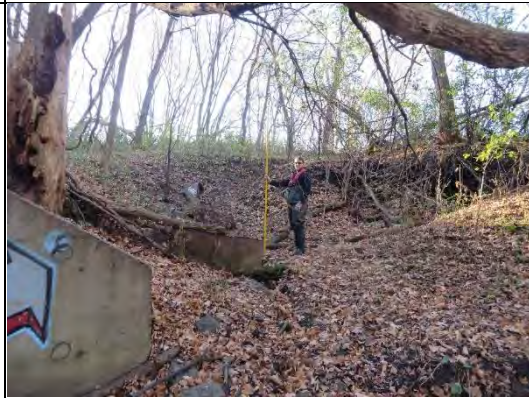
IMG-0238
Erosion from drainage on right bank; lots of dumped junk

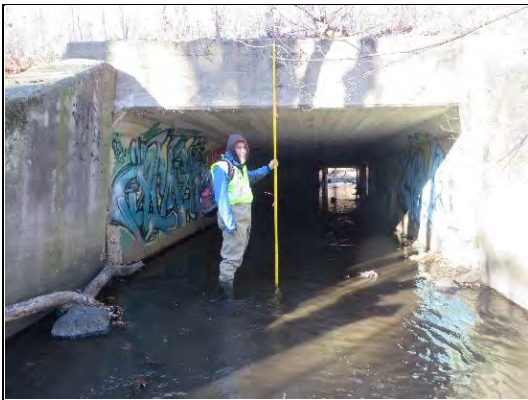
IMG-0240
Culvert under the railroad bridge (facing upstream)

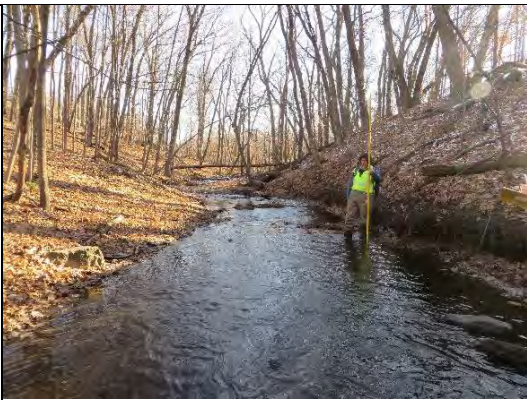
Right away there was continuous cutting along the right bank measuring about 0.5m high (IMG_0239). Moving downstream staff came upon the first woody debris/leaf litter dam which was small (IMG_0242). Early on channel development was good because of the increased flow concentrated at the culvert (IMG_0242). Gravel was present in small amounts during this stretch of the subreach, but the substrate consisted mostly of sand and silt (IMG_0246). One of the larger woody debris dams had a considerable amount of water pooling behind it (IMG_0249). Along this patch of woody debris was some deposition, as well as some erosion measuring about 2.5m tall by 6m long on the right bank (IMG_0250). Staff continued to monitor sediment types along stream; in one riffle, they observed a gravel/sand mixture (IMG_0254). Further down the stretch, a more severe patch of erosion was present on the left bank measuring 3.3m high by 9m long (IMG_0255).

IMG-0239
Cutting along right bank, about 0.5m high

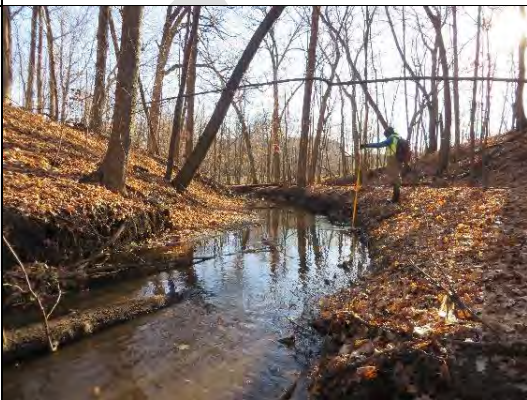
IMG-0243
Continued cutting along right bank; cutting on left bank

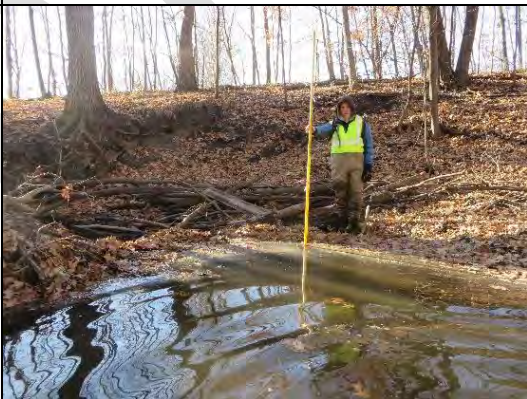
IMG-0249
Woody debris dam forming large pool; erosion on right bank

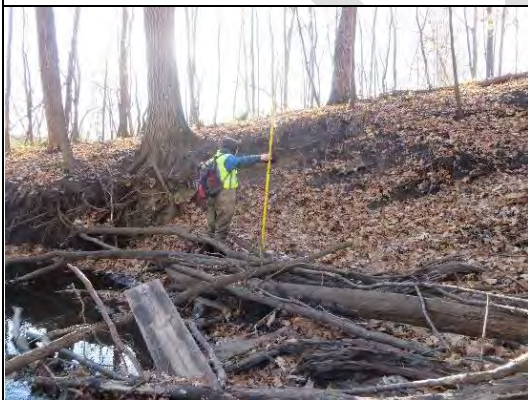
IMG-0250
Erosion 2.5m x 6m long on right bank.

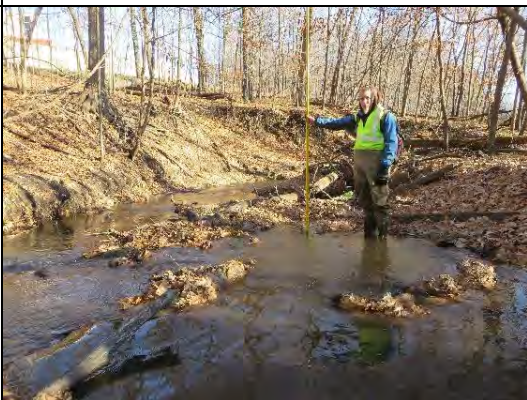
IMG-0253
Deposition and woody debris; erosion left bank

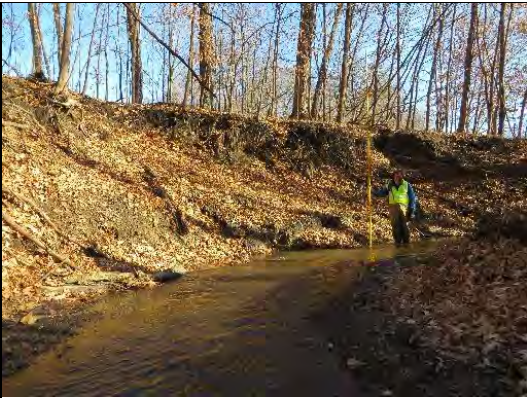
IMG-0255
Large erosion patch, 3.3m x 9m on right bank

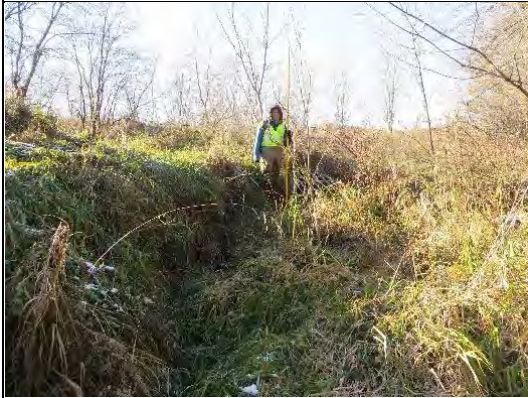
IMG-0257
Stormwater culvert channel entrance along right bank

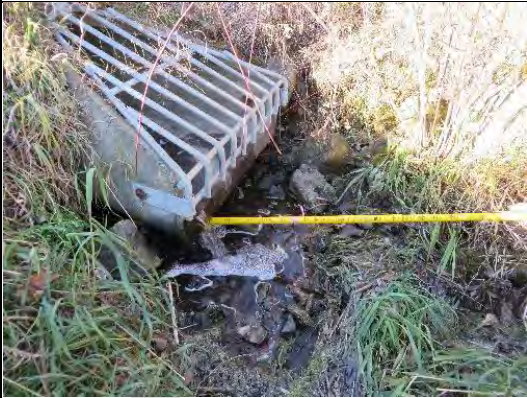
The vegetation along the banks soon shifted from patchy trees to dense herbaceous vegetation and graminoids; here the creek width and depth decreased (IMG_0259). At this point, a grated stormwater culvert was present on the right bank, which was undercut 0.6m and formed a small channel to the stream (IMG_0257 & IMG_0258). After the stormwater culvert, the right bank was experiencing a significant amount of bank sloughing (IMG_0257 IMG_0259). Soon, the vegetation composition on the banks shifted back towards patchy, woody vegetation with patchy herbaceous ground cover. The slope gradient around the stream greatly decreased by this point, to below 10%. Staff began to encounter more woody debris and deposition bars after this vegetation shift took place (IMG_0260 & IMG_0261). One deposition bar measured 3.5m long (IMG_0262). Staff also observed a short section of the right bank with 0.5m of undercutting. Another patch of erosion was present on the right bank, 1.4m high by 4m long (IMG_0261). For the rest of the subreach, staff observed continuous cutting along the right bank (IMG_0296). During this stretch, woody debris and downed trees above the stream continued to occur (IMG_0300, IMG_0306, IMG_0309). One of these occurrences created a debris dam that was holding back approximately 0.3m of water (IMG_0300). After the debris dam, there was a small stretch of stream where the left bank had continuous cutting about 0.7m high (IMG_0304). Before ending the subreach at Powers Blvd, the stream was trying to straighten by cutting through the narrow point on a small horseshoe curve (IMG_0311 & IMG_0312). The subreach ended at the culvert running underneath Powers Blvd (IMG_0315).

IMG-0258
Stormwater culvert along right bank, undercut 0.6m

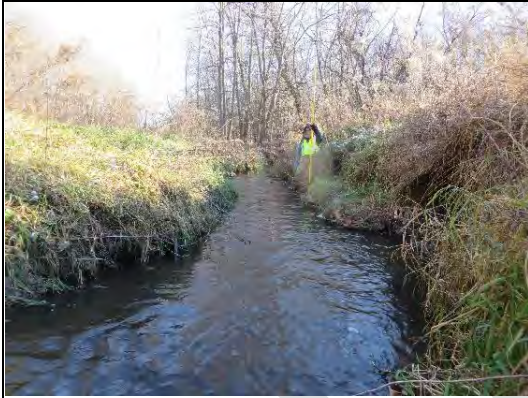
IMG-0259
Decrease in width and depth; increase in grasses; evidence of sloughing, right bank

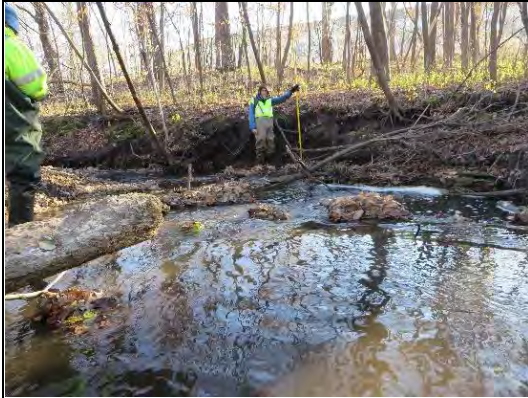
IMG-0261
Woody debris dam; erosion 1.4m x 4m long on right bank

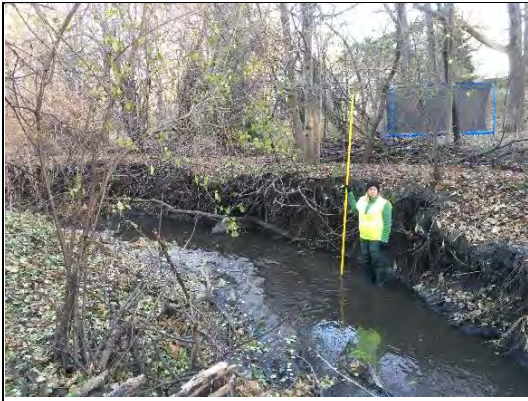
IMG-0324
Erosion on right bank measuring 1.6m by 6m long

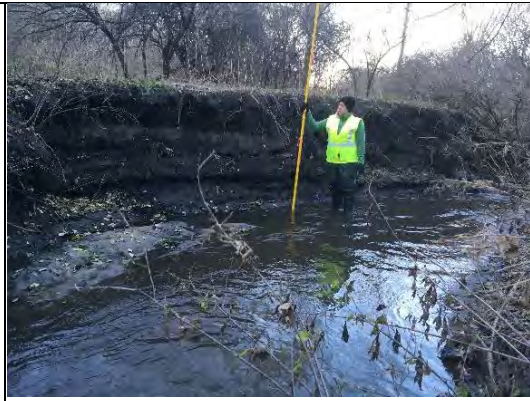
IMG-0325
Erosion 1.5m by 5m long; sand/silt deposition

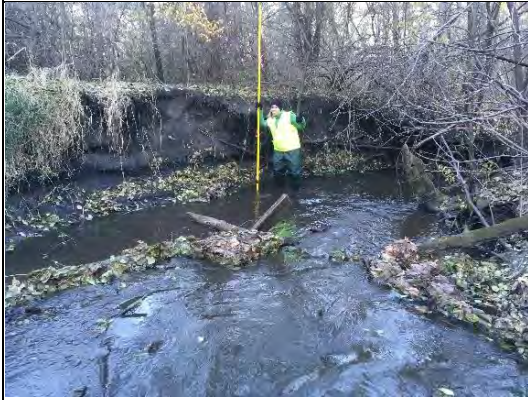
IMG-0326
Woody/leafy debris dam; erosion left bank

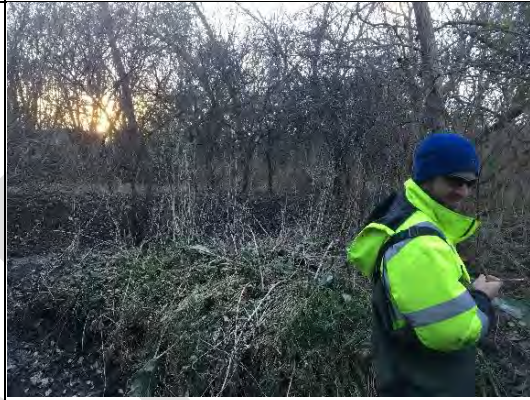
IMG-0327
Signs of major bank sloughing, partially healed over; right bank

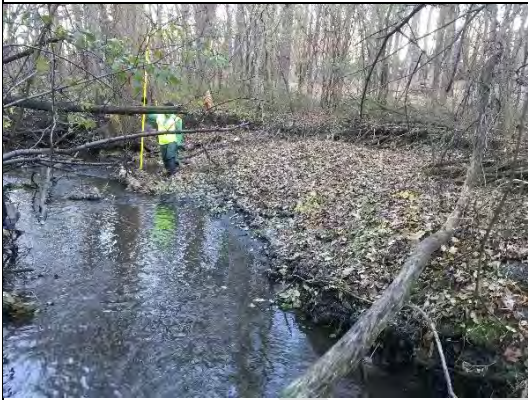
IMG-0328
Signs of major bank sloughing, partially healed over; right bank

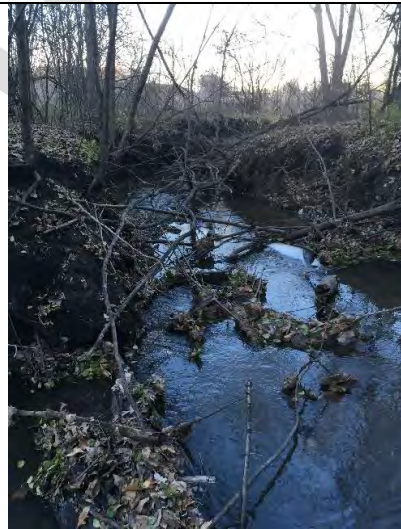
IMG-0329
Severely incised channel; small woody debris

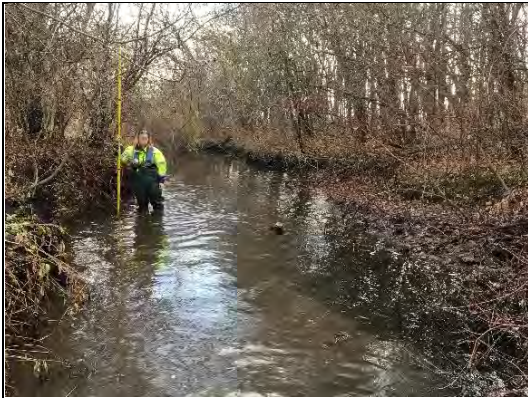
IMG-0336
General stream photo; channel widens and deepens
