# Upper Riley Creek Corridor Ecological Enhancement Plan from Highway 5 to Lake Susan

Prepared for  
Riley Purgatory Bluff Creek Watershed District and the City of  
Chanhassen

May 2021

## Ecological Enhancement Plan

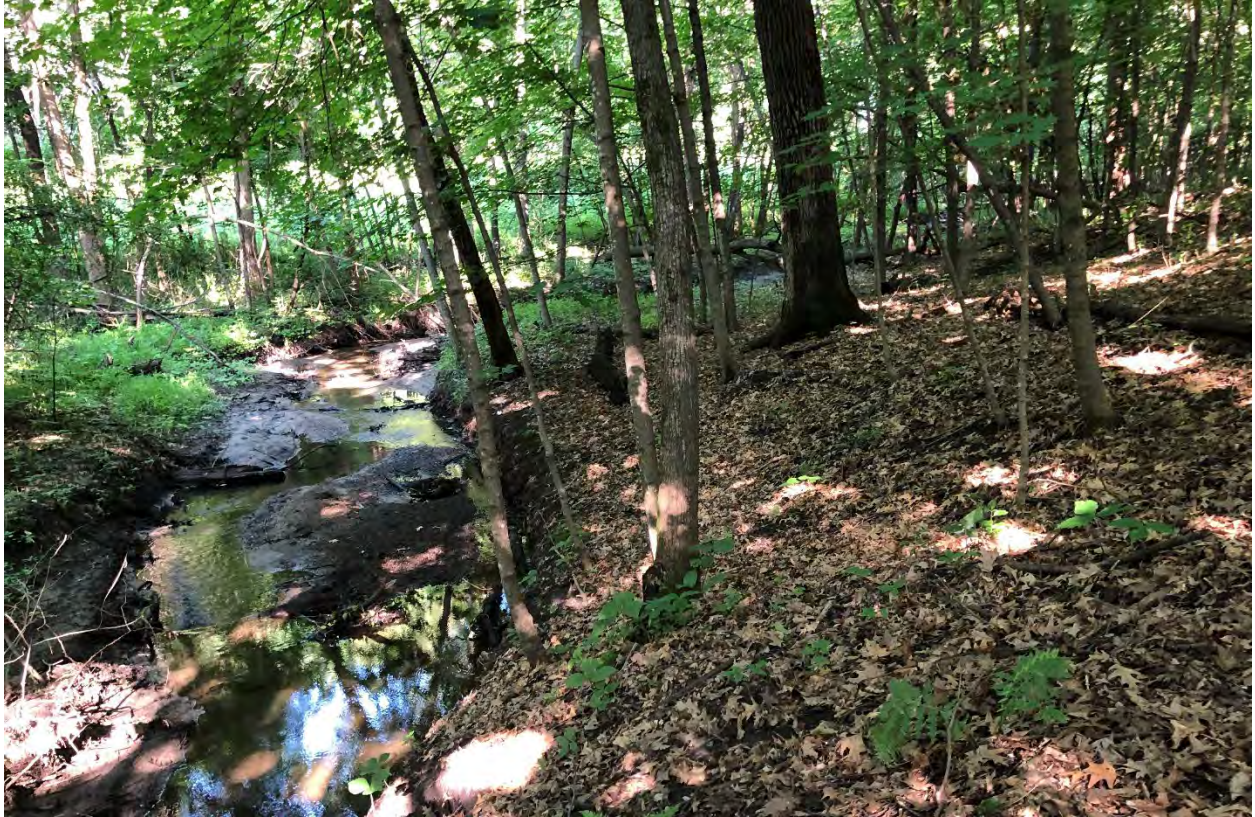
A vegetation assessment was completed in June 2020 to determine vegetation composition of the riparian portions of the Project area. The plant community surrounding the upper and middle portions of the Project reach are hardwood forest of marginal quality due to prevalence of non-native, invasive species, with a nearly continuous canopy cover (90-100%). The riparian area is dominated by green ash, boxelder, cottonwood, and silver maple. Sandbar willow becomes prevalent where the creek outlets to Lake Susan. European buckthorn, an invasive species, is prevalent throughout forested portions of the Project area, accounting for up to 75 percent of the canopy cover in some locations and comprising a portion of the understory. In general, the understory of forested sections is sparsely vegetated due to the high level of canopy cover (Figure 5-1).

**Figure 5-1 European Buckthorn and Native Hardwood Forest Community with Sparse Understory**

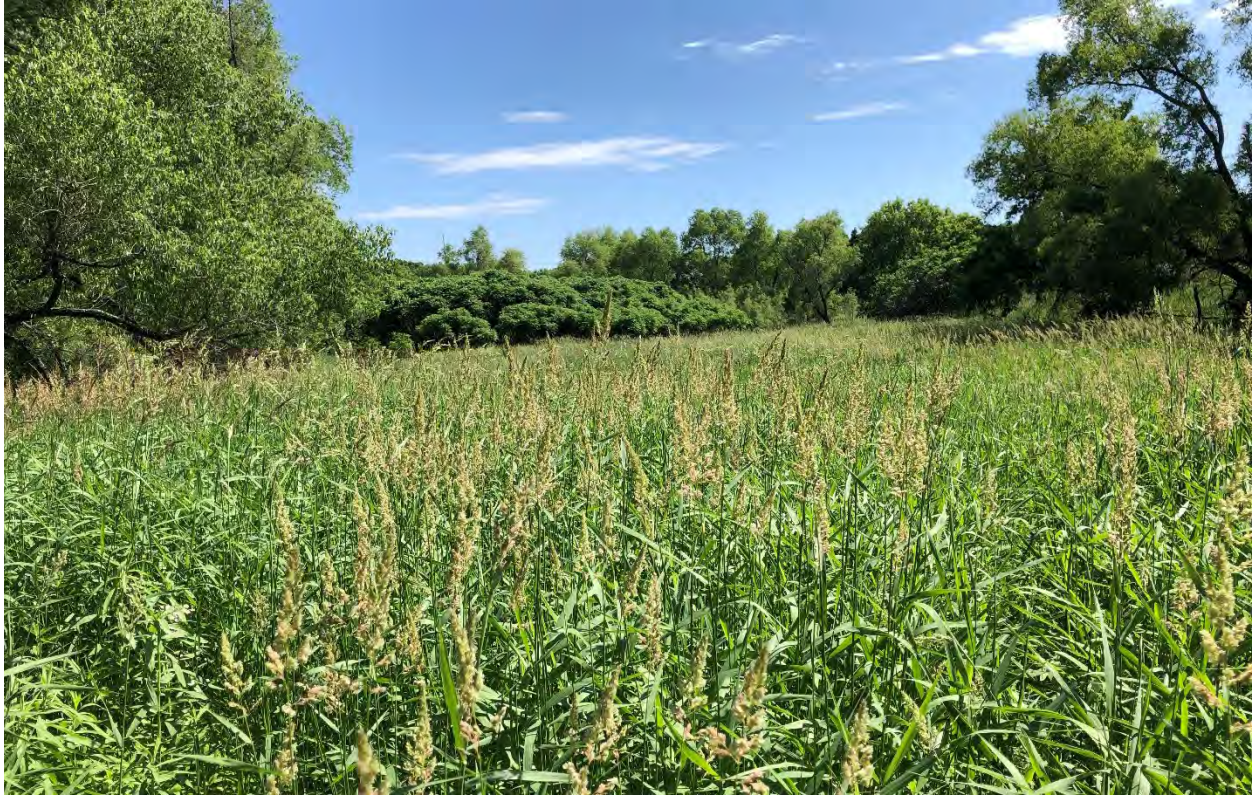
Unforested portions of the Project area reflect marsh and wet-meadow type settings dominated by river bulrush, and invasive reed canary grass and narrow-leaved cattail. Stinging nettle, smartweed, and goldenrod were also observed in the marsh and wet-meadow settings, though not as dominant species. In some portions of the Project area, reed canary grass accounts for nearly 100 percent of the vegetation cover (Figure 5-2).

Figure 5-2 Reed Canary Grass Dominated Plant Community in Project Area

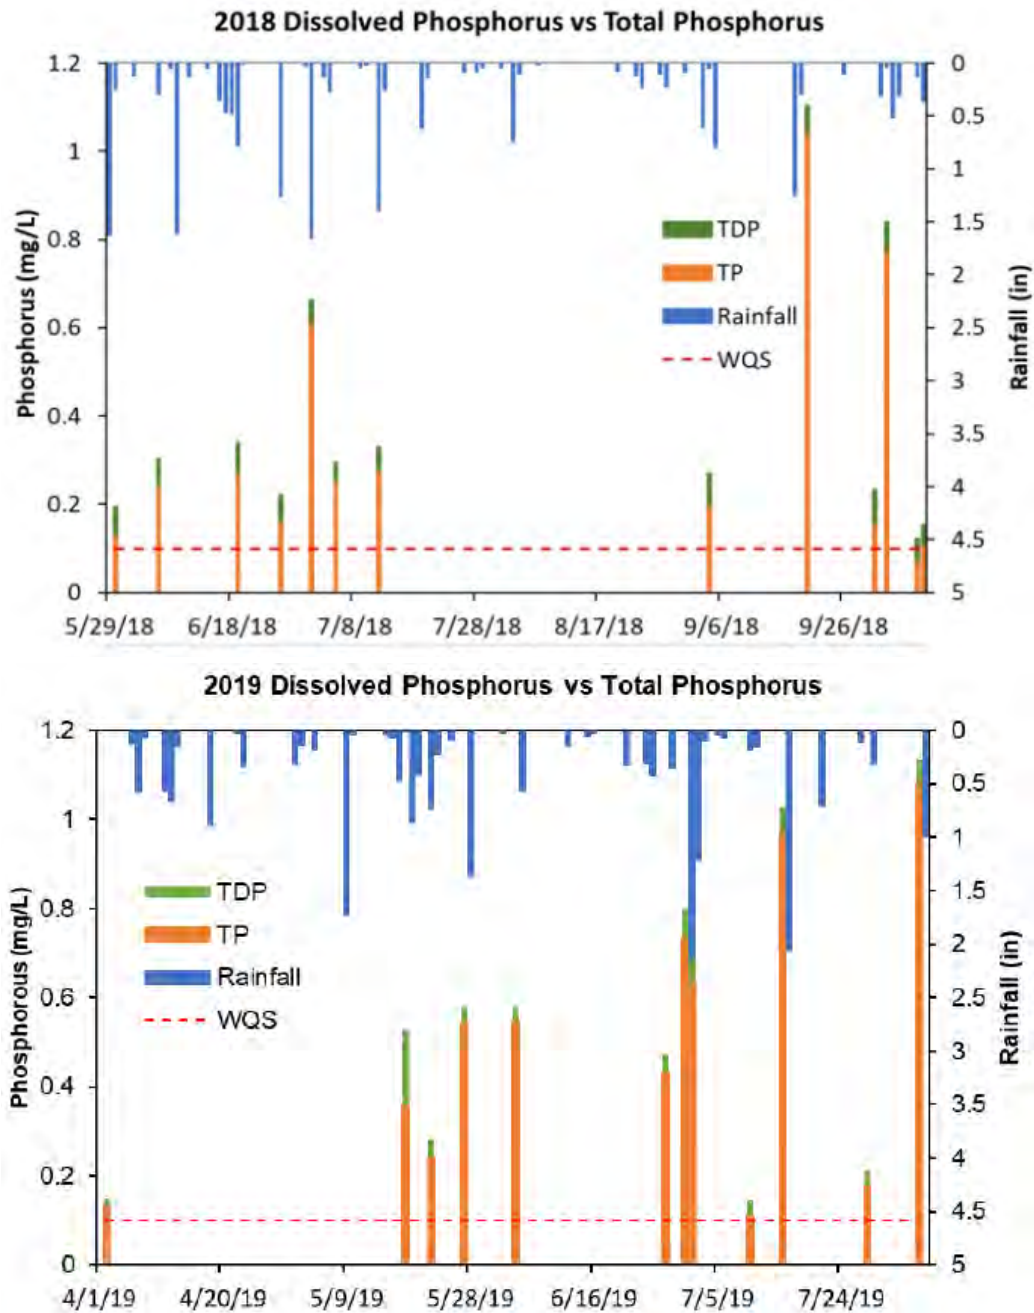
The TDP and TP concentrations measured at the Riley Creek/Powers Boulevard crossing from 2018 and 2019 are shown in Figure 5-4. The dashed line represents the MPCA’s TP standard in class 2B creeks ( $\leq 0.1$ mg/L). The average TP across the 12 samples collected in 2019 was 0.497mg/L. This level is about four times the MPCA eutrophication water quality standard for class 2B creeks ( $\leq 0.1$ mg/L). As shown in Figure 5-4, none of the TP

samples achieved the standard, and Upper Riley Creek is considered to be in poor health.

Figure 5-4 Upper Riley Creek TP and TDP Measurement at Powers Boulevard

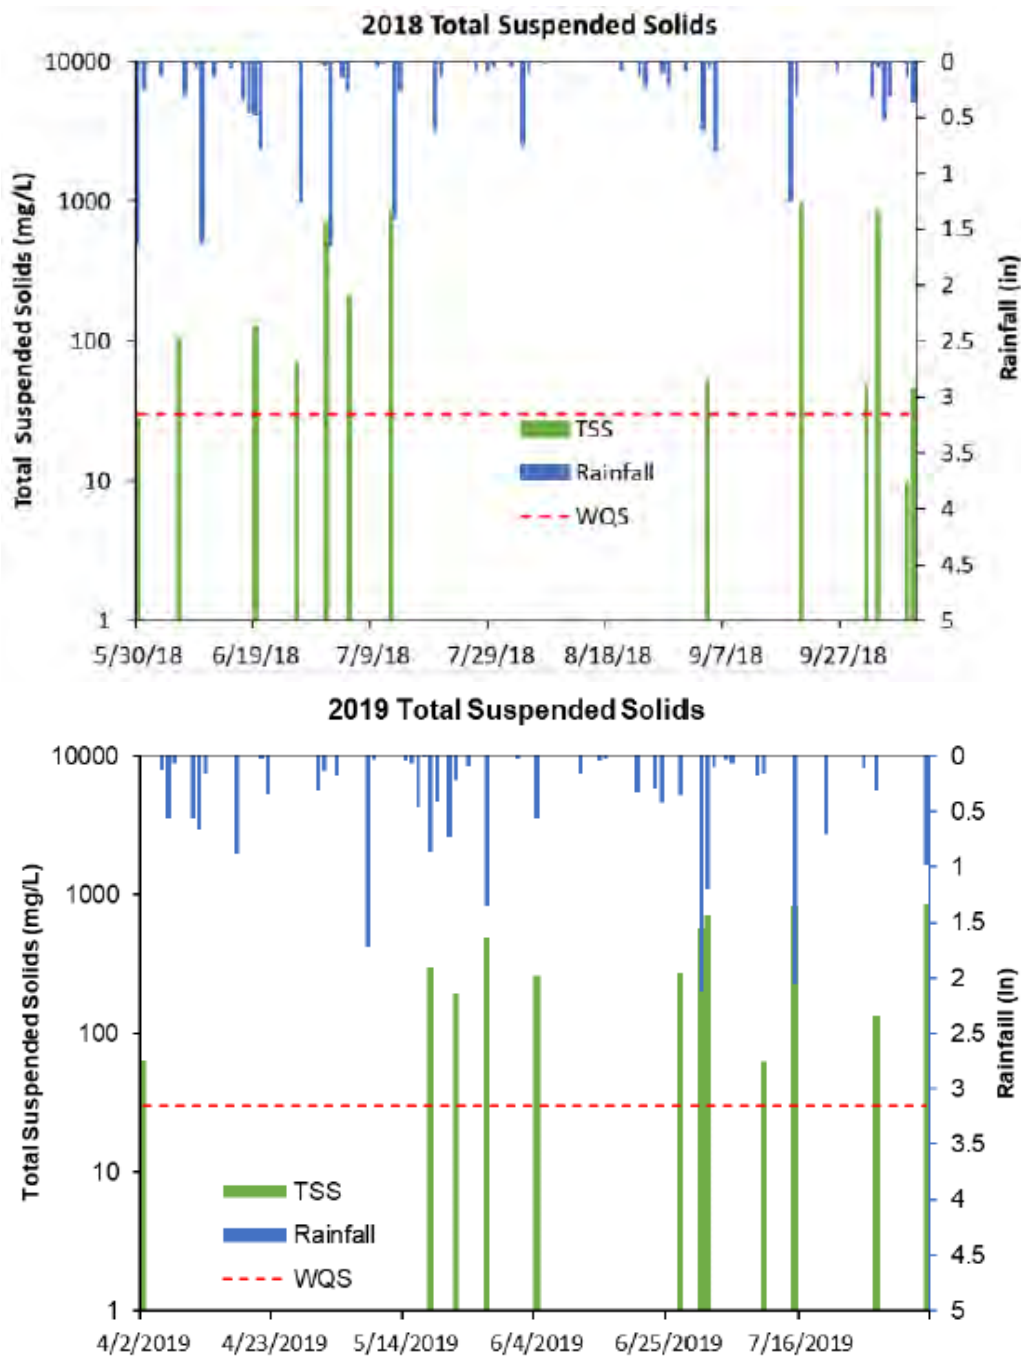
TSS concentrations measured at the Riley Creek/Powers Boulevard crossing from 2018 and 2019 are summarized in Figure 5-5. The dashed line represents the MPCA’s standard for TSS in class 2B creeks ( $\leq 30\text{mg/L}$  TSS no more than 10% of the time). Only two of the 2018 samples and

none of the 12 samples taken in 2019 fell below the 30mg/L TSS standard, thus confirming this creek reach is in poor health. The high TSS and TP measured at the Riley Creek/Powers Boulevard crossing confirm the potential for significant pollutant loading directly to Lake Susan.

Figure 5-5 Upper Riley Creek TSS Measurements at Powers Boulevard

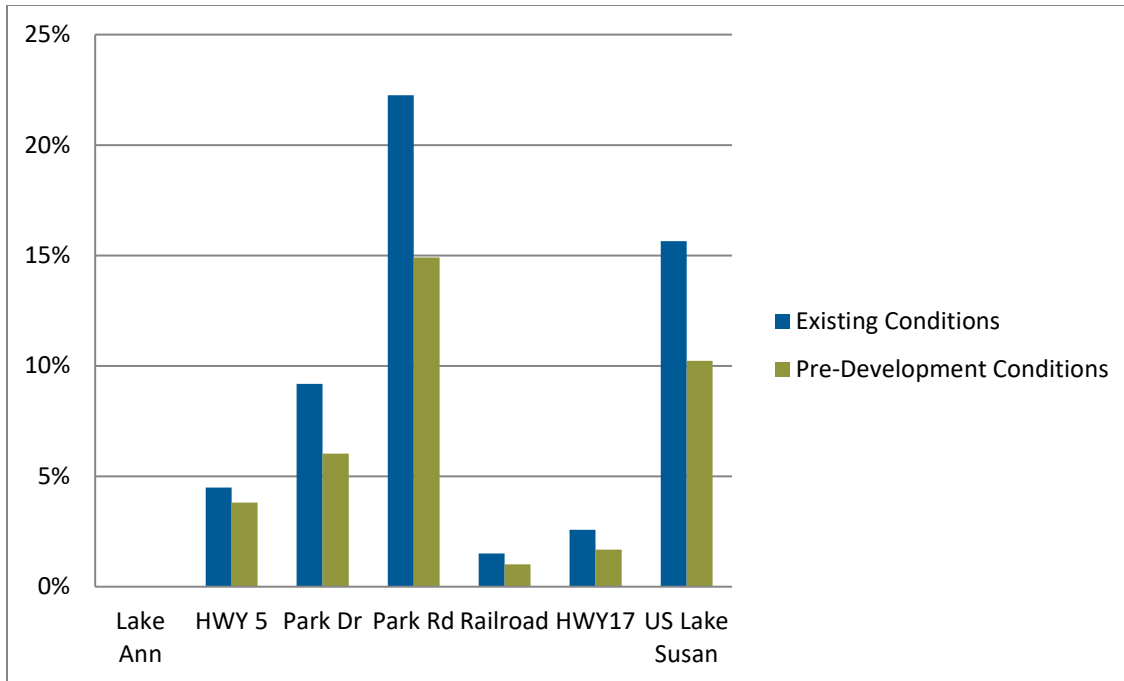
**Figure 5-10 Percent Increase in Segment Runoff Volume from the 2-year Design Storm from Lake Ann to Upstream of Lake Susan**

Compared to the pseudo pre-development condition, there is an estimated 52% increase in 2-year runoff volume entering Lake Susan under existing watershed conditions as shown in Figure 5-9. In addition, the true pre-development condition likely experienced less runoff volume and lower runoff rates than those approximated because of natural depressions and conveyances rather than the existing storm sewers. The segment immediately upstream of Lake Susan shows large increases in flow in Figure 5-10. The reach downstream of Park Road was also the creek section identified as having some of the most significant erosion.

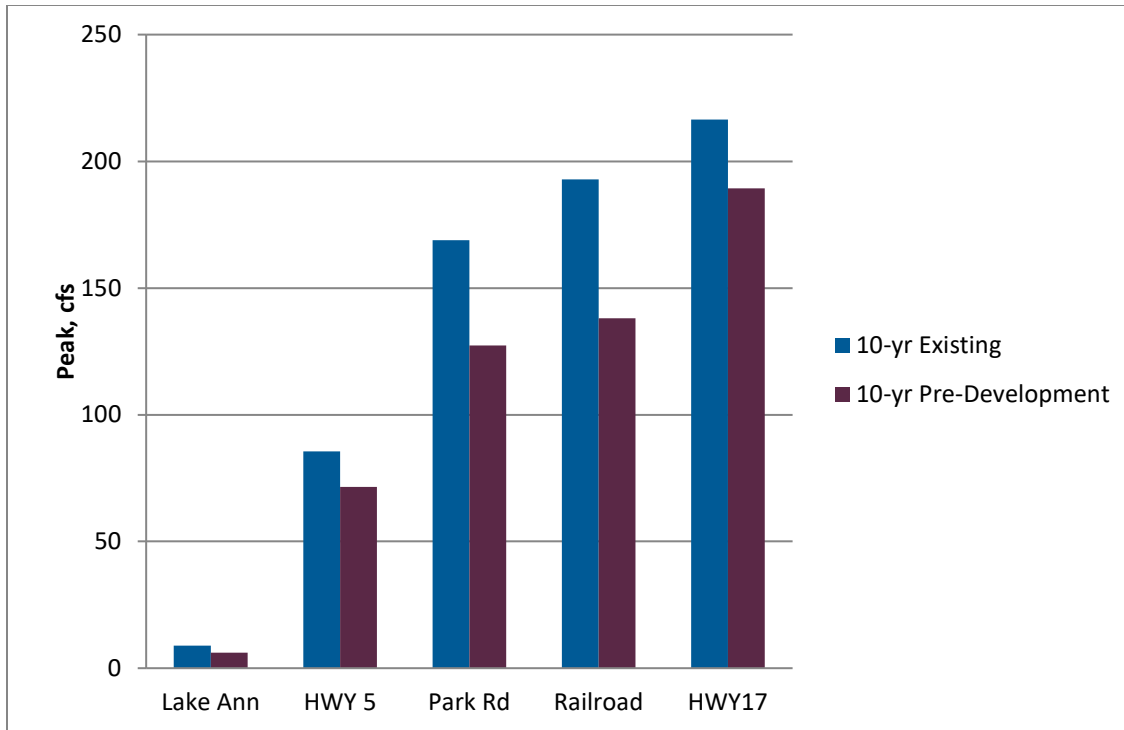
Figure 5-11 and Figure 5-12 provide the PCSWMM existing and pre-development 2-year and 10-year peak discharges. For the downstream section of the reach (HWY17), the 2-year peak discharge has increased by 125% as compared to pre-development conditions. The increase in the HWY17 reach is only 14% for the 10-year peak discharge. The 2-year event appears to have been impacted the most by watershed development and is critical when assessing stream erosion impacts.

**Figure 5-12 Peak 10-year Discharge in Riley Creek for Existing and Pre-Development Conditions**

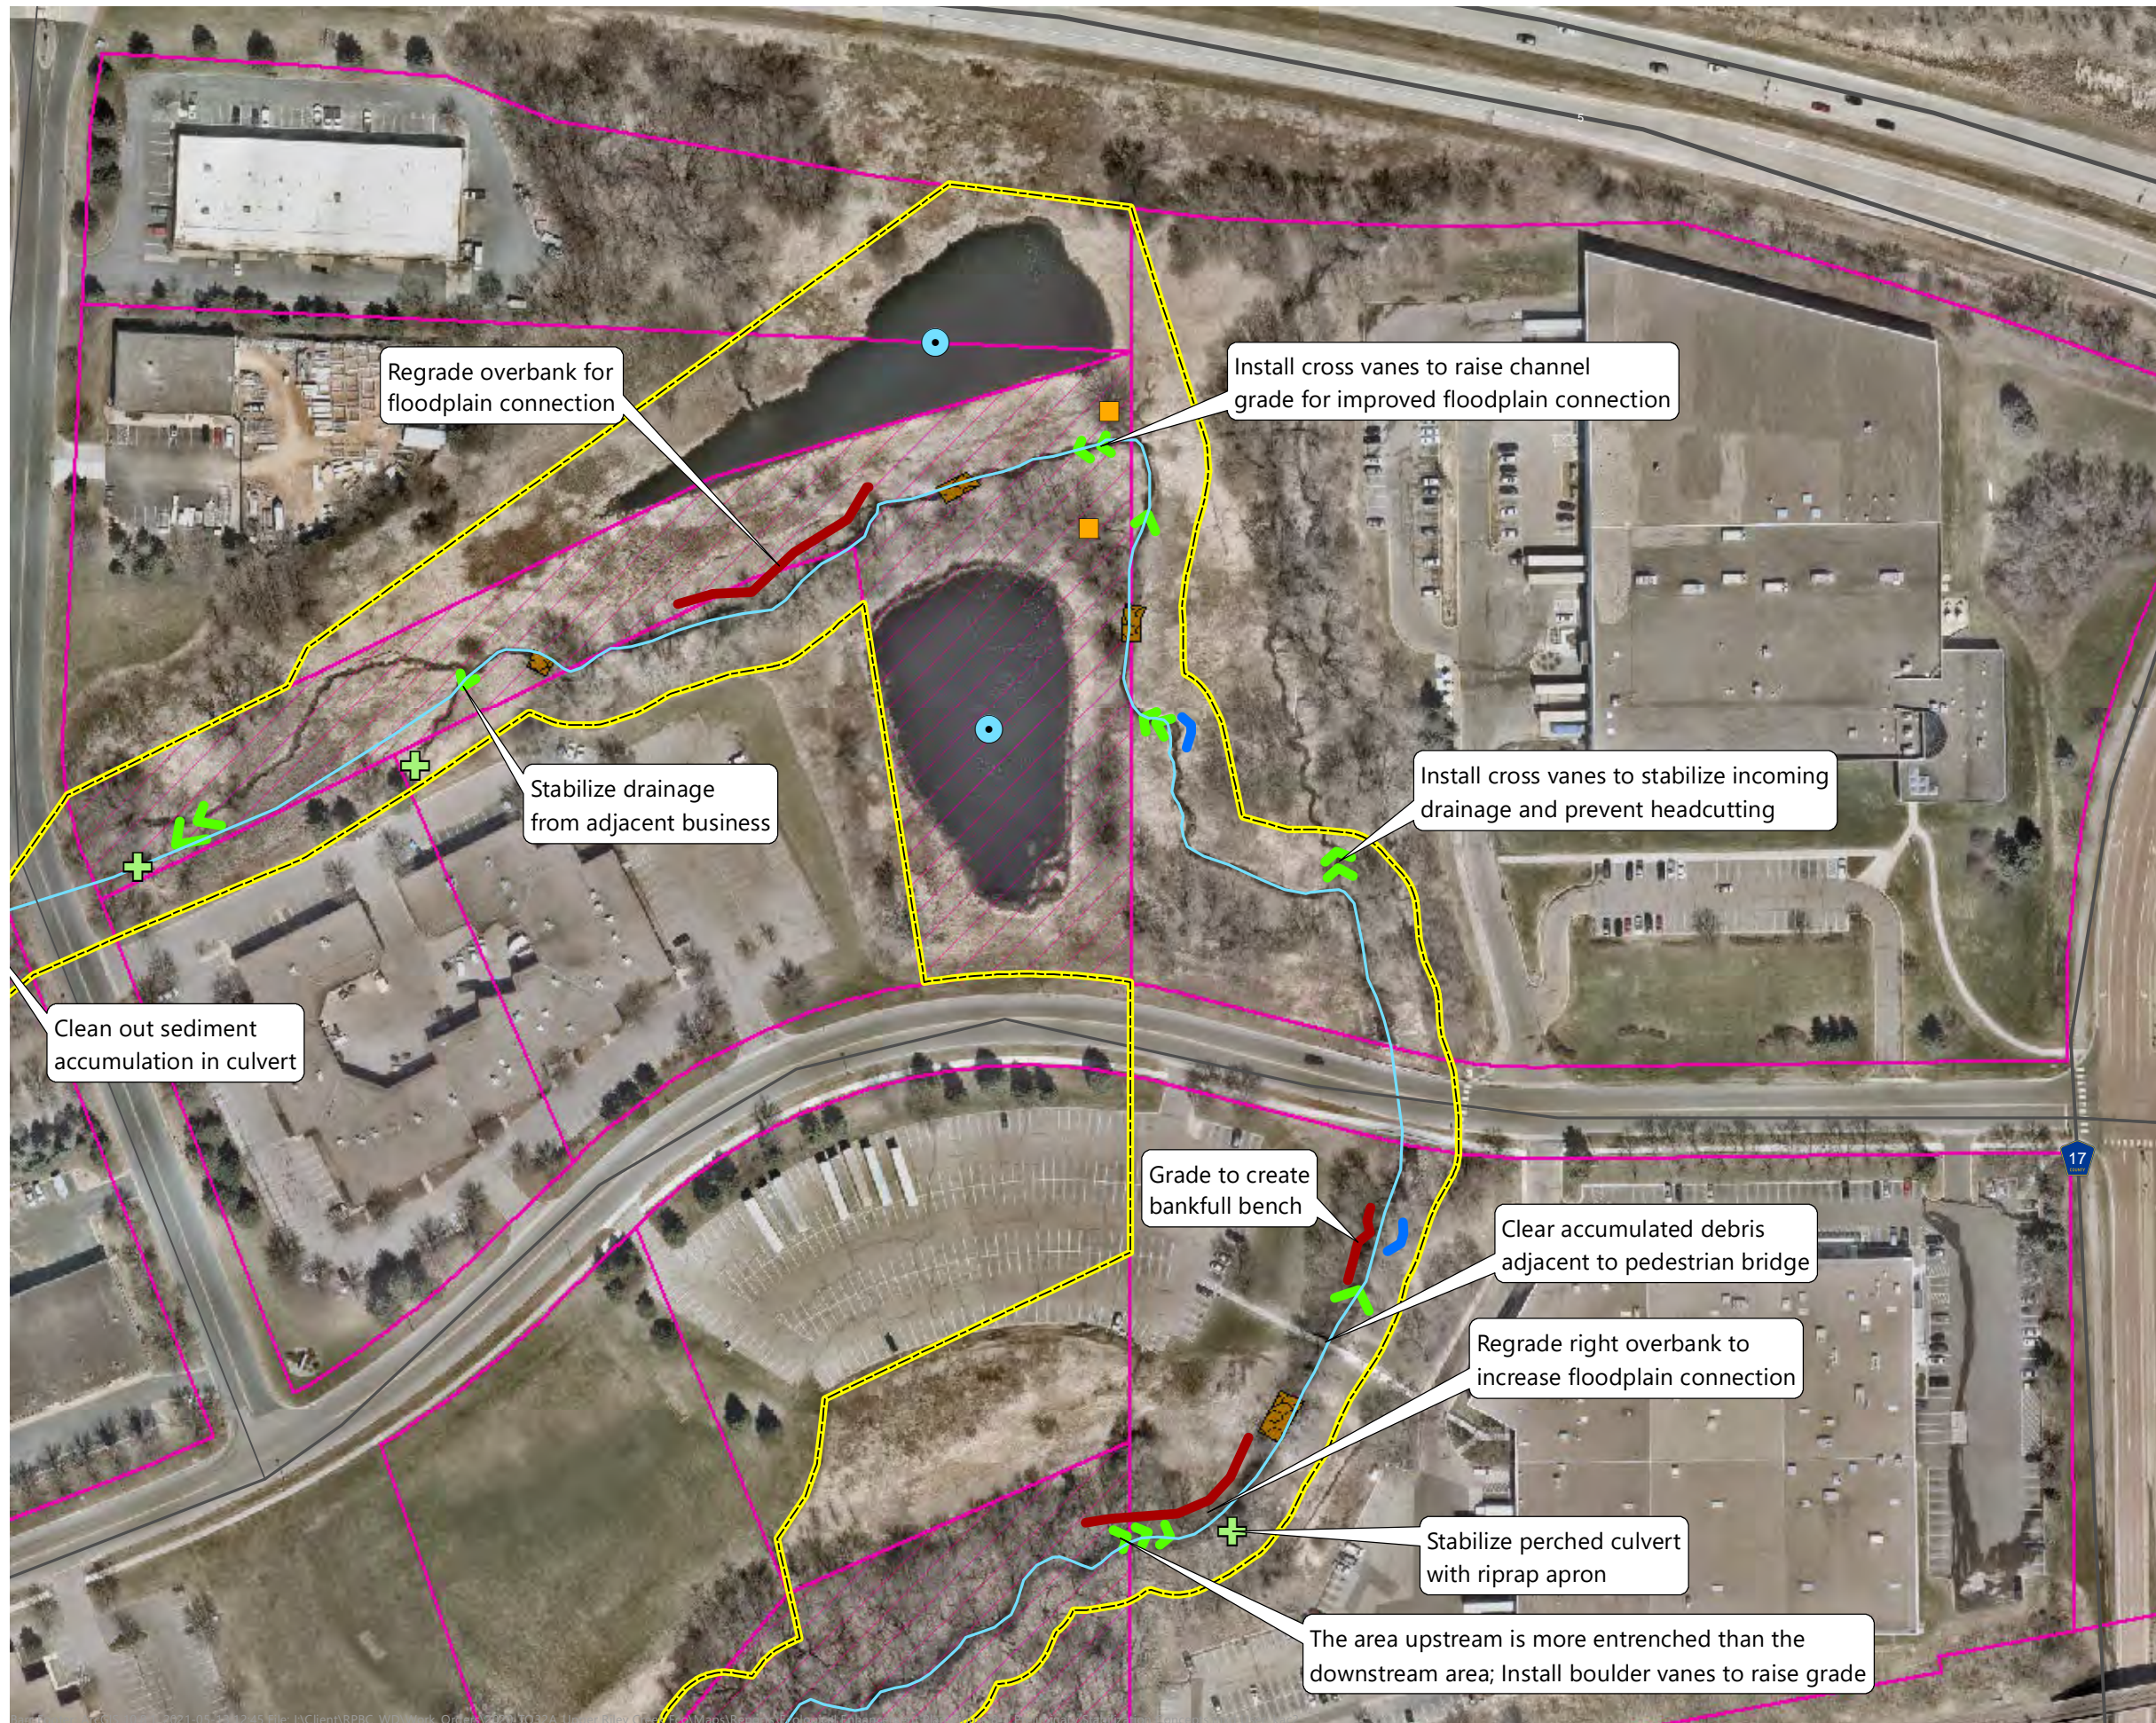
FIGURE 8-2

# PRELIMINARY STABILIZATION CONCEPTS

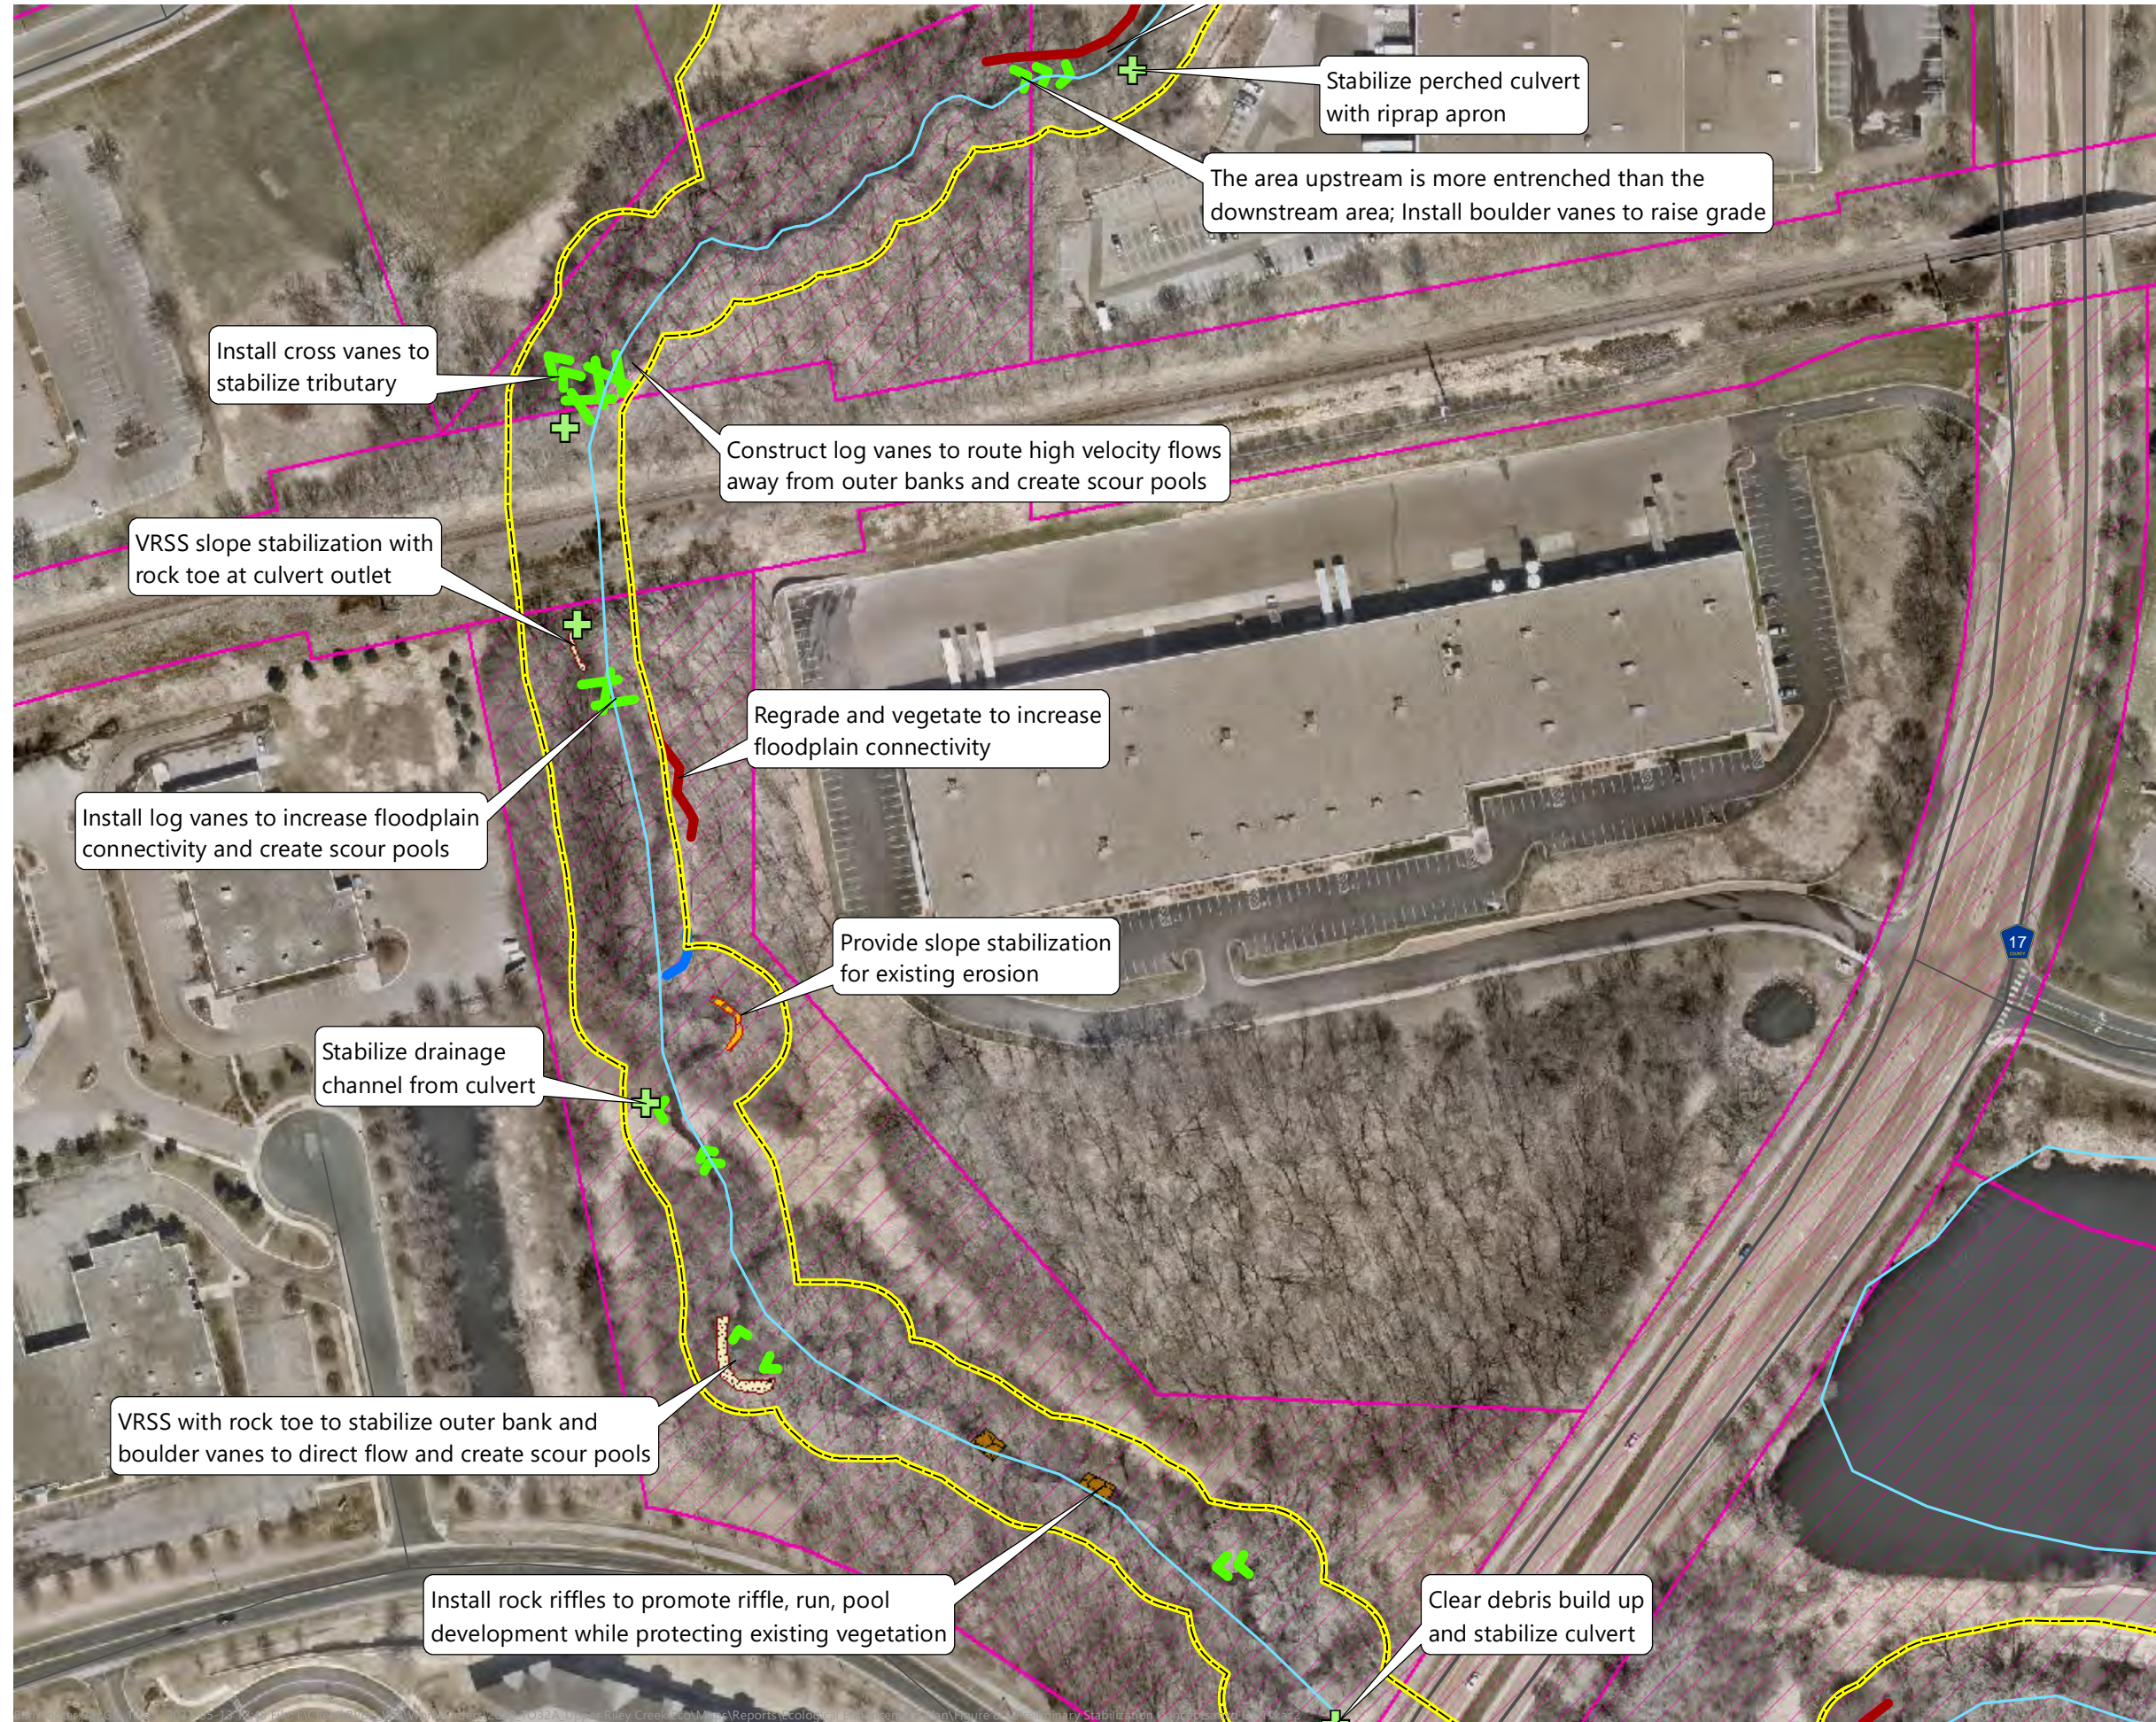
FIGURE 8-3

# PRELIMINARY STABILIZATION CONCEPTS

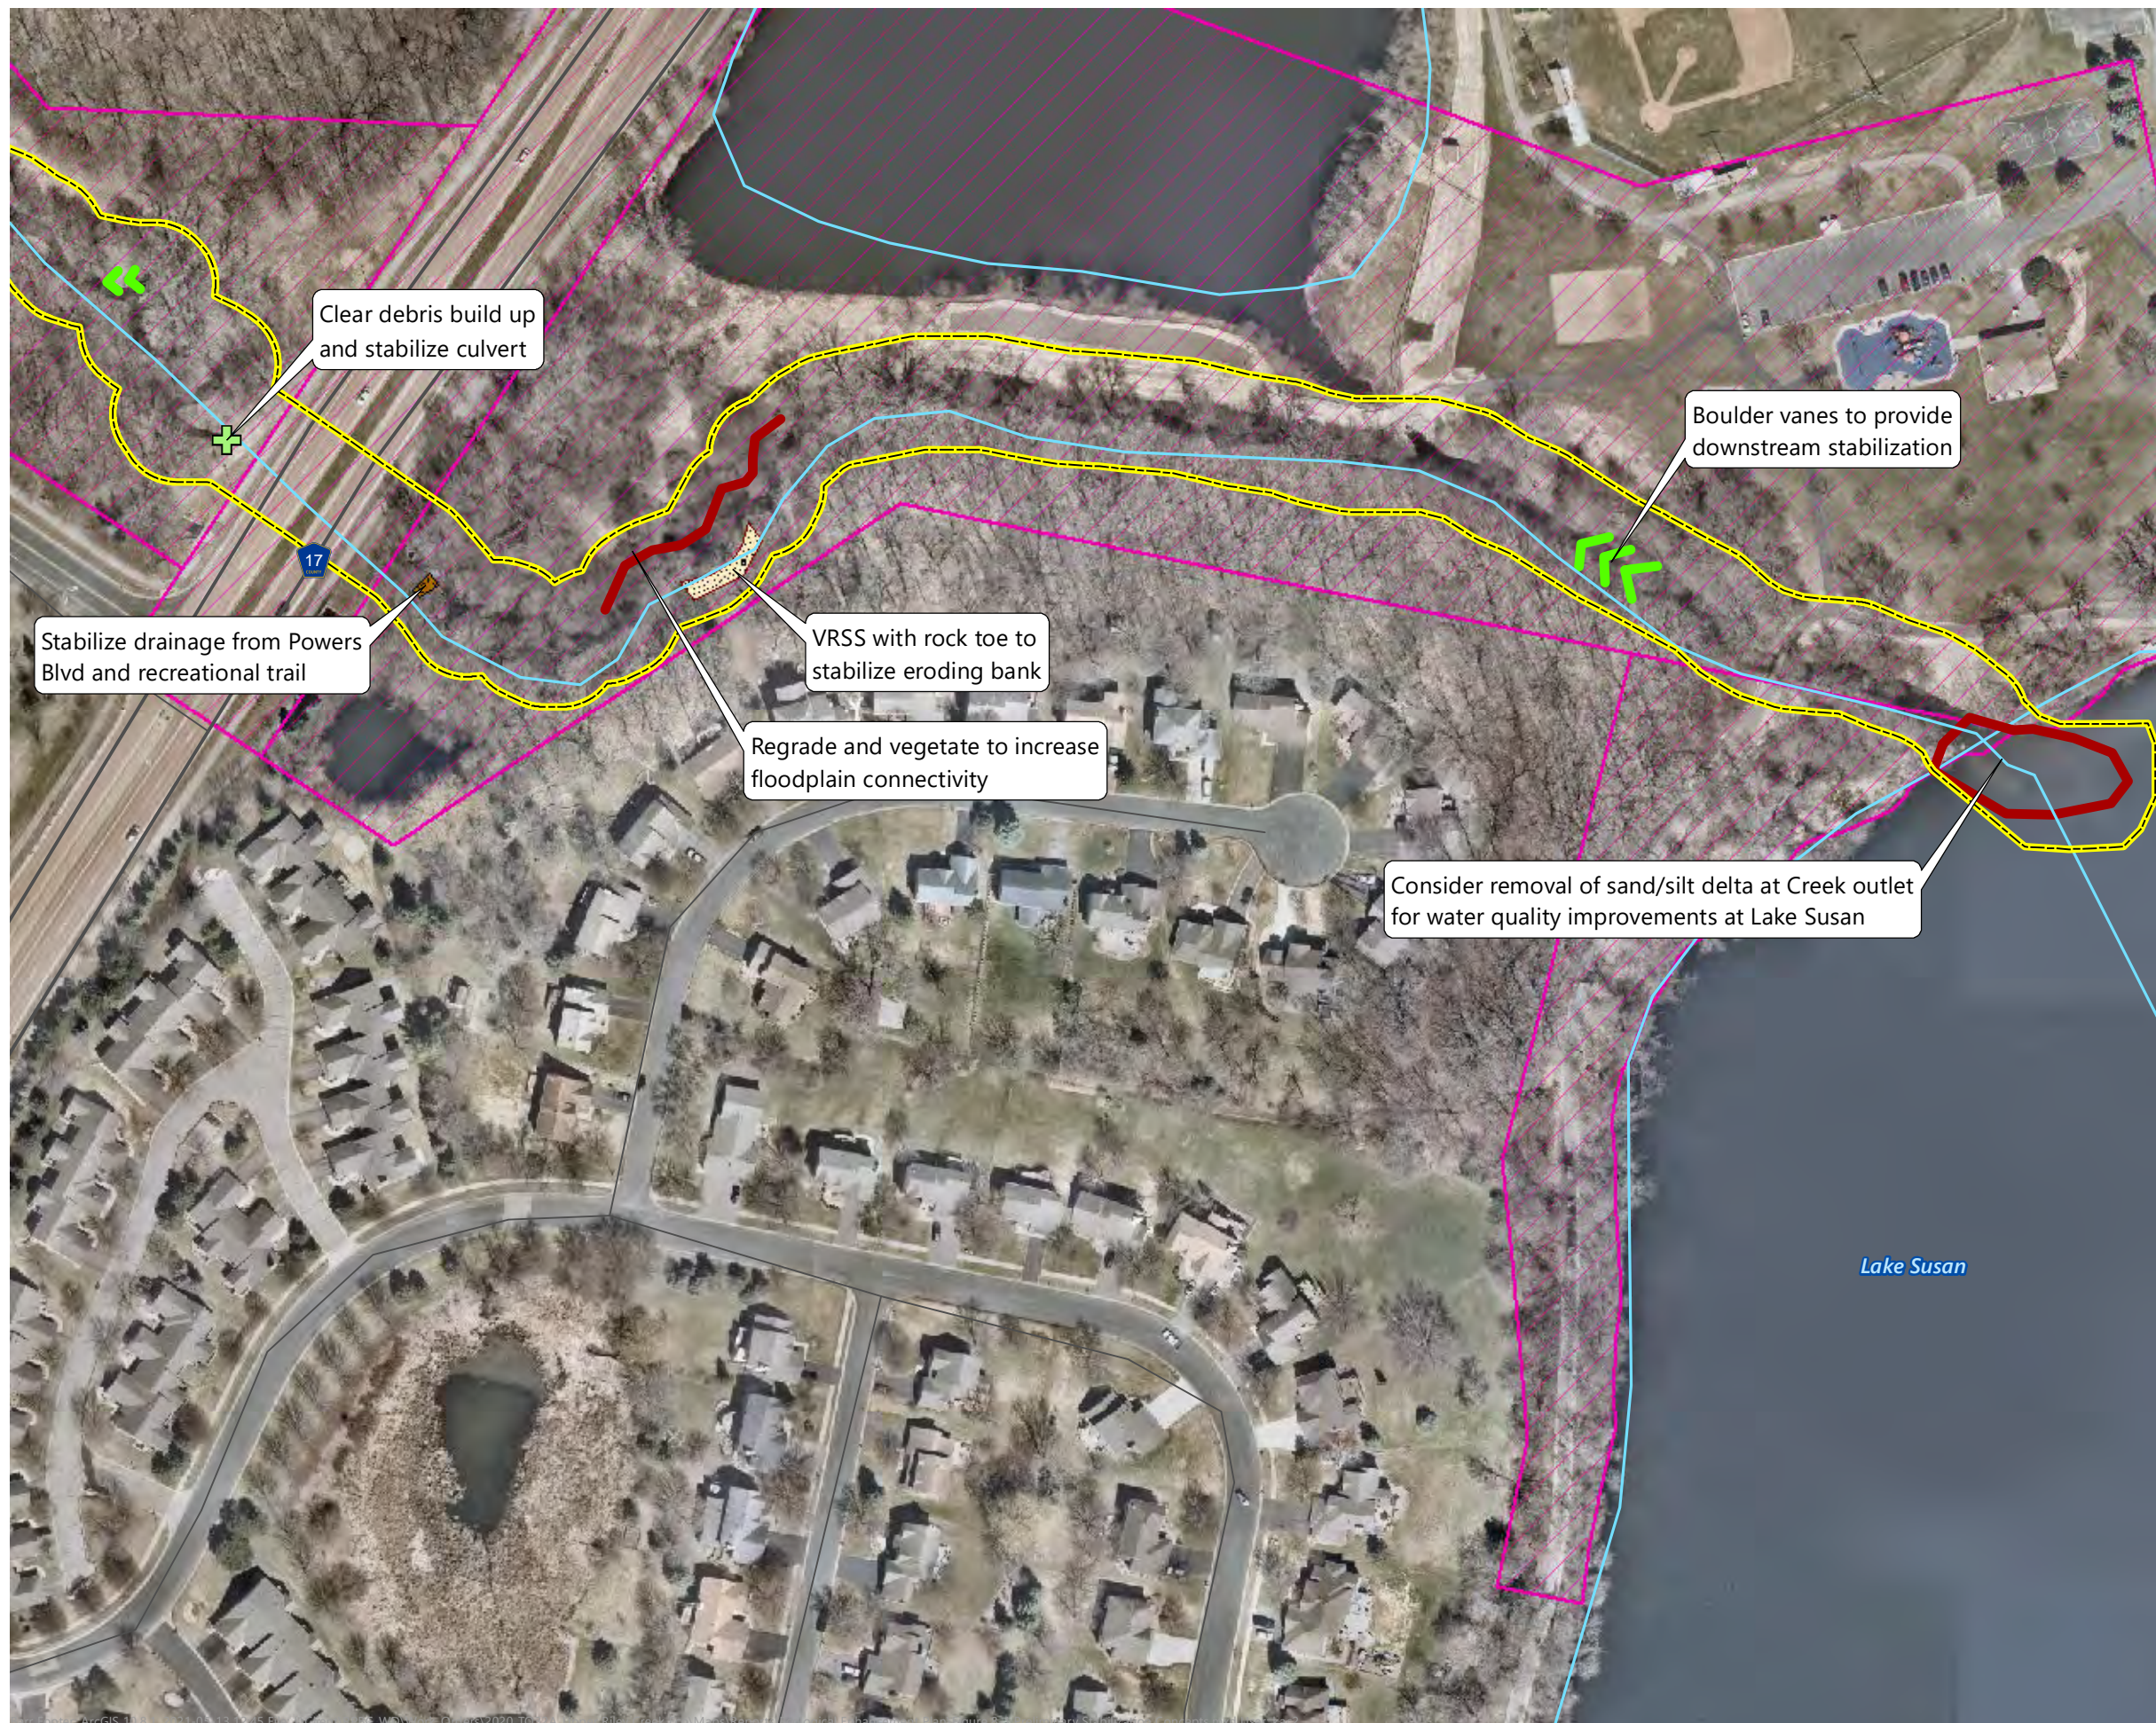
FIGURE 8-4

# PRELIMINARY STABILIZATION CONCEPTS

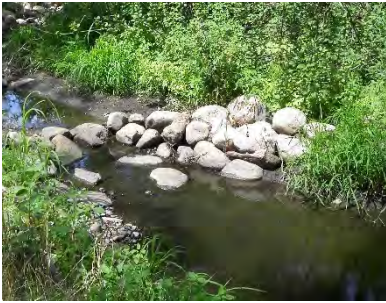
<p>Boulders buried in the stream bed and extending partially (“vanes”) or entirely across the stream (“cross vanes”) to achieve one or more of the following goals: re-direct flows away from banks, encourage sediment deposition in selected areas, and control stream bed elevations.</p>	<p>Scour pools develop over time near the vane, which provide habitat diversity for species that prefer pools to faster flowing in-channel habitat.</p> <p>Approximately 35 cross vanes are proposed in preliminary stabilization concept.</p>

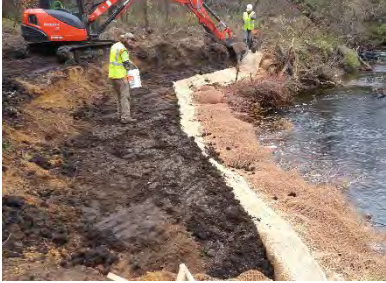
<p>Soil lifts created with a combination of root wads and long-lasting, biodegradable fabric and vegetated to stabilize steep slopes and encourage establishment of root systems for further stabilization.</p>	<p>Creates undercut/overhanging bank habitat features.</p> <p>Approximately 6 locations of VRSS and/or toe wood bank stabilization are proposed in preliminary stabilization concept.</p>

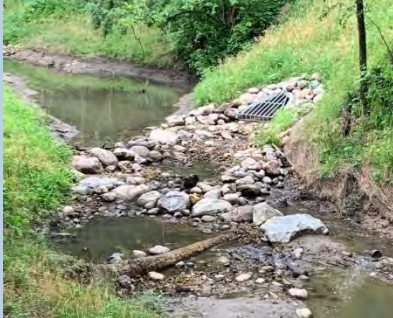
<p>Allows stormwater to outlet at an elevation more proximately to the channel elevation. This, along with placement of a material to dissipate flows, reduces potential for in-channel scour.</p>	<p>When flows are appropriately dissipated, there is less sedimentation and associated turbidity in the waterway. Up to 10 outlet adjustments and/or stabilizations are proposed in preliminary stabilization concept.</p>
<p><b>Floodplain Connectivity</b></p>

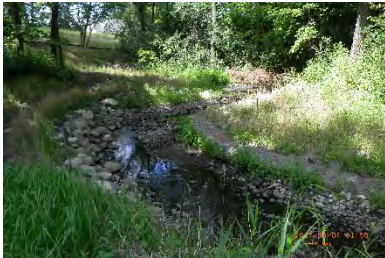
<p>Active floodplain/vegetated bench—modifications made to the stream cross section to increase floodplain connectivity and decrease erosive stress during flood flows; for this project, constructed by raising the channel bed.</p>	<p>Provides a smooth transition between in-channel, riparian, and upland habitat. Approximately 5 locations of opportunity to improve floodplain connectivity are proposed in preliminary stabilization concept.</p>

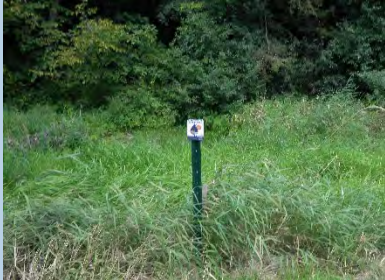
<p>Established along a stream bank or overbank area to stabilize bare soils and increase resistance to fluvial erosion.</p>	<p>Using trees, shrubs, and a seed mix of grass and forbs provides a diverse array of vegetation strata and habitat types. Allows for more naturalized aesthetics, with emphasis on native species.</p> <p>Project would be designed to comply with District buffer rules.</p>
<p><b>Pond Enhancement</b></p>

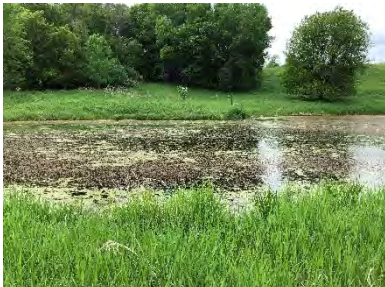
<p>Allows greater capacity for detention of flood flows and sediment removal.</p>	<p>Removal of sediments that have accumulated in ponds over times allows for a healthier aquatic ecosystem by removing pollutants and creates better opportunity for TSS to settle out of the water column.</p>
