# Upper Riley Creek Corridor Ecological Enhancement Plan from Highway 5 to Lake Susan

Prepared for  
Riley Purgatory Bluff Creek Watershed District and the City of  
Chanhassen

May 2021

## Ecological Enhancement Plan

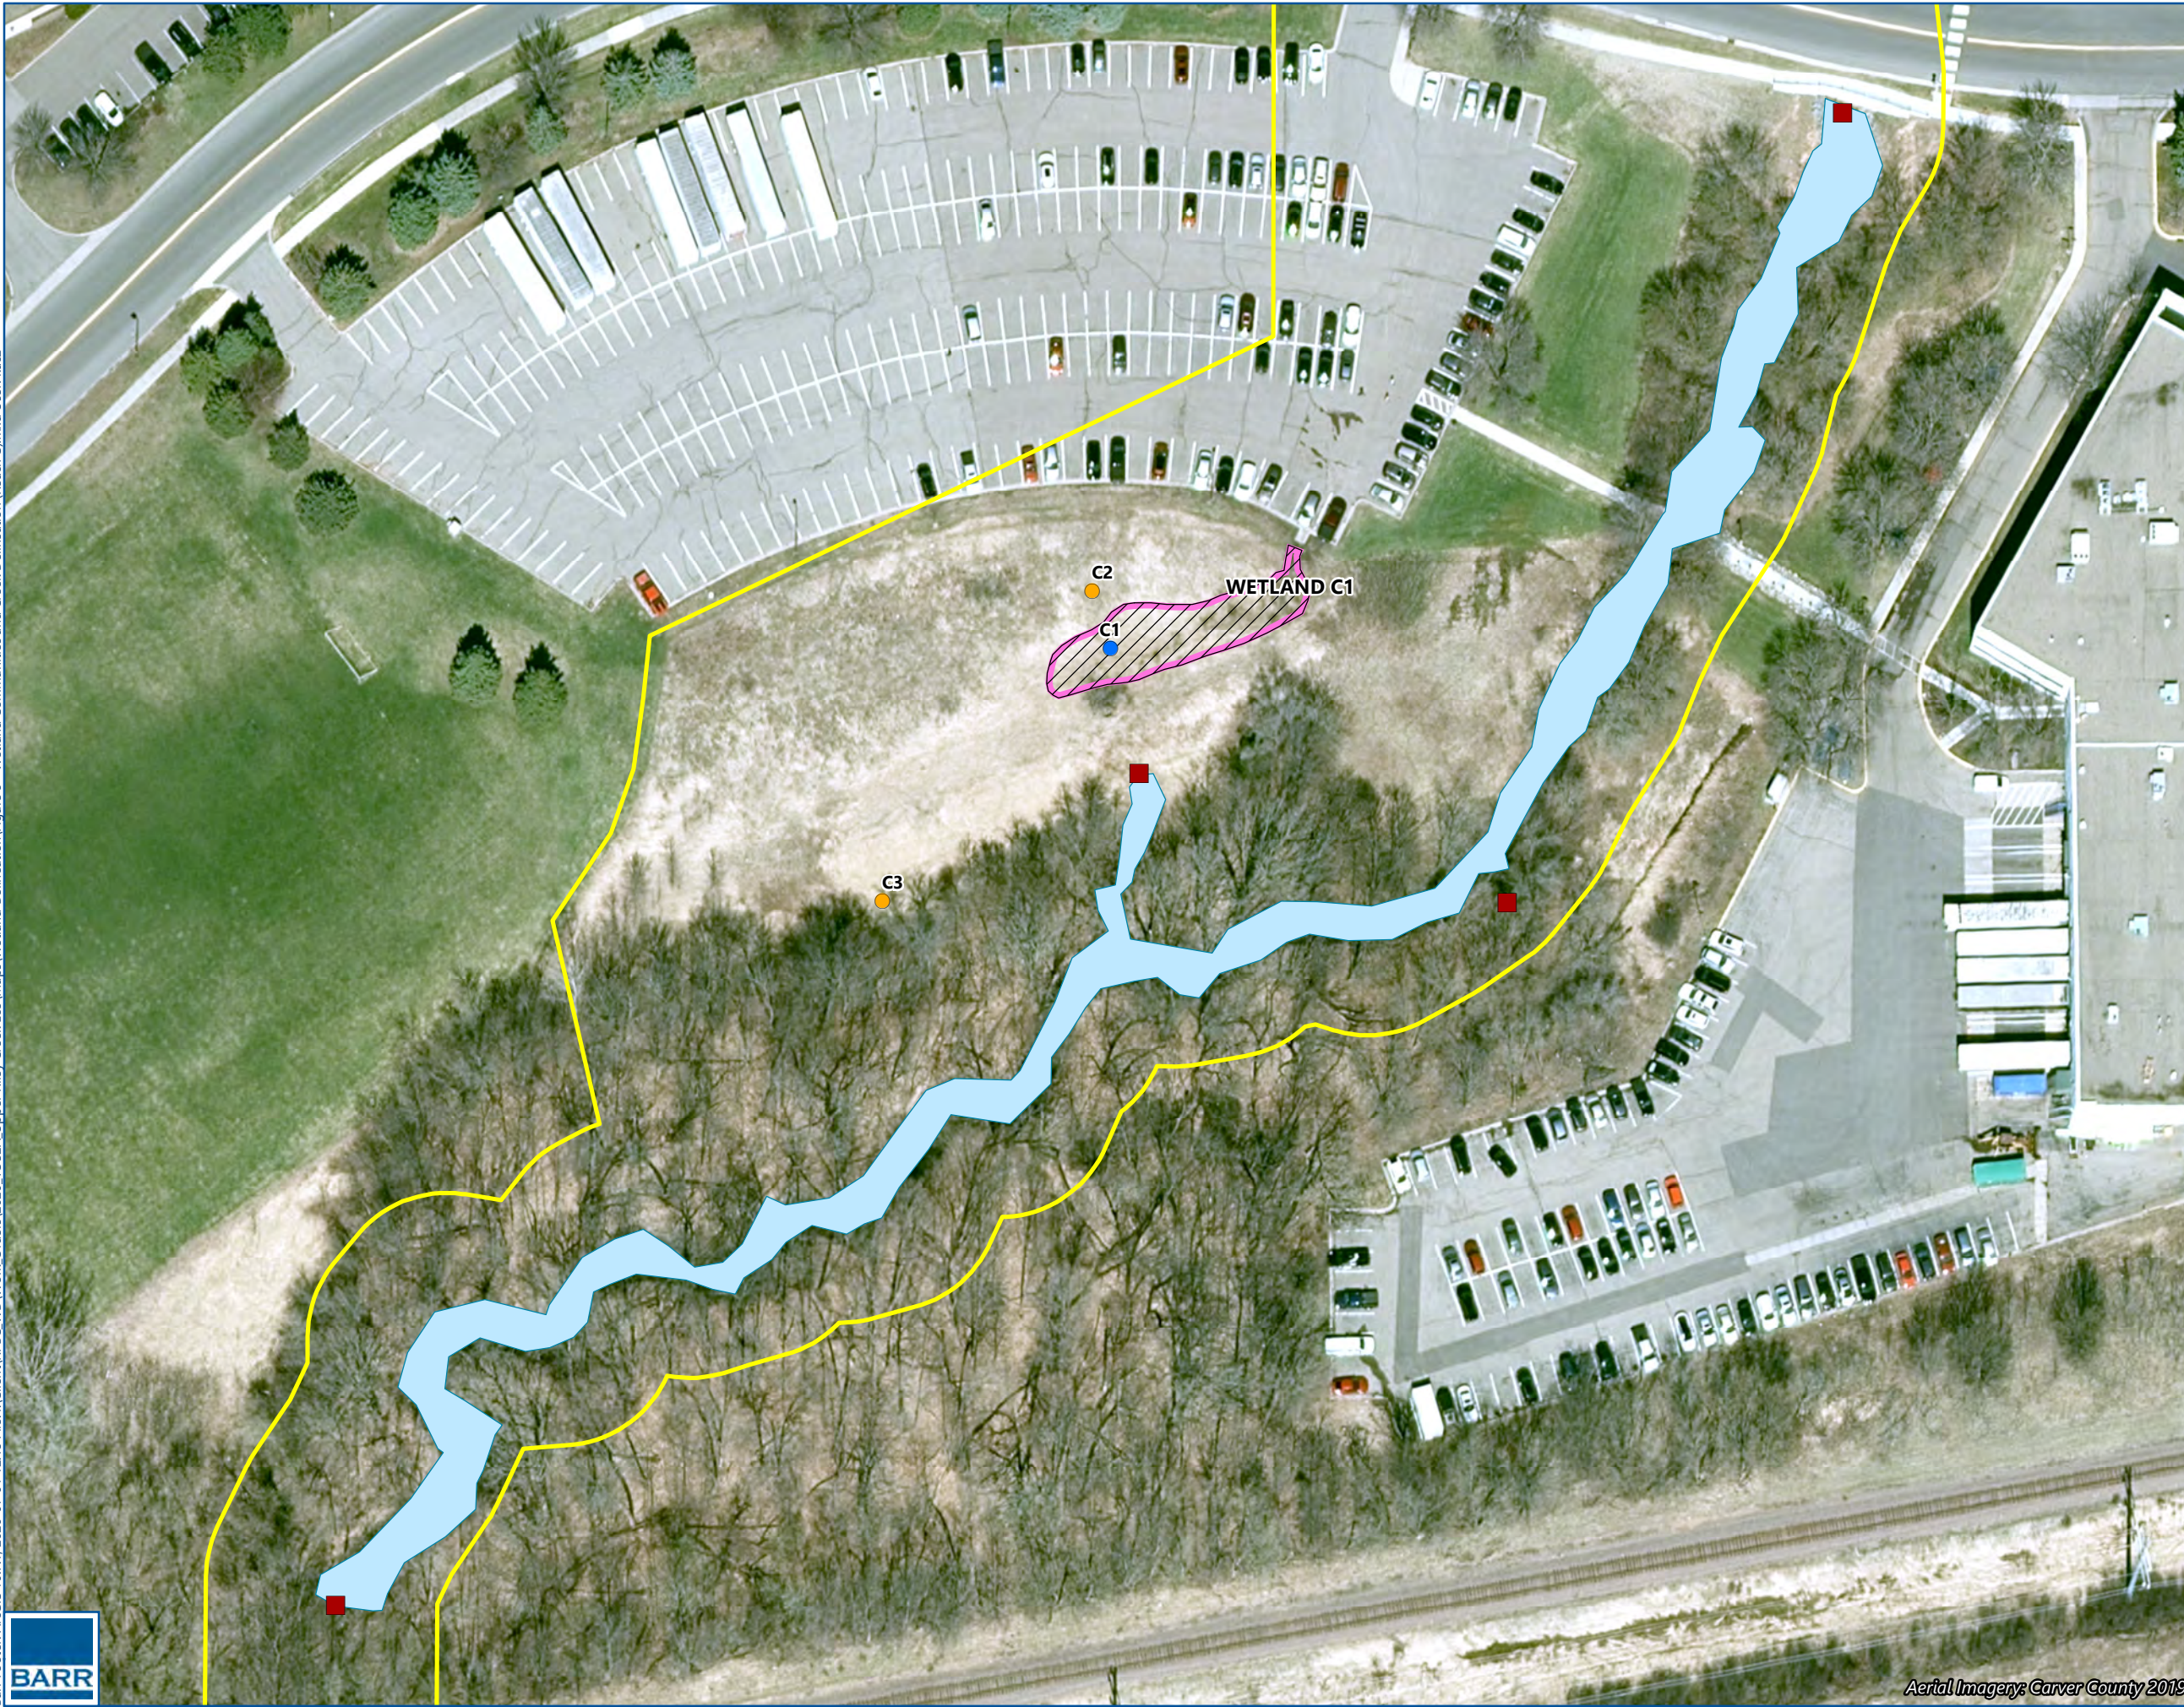
Barr Footer: ArcGIS 10.7.1, 2020-07-01 12:18 File: I:\Client\RPBC\_WD\Work\_Orders\2020\_TO32A\_Upper Riley Creek Eco Maps\Wetland Delineation\Figure 9 - Wetland Communities and Creek Delineation (Reach C).mxd User: lrac2
