Reserve at Autumn Woods

Natural Resources Memorandum

To: Riley Purgatory Bluff Creek Watershed District
From: ISG
Date: April 22, 2022
Subject: Reserve at Autumn Woods Natural Resources Memorandum
cc: Lennar Corporation

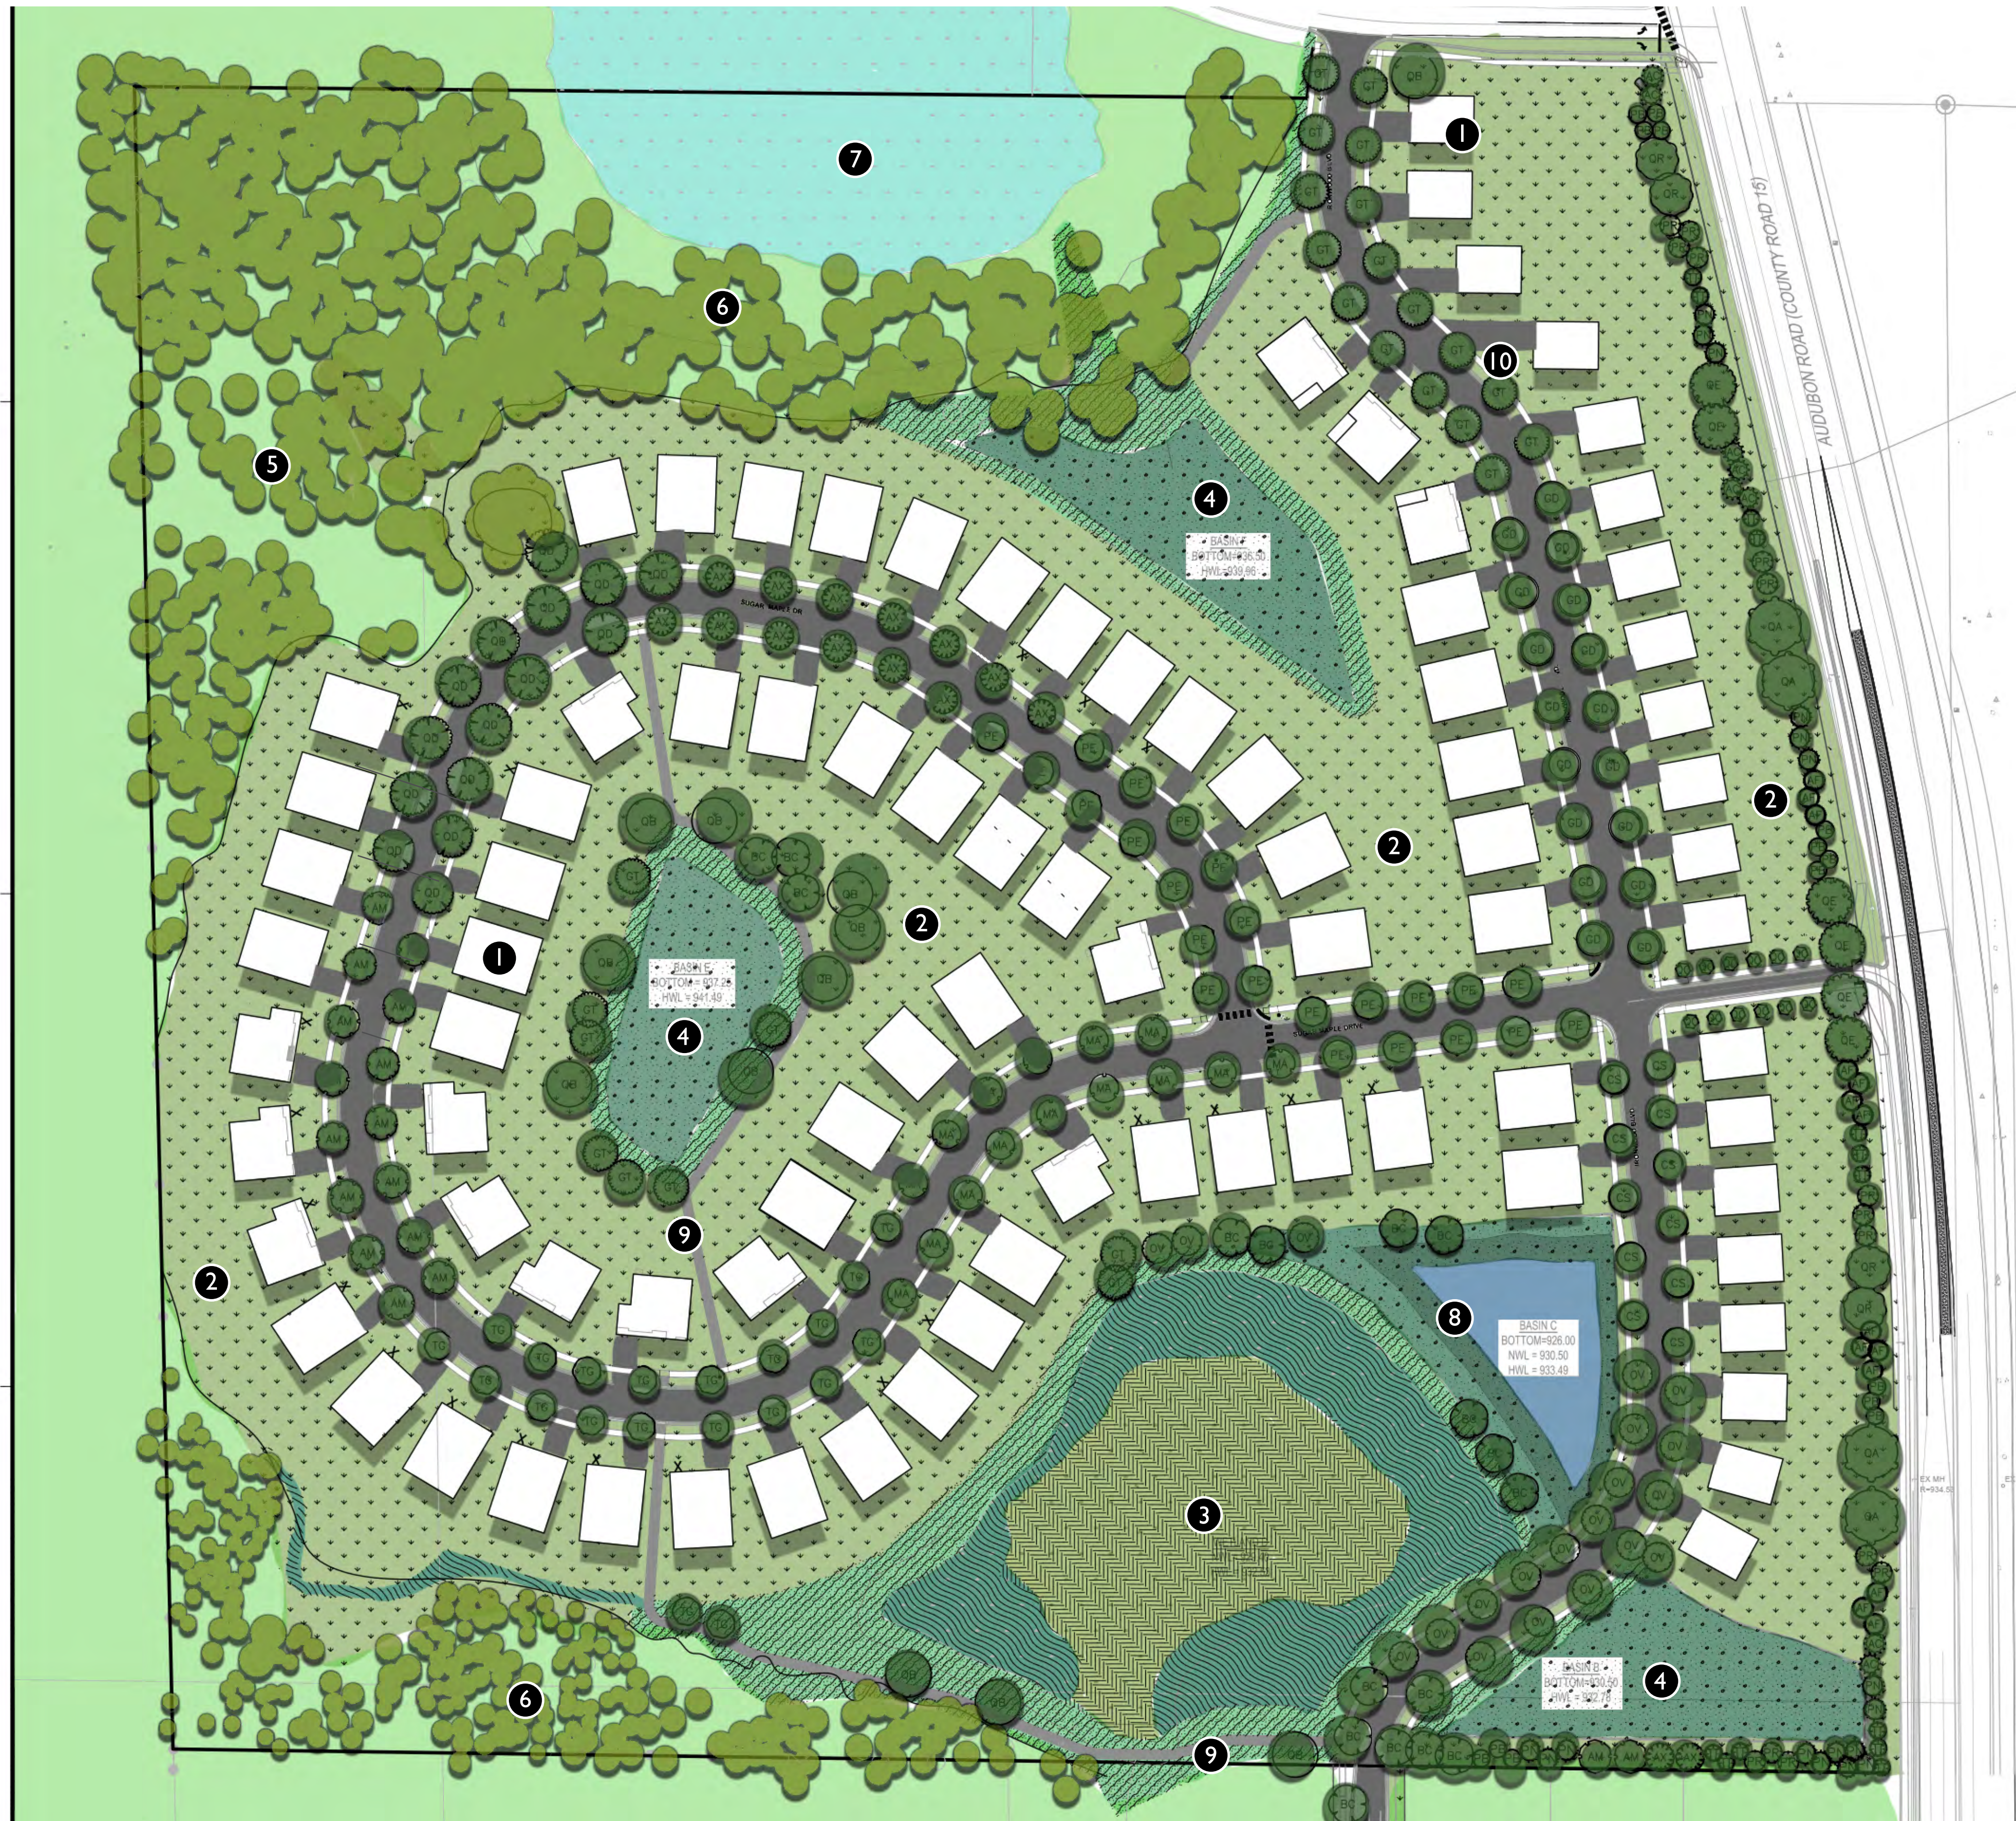
- 1 PROPOSED HOUSING
- 2 LOW MAINTENANCE TURF RESTORATION
- 3 WETLAND RESTORATION AREA
 - » Emergent Wetland Mix (MNDOT 34-181)
 - » Wet Meadow South & West Mix (MNDOT 34-271)
 - » Mesic Prairie General Mix (MNDOT 35-241)
- 4 INFILTRATION BASIN
 - » Stormwater South & West Mix (MNDOT 33-261)
 - » Mesic Prairie General Mix (MNDOT 35-241)
- 5 PROPOSED PARK AREA
- 6 TREE PRESERVATION AREA
- 7 EXISTING WETLAND AREA
- 8 STORMWATER BASIN
- 9 PROPOSED TRAILS
- 10 PROPOSED DRIVEWAYS
- PROPOSED TREES
- EXISTING TREES

Although development of the Wagner property will have impacts for the three smallest wetlands, the two largest wetlands will be preserved or restored as a part of this project. Wetland A, consisting of 1.3 acres onsite and extending offsite, will be preserved. The largest wetland, Wetland D covering 2.5 acres, will be restored both in terms of vegetation and hydrology. Vegetation will be restored by eradicating any invasive species present onsite, installing diverse native seed mixes, and adaptive management to ensure the native vegetation community establishes as planned. Hydrology will be restored by raising the outlet elevation of the wetland, which was historically altered by ditching, as well as by disabling the subsurface drain tile within the basin. An experienced, qualified contractor will work with the developer to ensure the wetland restoration is a success. These two wetlands represent a total of 3.8 acres, over 75% of the total wetland acreage onsite, which will be naturally vegetated following construction. Prior to this project, only 25% of the total wetland acreage onsite existed in a naturally vegetated state.

The stormwater infrastructure will be vegetated with a diverse native seed mix that includes 23 different species. These native plantings will increase the biodiversity onsite and help support wildlife like birds and butterflies. In addition, the native plants once established will have deeper and more extensive root systems than non-native species that prevent erosion while also further enhancing the infiltration rates and filtration and nutrient uptake within these stormwater features.
