Creek Restoration Action Strategy – Upper Riley Creek Sediment Source Assessment

Chanhassen, MN

Prepared for
Riley Purgatory Bluff Creek Watershed District

April 2017

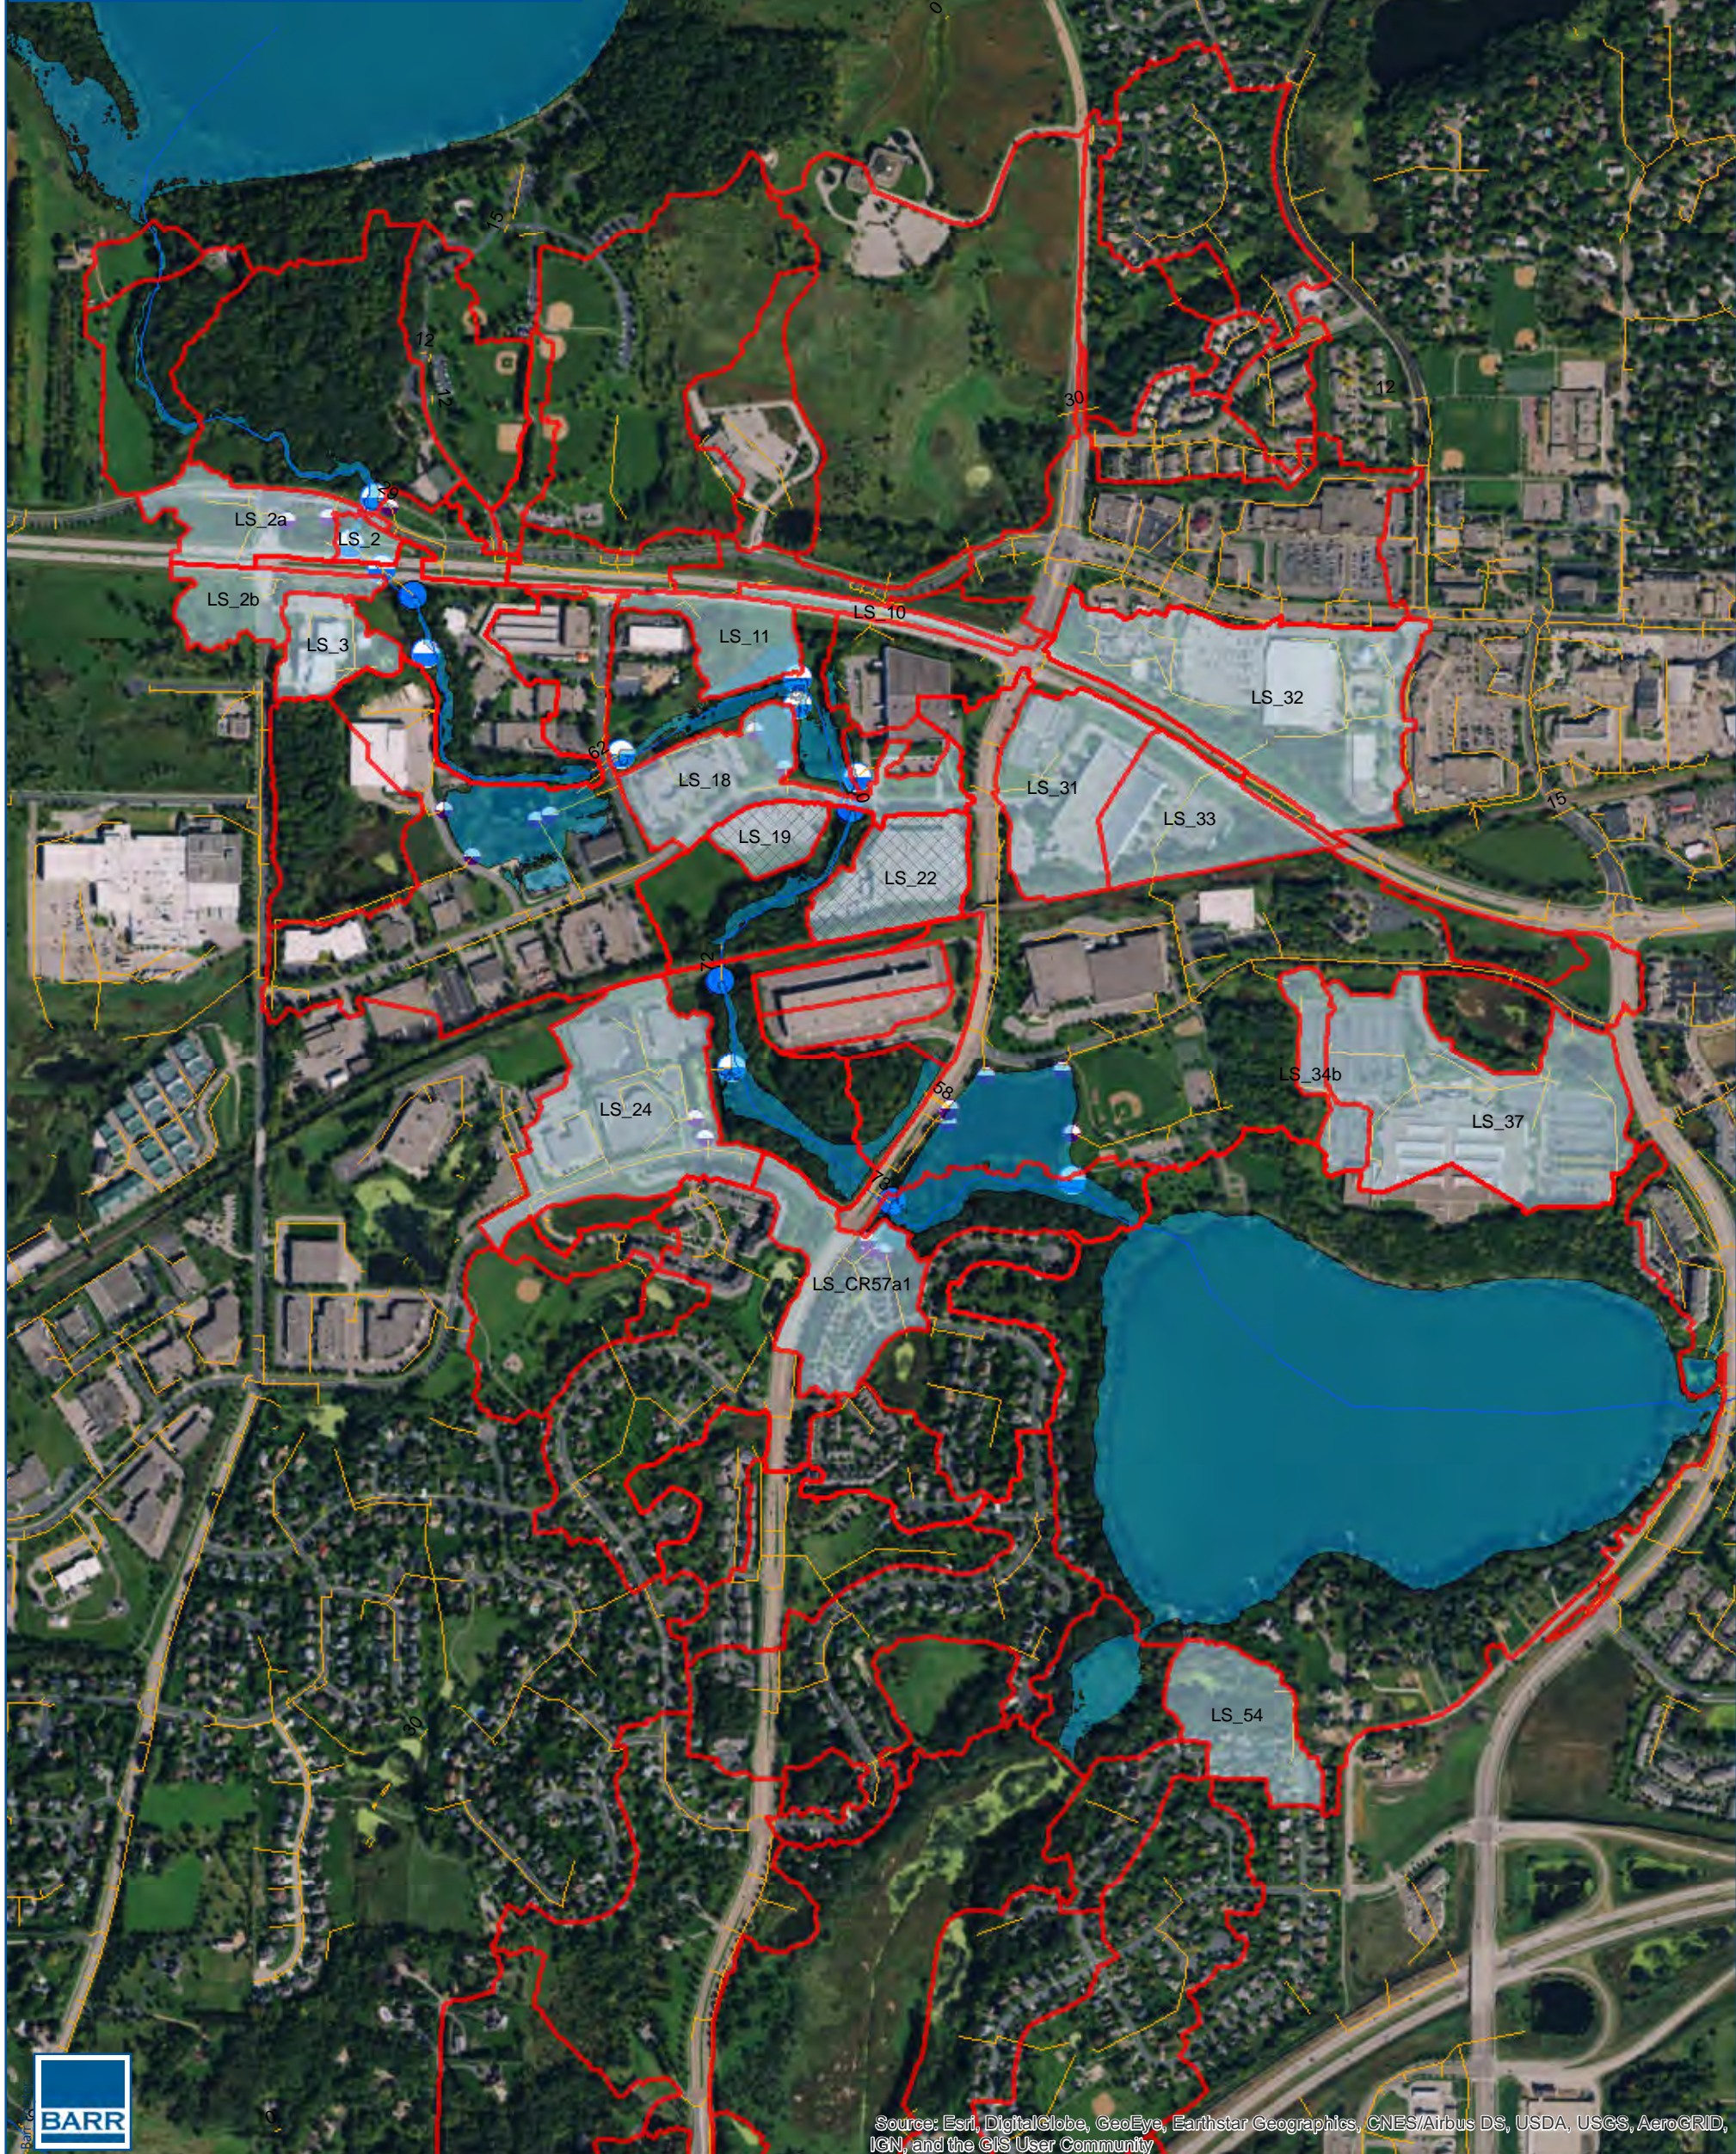
FIGURE 2-2

UPPER RILEY CREEK
WATERSHEDS WITH
MINIMAL TREATMENT
Riley Purgatory Bluff Creek
Watershed District

A P8 model, originally developed by Wenck Associates, Inc for RPBCWD and modified for the TMDL analysis (Reference (2)) was used for this study to highlight areas of minimal detention. Watersheds that reduced the runoff peak by less than 20% are highlighted on Figure 2-2. Many of these watersheds discharge runoff directly to Riley Creek with no detention or include ponds with minimal detention.

Many developments within this subwatershed appear to lack BMPs that meet minimum current requirements as many ponds were identified as being undersized. Undersized ponds are unlikely to effectively reduce peak flows or sufficiently remove sediment in stormwater runoff. Two watersheds with minimal total suspended solids removal are highlighted in Figure 2-2.

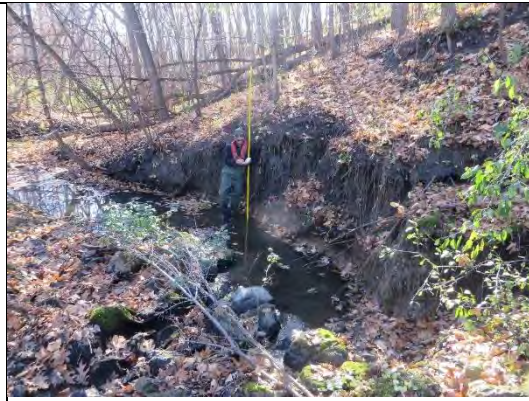
IMG-0184
Erosion on
right bank,
2m x 5m

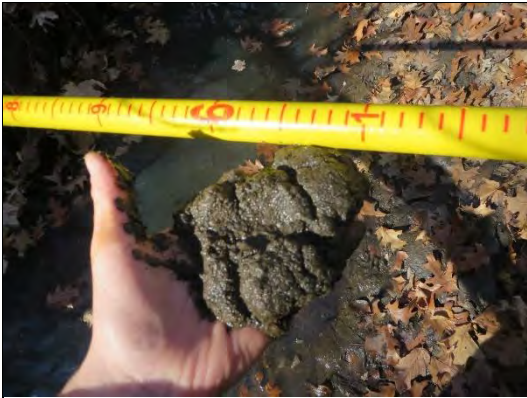
IMG-0189
Pool substrate, predominantly sand/silt

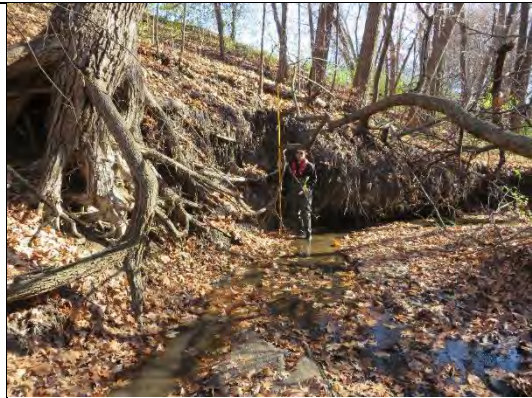
IMG-0190
Outside bend erosion on left bank, 2.3m x 10m

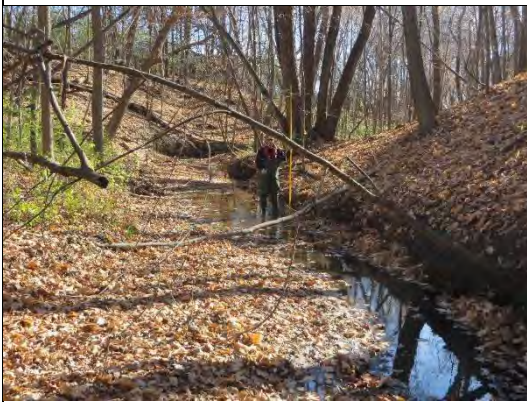
IMG-0191
Right bank erosion, 0.5m

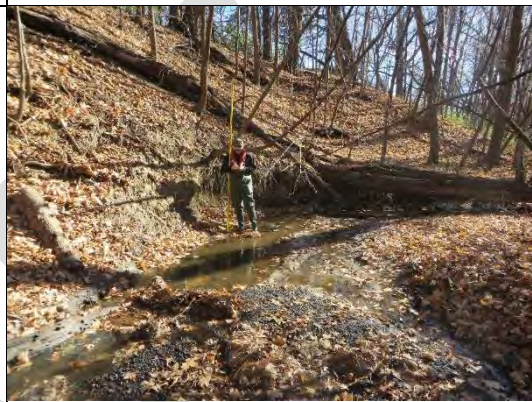
IMG-0192
Outside bend erosion of left bank, 1.6m x 4m

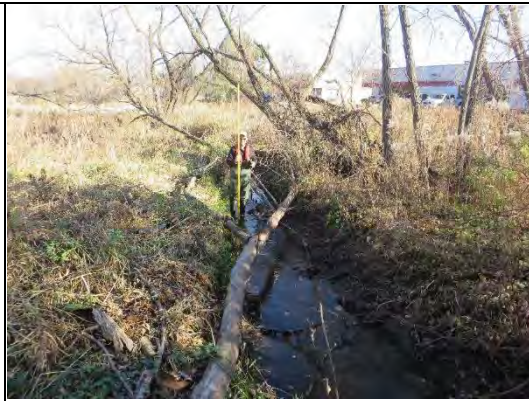
IMG-0205
General stream pic, sparse woody debris

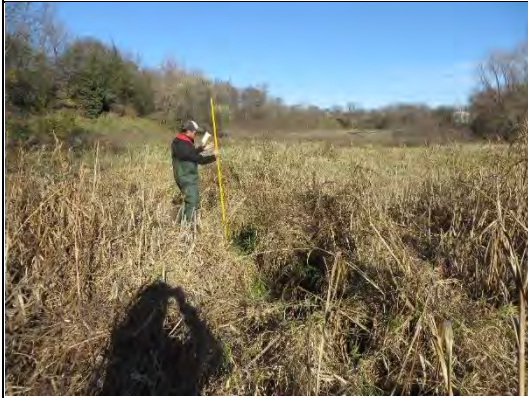
IMG-0206
Dense herbaceous vegetation and graminoids; some cattails present

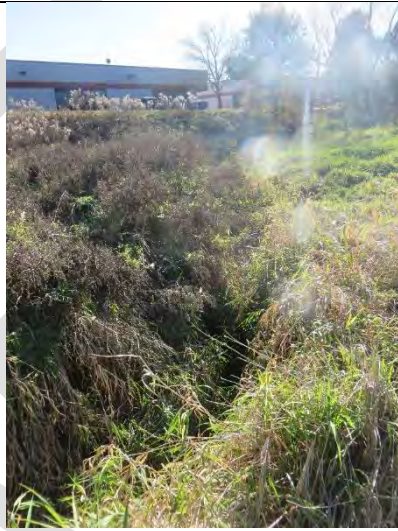
IMG-0207
Tributary from business park within 25m of left bank

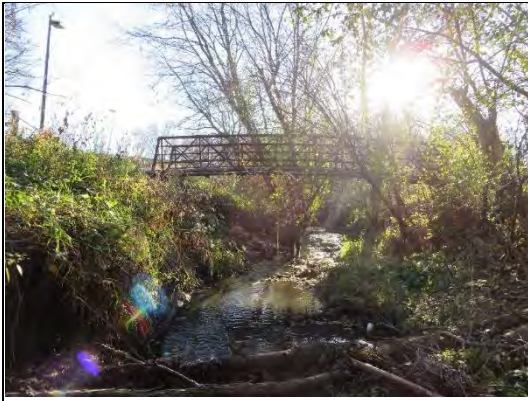
IMG-0223
Woody debris dam and IWOC bridge

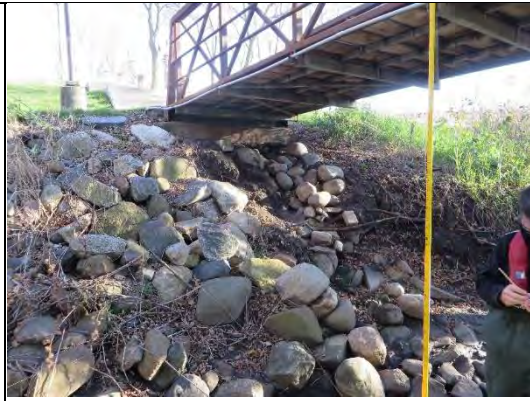
IMG-0224
Boulders under IWOC bridge left bank

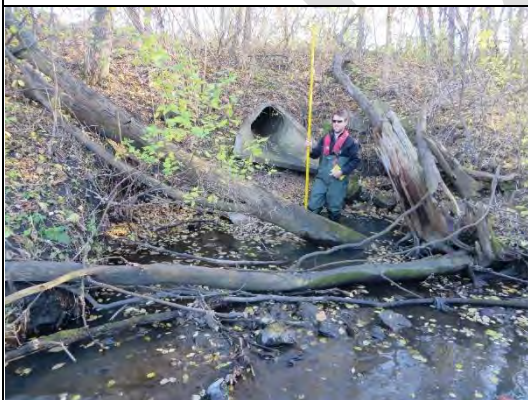
in 2014, the erosion was observed to be much more severe. After the bridge, staff observed more incising, about 1-1.5m along both banks (IMG_0227). Another large silt deposit was seen in the middle of the stream in IMG_0227, as well as silt deposition along the left bank and heavy woody debris in the background. From here the channel widened and formed a glide for a long stretch. The channel bankfull dimensions were estimated at 3.6m by 1m deep (IMG_0228) with current conditions at 2.7m by 0.3m deep. Staff soon encountered more heavy woody debris and small downed trees in front of a stormwater culvert (which was undercut 0.8m) along the left bank (IMG_0229).

IMG-0229
Stormwater culvert on left bank, undercut 0.8m.

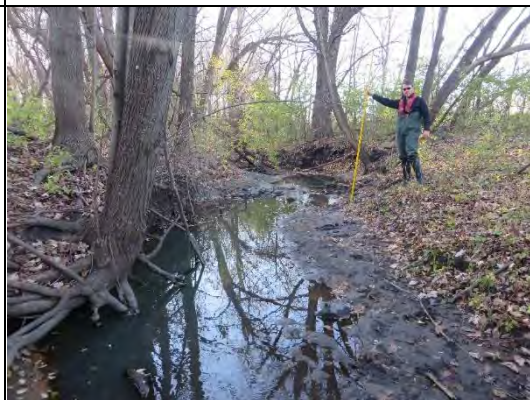
IMG-0230
General stream photo; deposition along channel

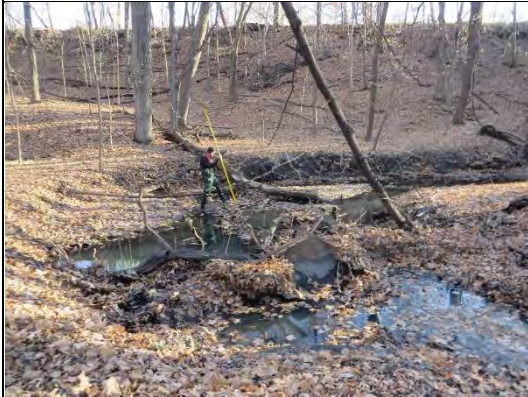
IMG-0235
Woody debris and silt/sand deposition

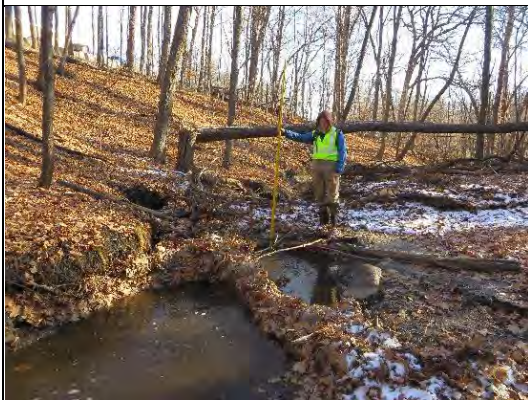
IMG-0242
Woody debris and leaf litter

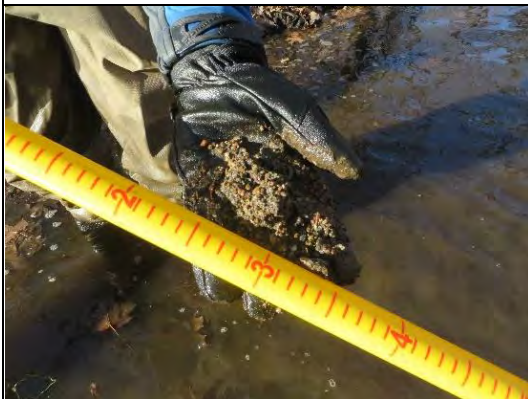
IMG-0246
Sediment is 50/50 sand/silt

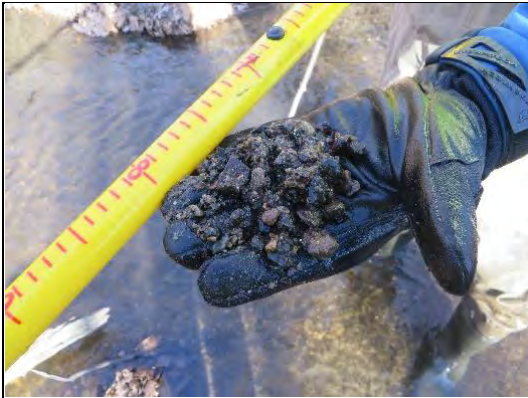
IMG-0254
Gravel and sand in a riffle

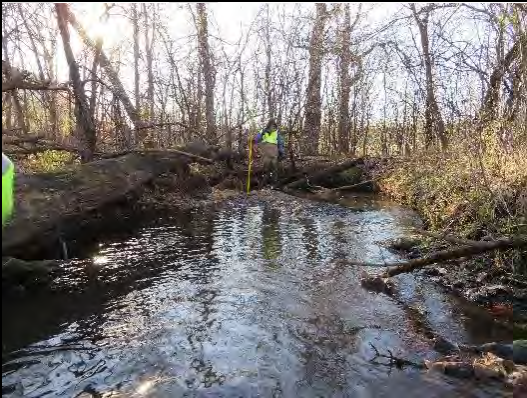
IMG-0260
Woody debris and gravel deposition bar

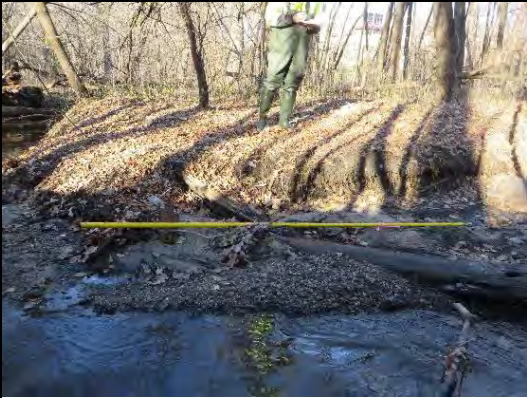
IMG-0262
Large deposition area on left bank, 3.5 m long

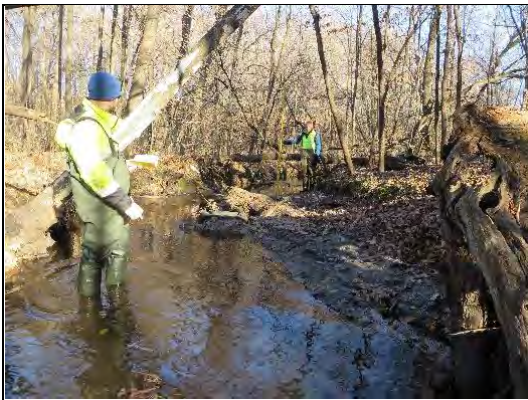
IMG-0264
Large stretch of deposition along right bank, 6m long

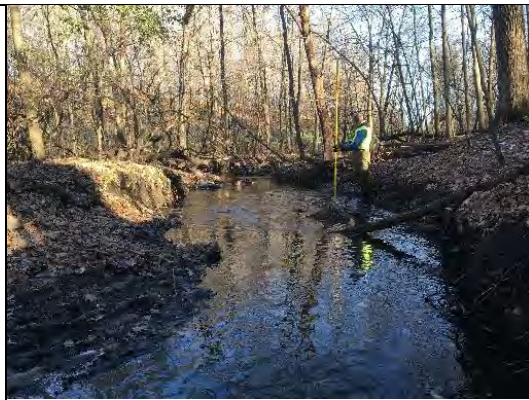
IMG-0296
Stream is incised 0.5 to 0.6m

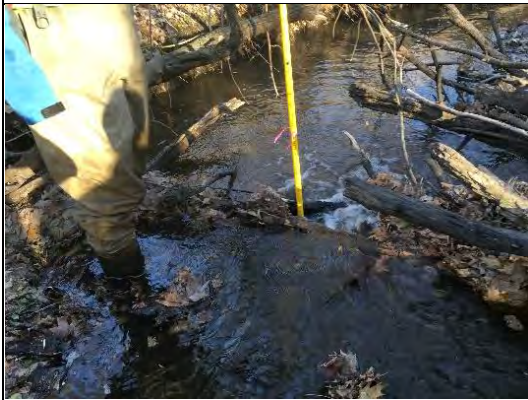
IMG-0300
Woody debris dam holding back about 0.3m of water

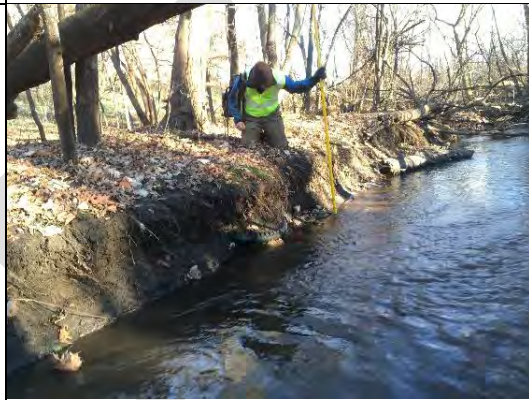
IMG-0304
Consistent cutting along left bank, about 0.7m high

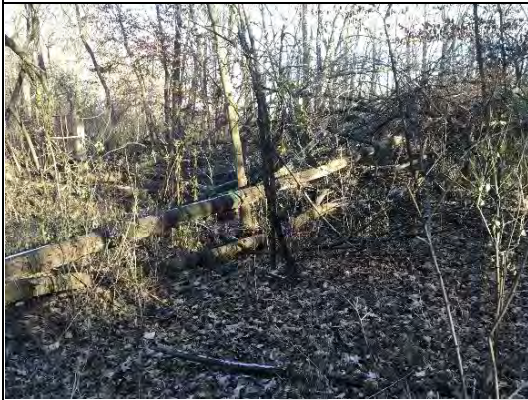
IMG-0306
Downed trees adding to woody debris

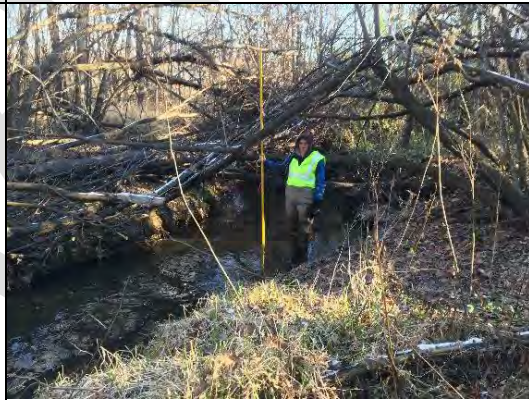
IMG-0309
Dense woody debris/downed trees above stream

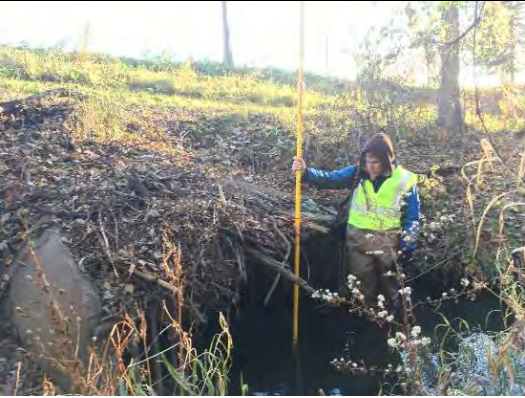
<p>IMG-0315</p> <p>Culvert under Powers Blvd; debris buildup</p>		
--	---	--	--

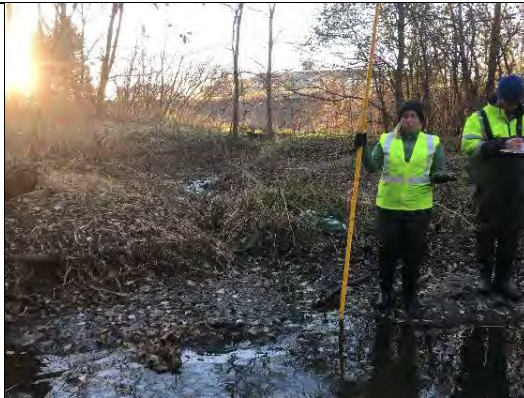
IMG-0317

Drainage eroding a channel and entering stream on the right bank

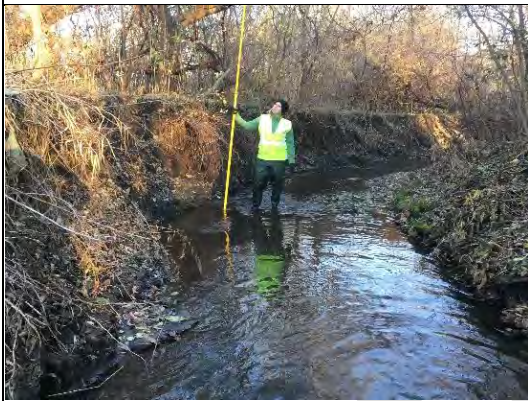
IMG-0319

Erosion along the left bank, 1.5m tall by 20m long

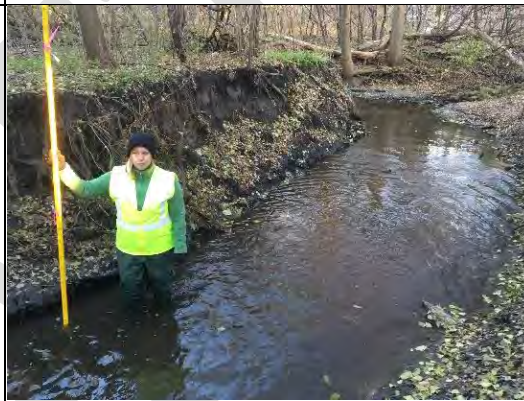
IMG-0320

Continuous erosion along left bank increased to 1.8m tall

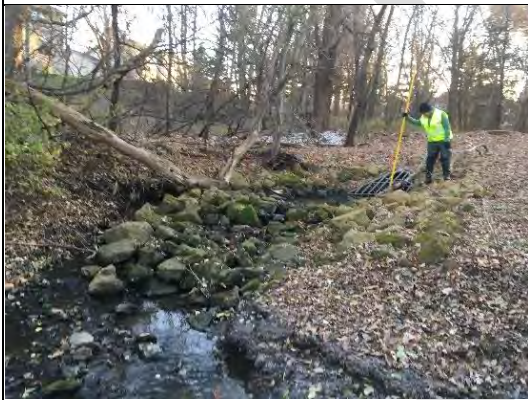
IMG-0321

Stormwater culvert on right bank; boulders at culvert

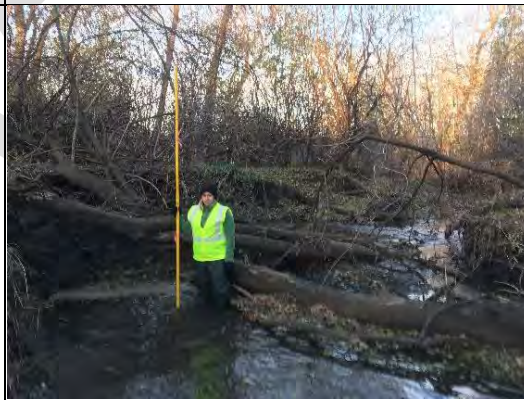
IMG-0323

Heavy woody debris and downed trees; continued erosion along left bank

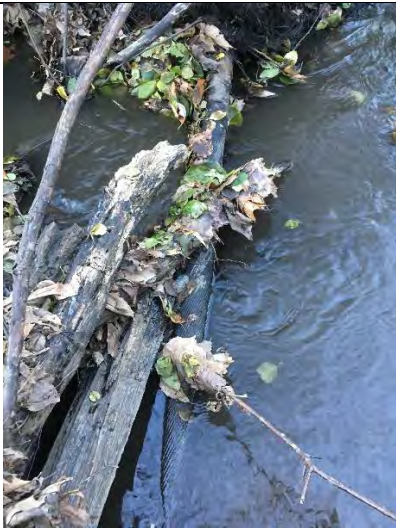
IMG-0330

Metal pipe/cable about 3 inches in diameter across channel

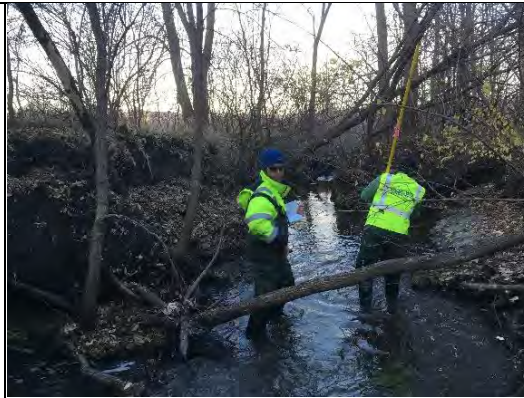
IMG-0331

Major bank sloughing and severely incised channel

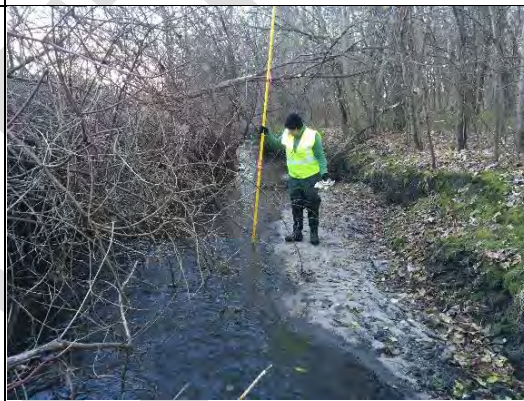
IMG-0333

Sandy/silt deposition along right bank; some evidence of bank sloughing on right bank

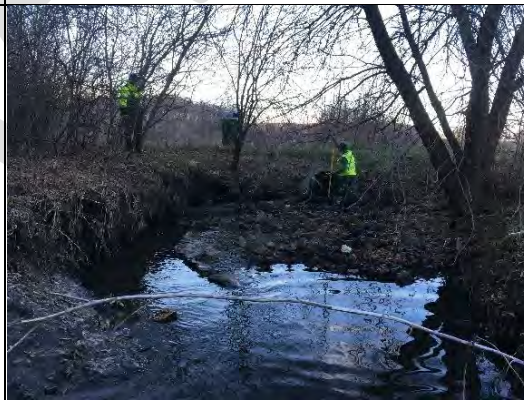
IMG-0335

The creek soon came to the Lake Susan Park Pond outlet located on the left bank (IMG_0335). The channel to the stream had significant erosion occurring and the culvert was undercut 0.2 m (IMG_0335). From Lake Susan Park Pond the stream remained a glide, widened, deepened, and became more straight. (IMG_0336 & IMG_0338). Herbaceous vegetation increased (patchy-dense) on the left bank; on the right bank, vegetation was a mixture of moderately dense woody and herbaceous vegetation. Staff observed some drainage forming a channel along the left bank which was suspected to be stormwater from Lake Susan Park. Soon after the drainage channel, the Creek

Culvert draining LSPP into the creek, undercut 0.2m; left bank

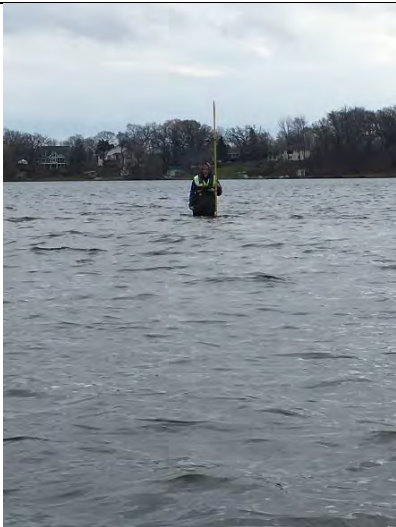
2m in height. Evidence of some bank sloughing was found across both reaches however R4E was considerably worse. At the end of R4E, there was also evidence of heavy deposition from the creek as seen by the delta extending 30m into the lake.

IMG-0342
Sand/silt deposition creating delta projecting about 30m into Lake Susan
